COMMONWEALTH OF KENTUCKY
BEFORE THE PUBLIC SERVICE COMMISSION

DUKE ENERGY KENTUCKY, INC.)	
_____)	
ALLEGED FAILURE TO COMPLY WITH)	CASE NO. 2014-00165
KRS 278.042)

ACCIDENT INVESTIGATION STAFF REPORT

Accident Location: 5940 Lieberman Road, Covington, Kentucky

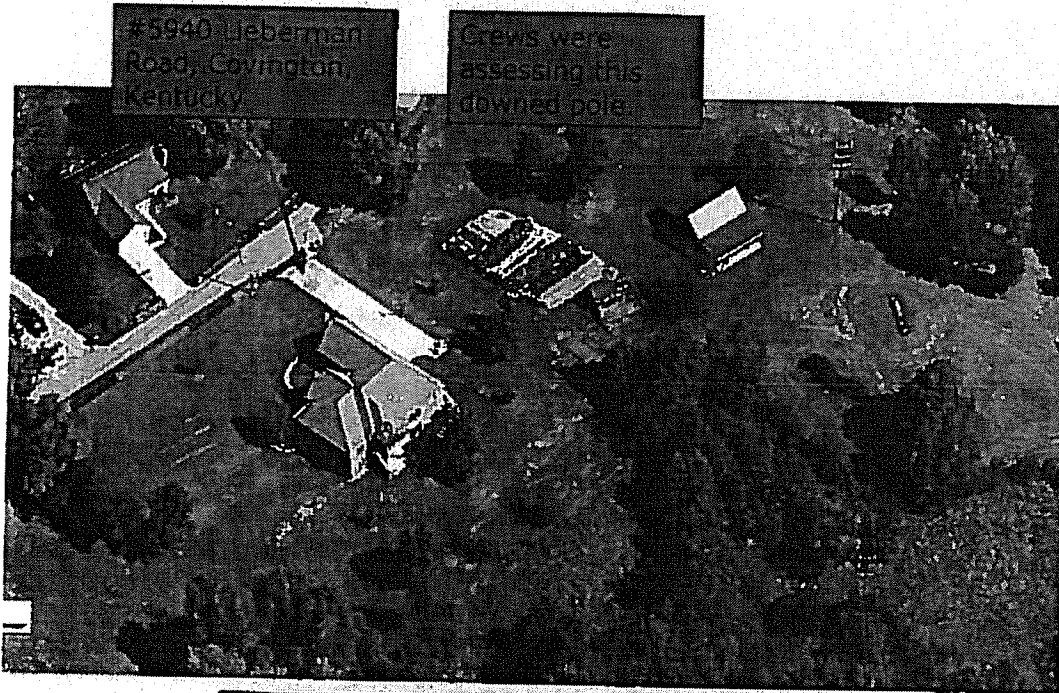
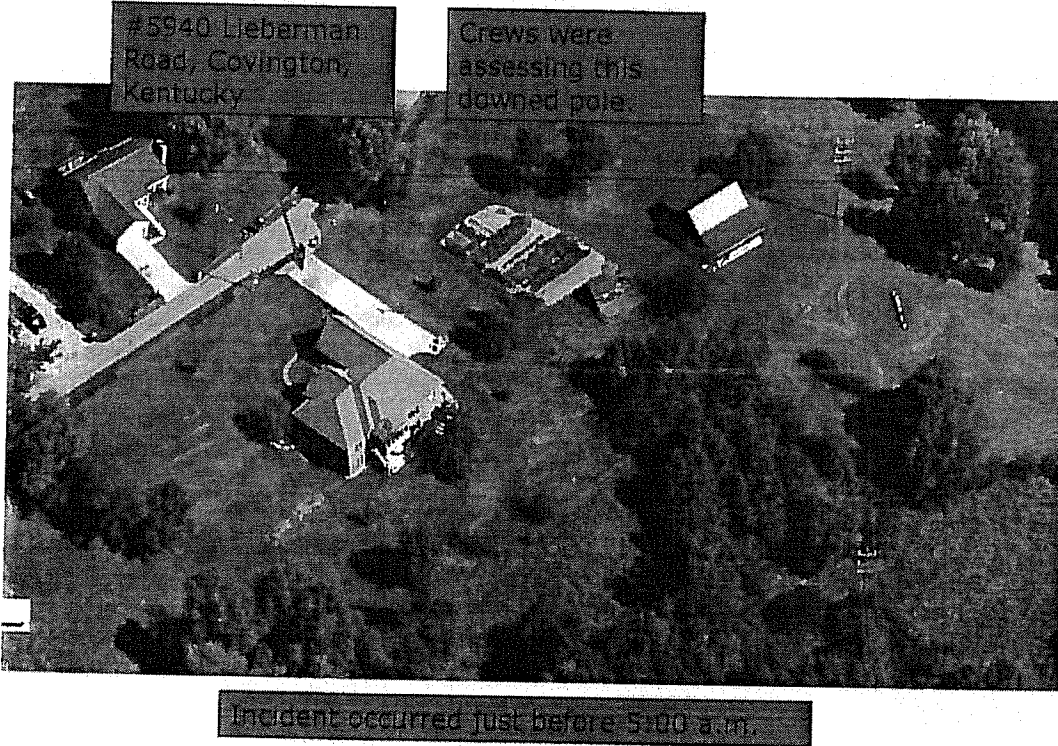
Exhibit A

Incident location prior to 5:00 a.m.

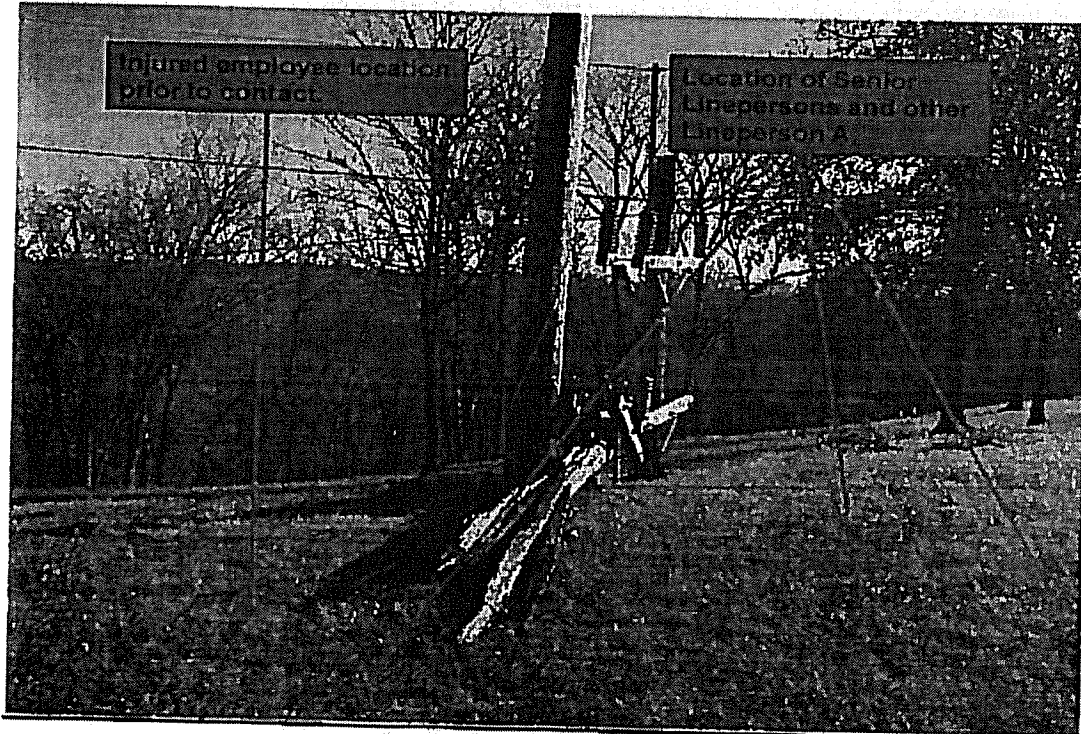
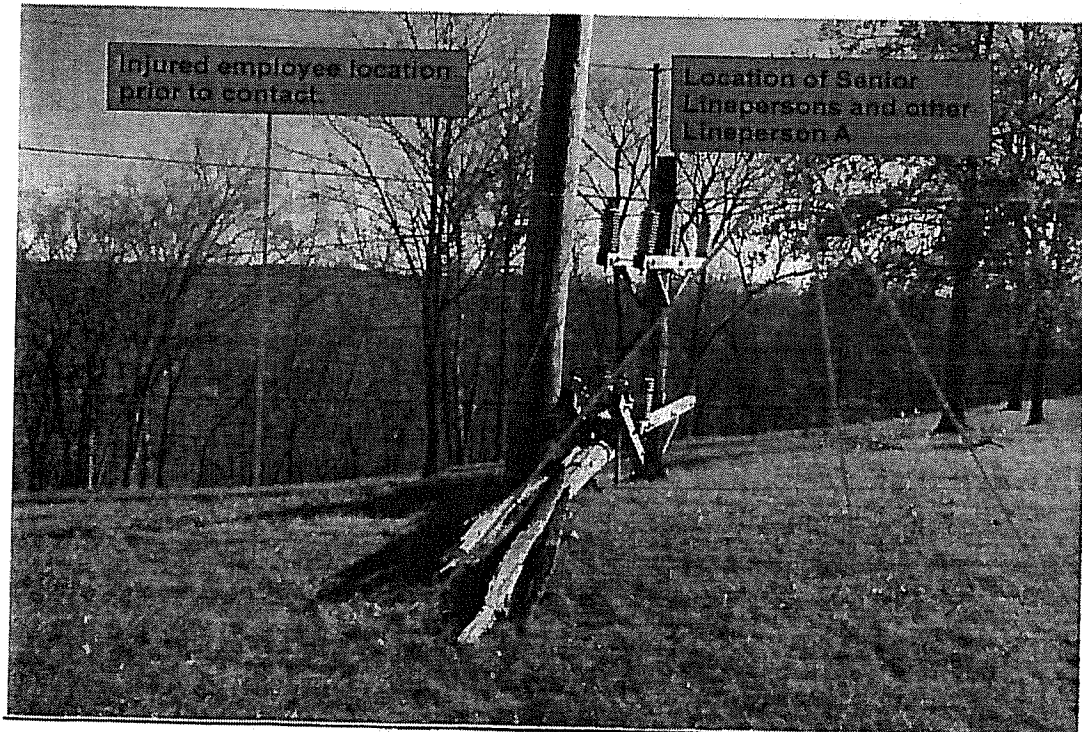
Exhibit B

Both crews met at 5940 Lieberman Road in Covington, Kentucky and walked down to assess the damage. The crews stopped approximately 12 to 14 feet from nearest conductor and discussed the possibility of induced voltage from an O.V.E.C line crossing circuit 5967 2 spans down. There was no isolation, there were no grounds, and everything was considered energized. The crew then directed their attention to identifying what materials were needed for repairs, and how to access the broken pole with equipment. After they were finished with assessing the damage, all crew members turned away from the damage and proceeded toward their trucks to report their findings to the Distribution Control Center to await further instructions. This was approximately 5:00 a.m. on November 18, 2013. Three of the crew members heard and saw a flash over their shoulders. As they turned, they saw one Lineperson A involved in the flash. The three crew members quickly determined the injured employee was clear of the conductors, and then they pulled the injured employee further from the conductors. One crew member called 911 while the others restrained the injured employee who was trying to get up. EMS arrived on scene within 10 minutes of the call and transported the injured employee to University Hospital in Cincinnati, Ohio.

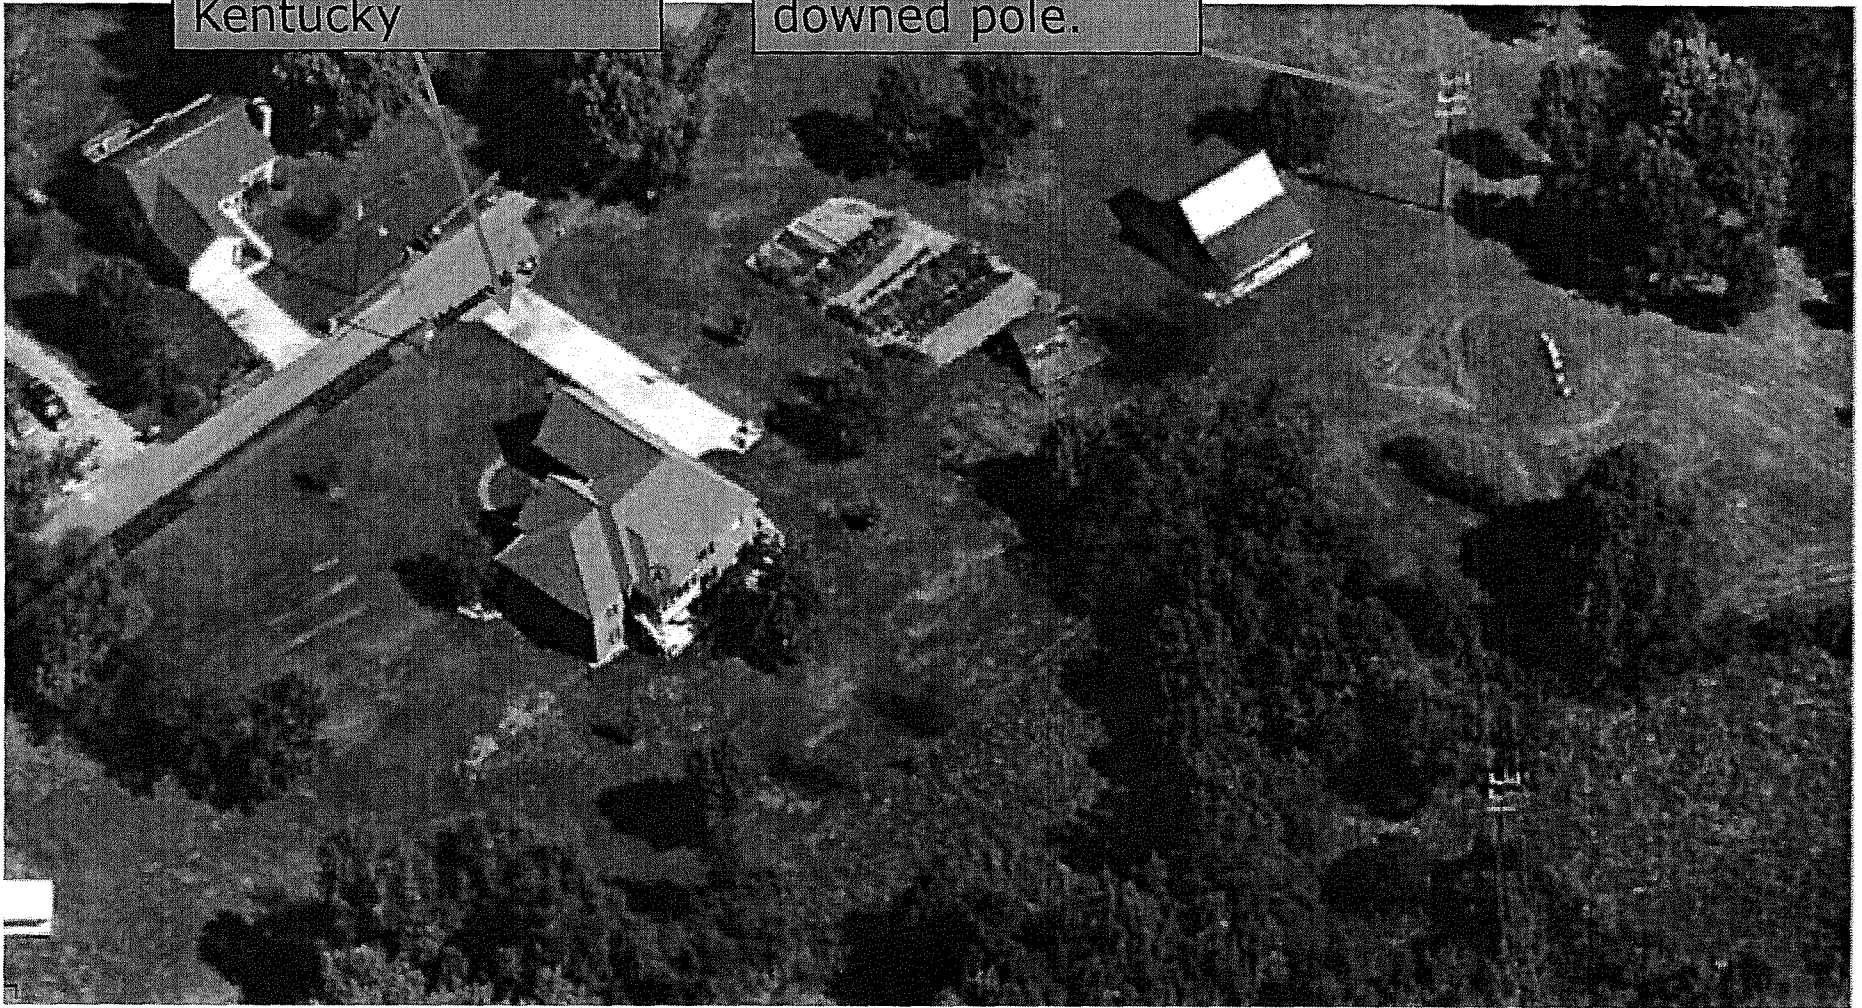
#5940 Lieberman
Road, Covington,
Kentucky

Crews were
assessing this
downed pole.

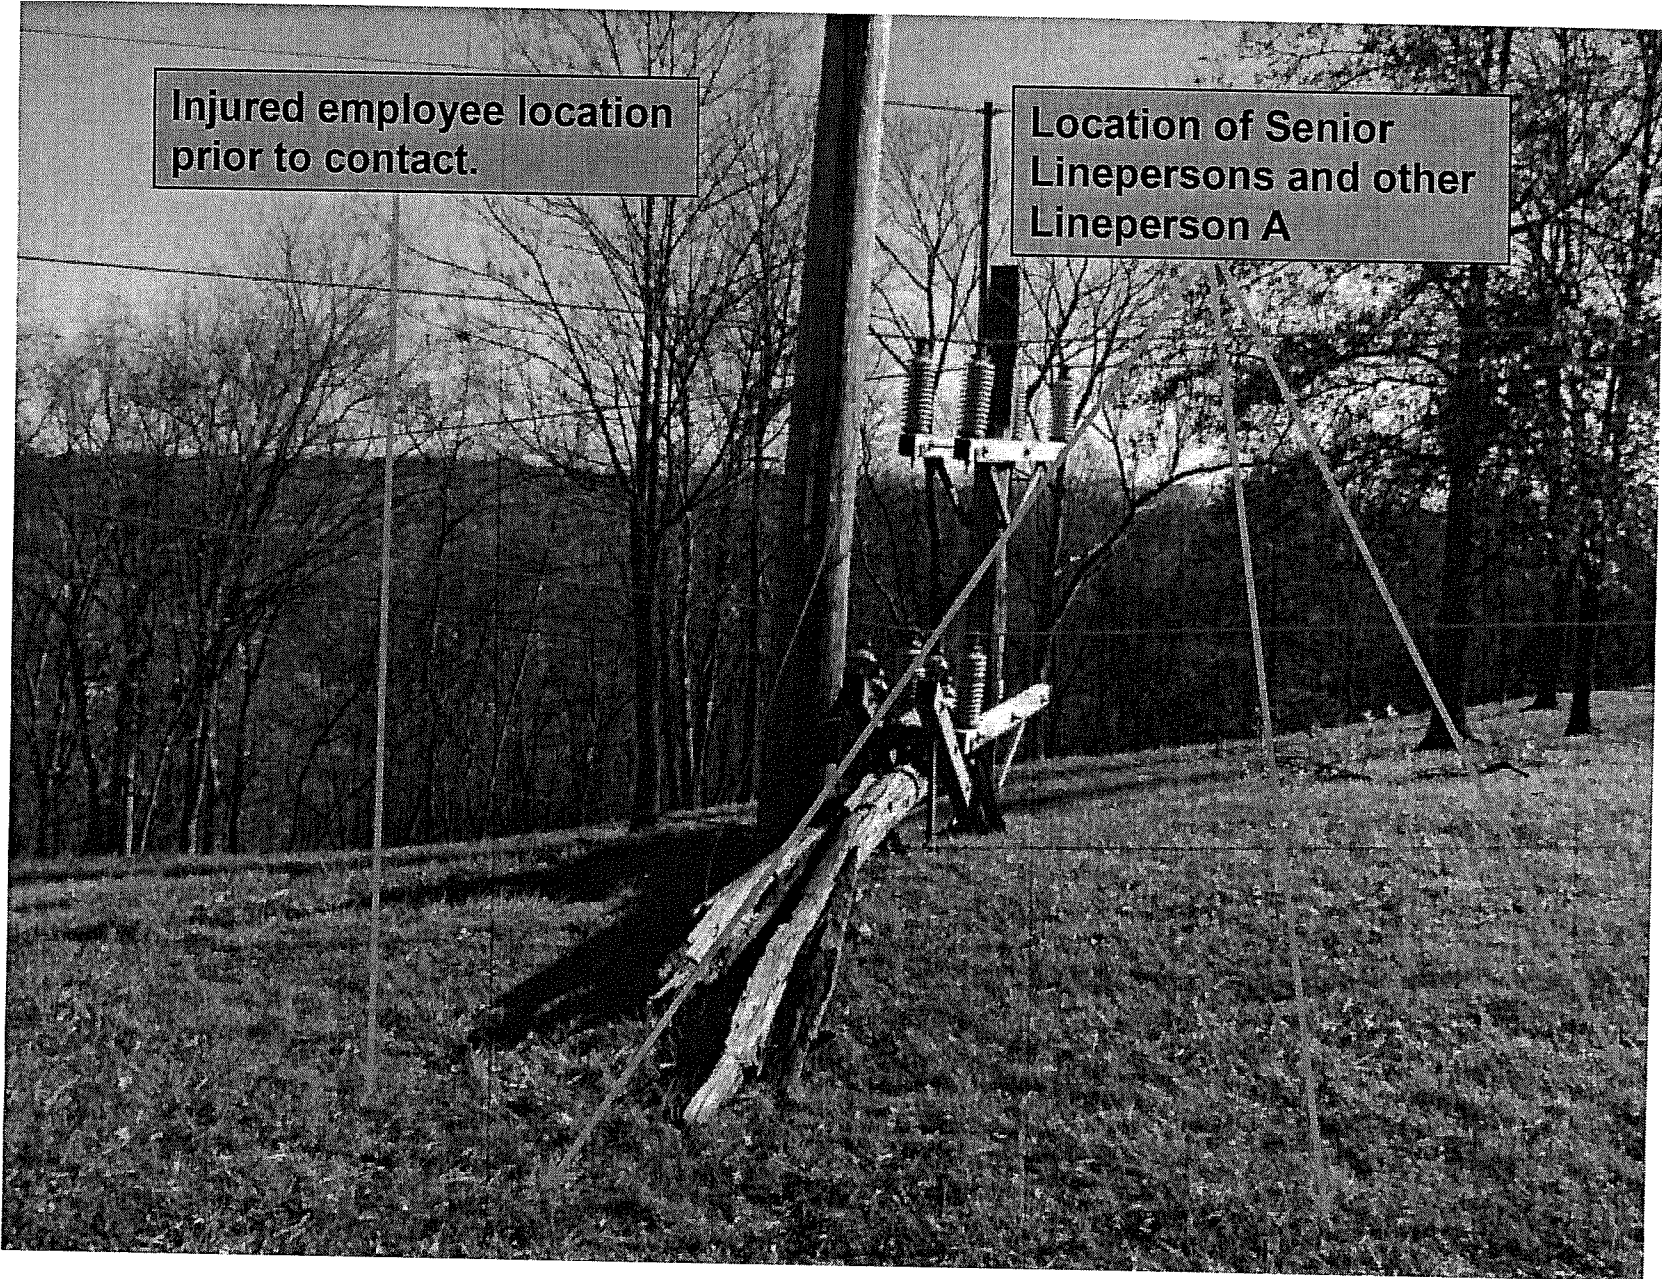
**Injured employee location
prior to contact.**

**Location of Senior
Linepersons and other
Lineperson A**

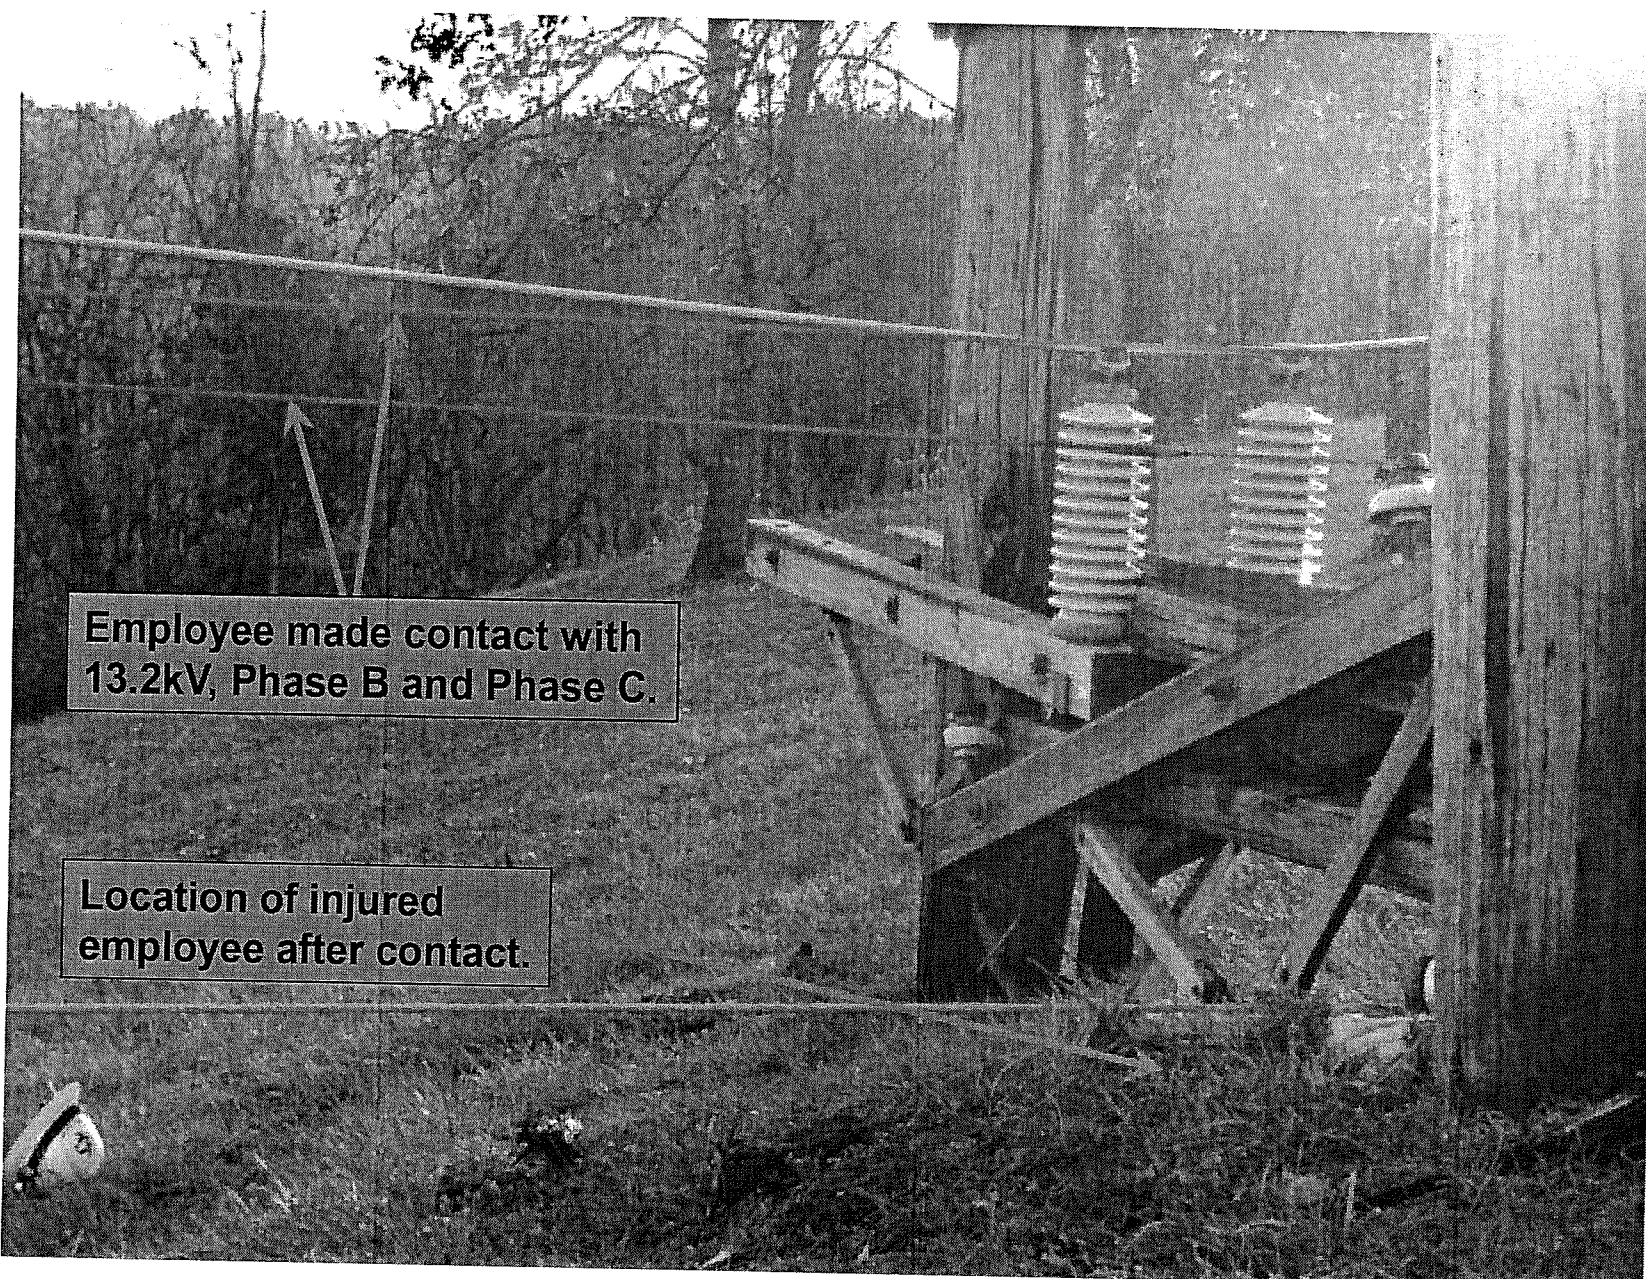
Crews were approximately 12' – 14' from energized conductors while assessing damage.

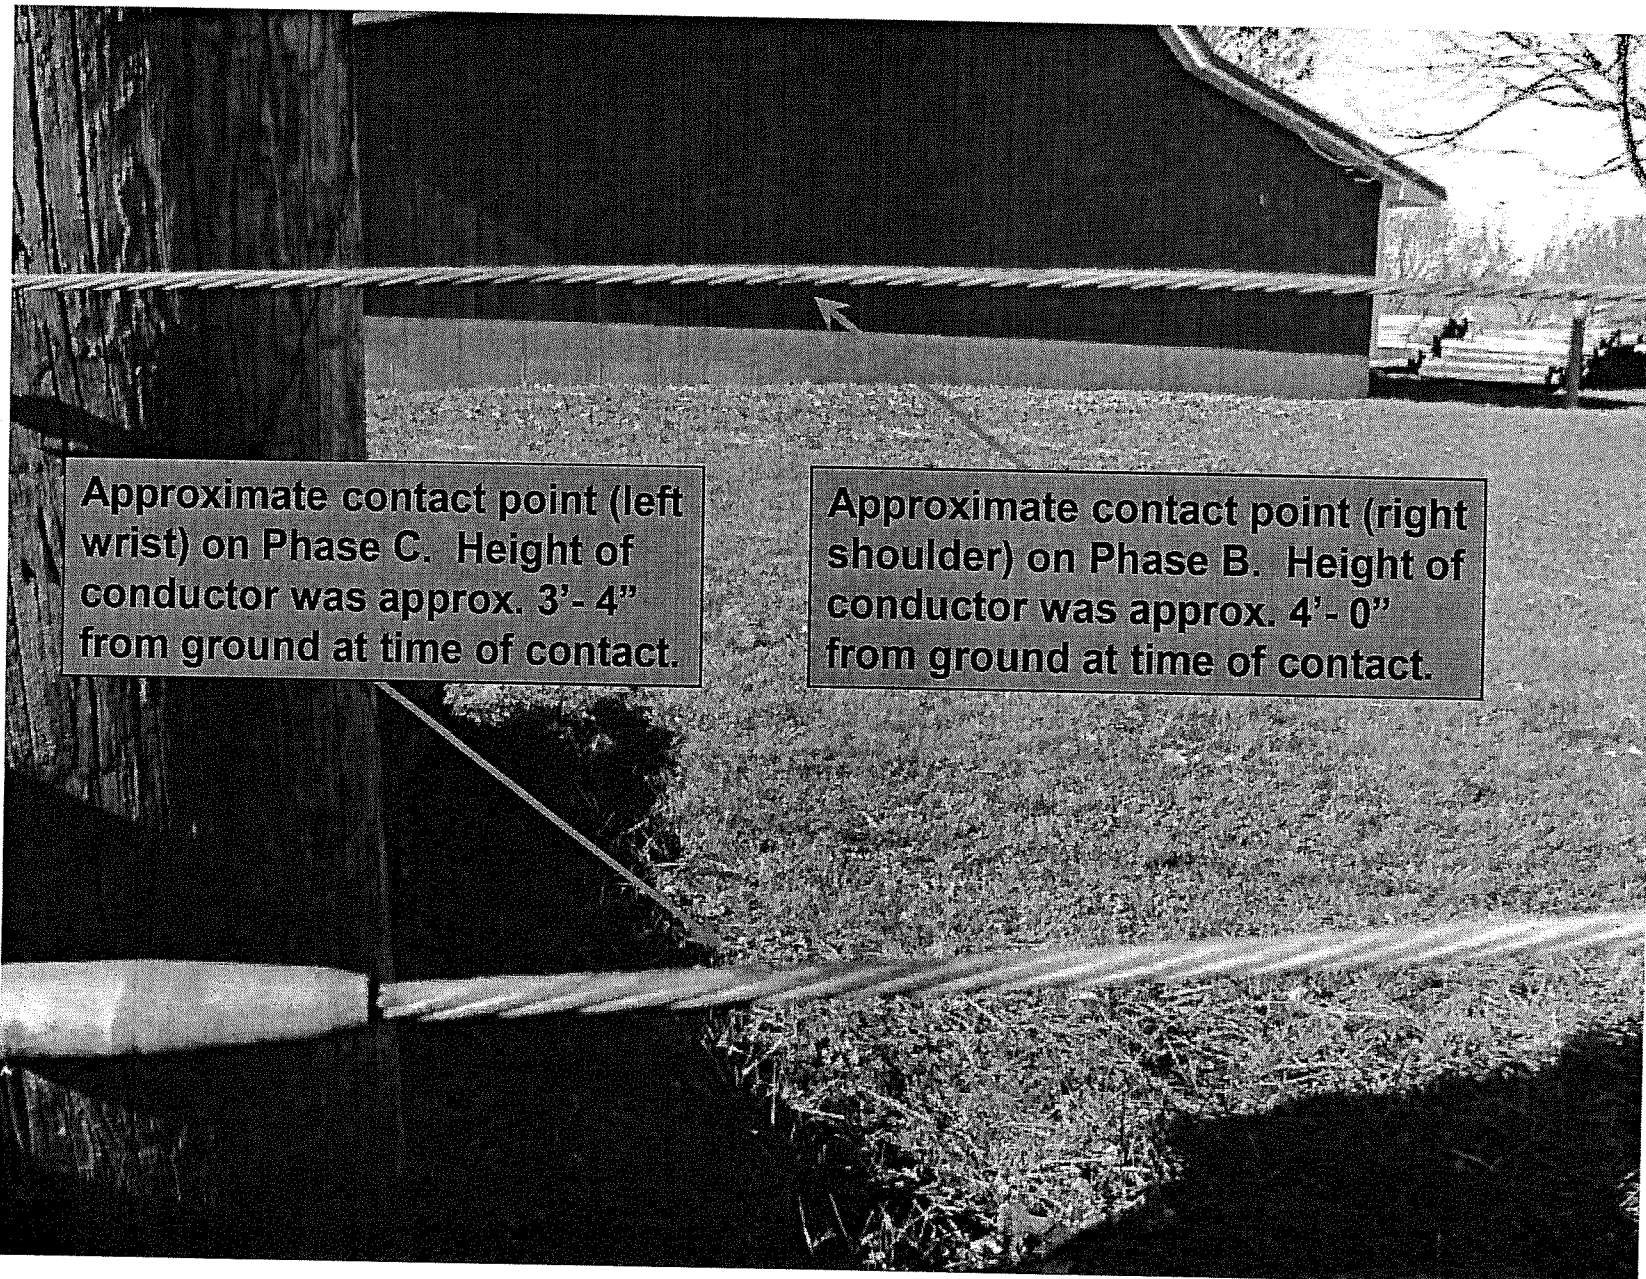
Employee made contact with 13.2kV, Phase B and Phase C.

Location of injured employee after contact.

Approximate contact point (left wrist) on Phase C. Height of conductor was approx. 3'-4" from ground at time of contact.

Approximate contact point (right shoulder) on Phase B. Height of conductor was approx. 4'-0" from ground at time of contact.

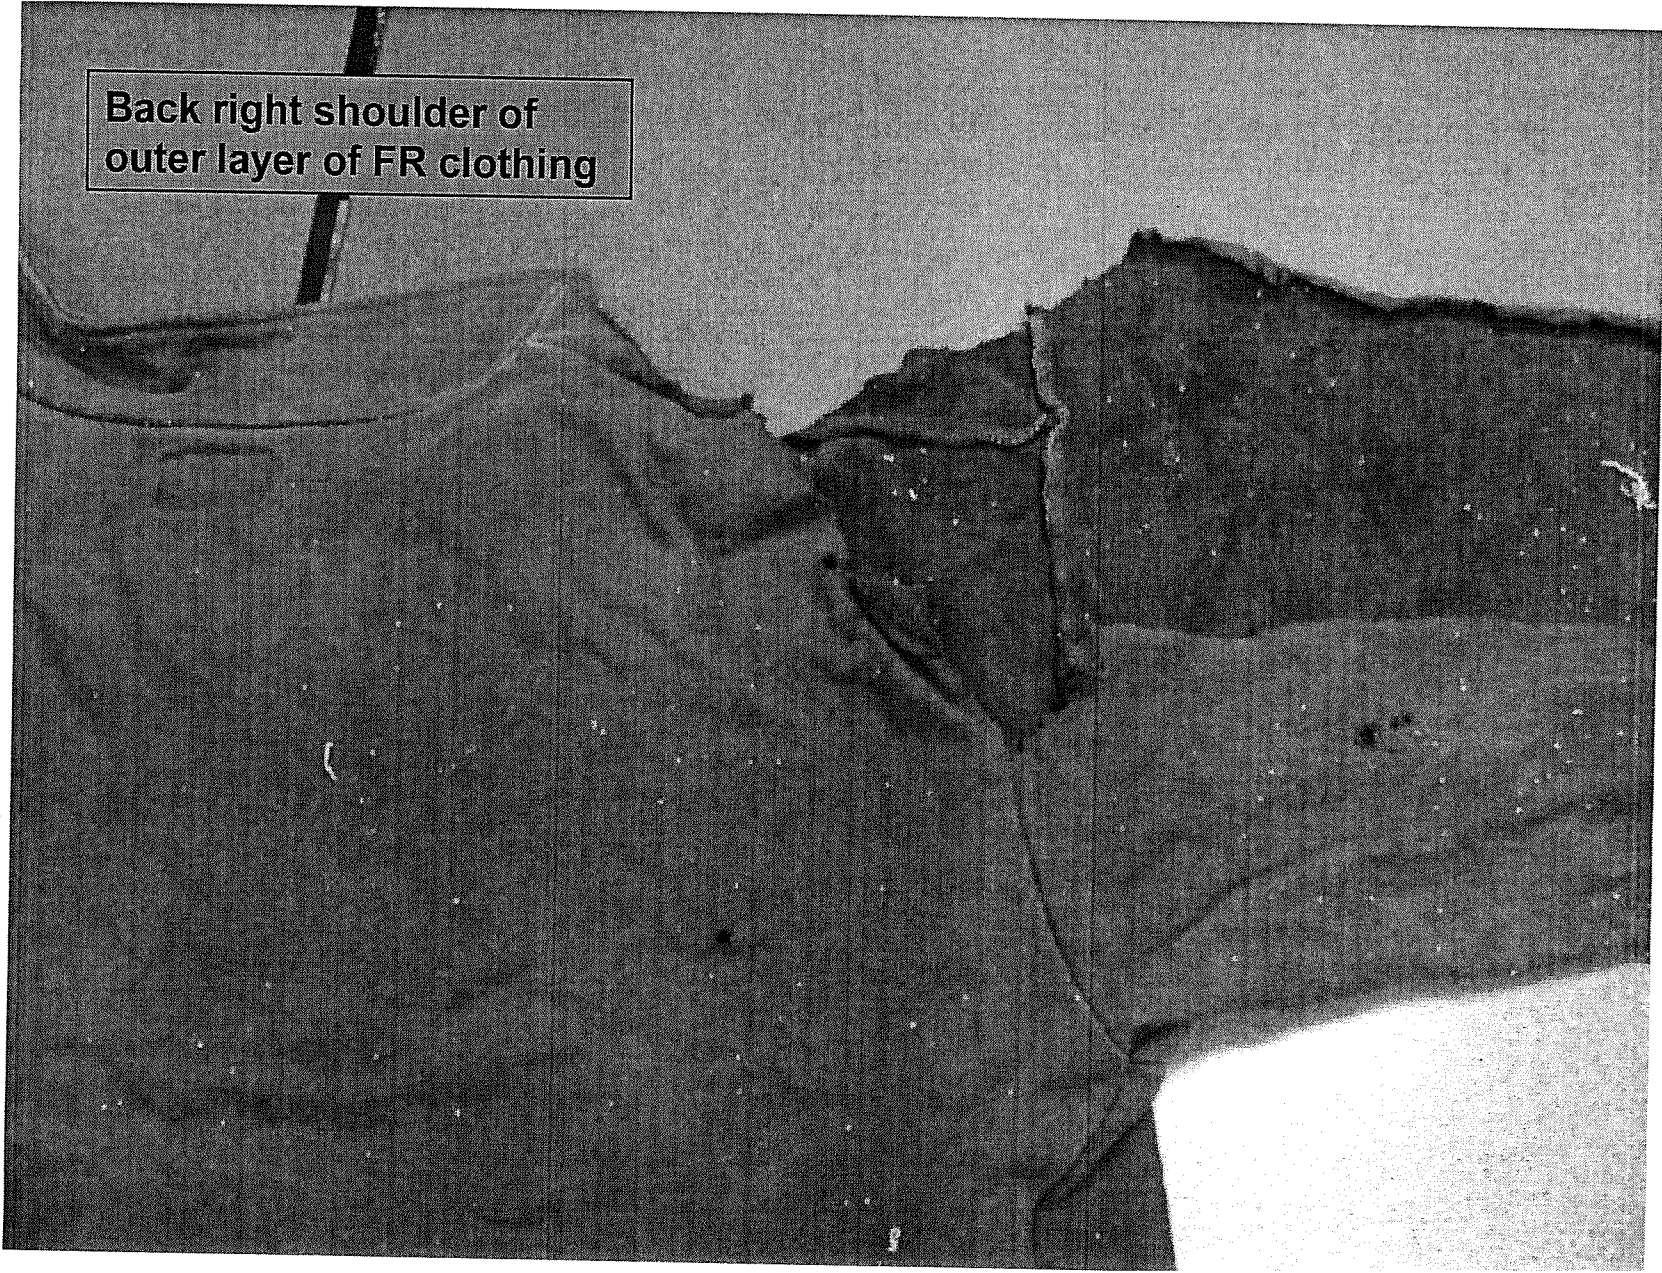
Back right shoulder of
outer layer of FR clothing

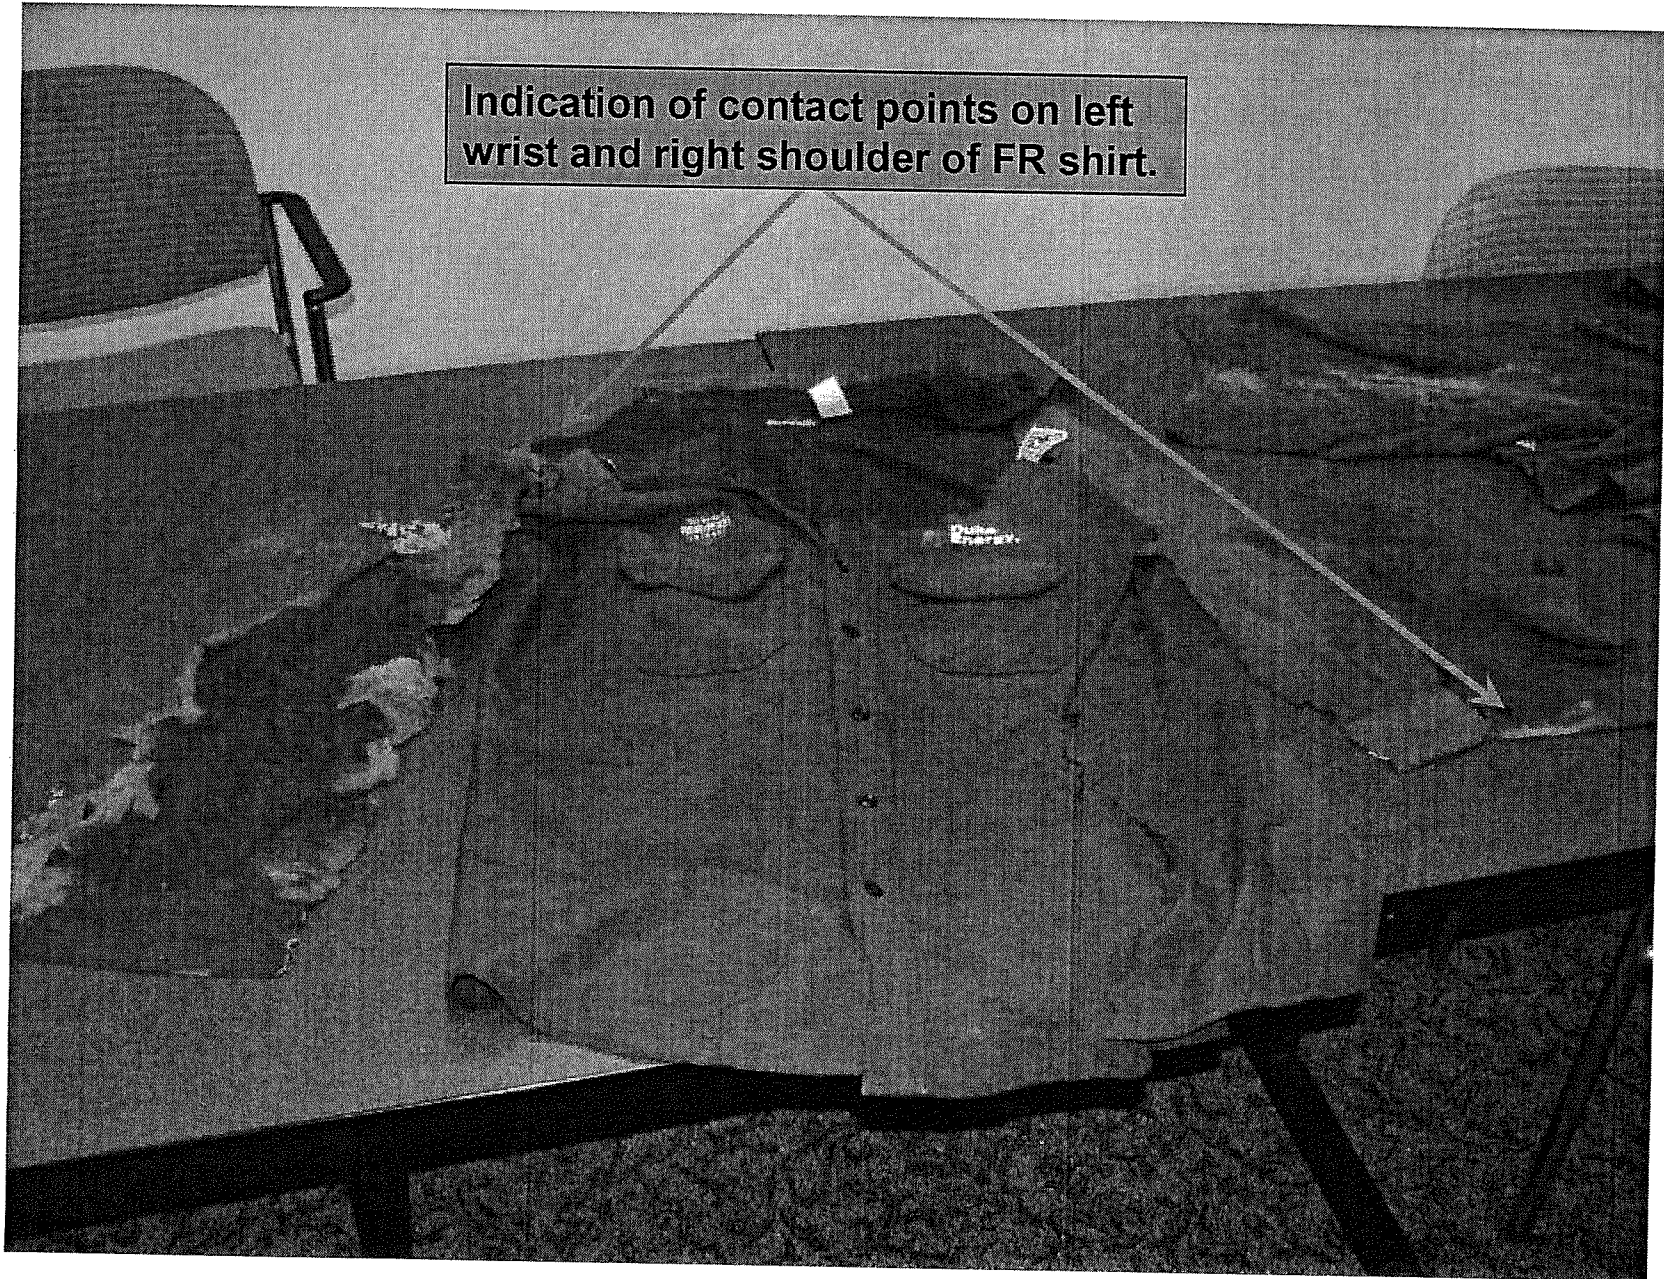
Indication of contact points on left wrist and right shoulder of FR shirt.

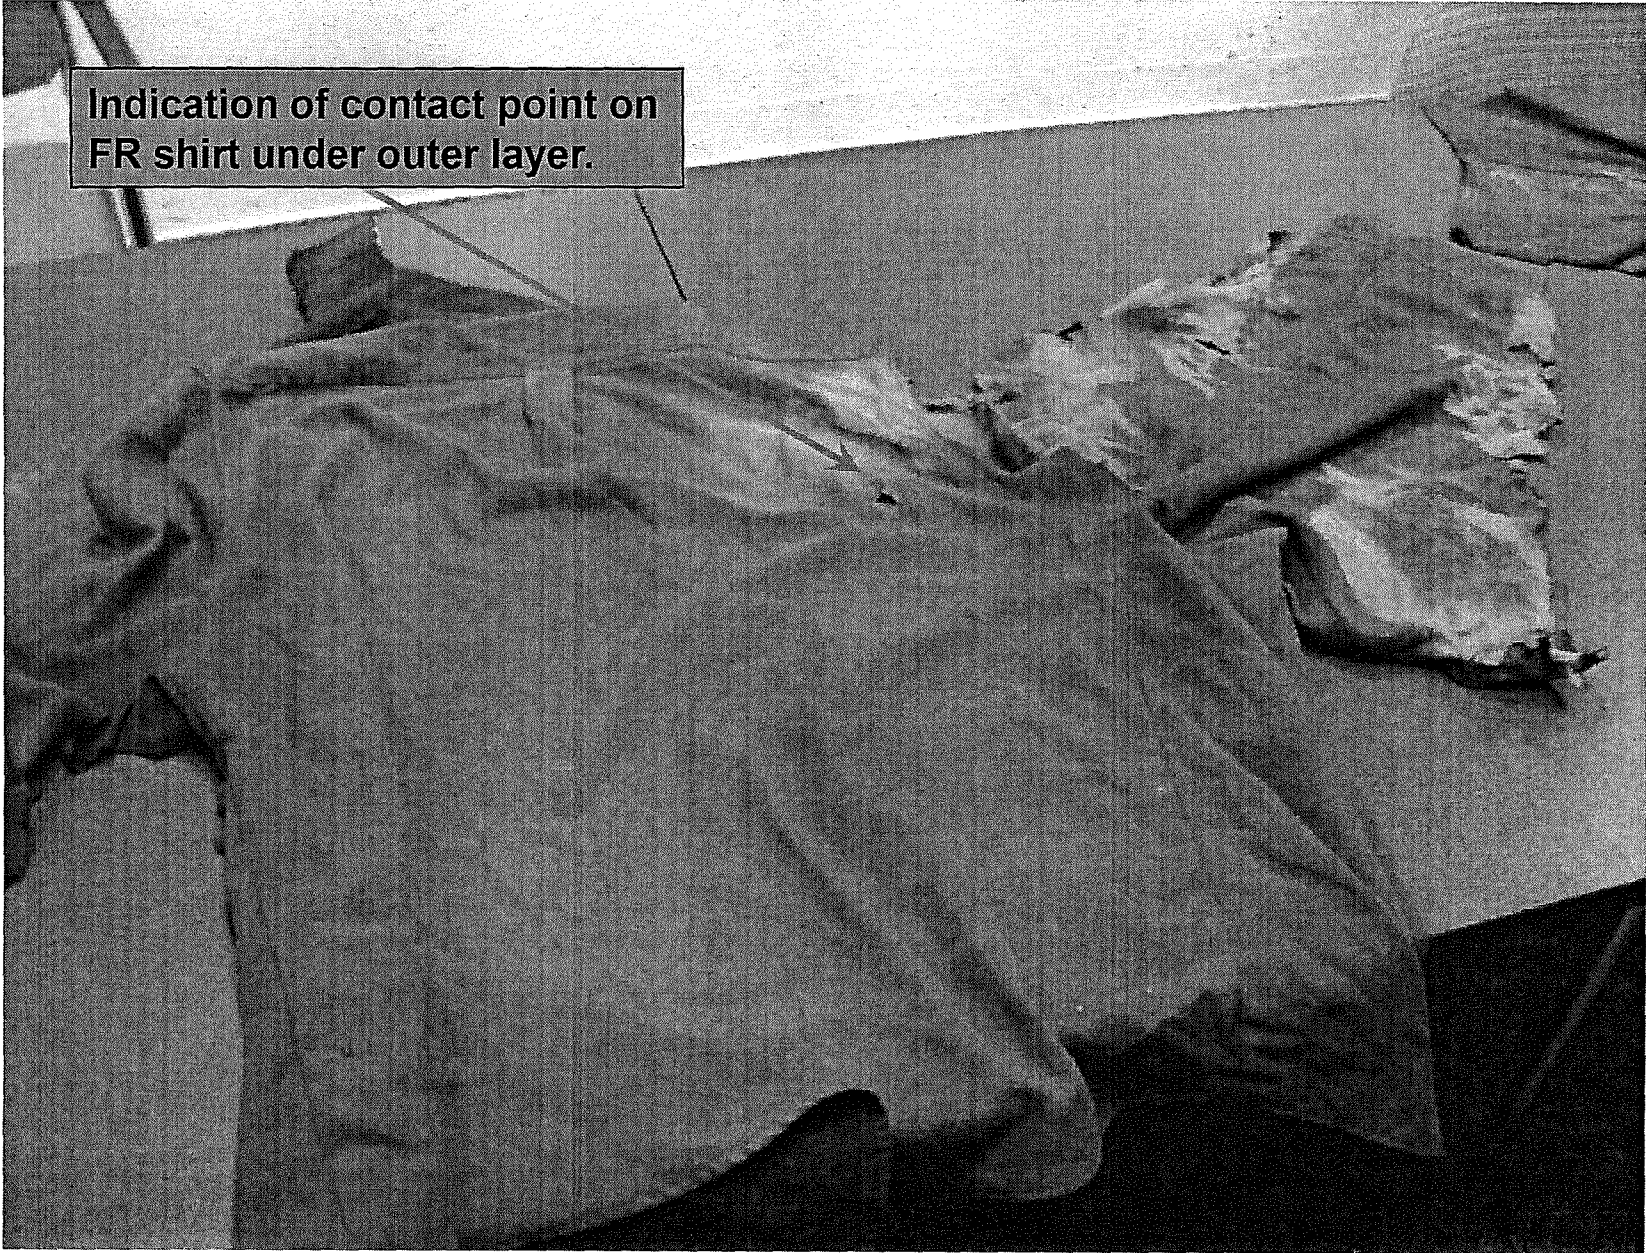
Indication of contact point on
FR shirt under outer layer.

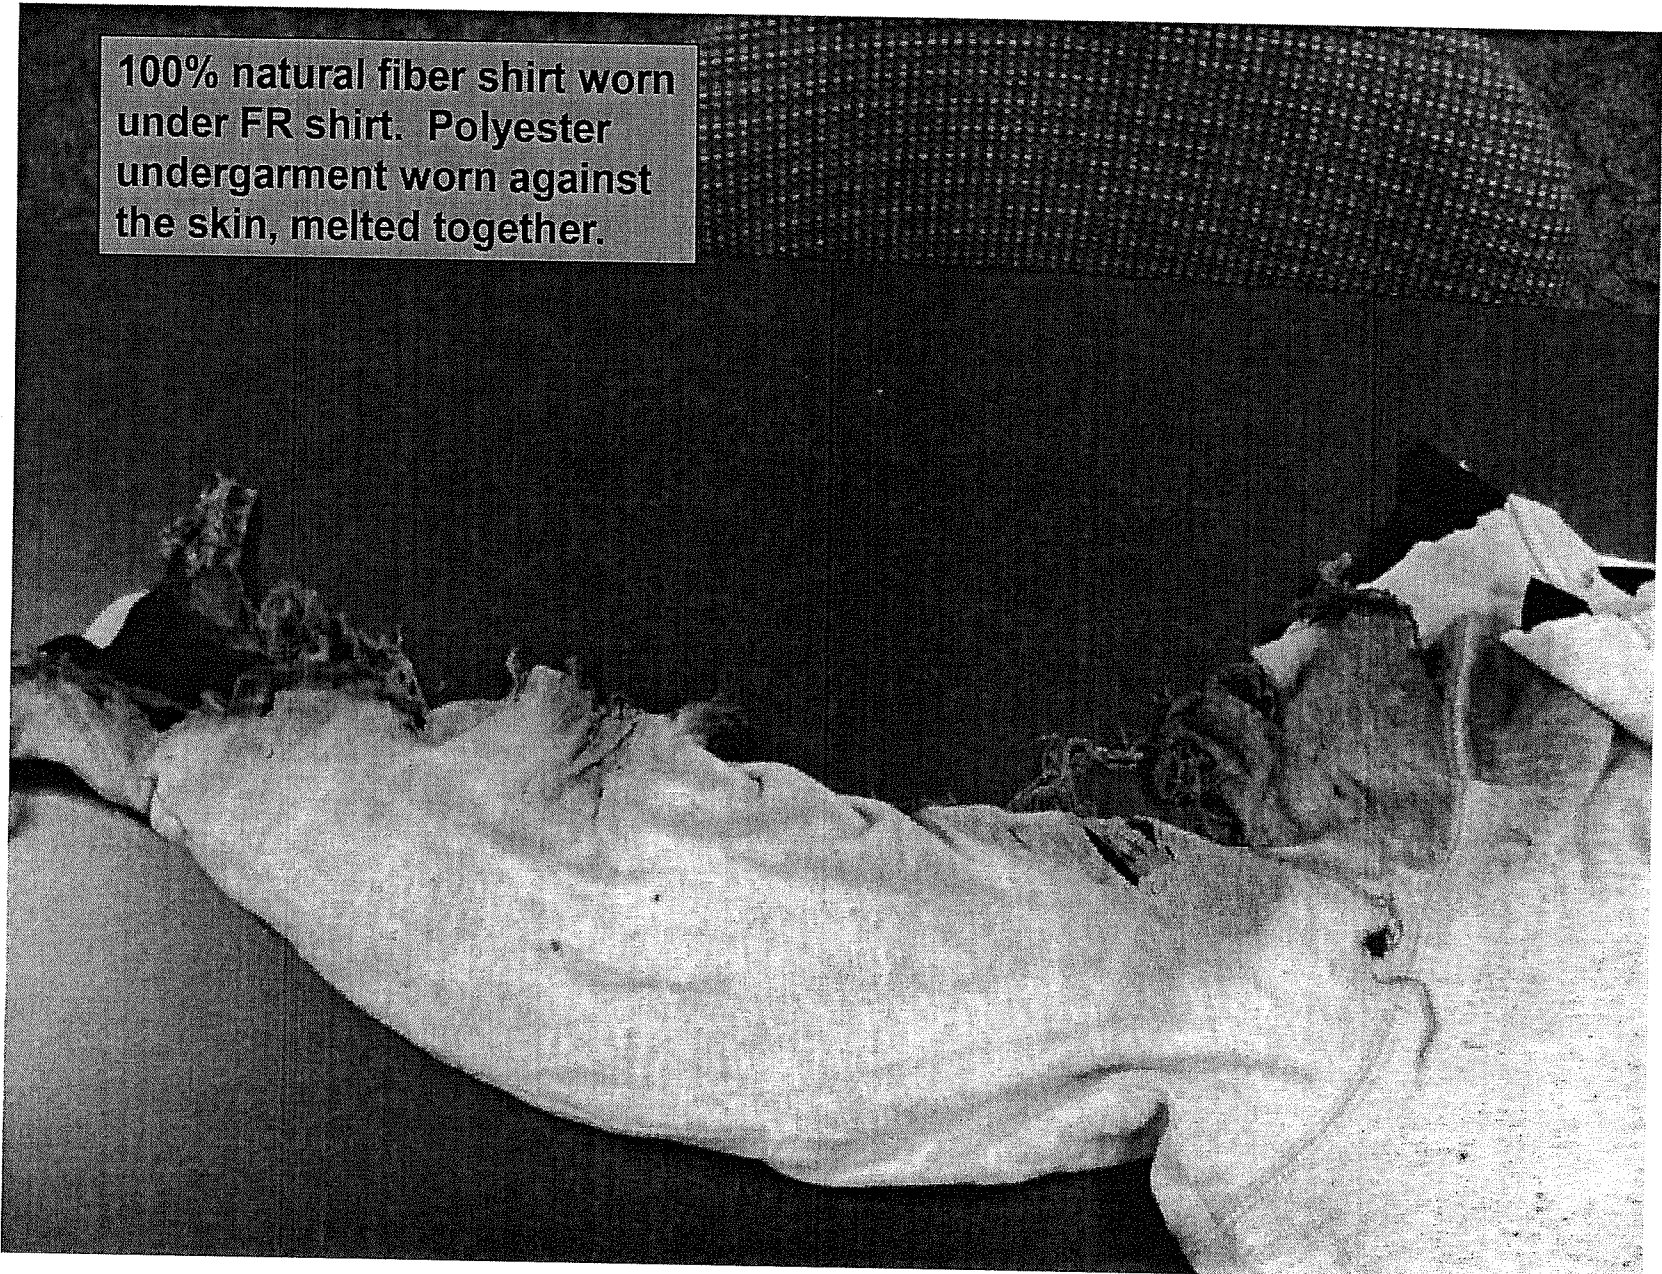
100% natural fiber shirt worn
under FR shirt. Polyester
undergarment worn against
the skin, melted together.

Error: Employee was wearing a polyester undergarment which contributed to the severity of the injuries.

Defense: FR clothing shall be worn when exposed to energized conductors or equipment. All clothing worn under FR shall be 100% natural fiber.

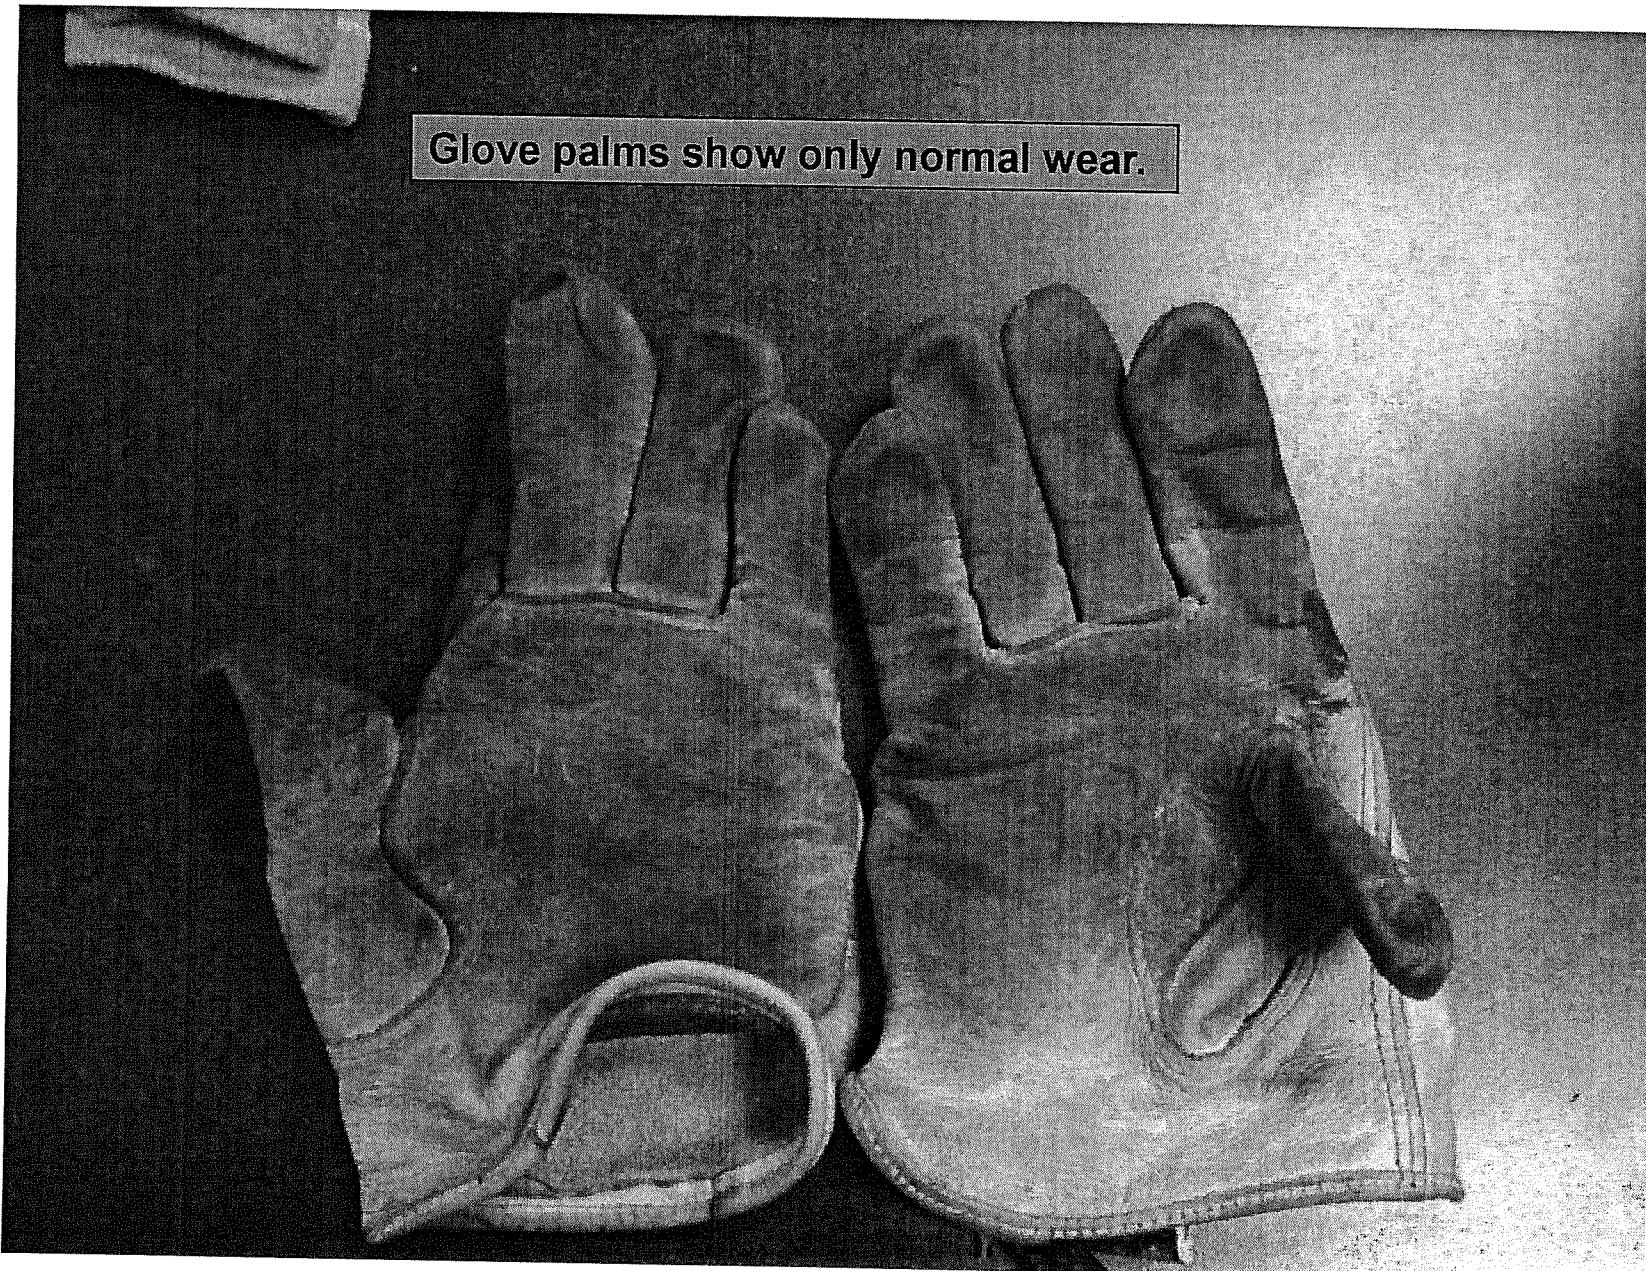
Glove palms show only normal wear.
