COMMONWEALTH OF KENTUCKY
BEFORE THE PUBLIC SERVICE COMMISSION

DUKE ENERGY KENTUCKY, INC.)	
_____)	
ALLEGED FAILURE TO COMPLY WITH)	CASE NO. 2014-00165
KRS 278.042)

ACCIDENT INVESTIGATION STAFF REPORT

Accident Location: 5940 Lieberman Road, Covington, Kentucky

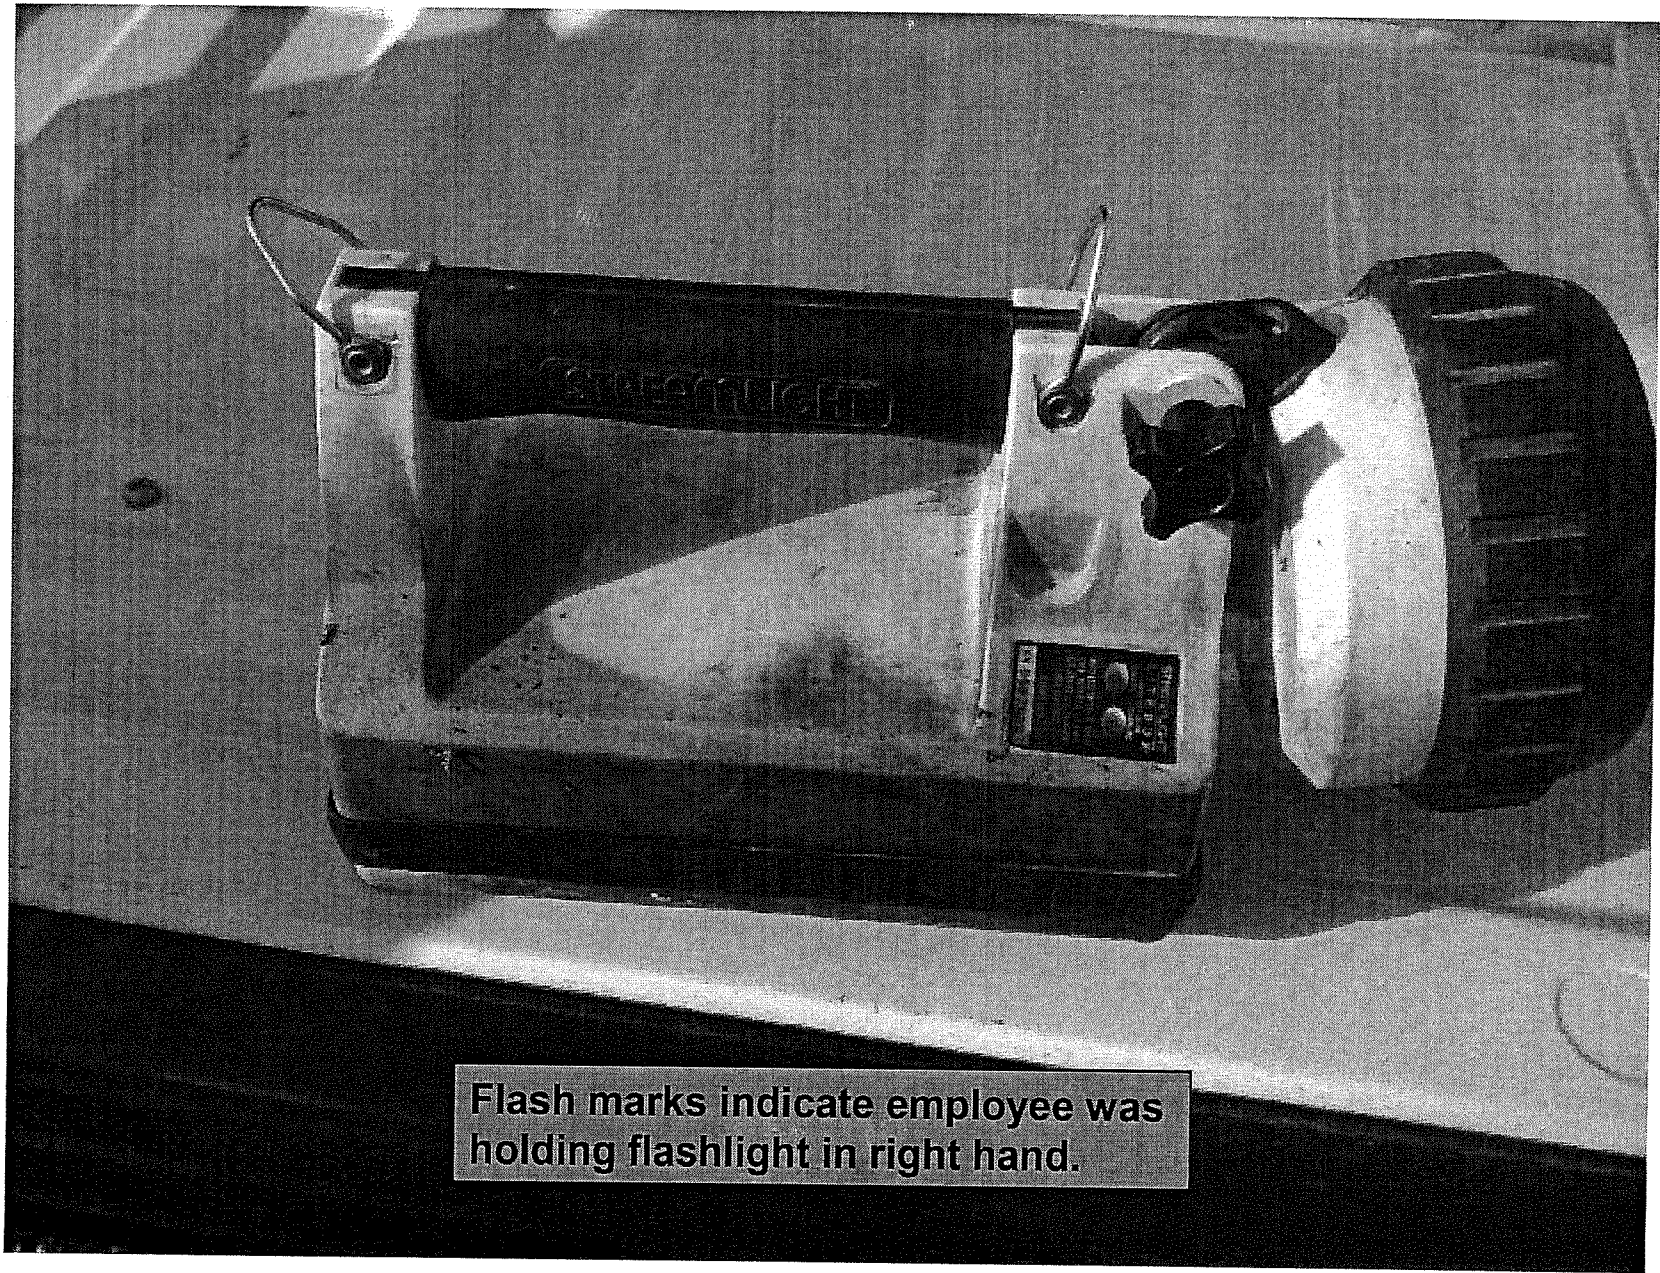
Flash indications on right glove cuff.

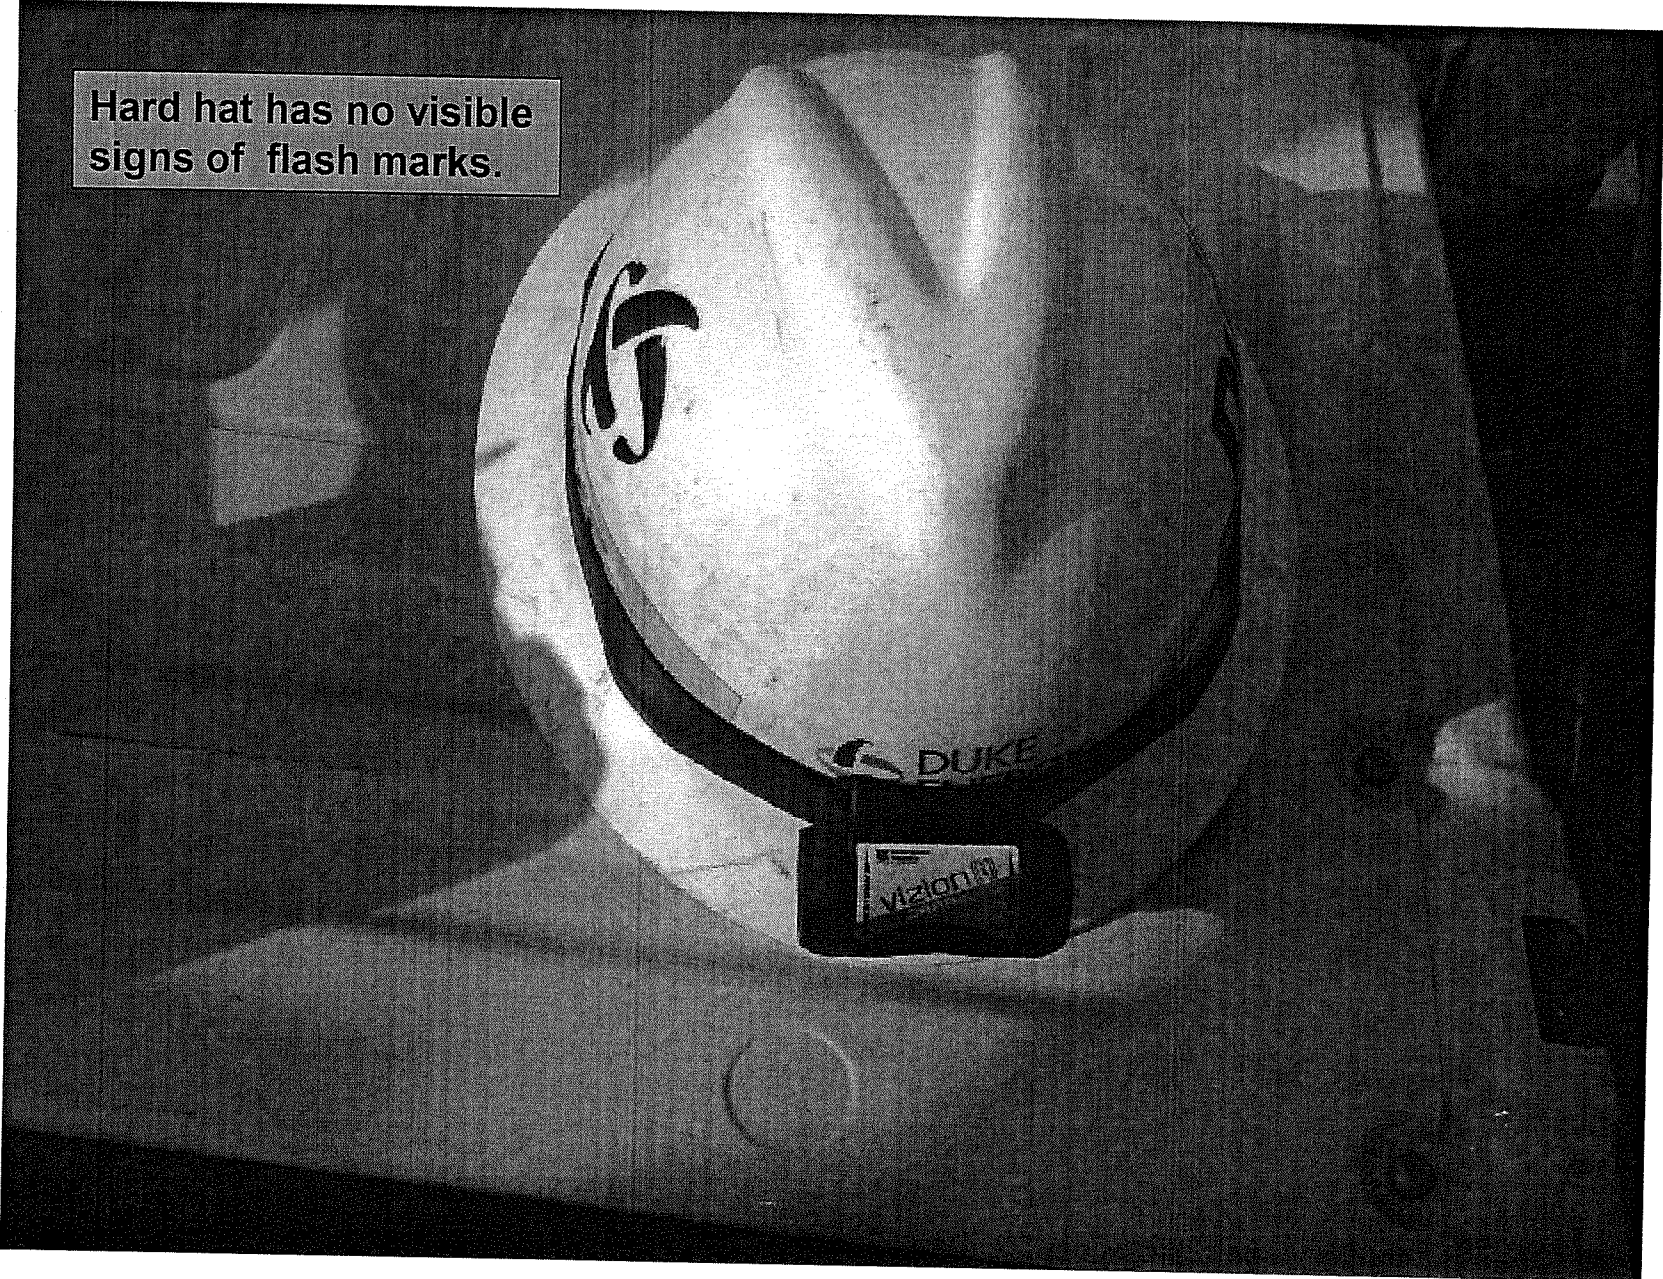
Flash marks indicate employee was holding flashlight in right hand.

Hard hat has no visible signs of flash marks.

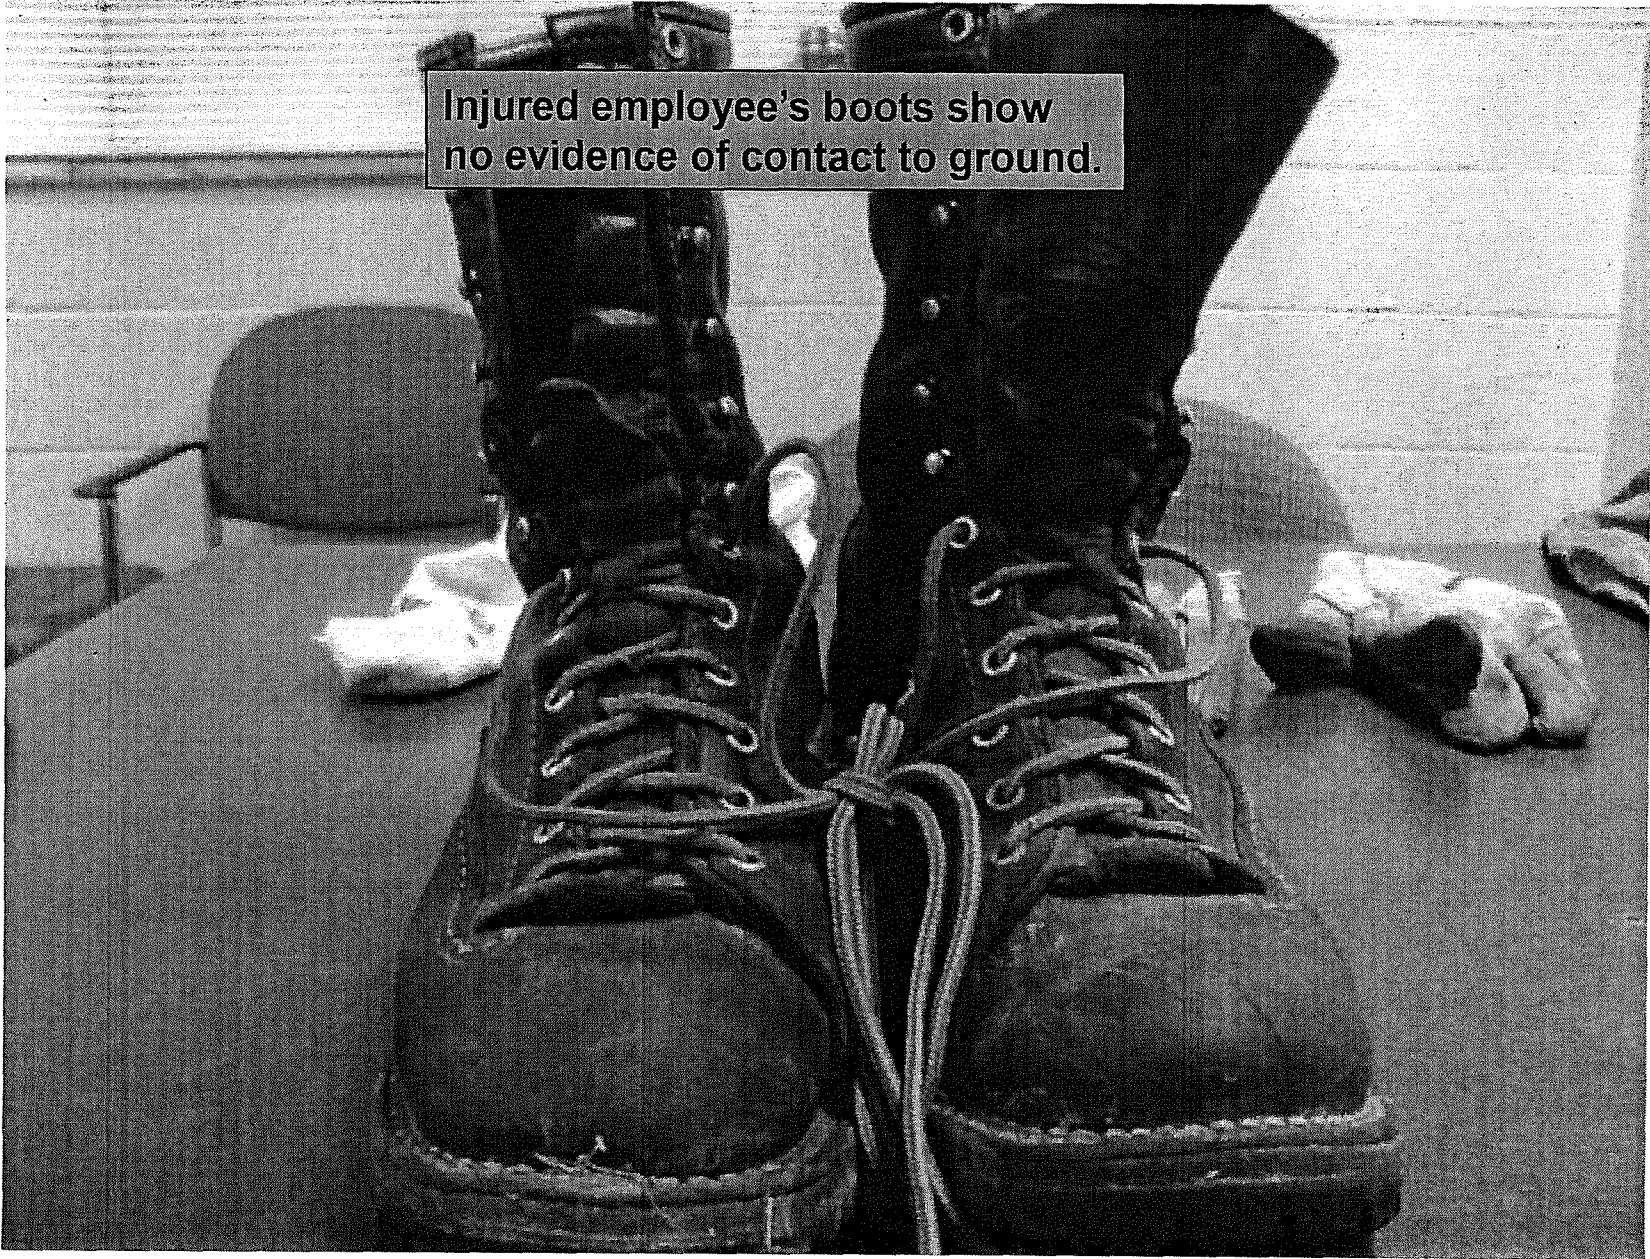
- No crew members were wearing Dielectric Footwear as required by PD Work Standards, and the injured employee was wearing a synthetic tee-shirt under two layers of FR and one layer of 100% natural fiber clothing.

**Injured employee's boots show
no evidence of contact to ground.**
