COMMONWEALTH OF KENTUCKY
BEFORE THE PUBLIC SERVICE COMMISSION

CASE NO.
2014-00141

**ANSWER TO KENTUCKY-AMERICAN WATER COMPANY'S FIRST REQUEST
FOR INFORMATION DATED MAY 30, 2014**

Address of Inspection: 3649 Winding Wood Lane

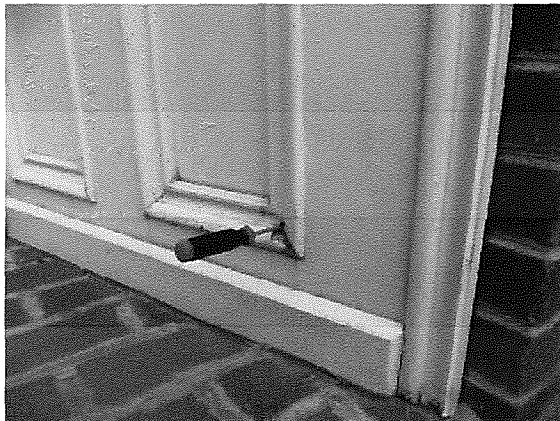
wooden trim was damaged at the front entry

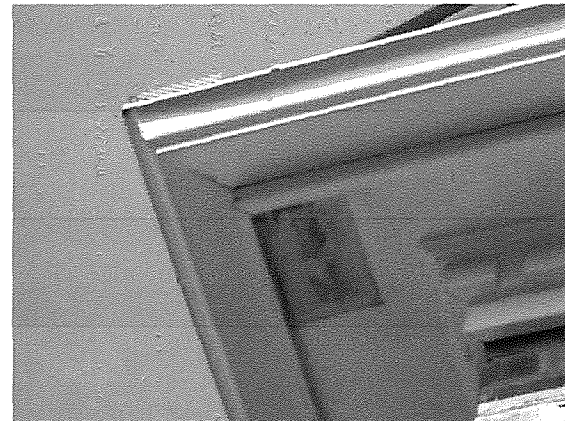
overhang at left of front entry door - ???

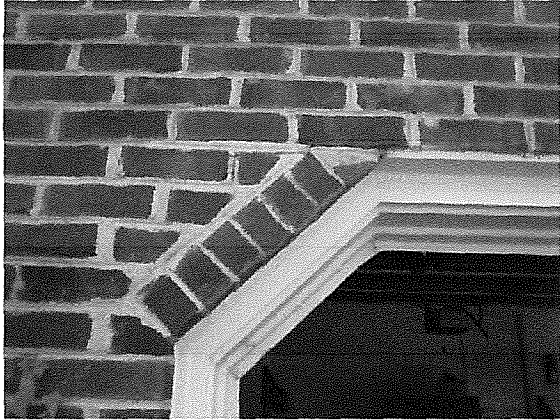
all brick and mortar separations should be repaired

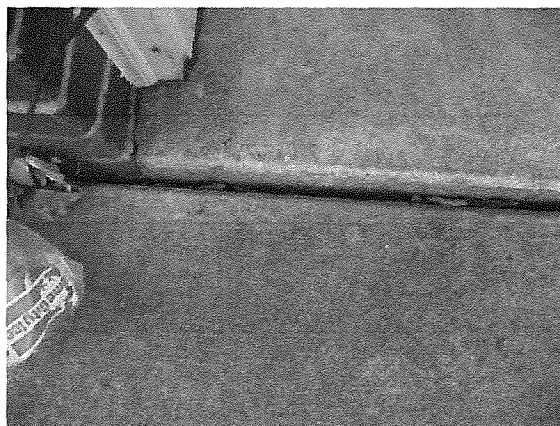
the driveway had settled; seal the opening to prevent water penetration

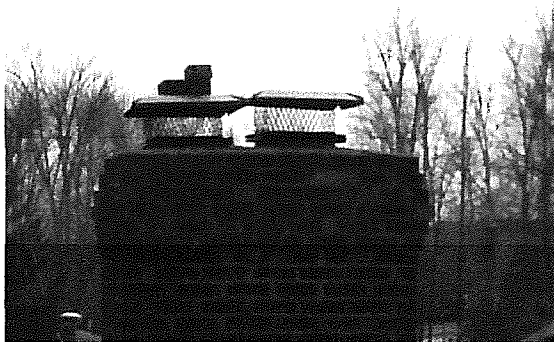
bricks could be a safety concern

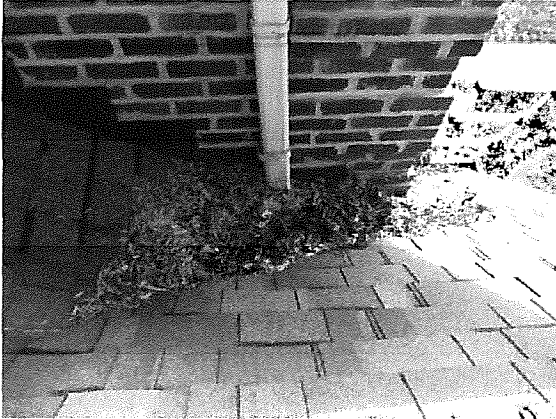
please monitor the valleys for debris accumulation

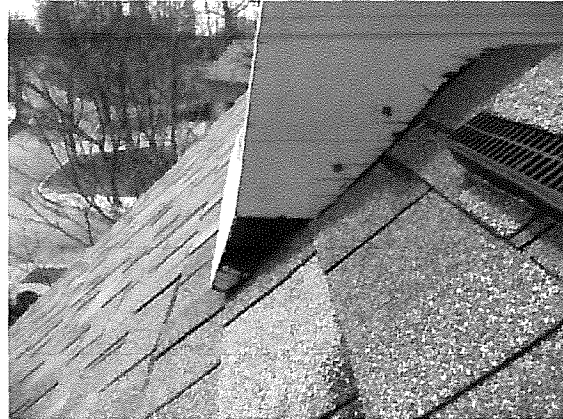
opening at the back side of the cupola should be sealed to help prevent pest entry

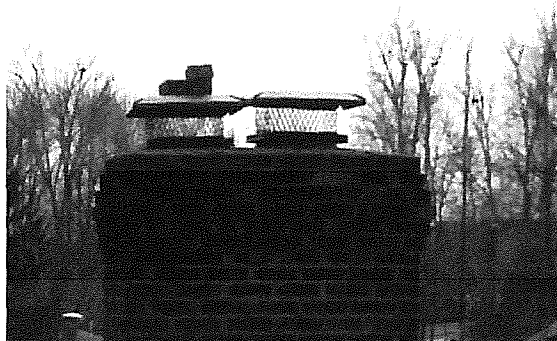
bricks could be a safety concern

The unsealed concrete at the top of the chimney could absorb water that may seep into the interior of the chimney structure. Moisture present in the interior of a chimney structure may increase the possibility of mortar deterioration and brick/stone spalling (the face of the brick/stone surface falling away). The concrete crown should be sealed with a brushable tar-based product to help prevent water absorption into the concrete crown and the interior of the chimney structure.

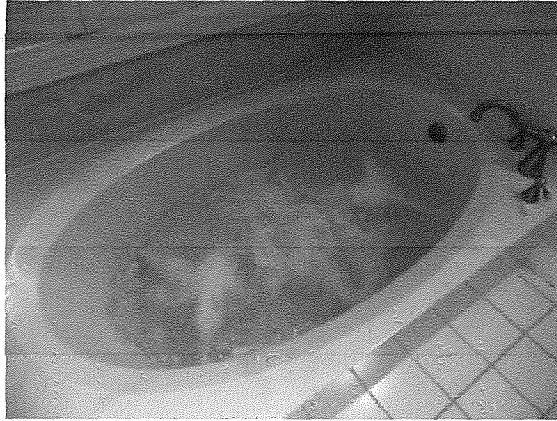
whirlpool in operation

The handle was not installed on the master bathroom shower faucet and the grout was cracked and the back right corner of the shower.

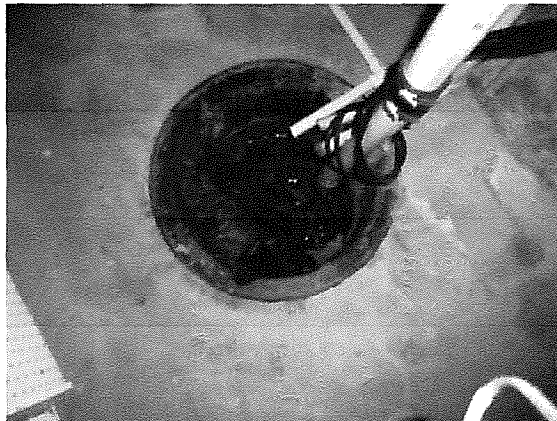
The sump well opening in the basement did not have a protective cover installed. The cover should be installed to help prevent injury from accidental entry into the sump well.

The sump pump motor was immersed in water and could not be tested for operation. Please confirm the operation of the motor with the seller.

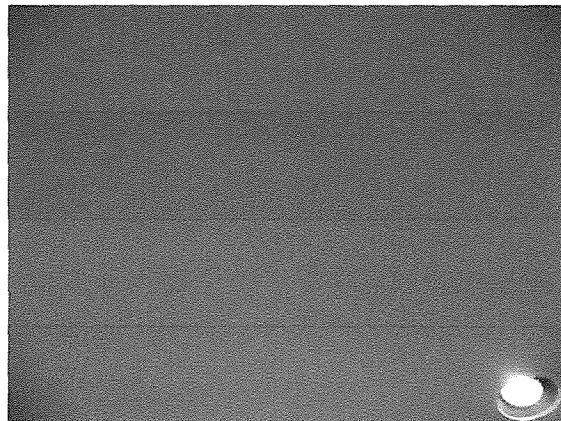
water stain on the living room ceiling below the jack-n-jill bathroom

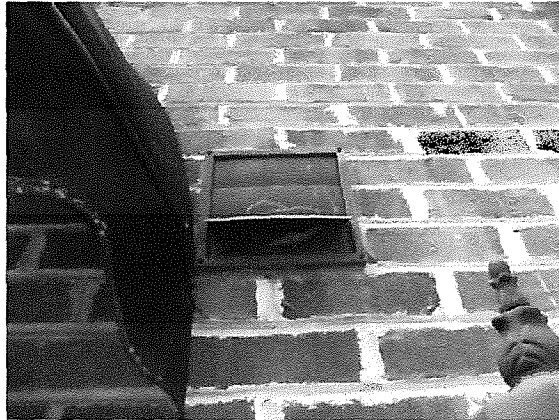
The exterior cover for the kitchen cook top downdraft exhaust was clogged and should be cleaned.

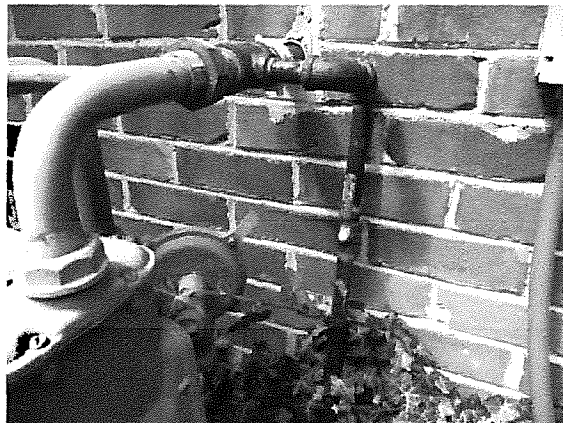
gas shut off valve for the basement fireplace gas log

The basement fireplace damper was not fully functional and should be repaired.

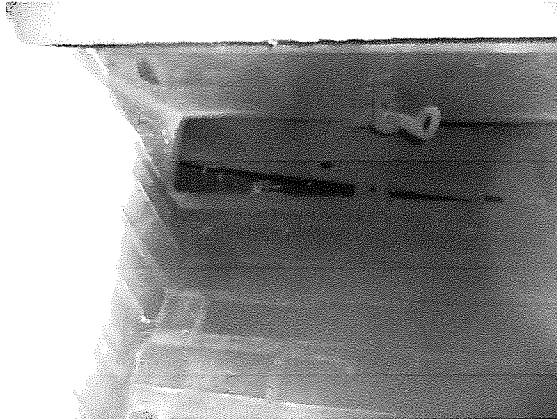
The fireplace gas logs did not have any safety features installed. Consider replacing with gas logs that have safety features.

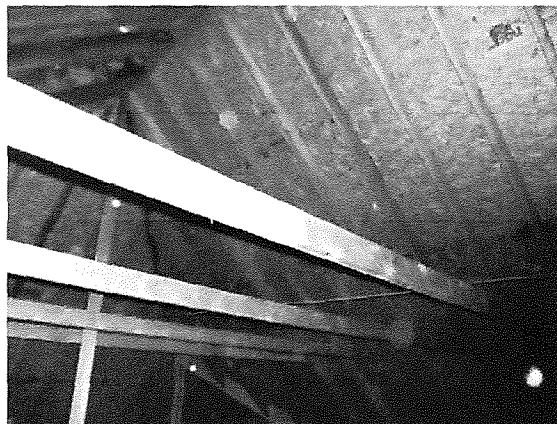
The roof structure valley rafters did not appear to be adequately supported with vertical bracing material. Adequate load-bearing bracing material should be installed to help maintain the structural integrity of the roof structure.

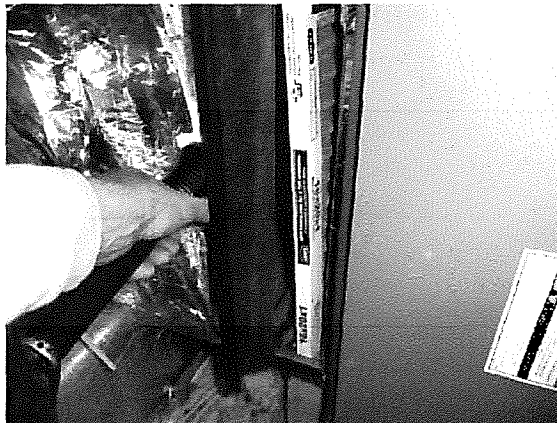
second filter location in the attic space
