SOUTH KENTUCKY R.E.C.C.	)	
	)	CASE NO. 2011-00404
ALLEGED FAILURE TO COMPLY WITH KRS 278.042	)

#### ORDER

## <u>ACCIDENT INVESTIGATION</u> ~ Staff Report

#### FRAÑKLIN REED INCIDENT 06/16/11

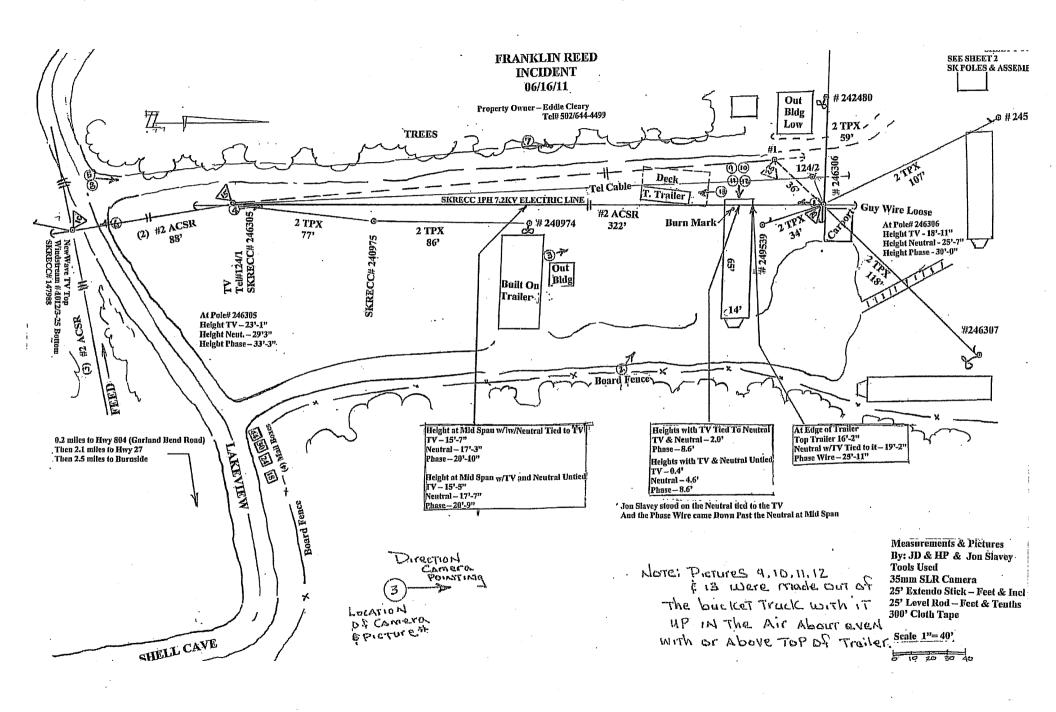
- Picture #1 With back toward Pole# 246306 looking at Pole# 246305
- Picture# 2 61' off Right Front Corner of Trailer
- Picture# 3 Standing at Back of Trailer Looking at Top of Trailer & Wire Crossing
