COMMONWEALTH OF KENTUCKY  
BEFORE THE PUBLIC SERVICE COMMISSION

U.S.60 WATER DISTRICT	)	
	)	
_____	)	CASE NO.
	)	2015-00037
ALLEGED FAILURE TO COMPLY WITH	)	
807 KAR 5:006, SECTIONS 26 AND 27,	)	
AND 807 KAR 5:066, SECTION 7	)

ORDER

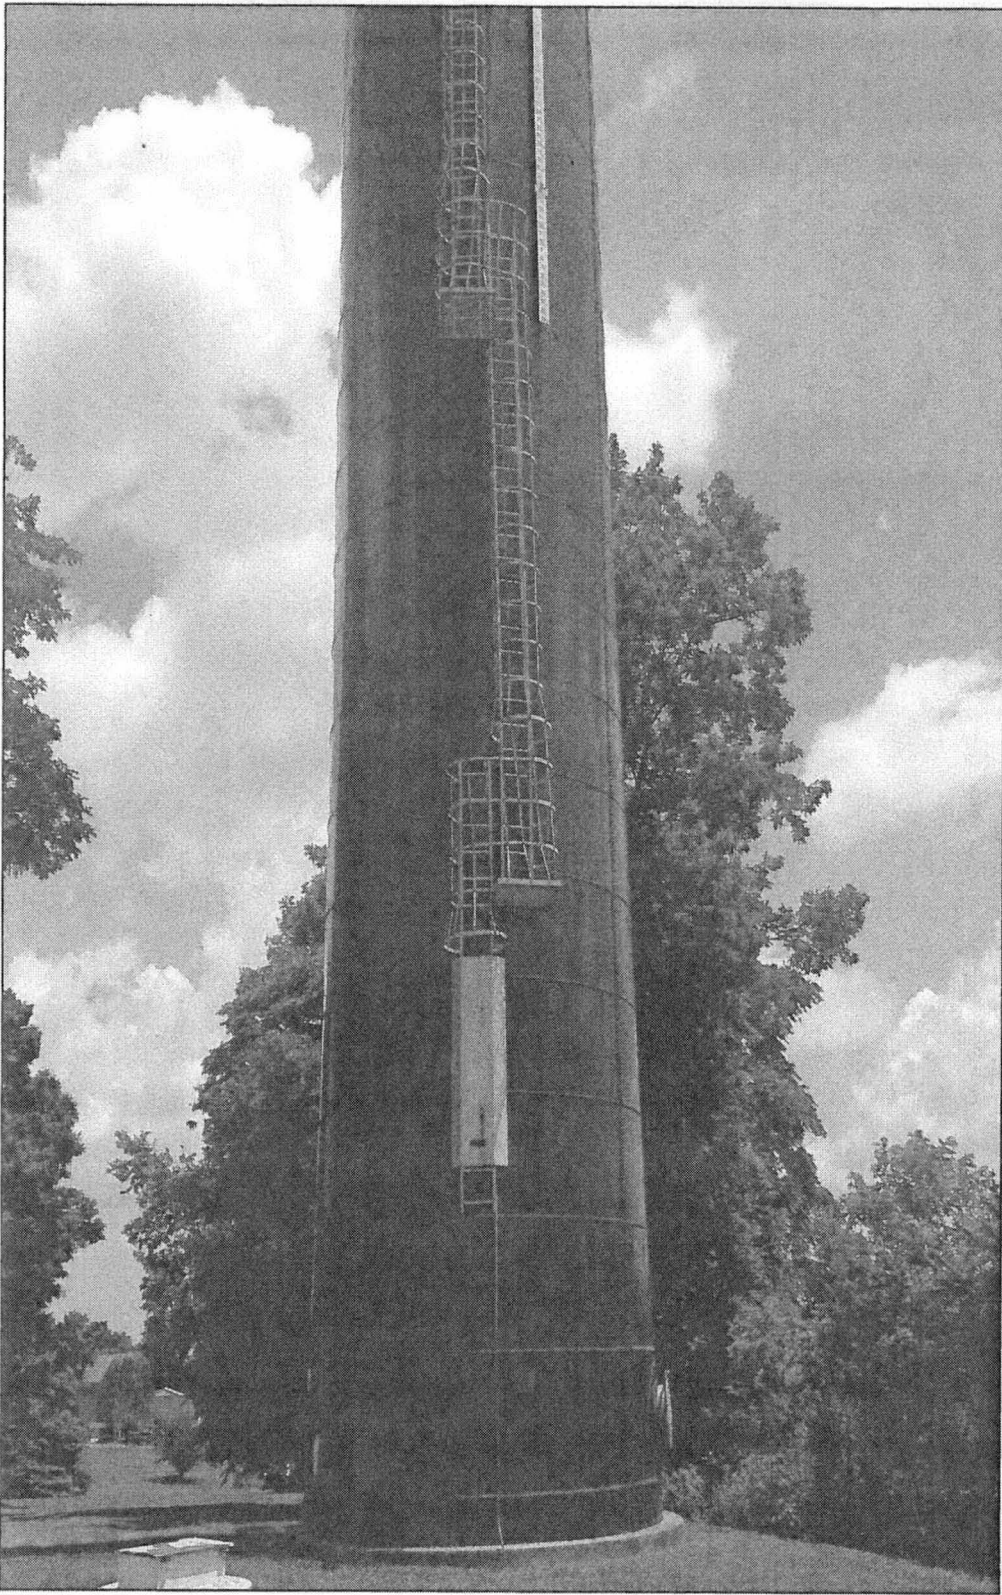
**U.S. 60 Water District Water Storage Tank  
Picture Taken June 16, 2014**

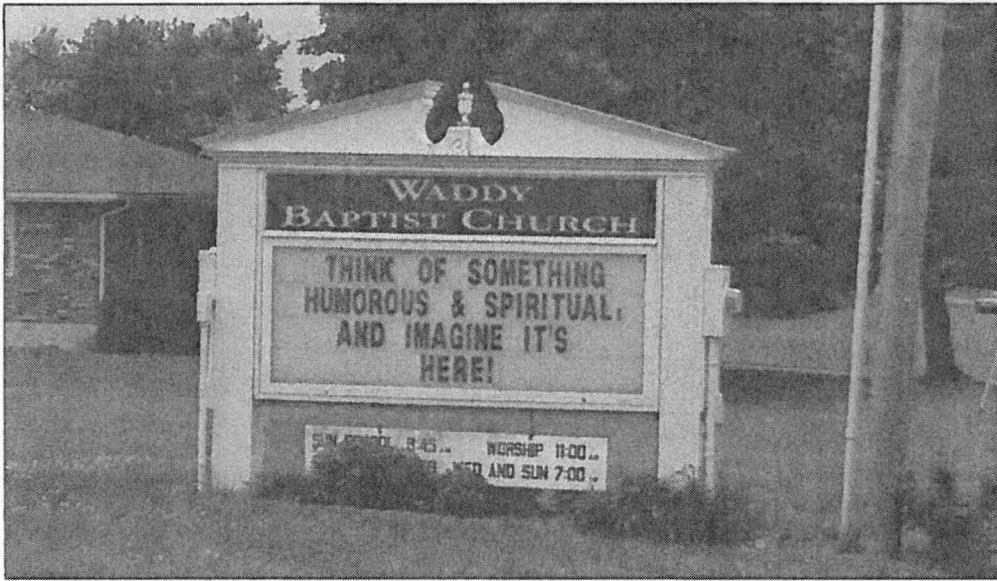
**#1**

Waddy tank sat behind the Waddy Baptist Church

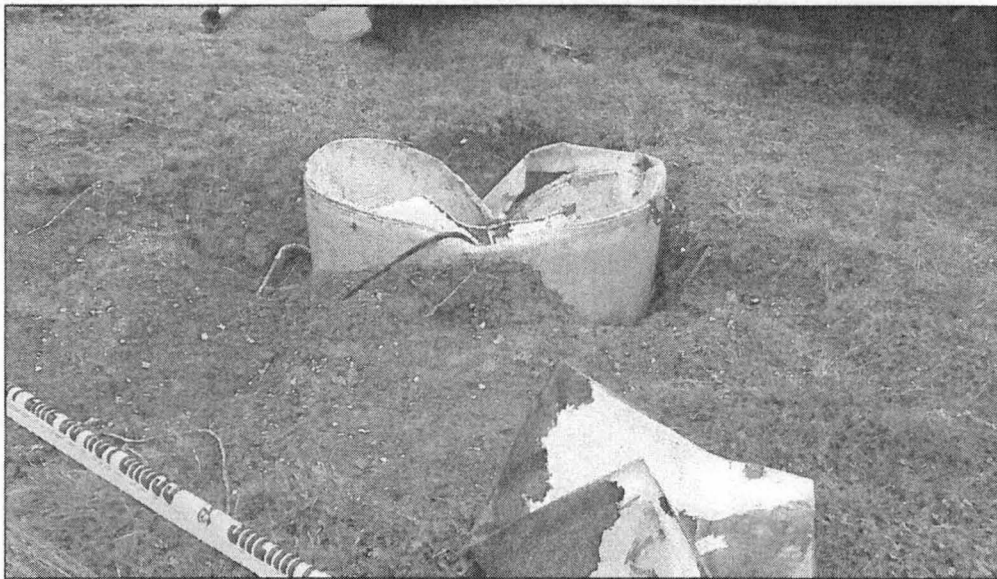
**#2**

Tank valve pit that collapsed due to water pressure

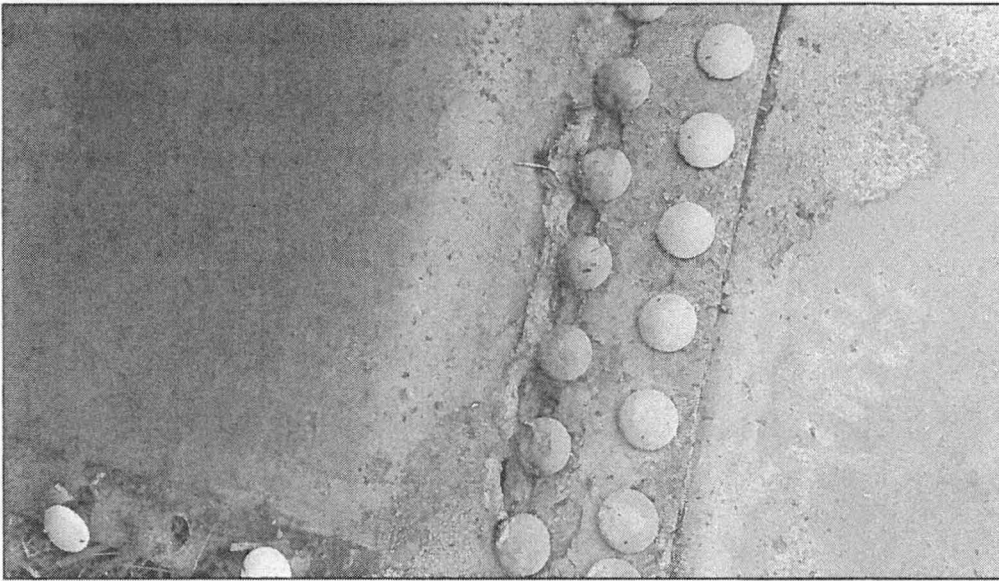
**#3**  
Interior bolts of the Waddy tank

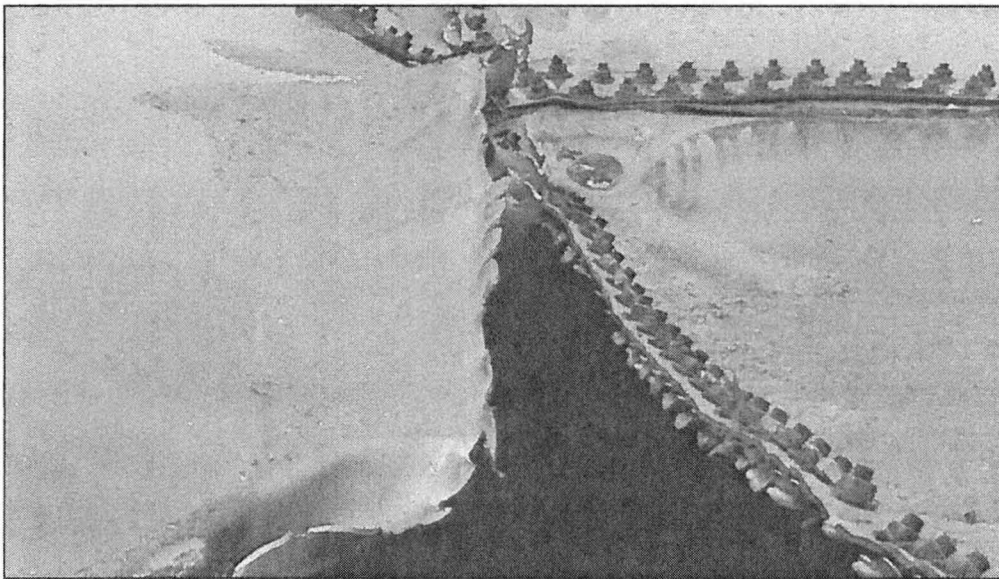
**#4**  
Exterior of Waddy tank shows where the tank ripped up the  
horizontal seam

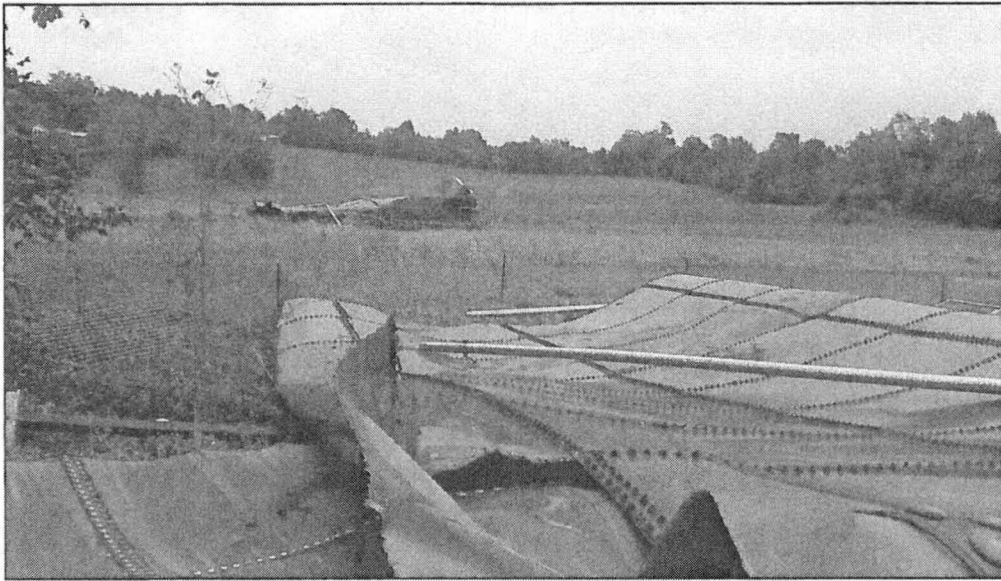
**#5**

Top section of the Waddy tank moved approximately 135 feet from base of the tank

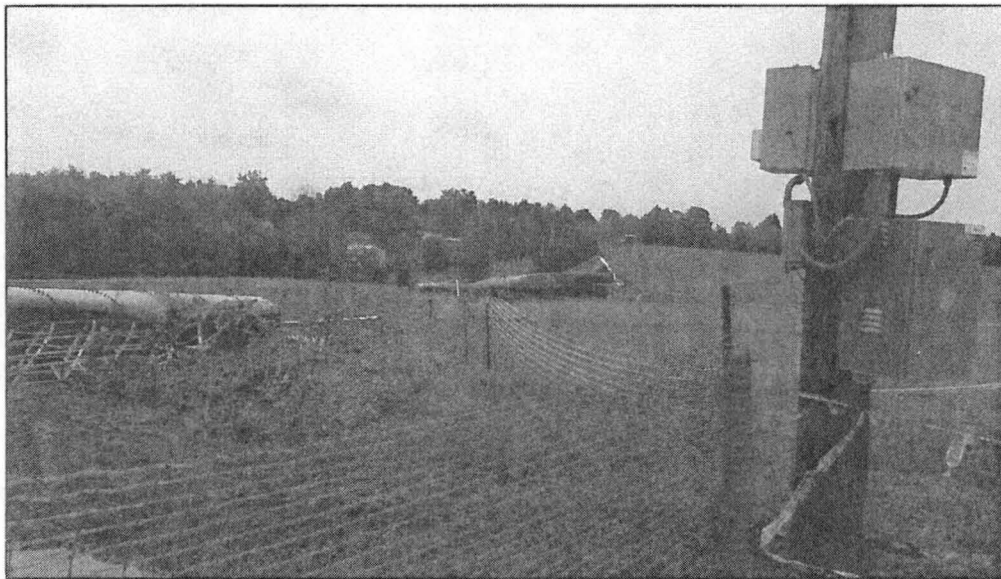
**#6**

US 60 Water District has fenced off tank site and has utility employees watching the tank until clean up

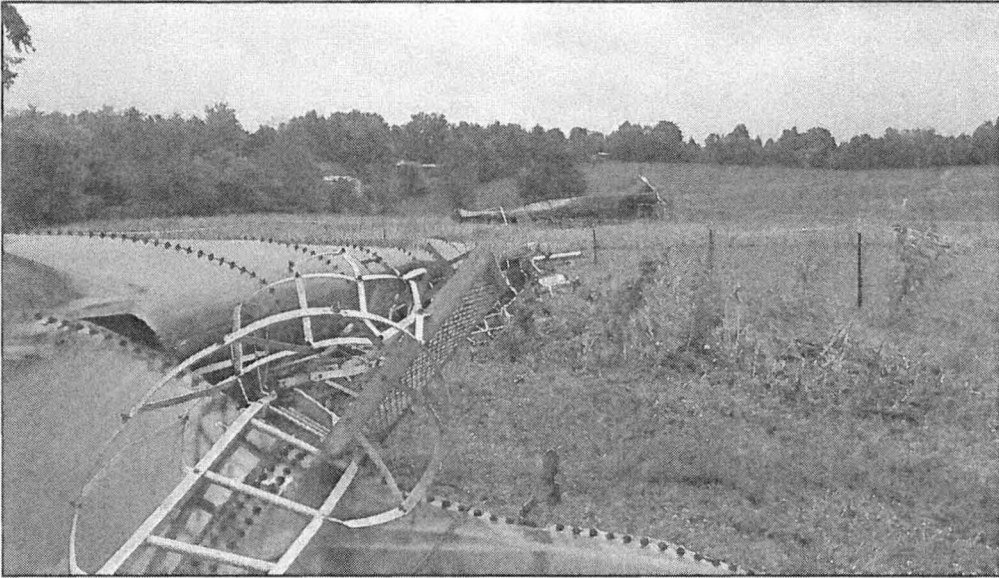
**#7**  
Bottom section of tank

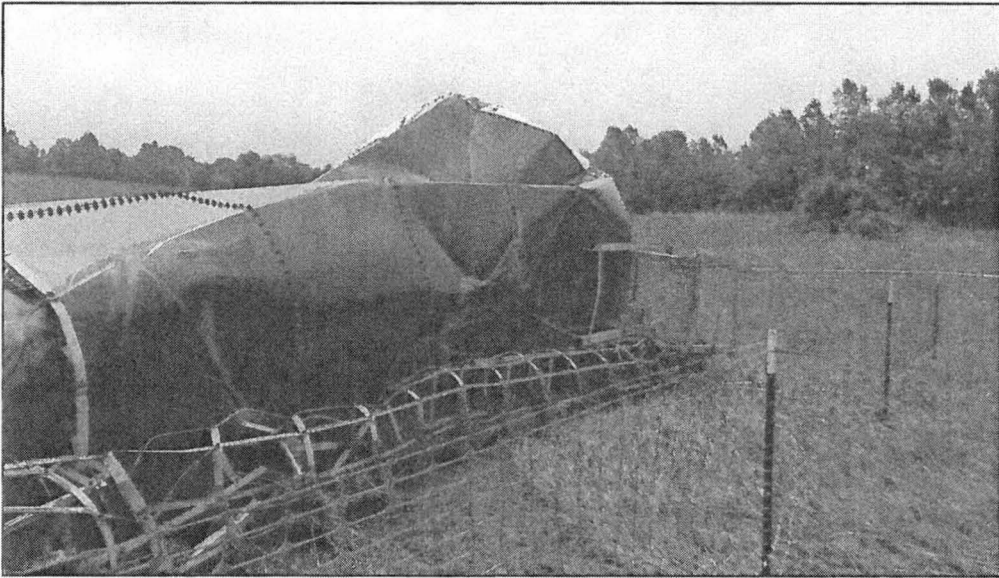
**#8**  
Top section of the tank

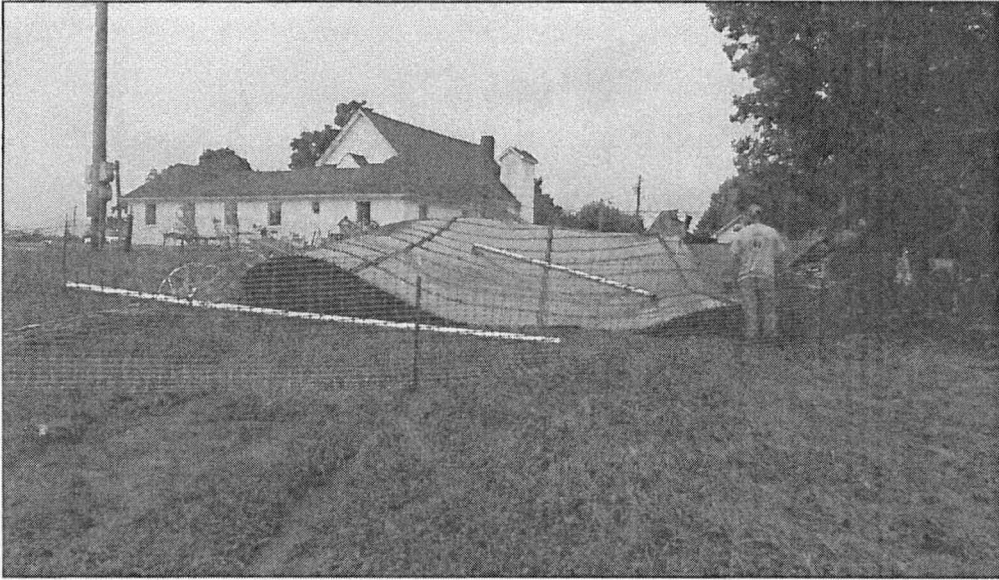
**#9**  
Bottom section of tank and Waddy Baptist Church

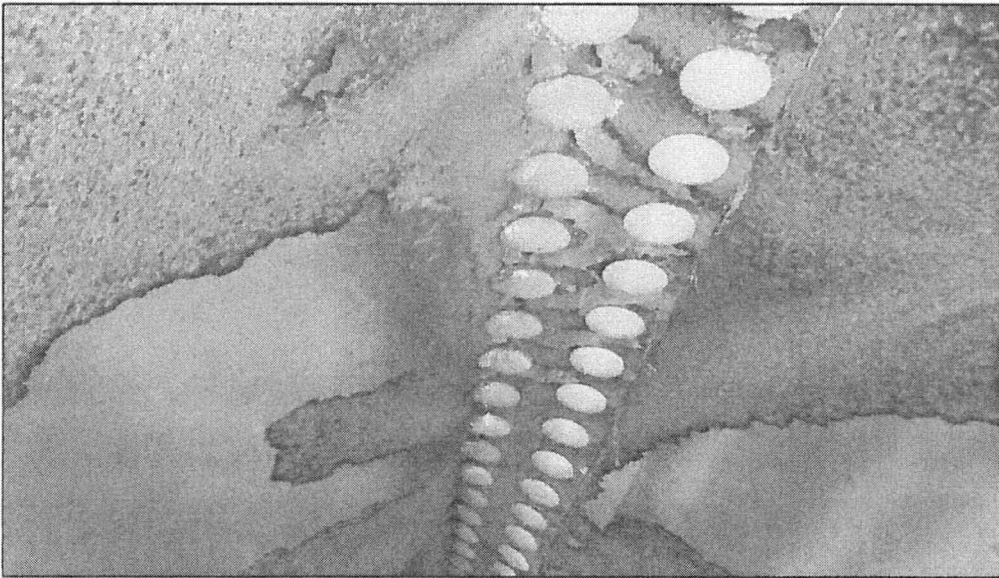
**#10**  
Interior vertical seem of Waddy tank

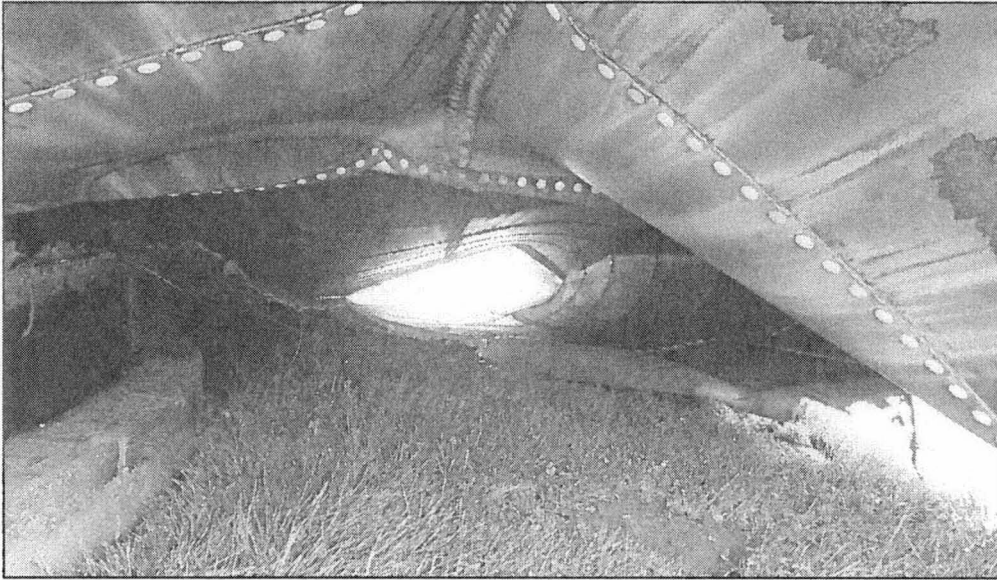
**#11**

To the left is the base of the tank and the interior of the tank

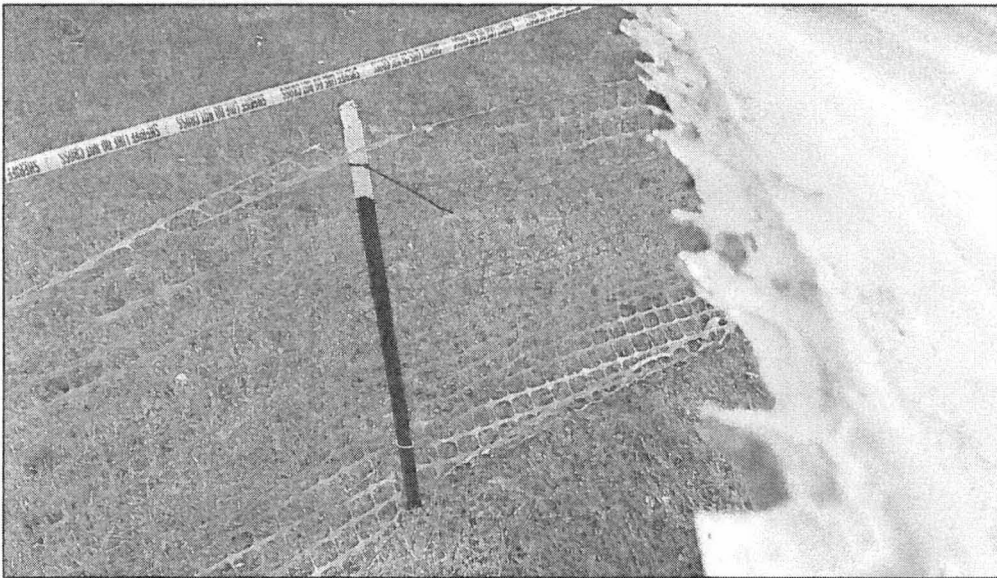
**#12**

The apparent cause of the collapse was a sudden failure in a vertical seam in a lower panel which have bolted seams. The reason for the seam failure was due to corrosion which could not be seen during our regular inspection from the outside the tank looked pristine as do all of these glass lined tanks.

Where US 60 engineer believes the tank failed

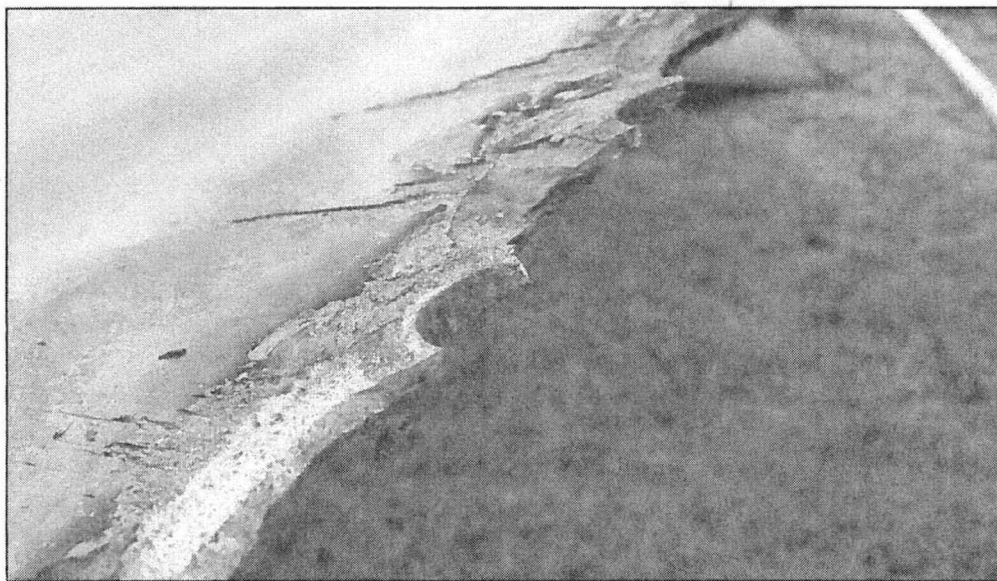
**#14**

Bolts when up the seam of the tank and metal seemed to have lost thickness

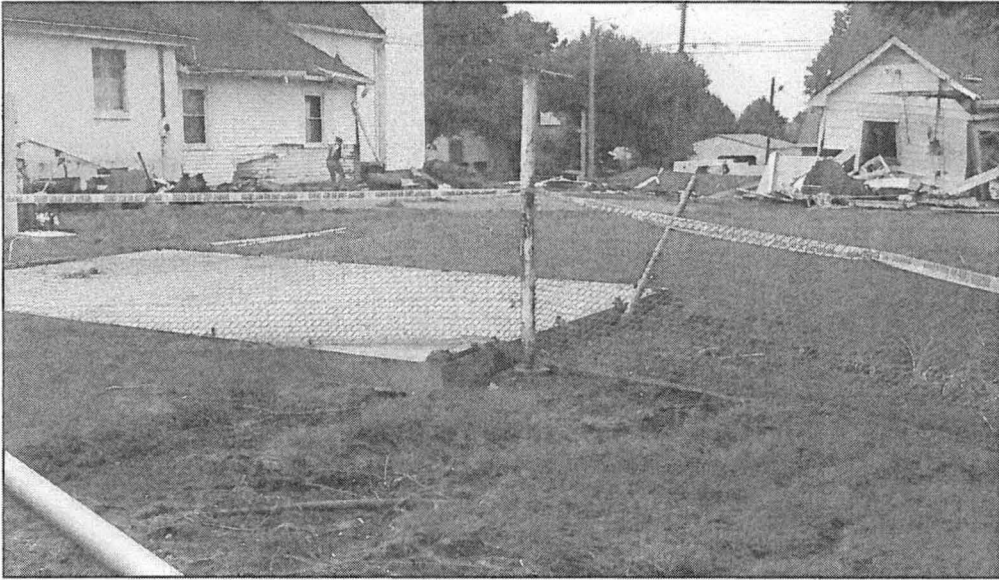
**#15**

Concrete pad where maintenance shed for Church sat. To the left is the Church and the right is the Sunday school building.

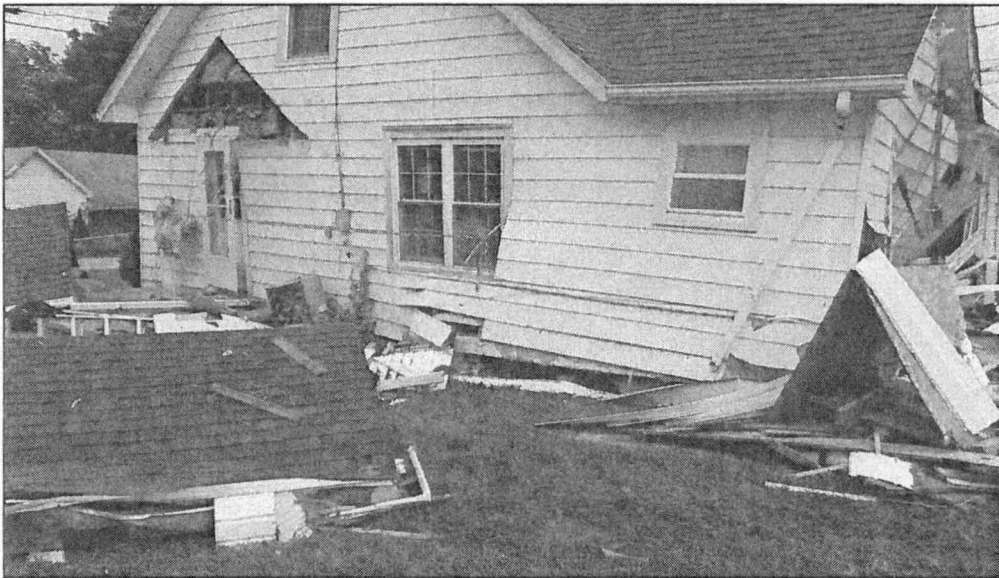
**#16**

Roof of maintenance shed in lower left and side of Sunday school building

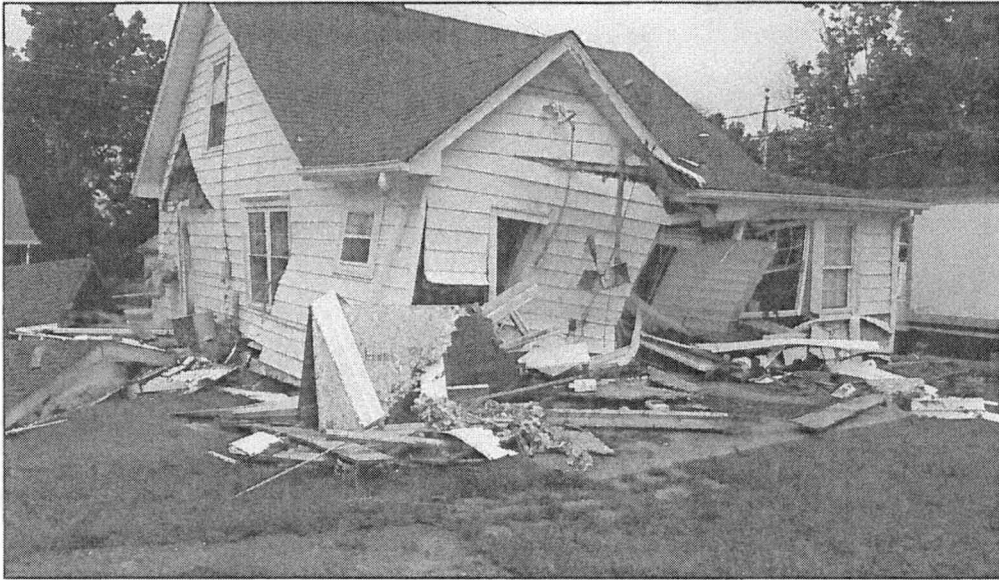
**#17**  
Back of Sunday school building.

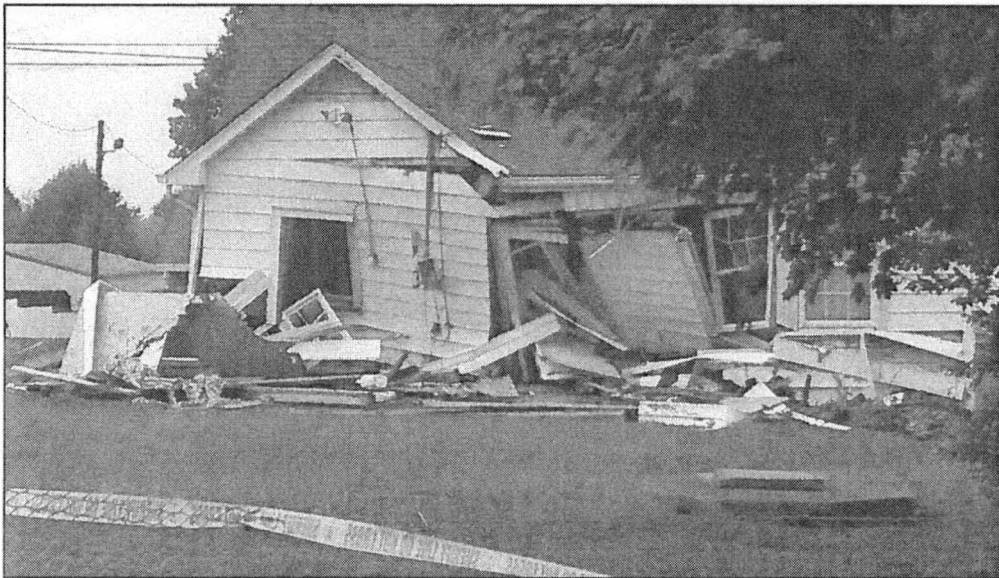
**#18**  
Back of Sunday school building and debris from maintenance shed

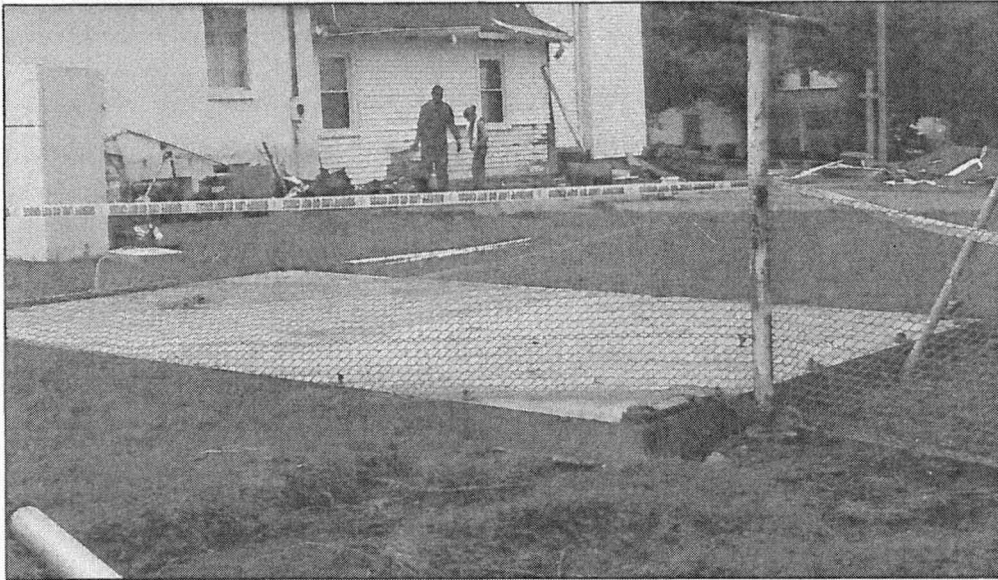
**#19**  
Side of church

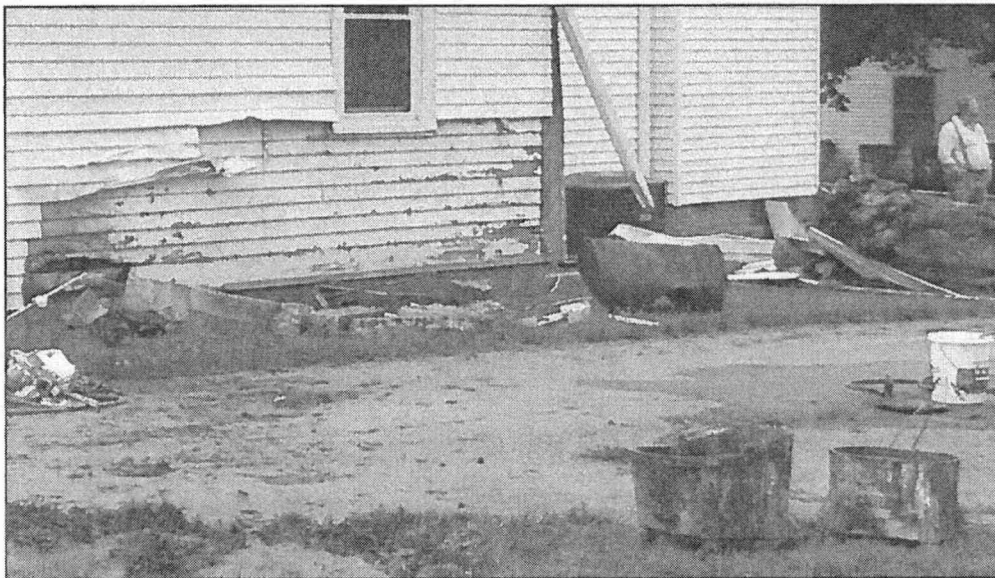
**#20**  
Side of the Church and in right corner a tree stump that was pulled out by the water

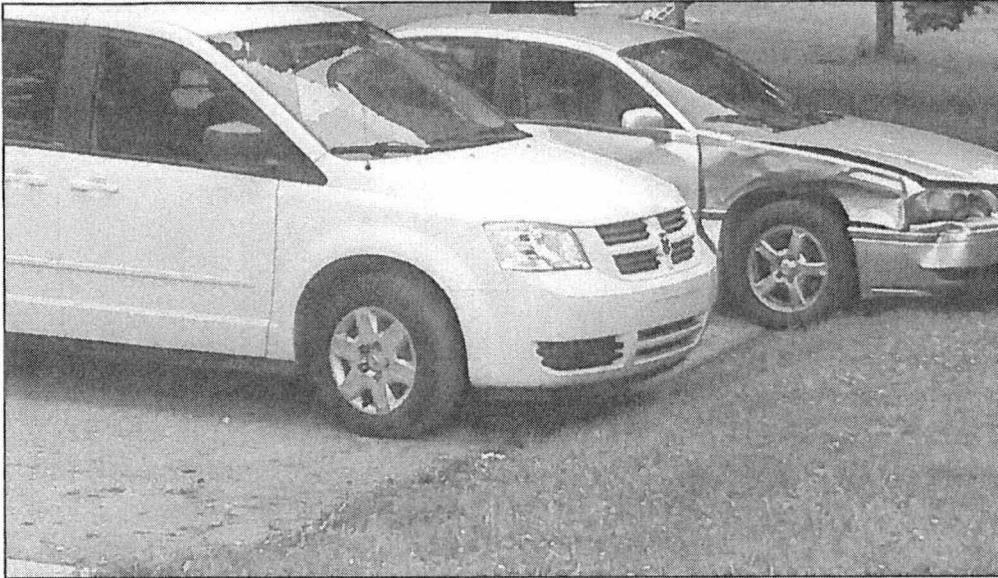
**#21**  
Car that was damaged

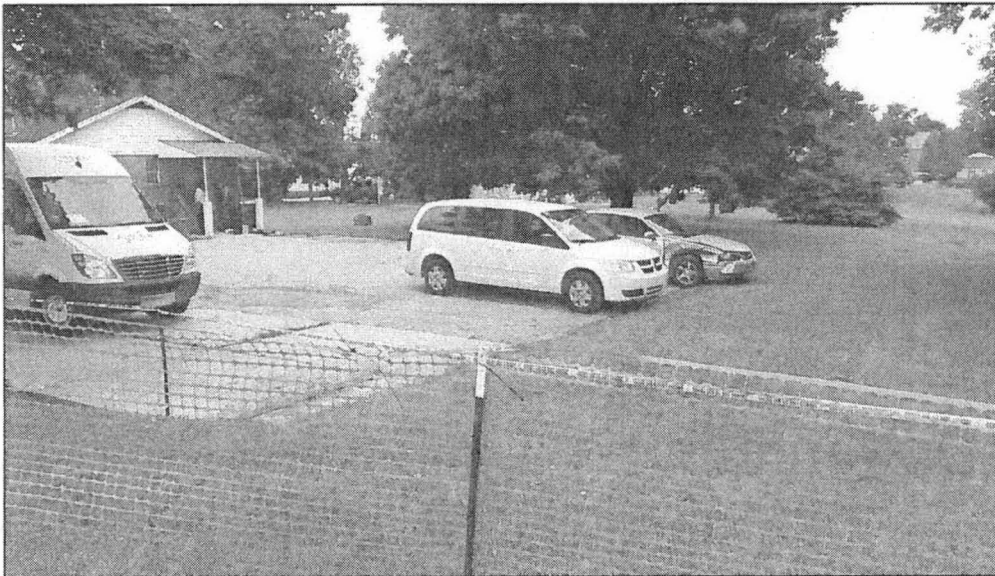
**#22**  
Car was parked in furthest left parking spot and pushed out beyond the tree

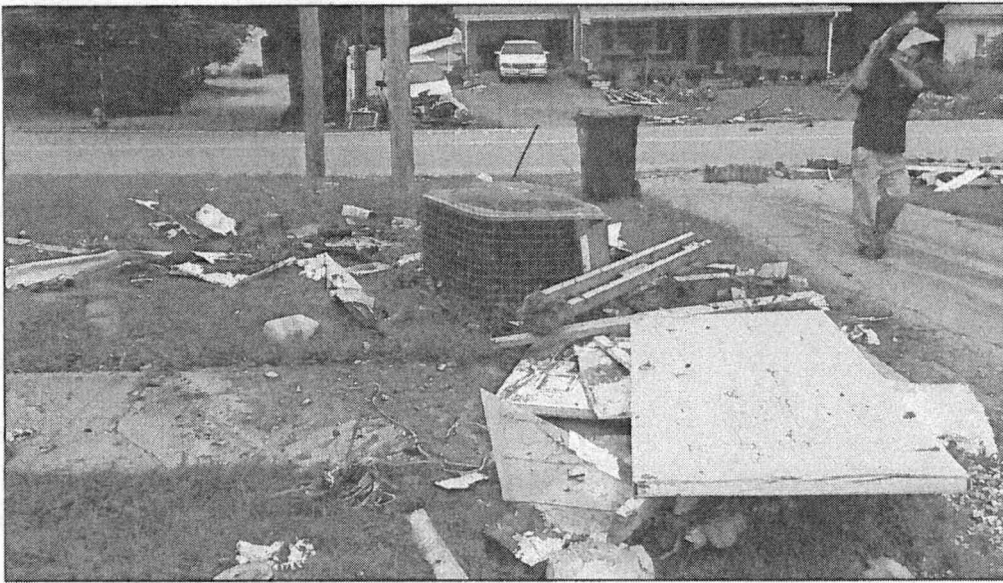
**#23**  
Front sidewalk to church

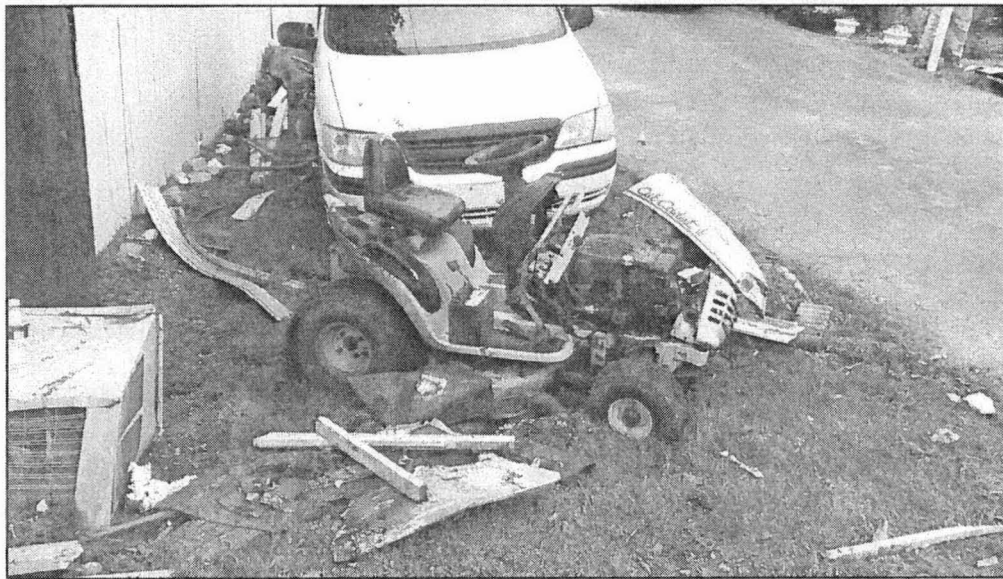
**#24**  
Lawnmower that was pushed out from the maintenance shed and  
across the road

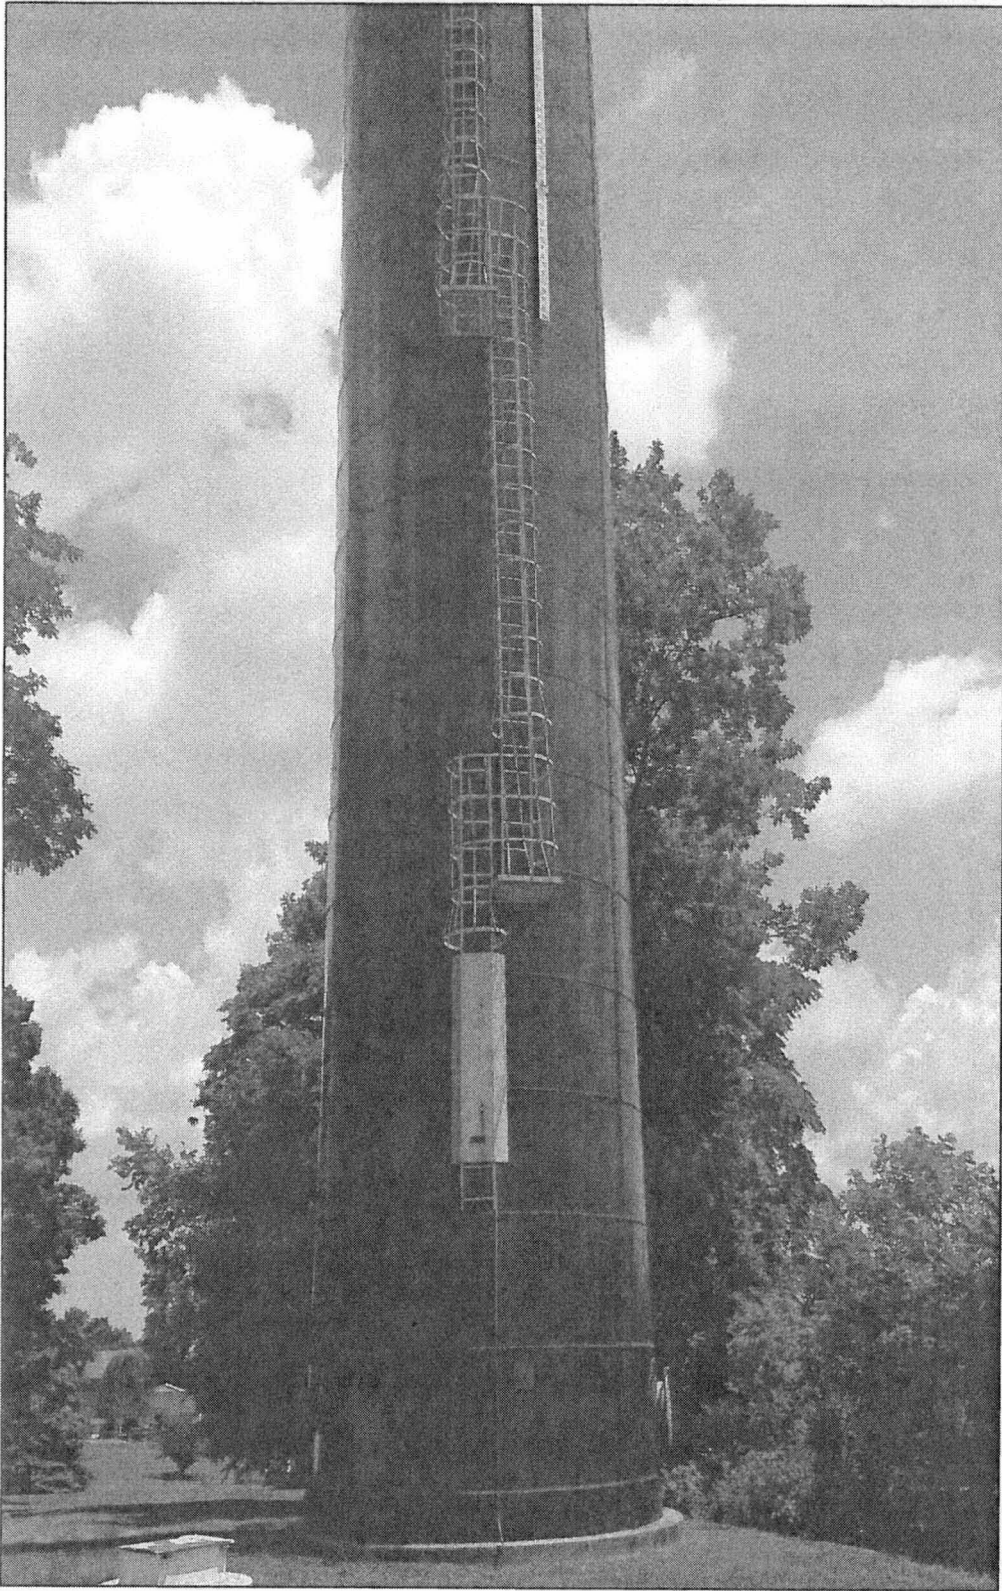
**U.S. 60 Water District Water Storage Tank  
Picture Taken June 16, 2014**

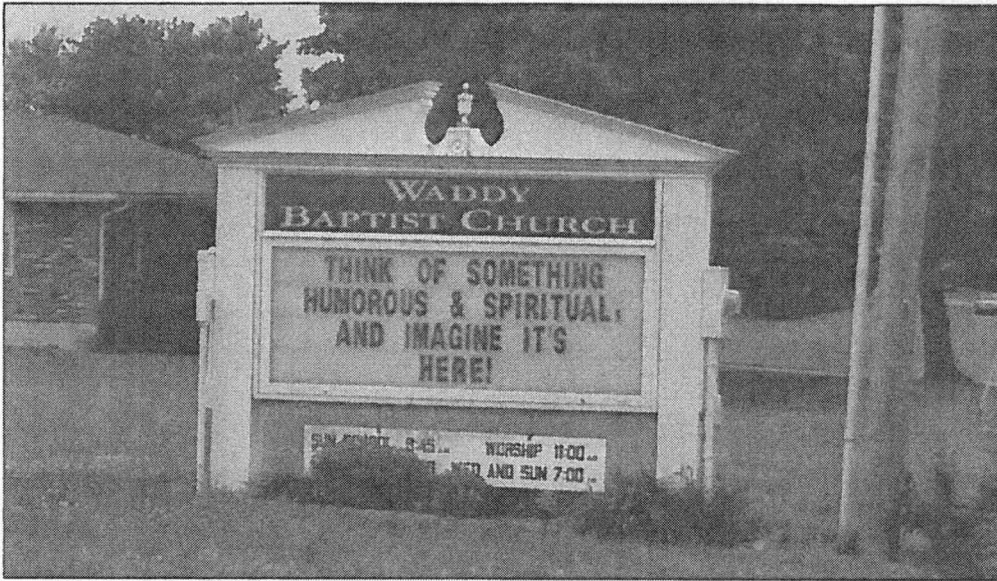
**#1**

Waddy tank sat behind the Waddy Baptist Church

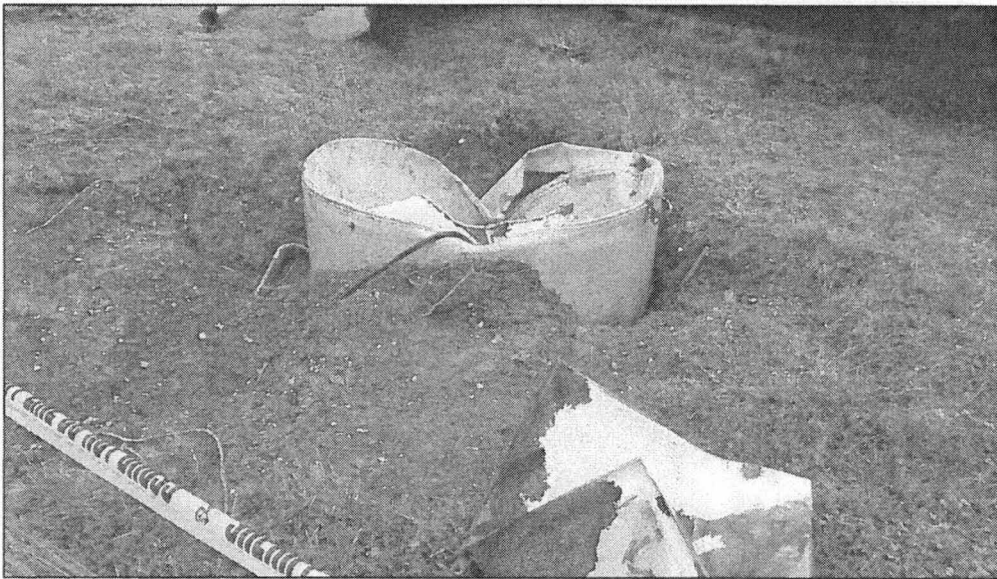
**#2**

Tank valve pit that collapsed due to water pressure

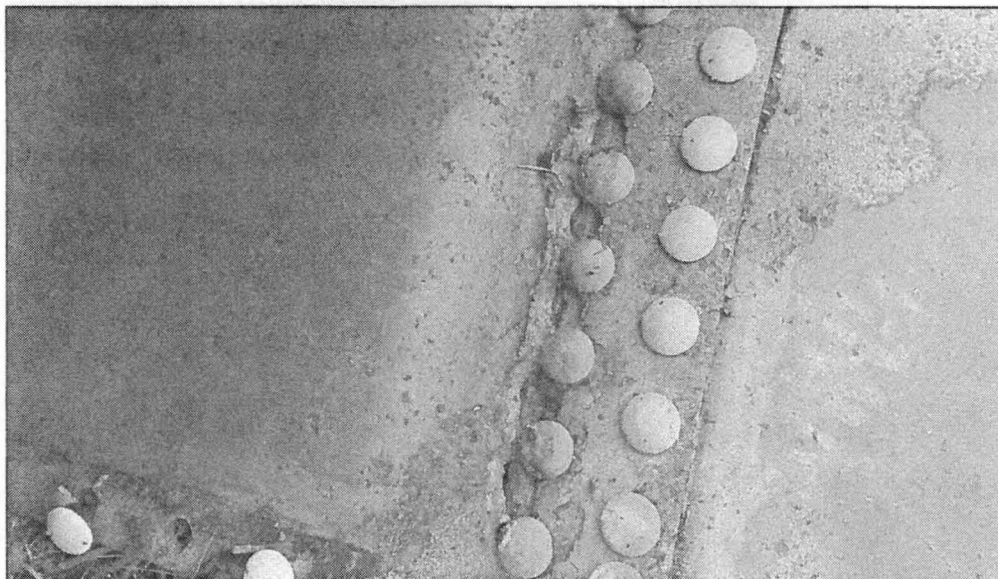
#3  
Interior bolts of the Waddy tank

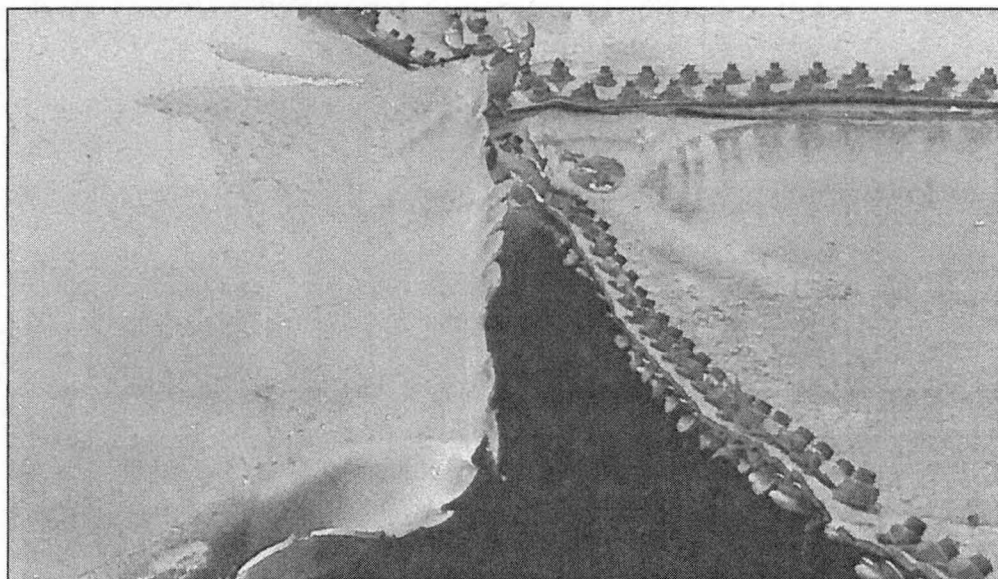
#4  
Exterior of Waddy tank shows where the tank ripped up the horizontal seam

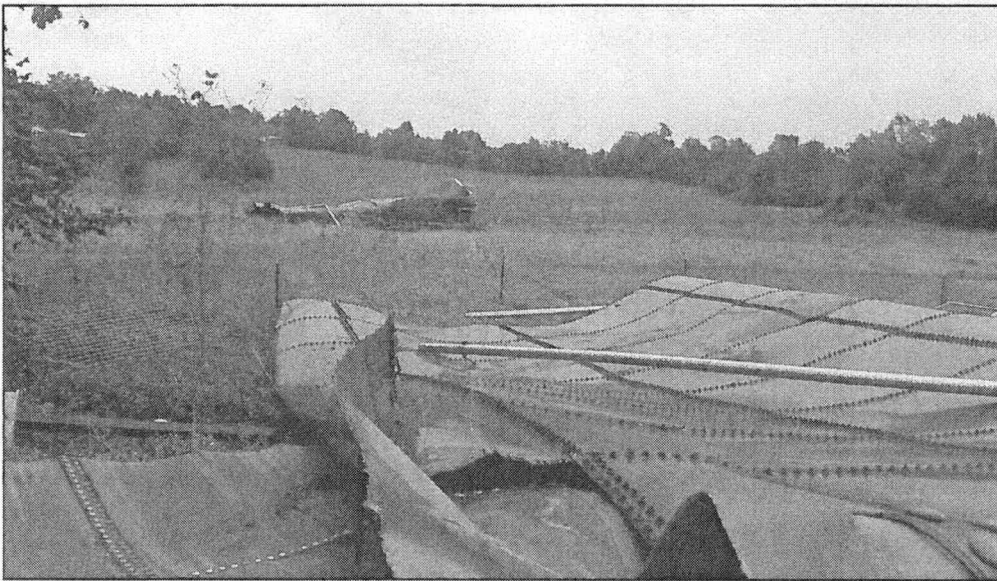
**#5**

Top section of the Waddy tank moved approximately 135 feet from base of the tank

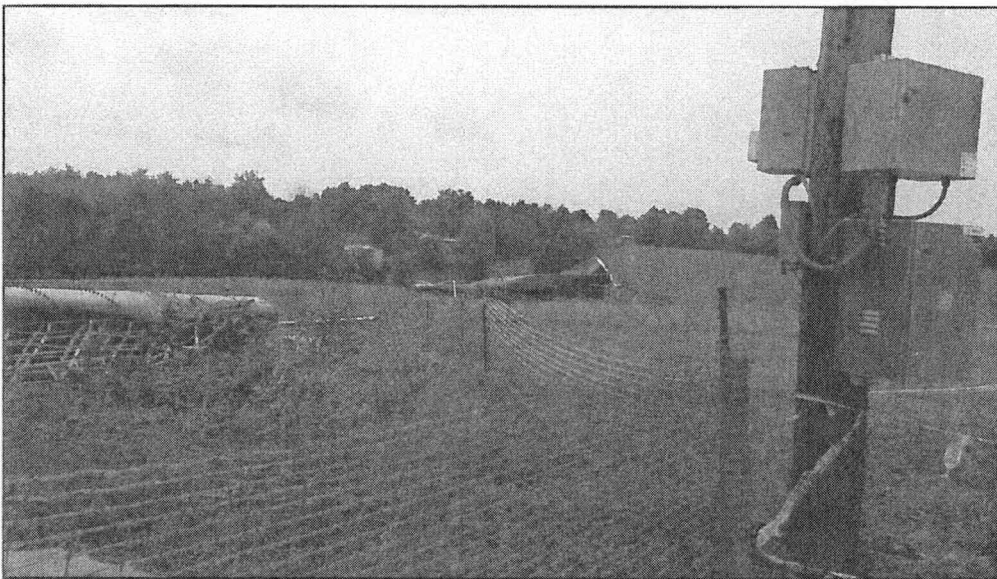
**#6**

US 60 Water District has fenced off tank site and has utility employees watching the tank until clean up

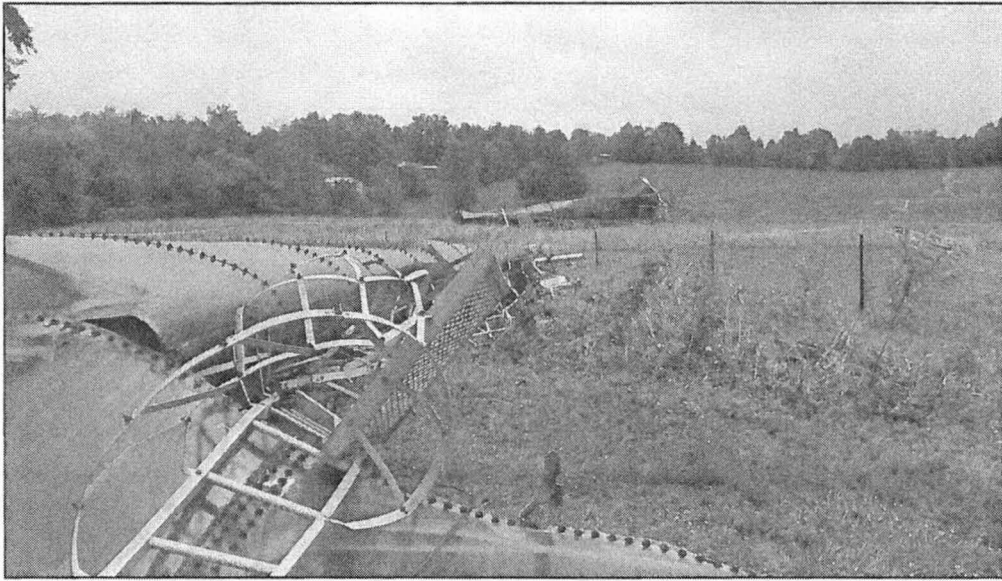
**#7**  
Bottom section of tank

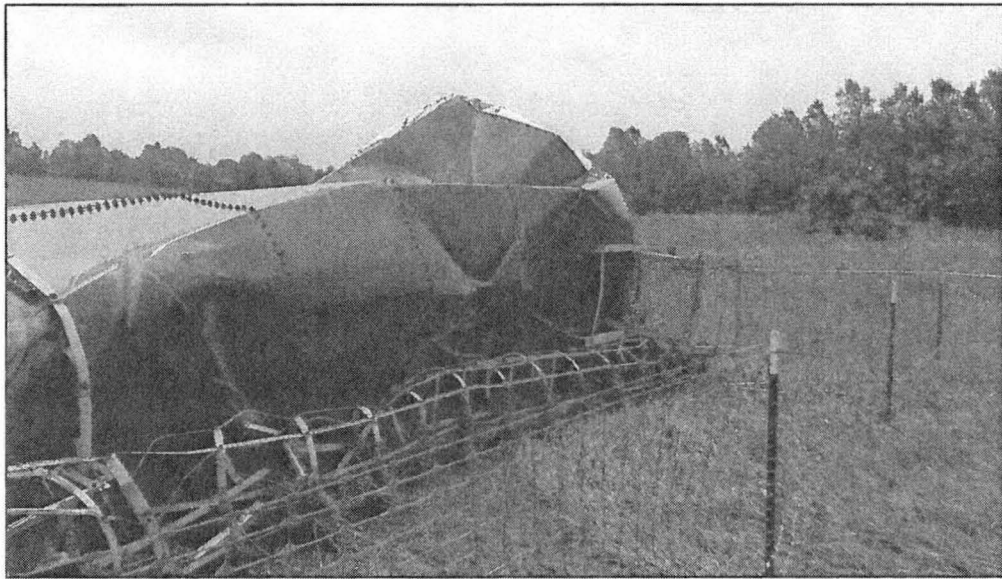
**#8**  
Top section of the tank

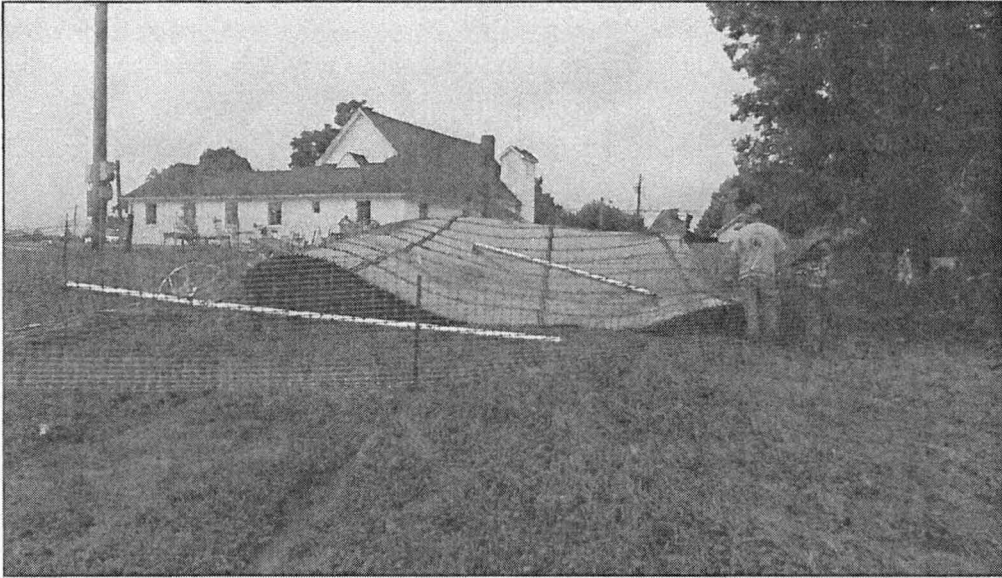
**#9**  
Bottom section of tank and Waddy Baptist Church

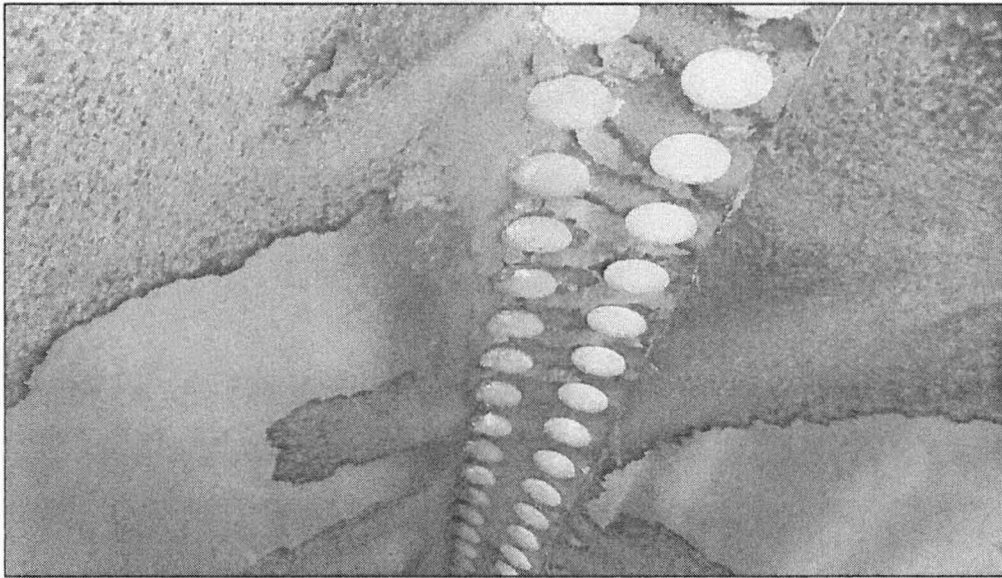
**#10**  
Interior vertical seem of Waddy tank
