COMMONWEALTH OF KENTUCKY  
BEFORE THE PUBLIC SERVICE COMMISSION

U.S.60 WATER DISTRICT	)	
	)	
_____	)	CASE NO.
	)	2015-00037
ALLEGED FAILURE TO COMPLY WITH	)	
807 KAR 5:006, SECTIONS 26 AND 27,	)	
AND 807 KAR 5:066, SECTION 7	)

ORDER

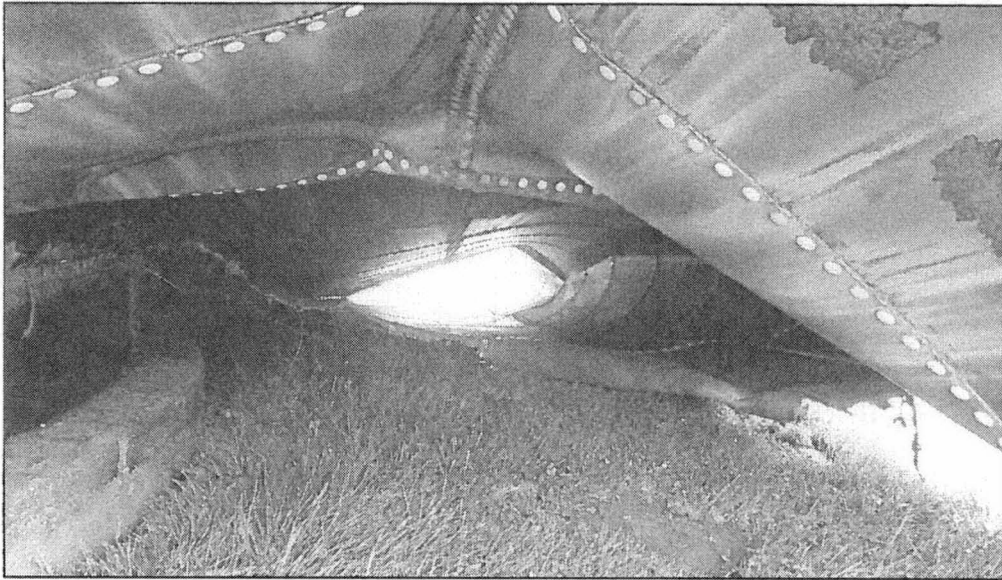
**#11**

To the left is the base of the tank and the interior of the tank

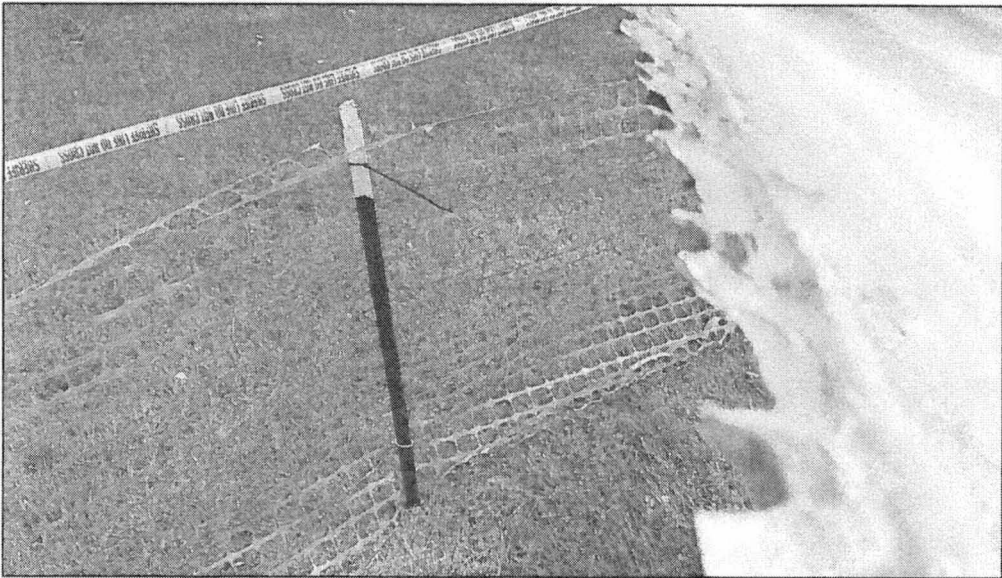
**#12**

Where US 60 engineer believes the tank failed

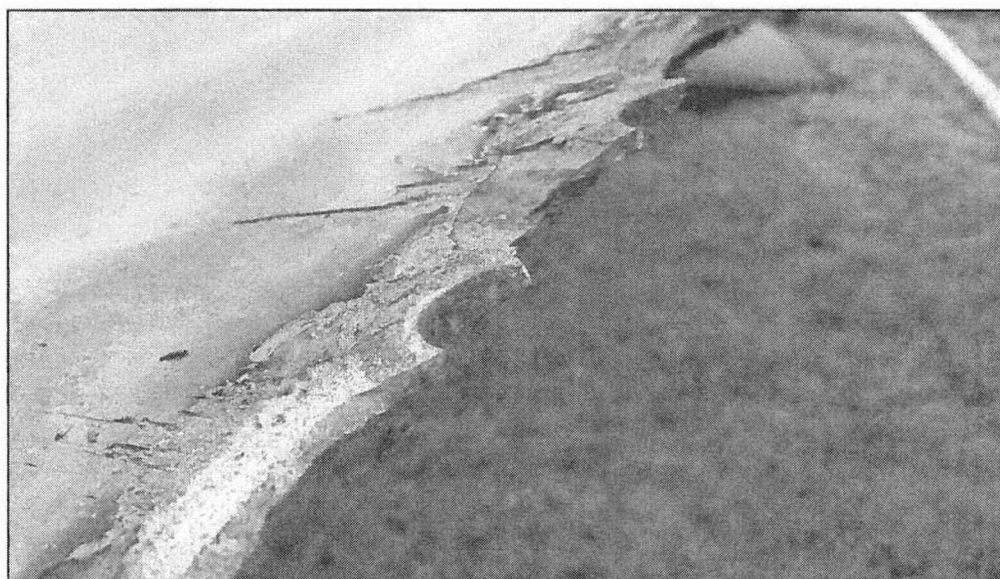
**#14**

Bolts when up the seam of the tank and metal seemed to have lost thickness

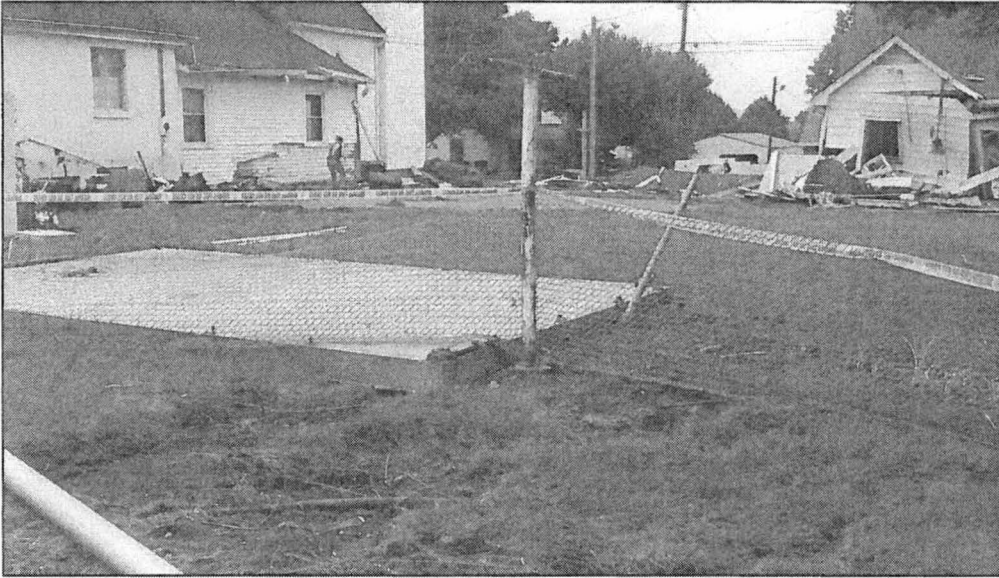
**#15**

Concrete pad where maintenance shed for Church sat. To the left is the Church and the right is the Sunday school building.

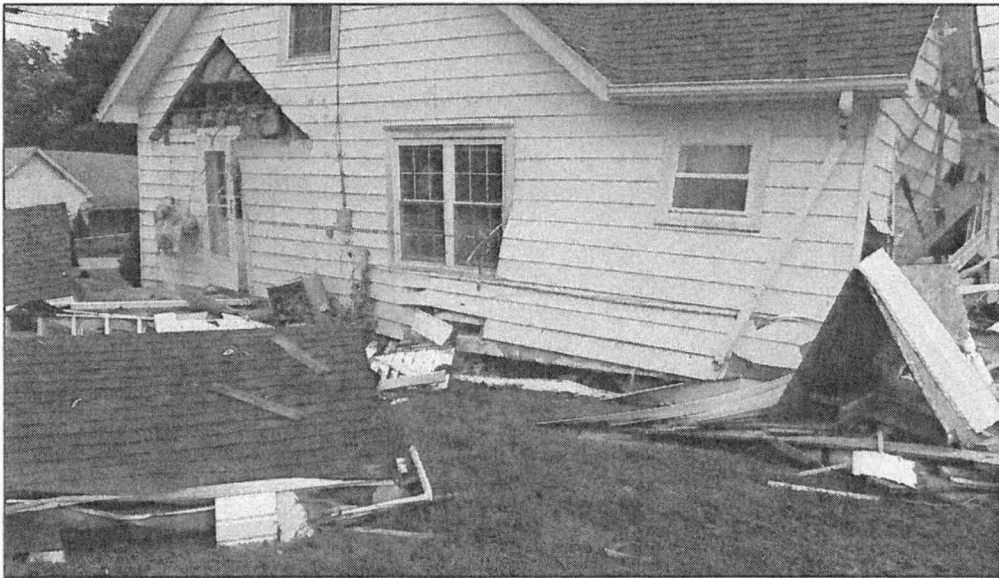
**#16**

Roof of maintenance shed in lower left and side of Sunday school building

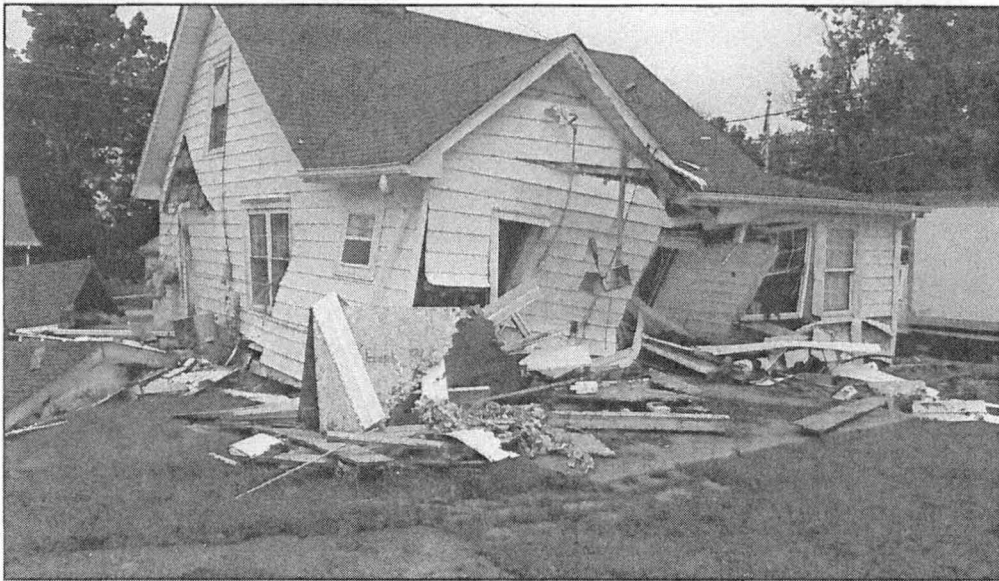
**#17**  
Back of Sunday school building.

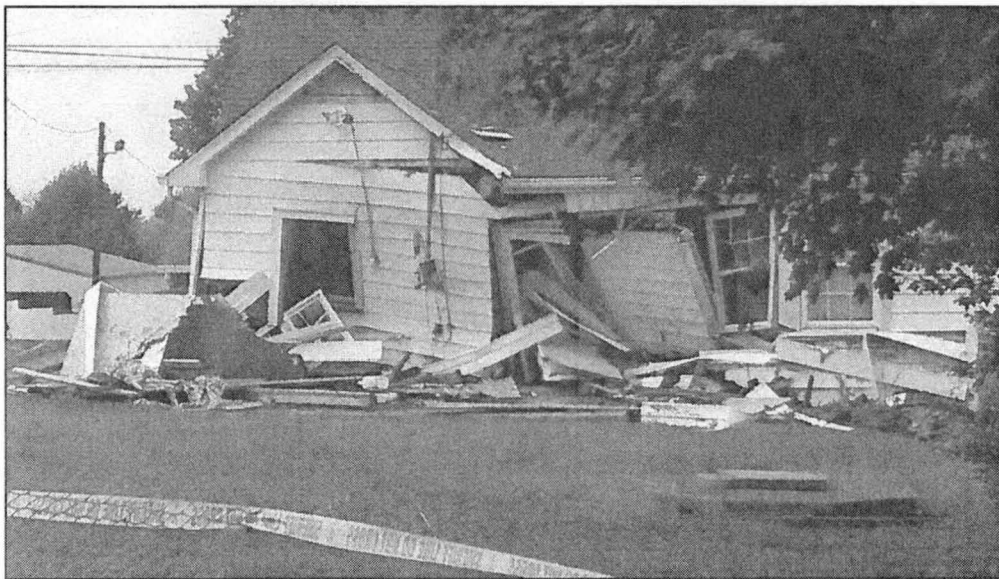
**#18**  
Back of Sunday school building and debris from maintenance shed

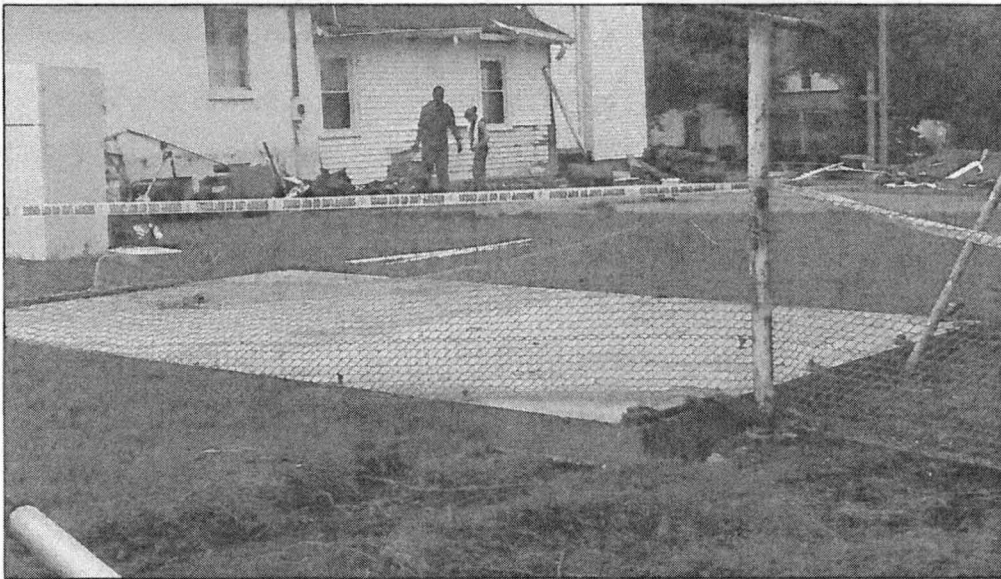
**#19**  
Side of church

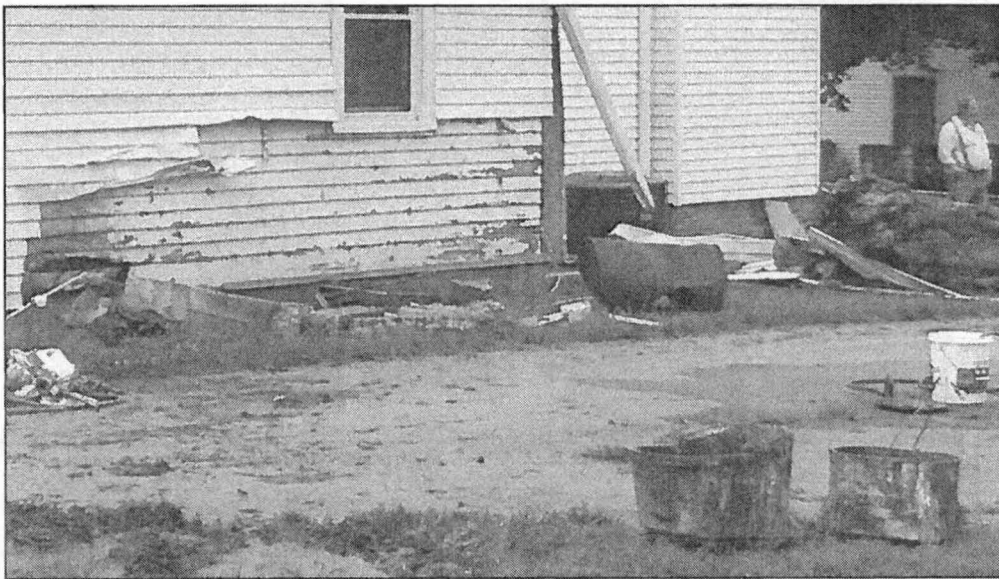
**#20**  
Side of the Church and in right corner a tree stump that was pulled out by the water

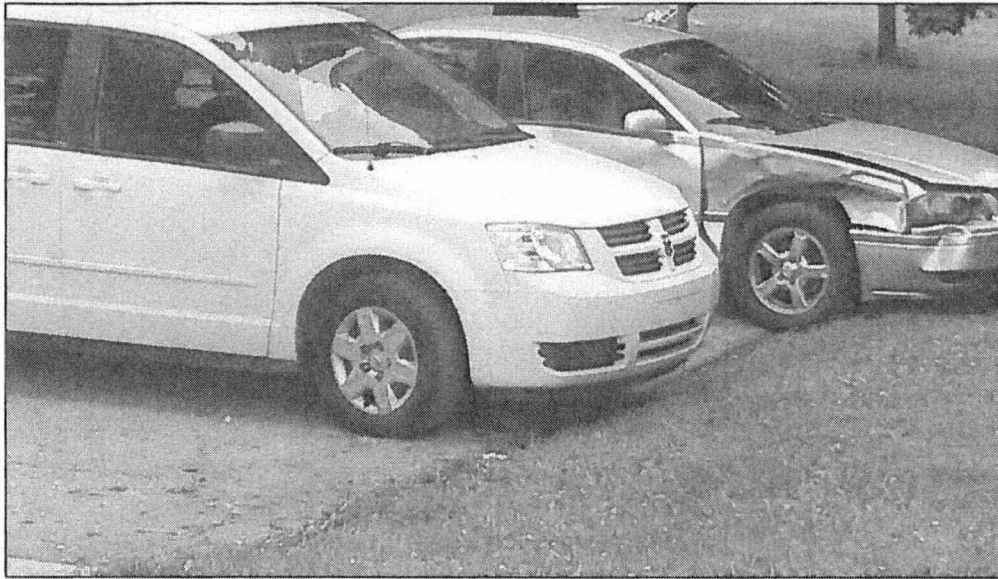
**#21**  
Car that was damaged

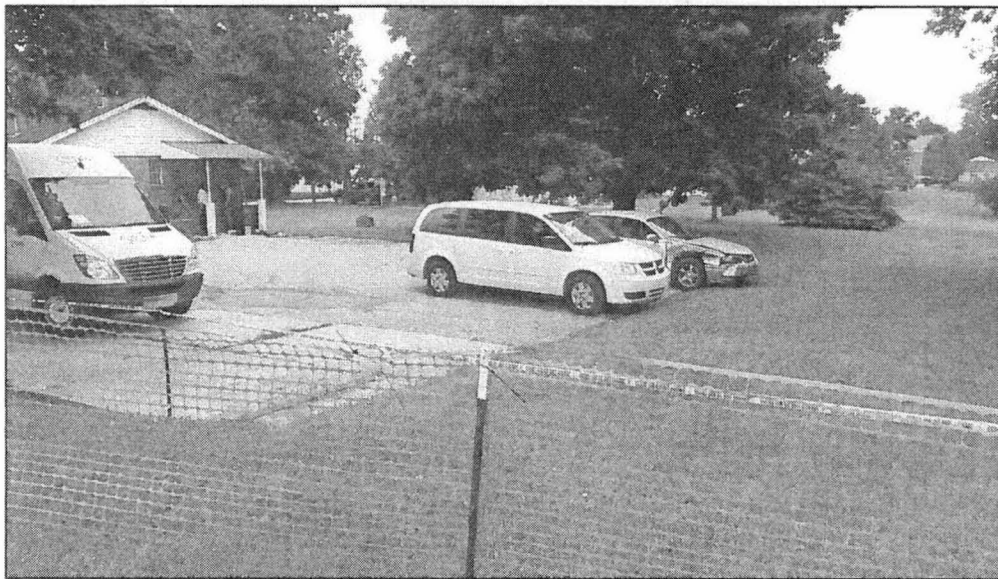
**#22**  
Car was parked in furthest left parking spot and pushed out beyond  
the tree

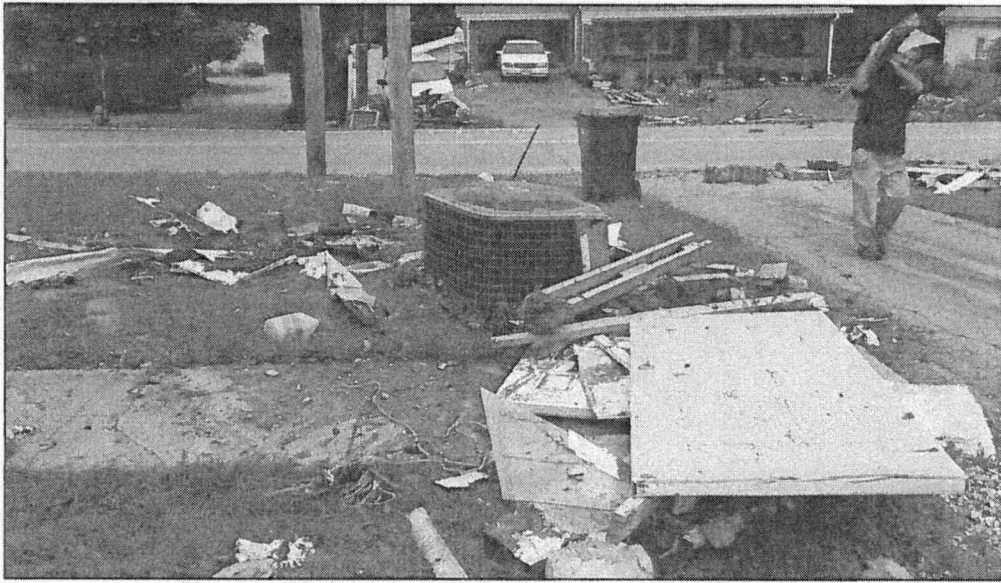
**#23**  
Front sidewalk to church

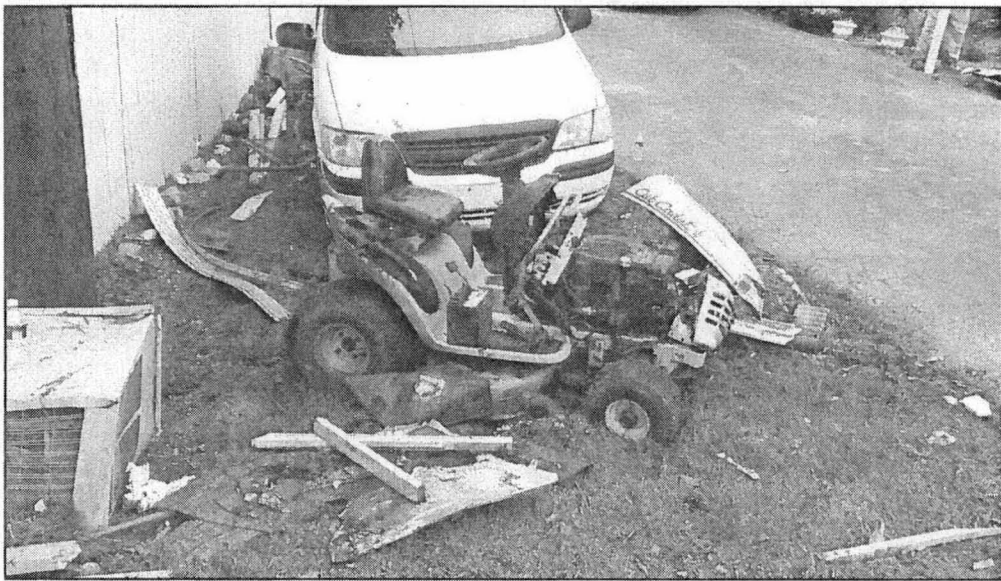
**#24**  
Lawnmower that was pushed out from the maintenance shed and  
across the road
