Re: **BULLITT UTILITIES, INC.'S NOTICE OF SURRENDER
AND ABANDONMENT OF UTILITY PROPERTY**

**SUBJECT: Hunters Hollow Treatment Plant
Field Inspection for Steel Tank
Bullitt County, Kentucky**

**SUBJECT: Hunters Hollow Treatment Plant
Field Inspection & Analysis for Structural Slab/Foundation
Bullitt County, Kentucky**

**SUBJECT: Hunters Hollow Treatment Plant
Addendum for Field Inspection & Analysis for
Structural Slab/Foundation
Bullitt County, Kentucky**

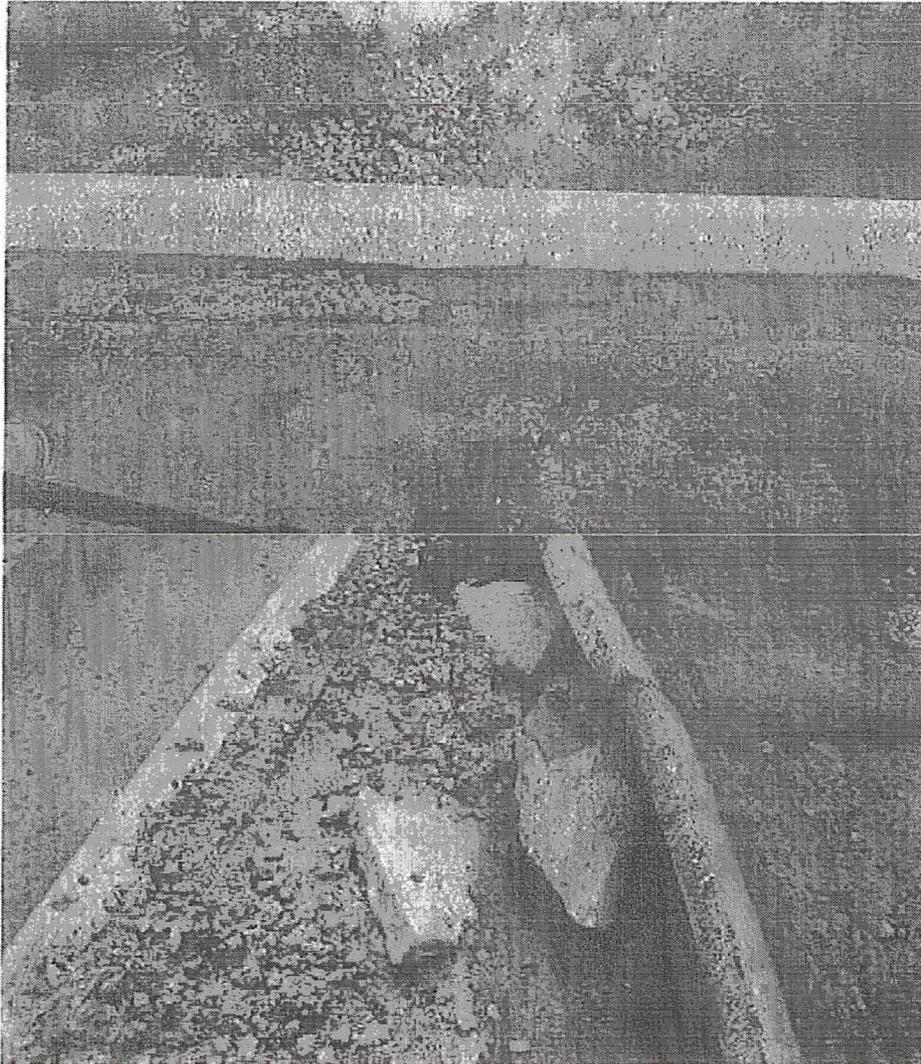
Inspection of the existing welds did not identify that structural tank failure occurred at these weld joints, as can be seen in the attached photographs. The steel tank pieces were welded to a piece of 8" channel to join the tank that was originally set in a concrete foundation about 4" deep (on the channel). These steel tank pieces and channel were observed to have been ripped out of the concrete foundation of the tank. Additionally, large chunks of concrete foundation were scattered about the site and around the steel tank pieces that had been stacked.

Since the lower portion of the tank receives a higher structural load and based on review of the channel pulled from the concrete foundation, we have estimated that separation must have occurred at the bottom of the tank and from a possible rupture or failure directly at the concrete foundation level. This could have been caused from concrete cracking, or insufficient sub-surface conditions that allows differential settlement. It was noted from talking with the treatment plant operator that this site has typically been identified as a wet "swampy" area adjacent to this existing stream.

We were unable to inspect the tank concrete foundation in detail due to the great amount of sludge that was covering the entire foundation section. Once this material has been cleared from the site additional inspection of the concrete foundation slab is recommended. Additionally, testing by a geotechnical engineer to determine concrete foundation thickness, soil testing beneath the slab, and depth to rock is also

recommended. This could also determine if any groundwater is present underneath the slab. Additionally, once the sludge has been removed specific areas of the concrete foundation can be further inspected to identify if the exact location of the failure can be determined.

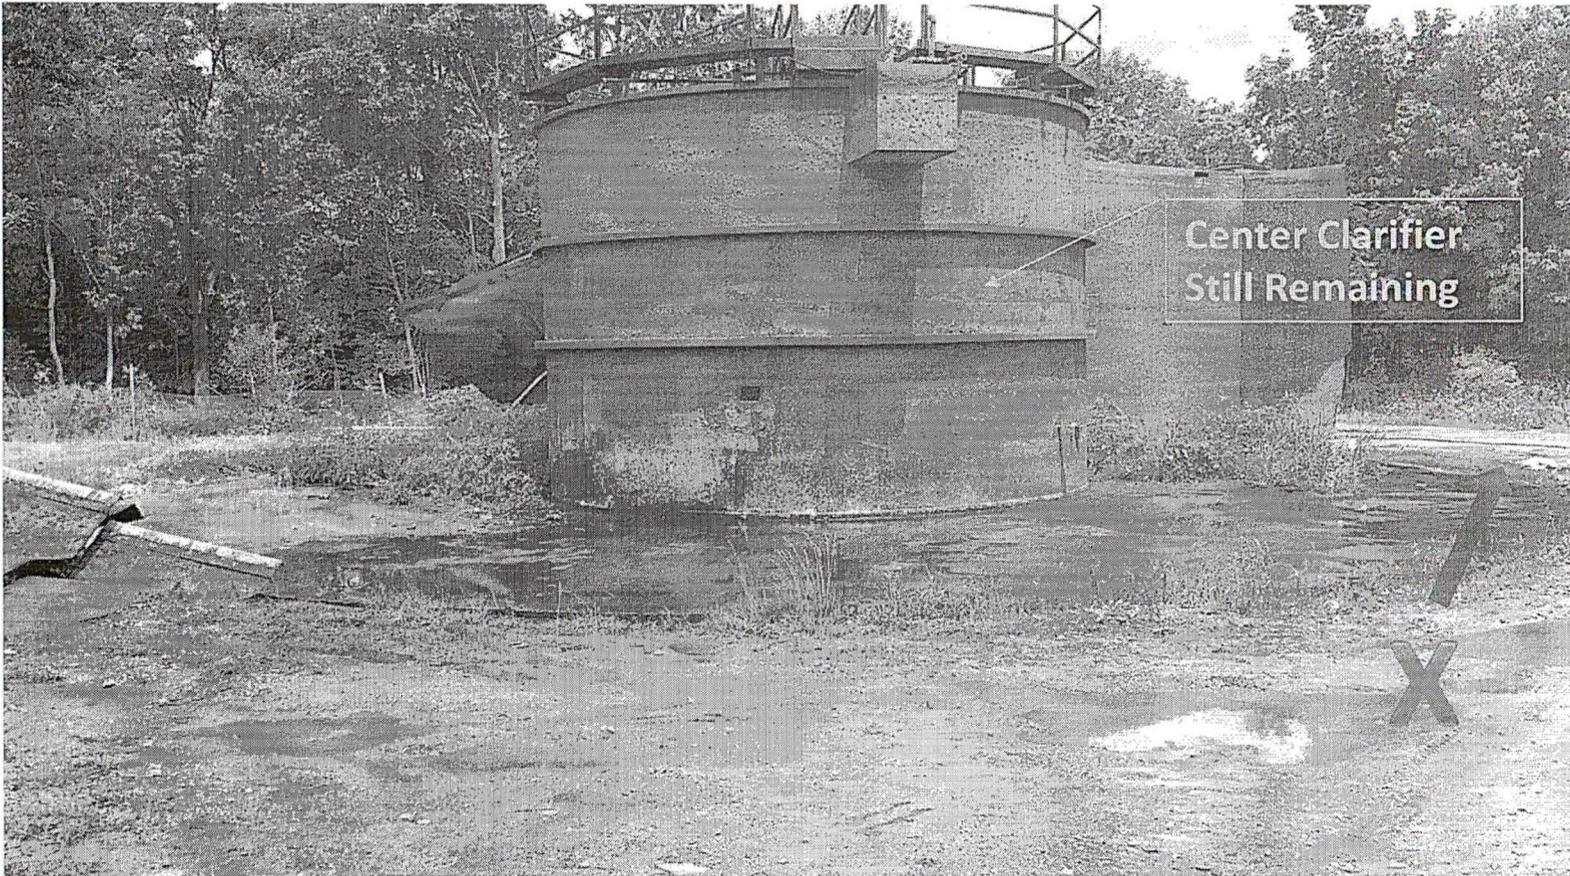
Exhibit "B" – Interior Concrete Slab
(looking East)

The field review noted that the "interior" concrete slab was actually in very good condition and did not show signs cracking or settlement (Exhibit "B"). A concrete scan was not performed, but the interior slab should have steel reinforcement that held the slab in place during the failure of the tank. While not all of the slab was visible due to some portions still remaining covered with sludge material and/or the remaining section of reinforced mixing tank/stairs and clarifier, Exhibit "C" shows the areas that were cleared and visible, mostly on the west side to the south and southeast (a majority of the slab that existed under the area of the aeration tank that failed).

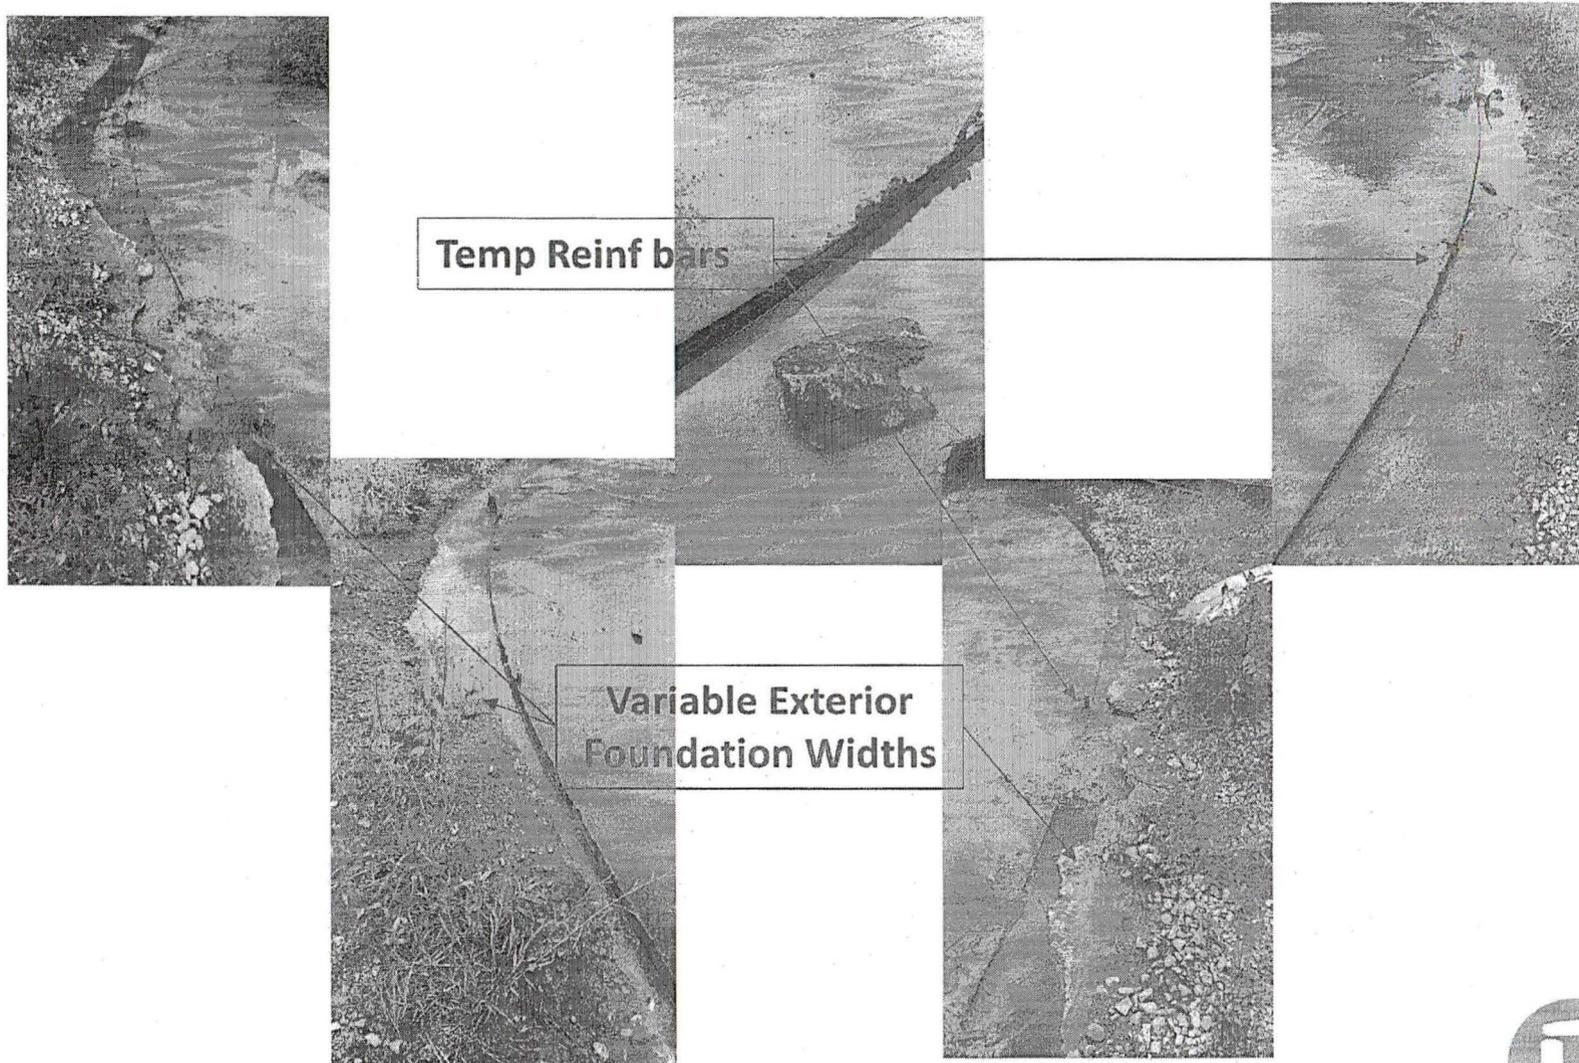
**Exhibit "D" – Concrete Slab Edge &
Variable Exterior Foundation Widths**

The concrete slab "edge" where the concrete abutted the steel tank channel on the interior side is in good condition as shown in Exhibit "D". Only a couple damaged locations are shown along this interior edge, from where the temporary welded steel reinforcement bars were installed in the foundation at the time of the initial concrete pour to provide a connection for the tankage while the steel channel was installed and the second concrete pour for the foundation was completed. Exhibit "D" additionally shows various locations along the exterior foundation slab indicating the variable width of concrete slab on the "exterior" portion of the foundation. These widths range from only 4 or 5 inches, all the way up to 2 feet.

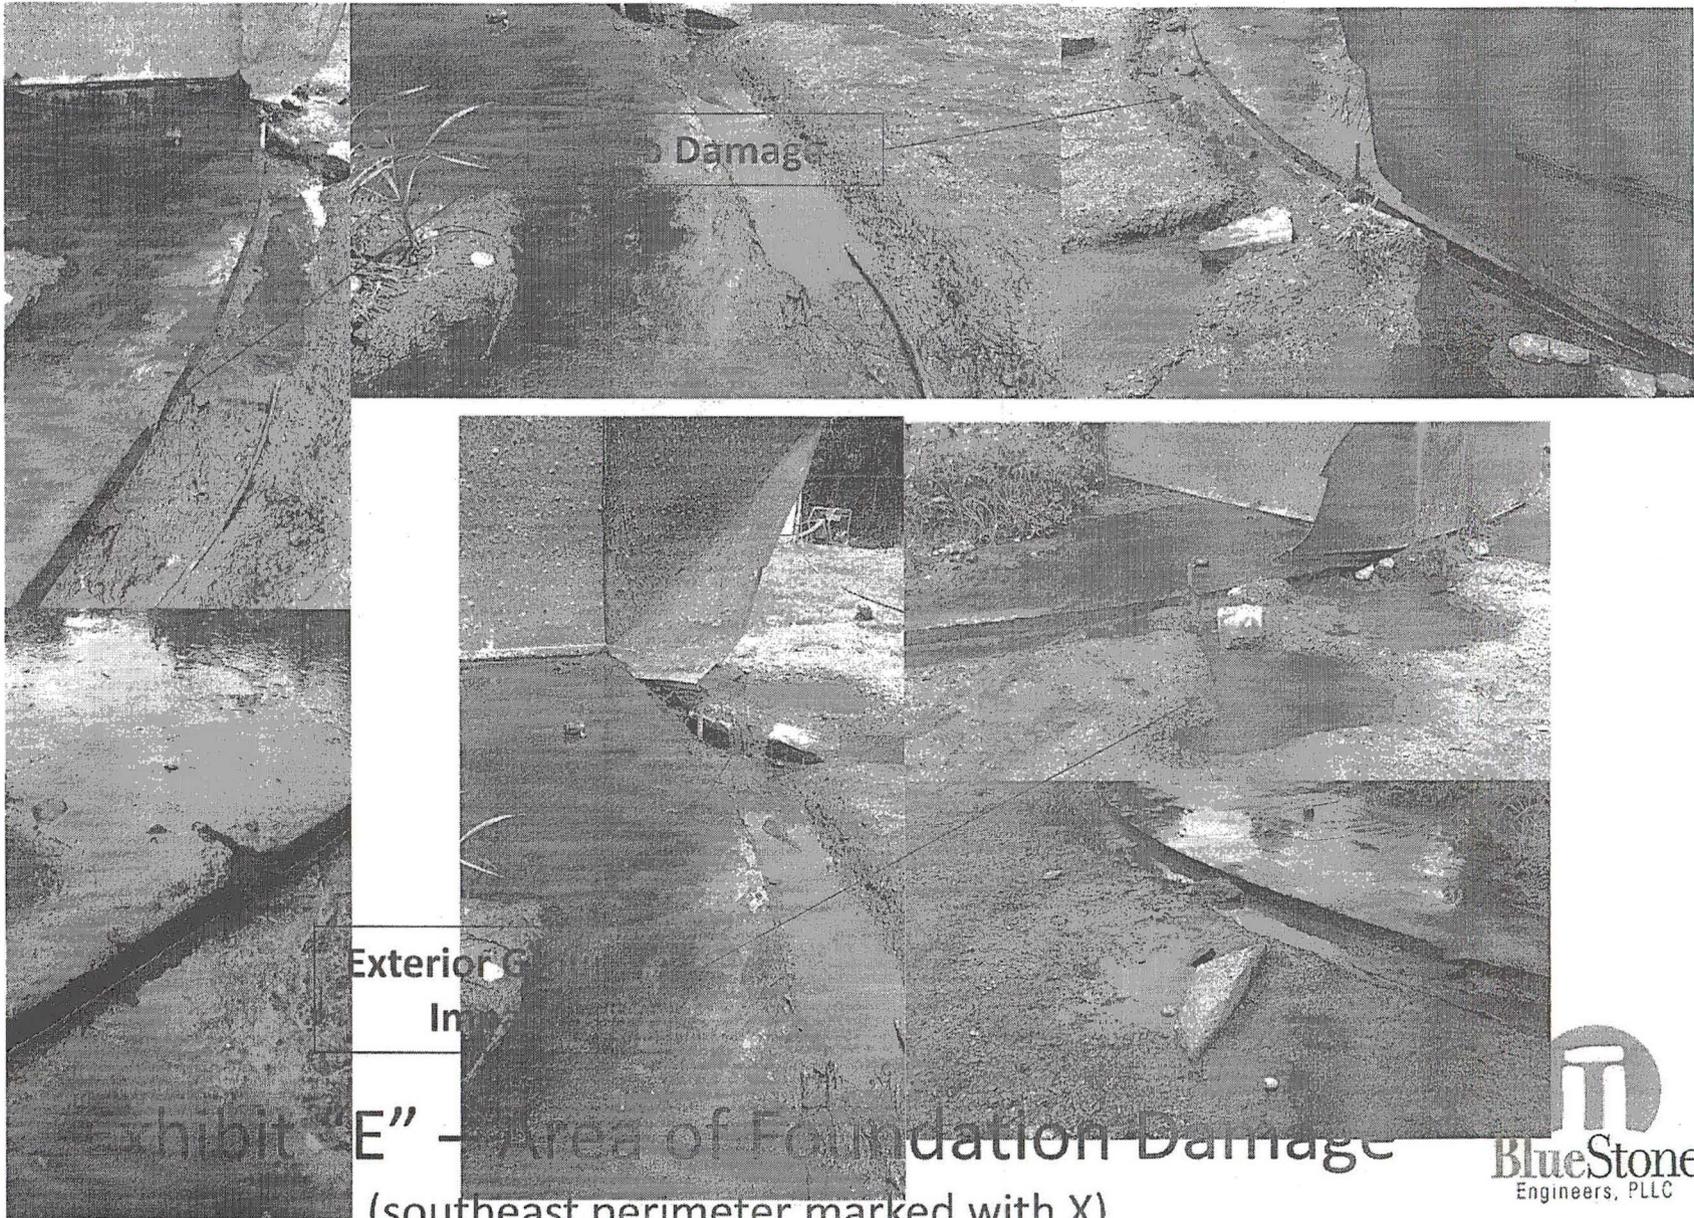
Exhibit "E" - Area of Foundation Damage

The most notable area of damage is shown in the southeast quadrant of the tankage -- this area looks to have received the most damage along the exterior foundation as compared to rest of the perimeter foundation -- this can be seen in Exhibit "E".

From inspection of the interior slab condition (very good), as well as inspection of the exterior of the foundation section (pieces that have broken off from the foundation and are scattered about the site) this is indicative of a shear failure of the concrete foundation between the interior and exterior sections of the foundation where the steel channel was installed, see Exhibit "G" for typical detail. Since the exterior portion of the concrete foundation did not include any additional steel reinforcement, the section of foundation from the steel channel outward separated along the shear plane and pulled free from the interior foundation and slab during the failure of the plant. Most likely this occurred at the exterior foundation's weakest point along the perimeter, which from the review of the perimeter damage seems to be at location "X" as seen in Exhibit "A" and "B", and as shown on Exhibit "E". Pictures of the exterior foundation pieces showing the shear plane are shown on Exhibit "F".

(southeast perimeter marked with X)

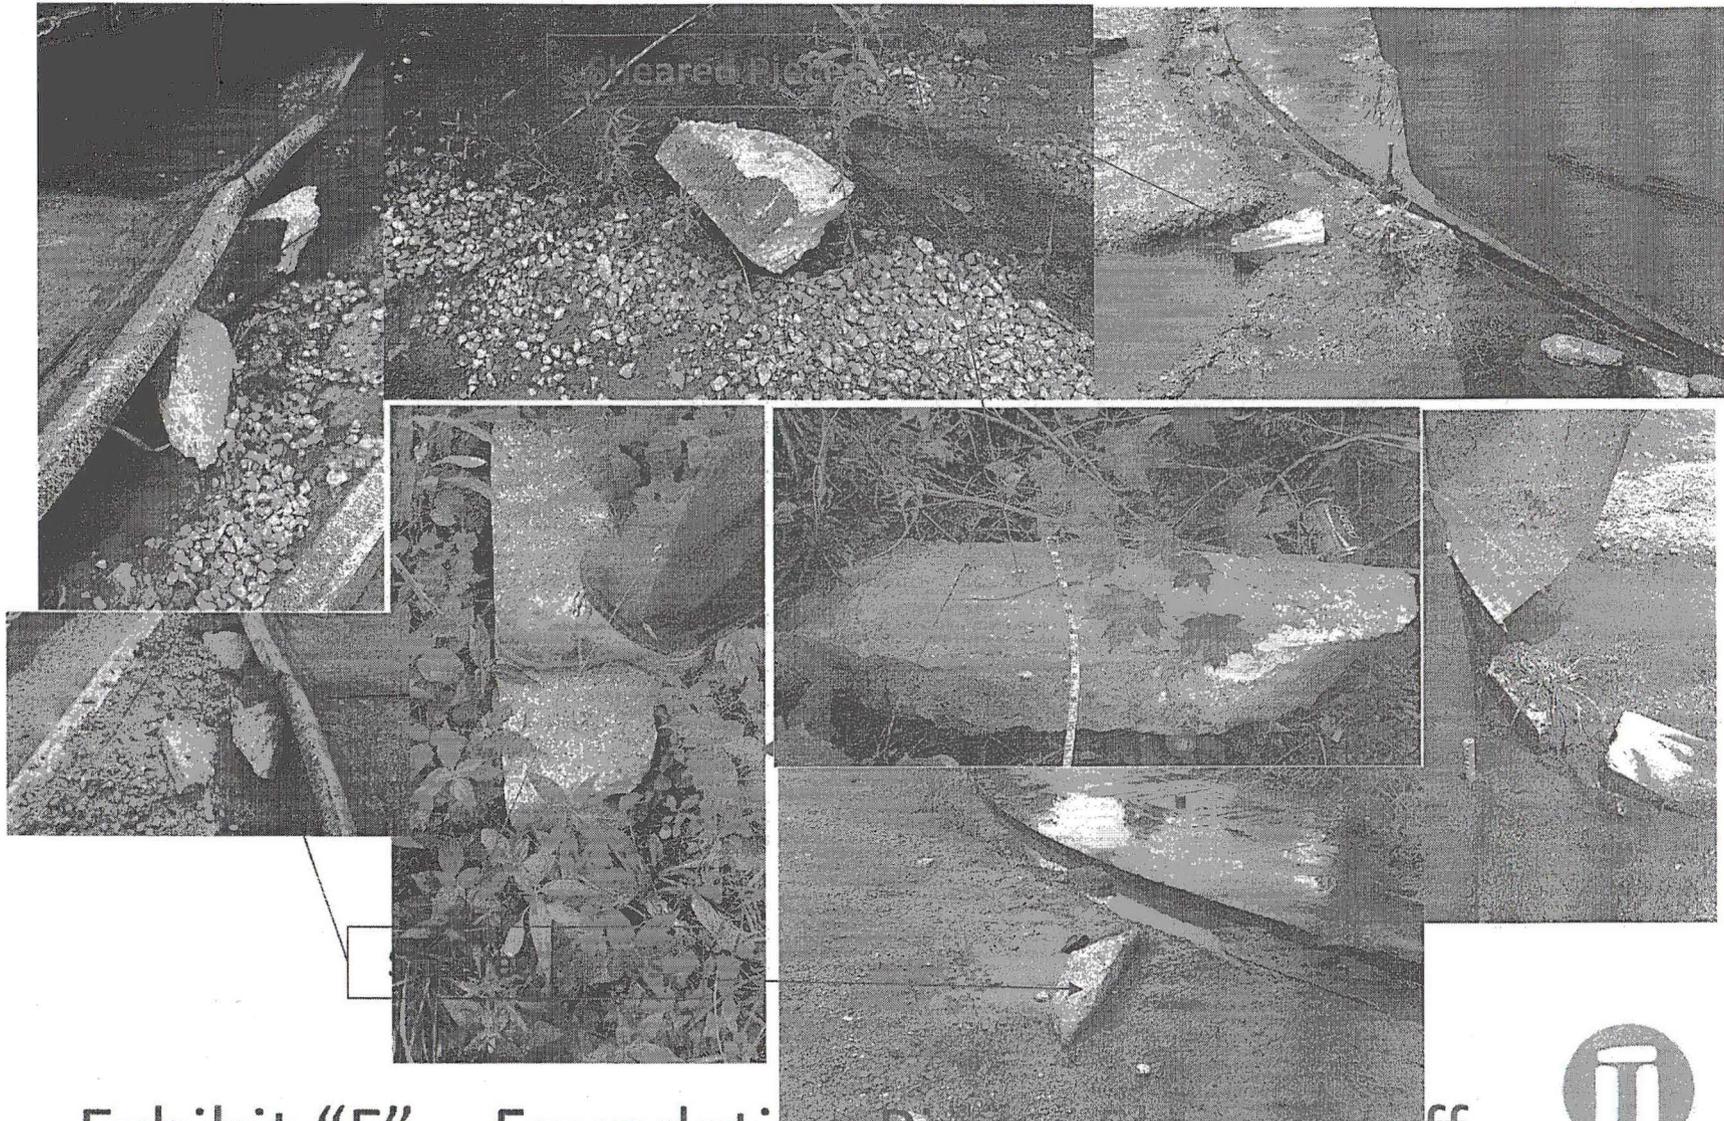
Exhibit "F" – Foundation Pieces Sheared off
(no steel reinforcement)

Most important to note is that none of the exterior portion of the concrete foundation that held the steel channel in place includes structural steel reinforcement. Upon failure of the tank and foundation, when the steel channel was pulled from the foundation, these exterior pieces of concrete slab separated into typical 3' and smaller sections that are scattered around the site. Examples of some of these exterior foundation slab pieces are shown in Exhibit "F". These exterior slab pieces were found as far as 100 feet away from the tank foundation site.

2. The exterior portion of the concrete foundation did not include steel reinforcement to account for "tension" force created by the channel pulling out of the foundation. Thus, the many pieces of concrete foundation that separated from the tank foundation demonstrate this smooth "shear plane" on their interior side.
3. The interior slab looks to be in excellent condition

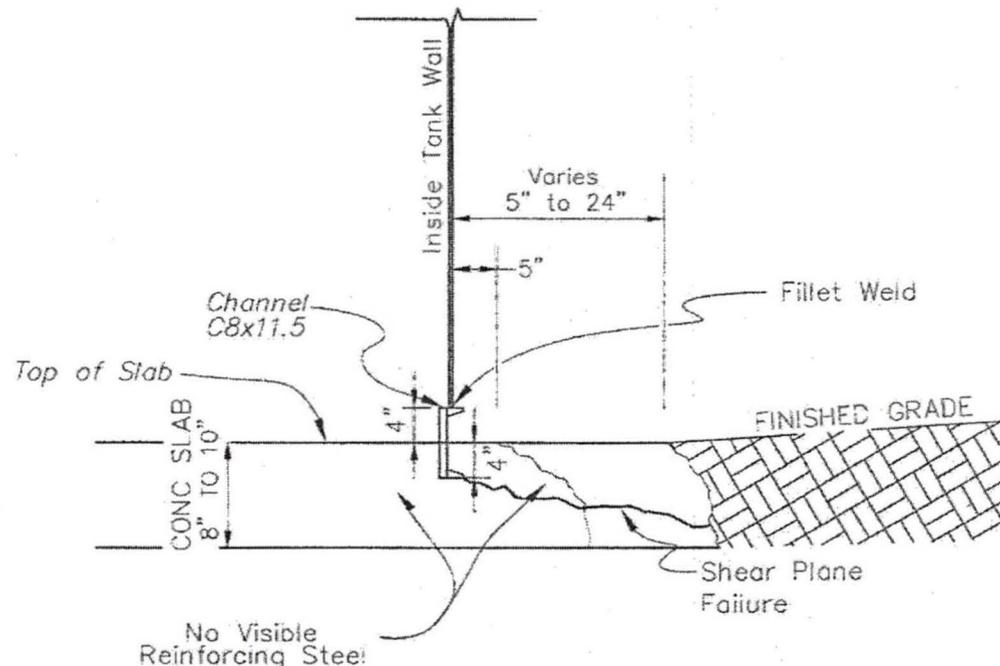
Exhibit "G" – Foundation Section

(shear plane failure)
