COMMONWEALTH OF KENTUCKY
BEFORE THE PUBLIC SERVICE COMMISSION

LOUISVILLE GAS & ELECTRIC)
COMPANY)
_____) CASE NO. 2017-00119
)
ALLEGED FAILURE TO COMPLY WITH)
KRS 278.495, 807 KAR 5:022, AND)
49 C.F.R. PART 192)

ORDER

LG&E Natural Gas Pipeline Rupture

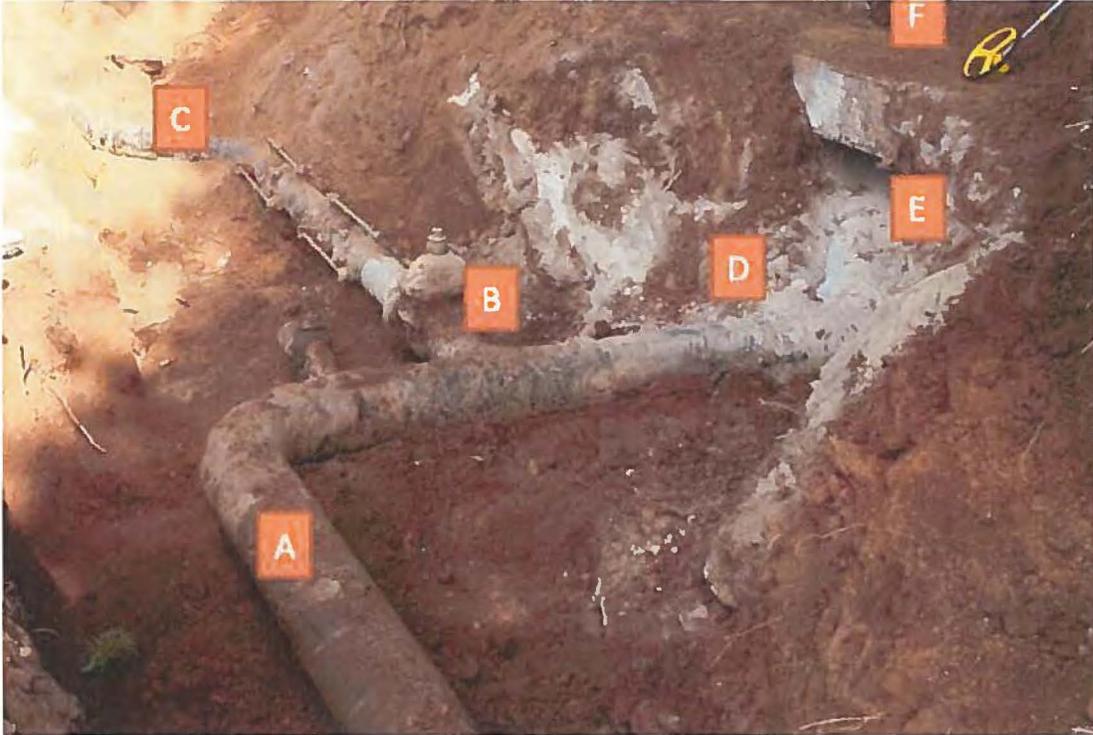
Figure 1. Highway 42 Goshen KY intersection excavation prior to pipe separation

Figure 1 above shows the layout of the pipes prior to the incident. The mechanical coupling that failed can be seen just to the left of the letter E. After the incident the pipes involved were moved offsite and photographed by LG&E.

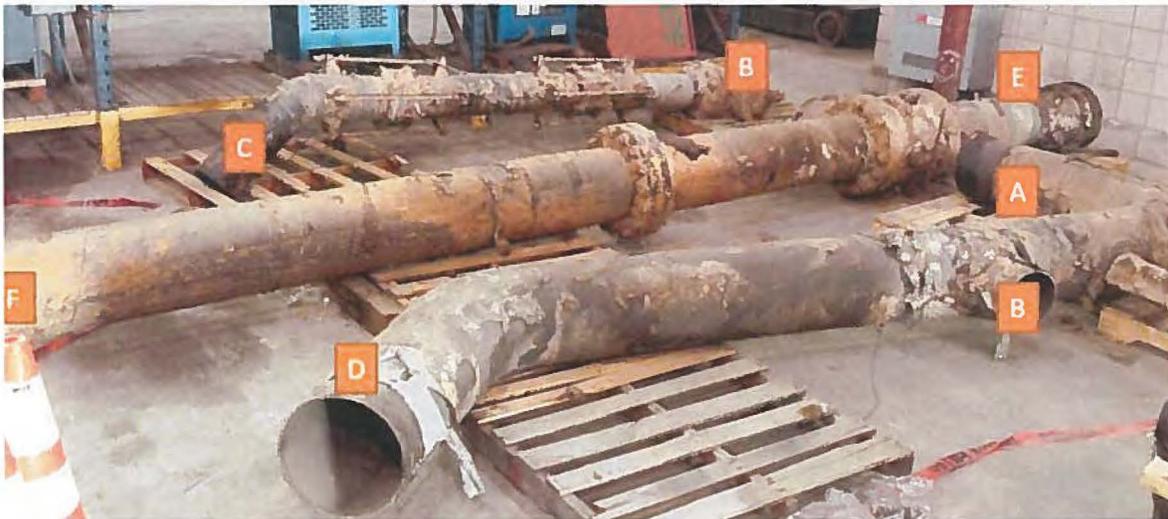
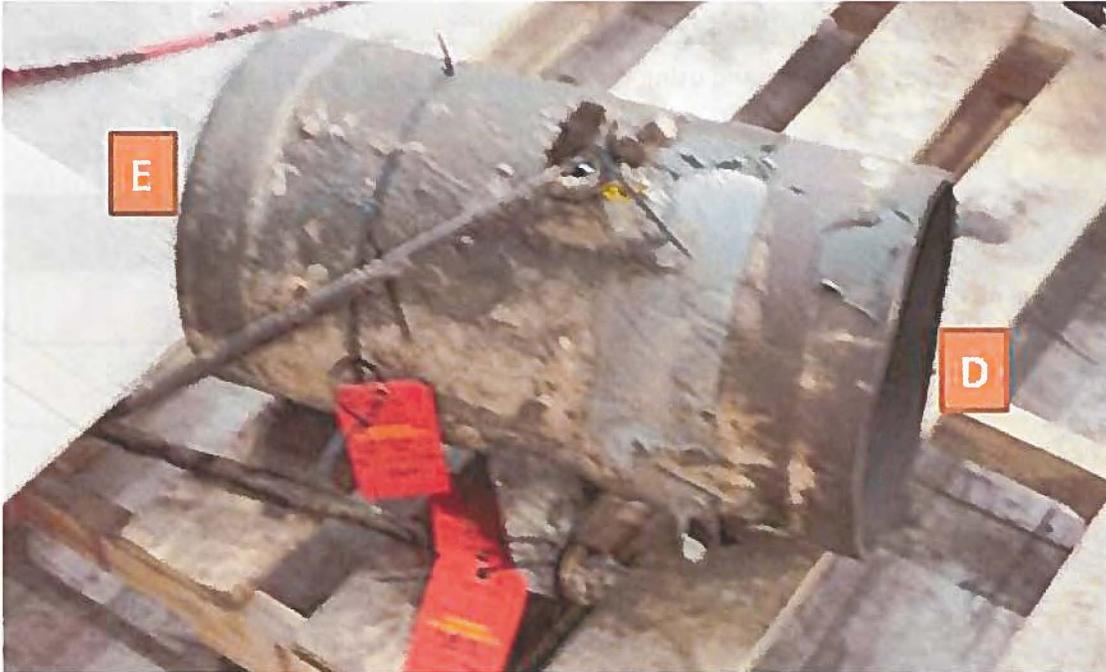
Figure 2. Pipes removed from Goshen Intersection as photographed by LG&E

Figure 3. End segment D-E, pipe was cut by LG&E at D after incident

Figures 2 and 3 above are photographs of the pipes submitted by LG&E after they were removed from the field. Segment D-E was cut from what was originally A-E and henceforth will be referred to as pipe A-D. The uncoated area around the pipe seen at the left at E in Figure 3 was within the coupling seen at E in Figure 2. The 8" pipe seen at the top of Figure 2, segment C-B, was not involved in the incident. LG&E submitted it to GTI for inspection and evaluation of the integrity of the couplings.

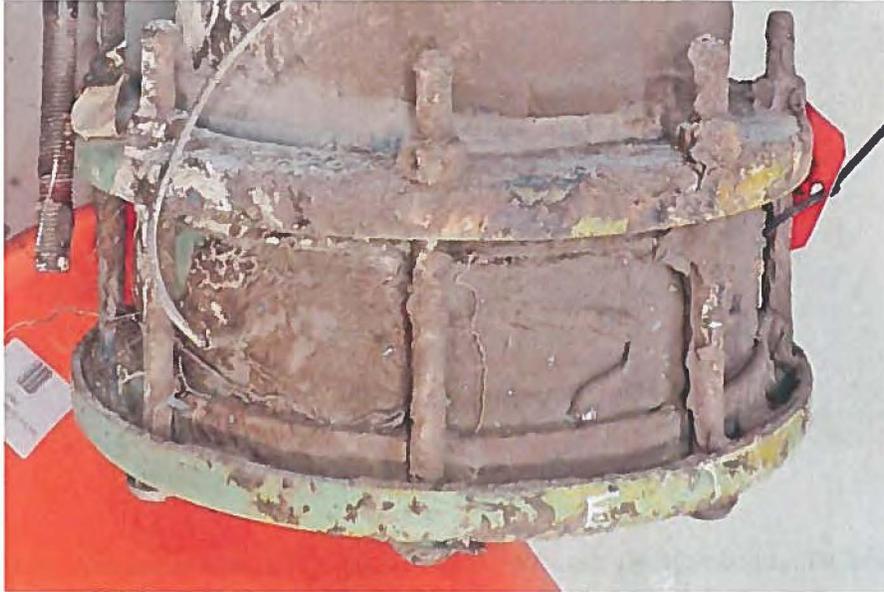
Upon receipt of the coupling it was inspected to ascertain its type and model number (Figure 4). Its appearance did not match that of any picture in the Coupling Systems Inc. catalog.

Figure 4. Failed 12" gas pipe coupling

However, based upon the number and size of the circle bolts, eight of $\frac{5}{8}$ " dia. X 9", the probable model number is E-1208B5-S. Because of the bolt diameter the coupling is definitely of the "seal-only" type, meaning it is not designed to provide pipe restraint. By design it is to be used only with rod and lug restraint devices (i.e., weld on brackets). Those couplings designed to perform both pipe sealing and pipe restraint, the Maxi-Grip couplings, utilize $\frac{3}{4}$ " dia. bolts. Because the coupling is not designed to prevent pullout, but gas sealing only, little more will be said of the coupling itself.

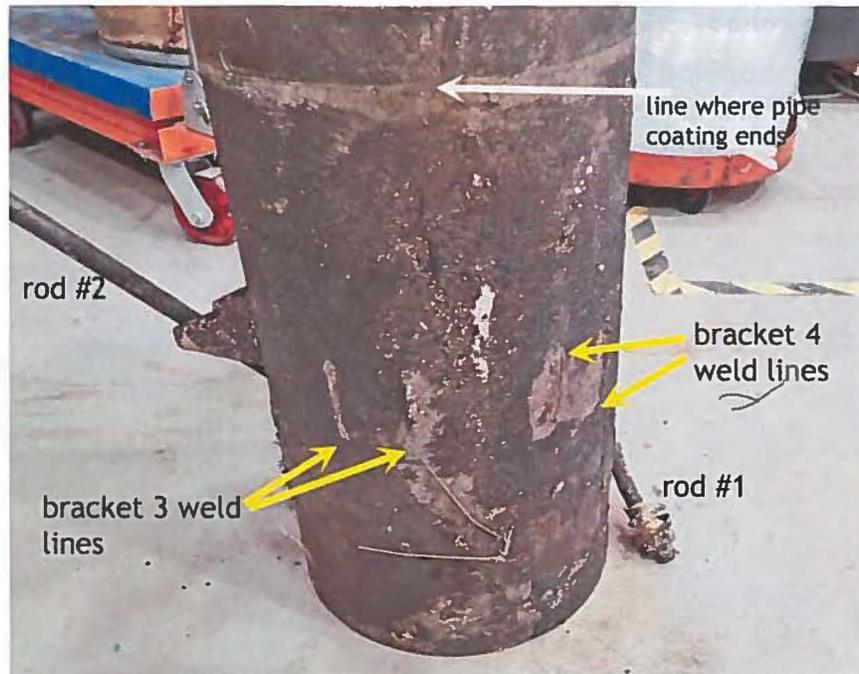
Figure 5. Pipe segment D-E (D side Zorn)

Brackets #3 and #4 had completely detached from the pipe. The welded surface of the pipe was examined and photographed, as shown in Figures 6 and 7.

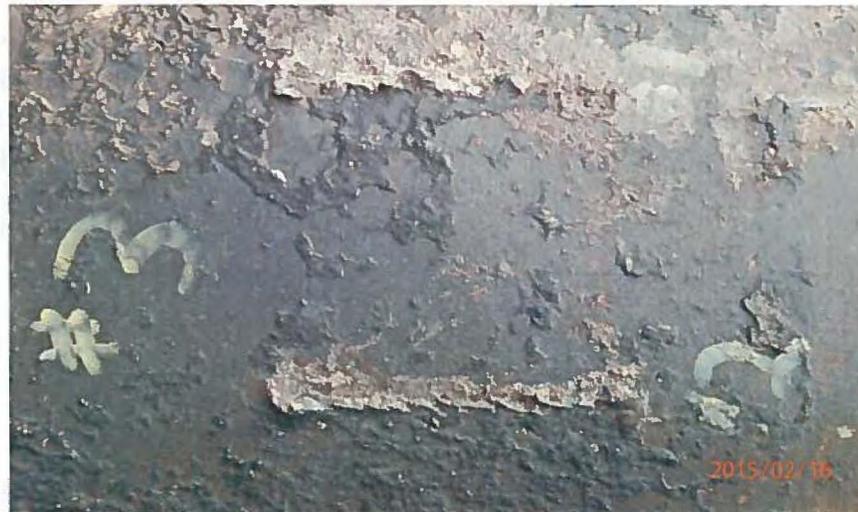
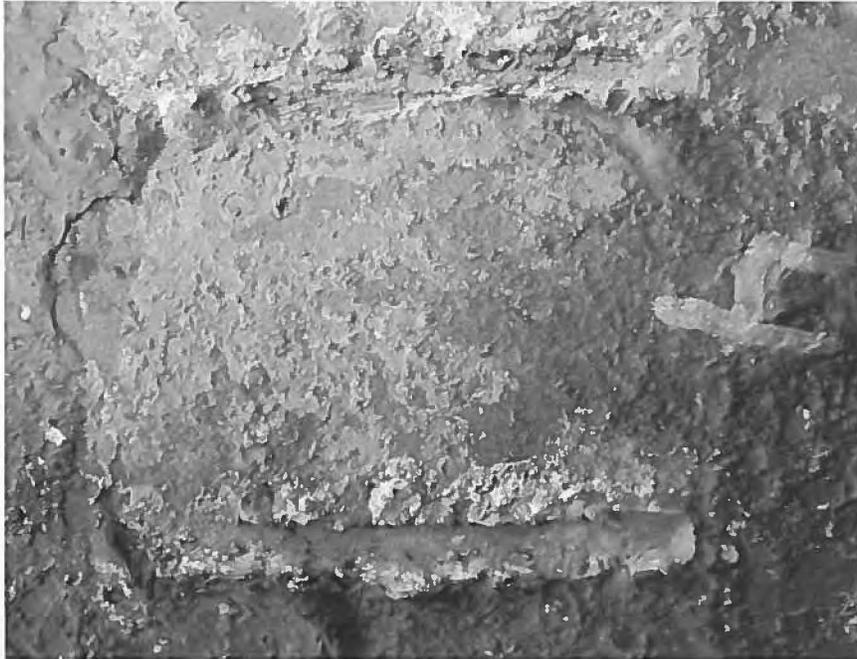
Figure 6. Bracket #3 weld surface on pipe segment D-E

Figure 7. Bracket #4 weld surface on pipe segment D-E

Close examination of the weld fracture surface showed considerable oxidation and dirt where brackets 3 and 4 were attached. Some areas of the pipe had no coating on them, but did not appear to be more corroded or dirty than the fracture surface itself. This suggests that brackets #3 and #4 had broken away long before the September 2014 incident. After inspecting the pipe surfaces, brackets #3 and #4 were examined.

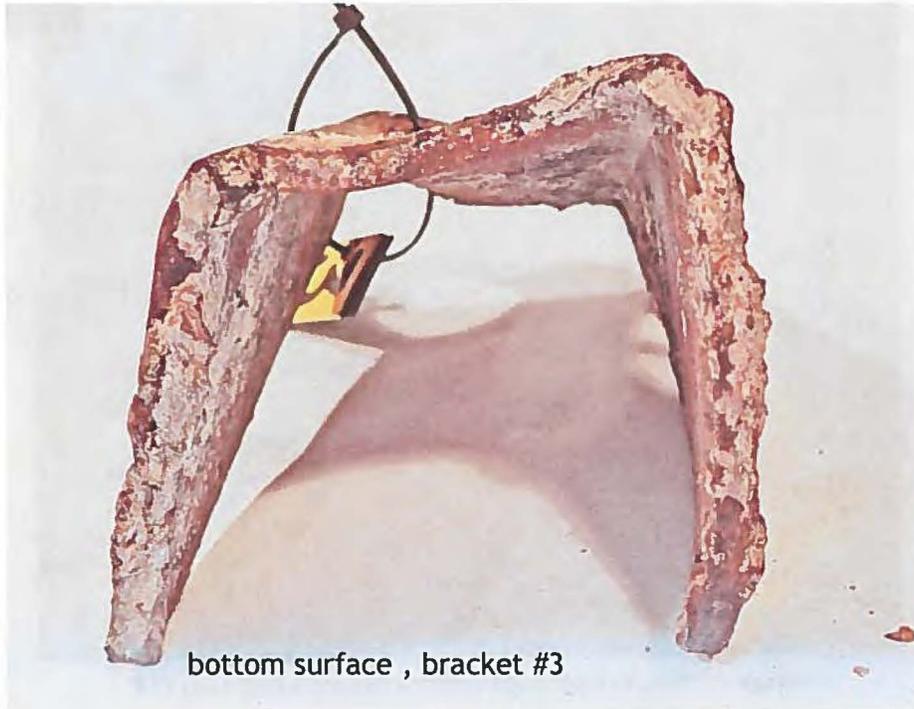
Bracket #3 was severely deformed. It appears that a compression load applied to the top bracket surface overloaded the bracket legs causing them to deform and spread open out (see **Figures 8, 9, and 10**). Examination of the bracket hole revealed metal flow in the direction of the coupling indicating that the threaded rod must have pulled through the bracket in this direction.

Figure 8. Bracket #3 as-received, 152148-001

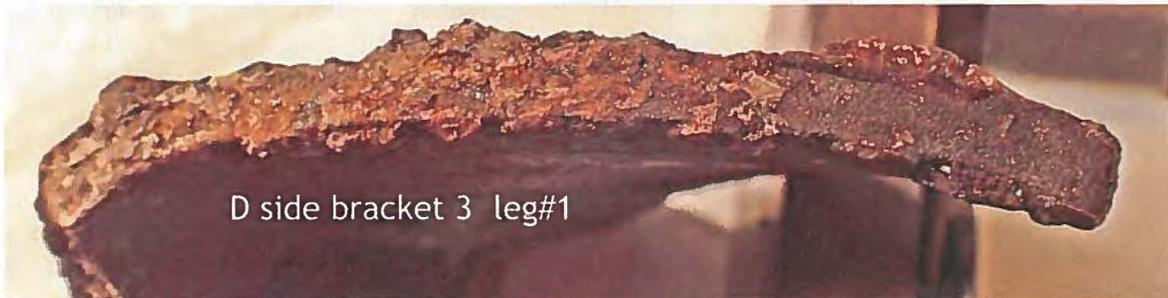
Figure 9. D side bracket #3, leg #1 before cleaning

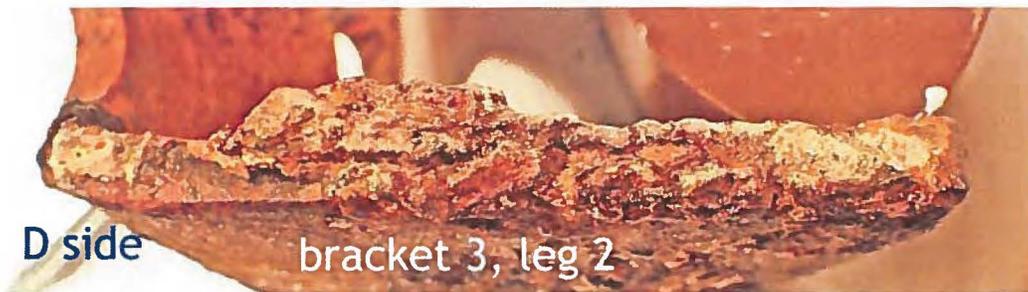
Figure 10. D side bracket #3, leg #2

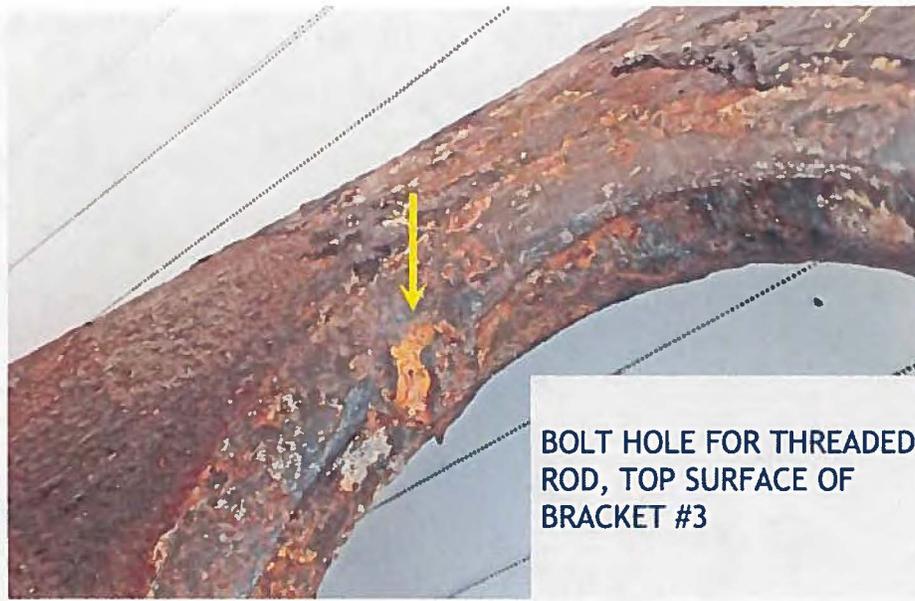
Figure 11. D side bracket, arrow shows direction of metal flow

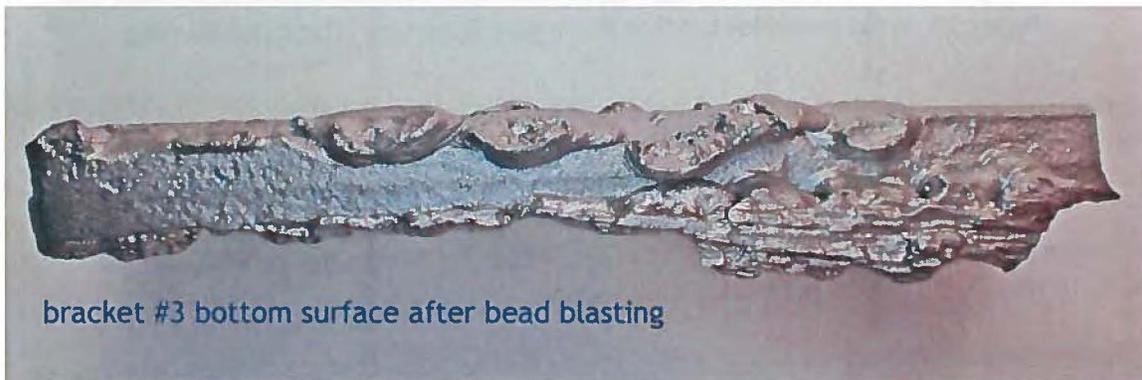
Figure 12. D side bracket #3, leg #2 after glass bead blasting

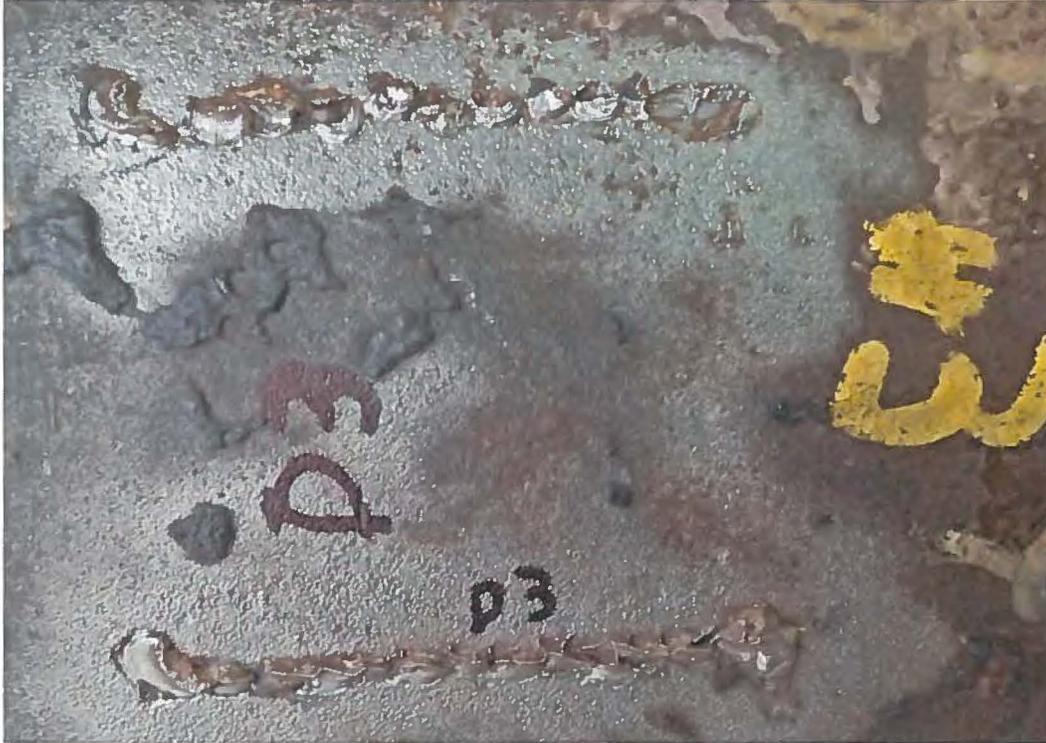
Finding: LG&E GOM&I Figure D-8 – Typical Harness Installation. Both inside and outside welding surfaces of lugs are to be welded to pipe. The lugs on the failed coupling were welded on one side only.

LG&E did not adequately inspect the welds made on the lug brackets as part of the installation of the failed 12 inch coupling installed on 1/5/1998 to detect the quality of the welds and that some were only welded on 1 side.

Figure 13 Weld beads for bracket #3 on pipe D surface after bead blasting

The pipe surface where bracket #3 was welded showed a weld bead along only one side of both bracket legs. Weld penetration would have to be described as poor. Two welders at GTI who examined it described it as looking like a stitch or tack weld.

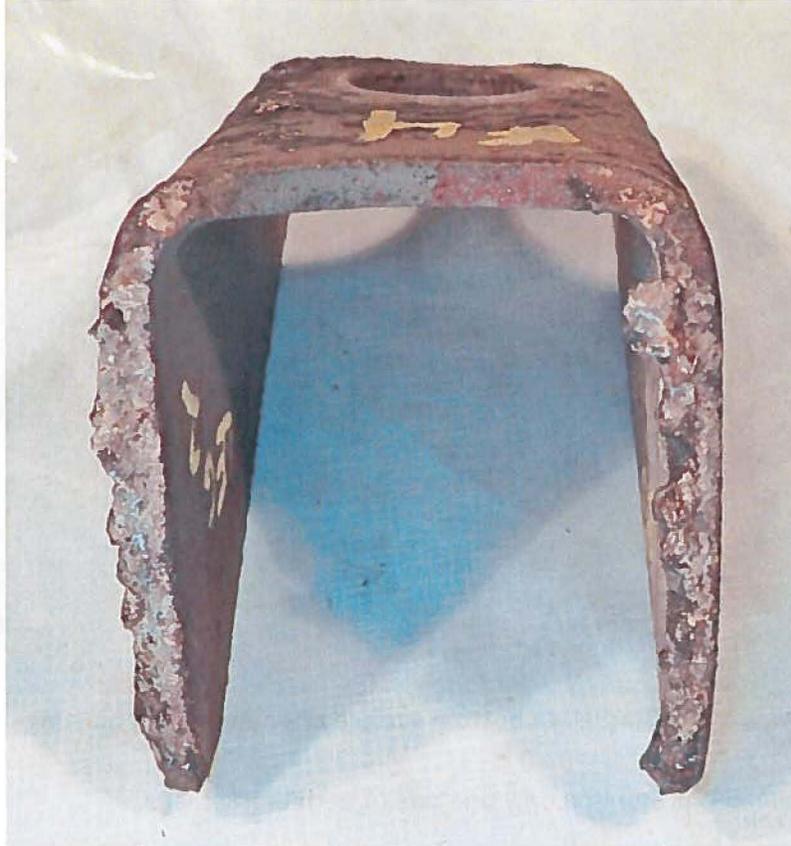
Bracket#4, shown in **Figure 14** below, differed from bracket #3 in that it exhibited only a minor degree of deformation. It also did not display any fresh fracture surfaces; the entire bottom leg surfaces were dirty and corroded.

Figure 14. Bottom surface of D side bracket #4

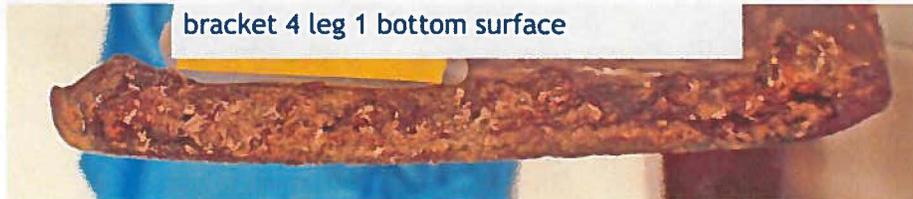
Figure 15. Close-up of bracket #4, leg #1

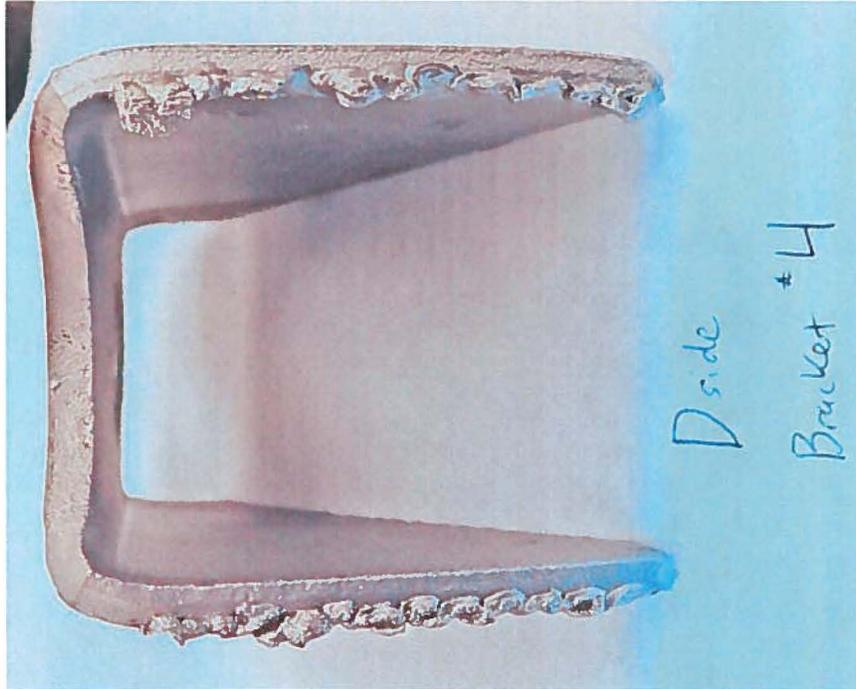
The appearance of the bottom surface of bracket #4 after glass bead blasting is shown in **Figure 16** below.

Figure 16. Bracket #4 bottom surface after glass bead blasting

Note that a weld bead is present on only one side of each bracket leg.

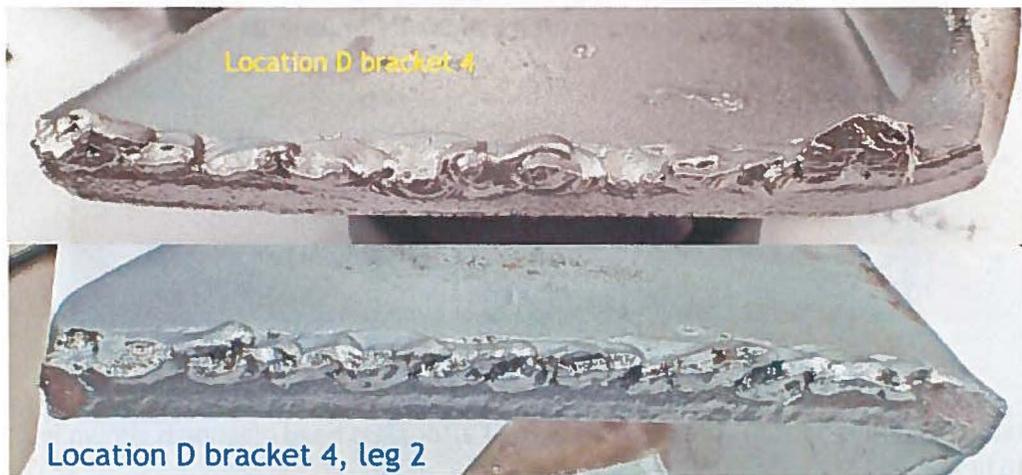
Figure 17. Close-ups of leg bottom surfaces of bracket #4

Fractures of the weld bead can be seen in these two close-up photos (Figure 17). They represent probably less than 30% of the bead area; no bond to the pipe was present at some places along the bead even though a lot of weld metal is present. The weld contact area on the pipe was also bead blasted.

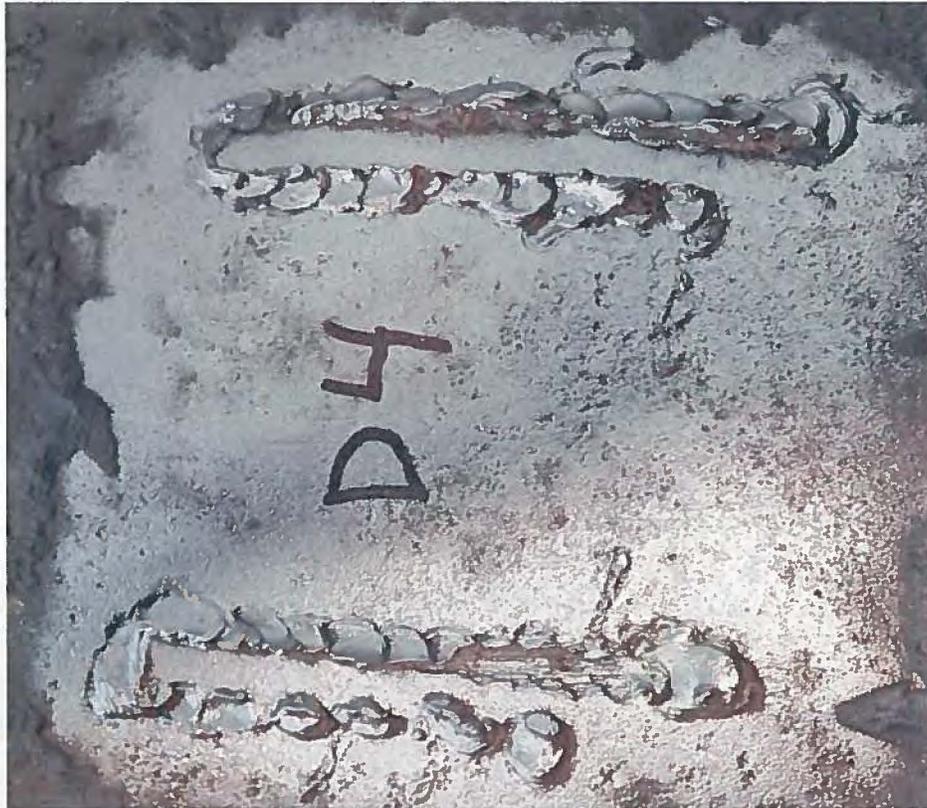
(Comparing the pipe contact surfaces to the bracket, note that the pipe surface D4 shows a weld bead present on both sides of the legs but a bead is visible on only one side of each of bracket D4's legs. After careful examination of the mating surfaces we believe that the two detached brackets were misidentified and that what GTI received as #3 was actually #4 and vice versa.) The inside bead of pipe surface D4 does show one large fractured weld spot measuring approximately 0.750" x 0.15". The rest of the bead shown in **Figure 17** makes only narrow contact with the bracket.

Figure 18. Pipe D bracket #4 weld bead on surface

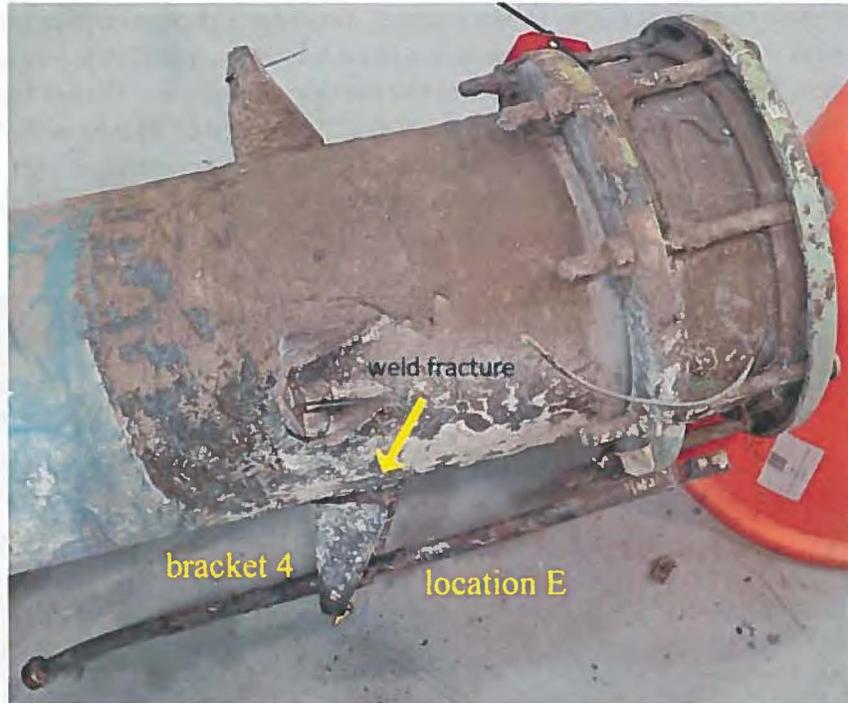
Figure 19. E side Bracket #4 partial detachment

One leg appeared to be almost entirely detached while the other leg seemed to be intact.

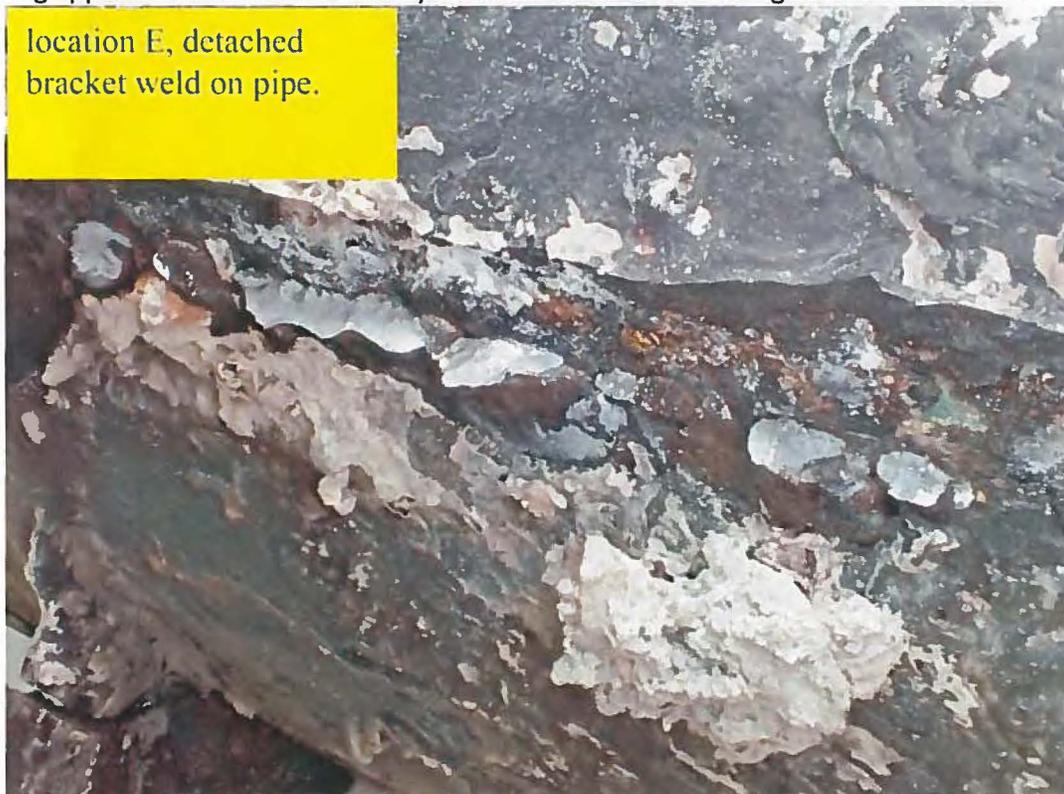
Figure 20. E side Bracket #4, close-up of weld fracture (Elder Park Side)

This weld fracture face on the E side differs dramatically from the D side fractures because it appears to be very fresh.

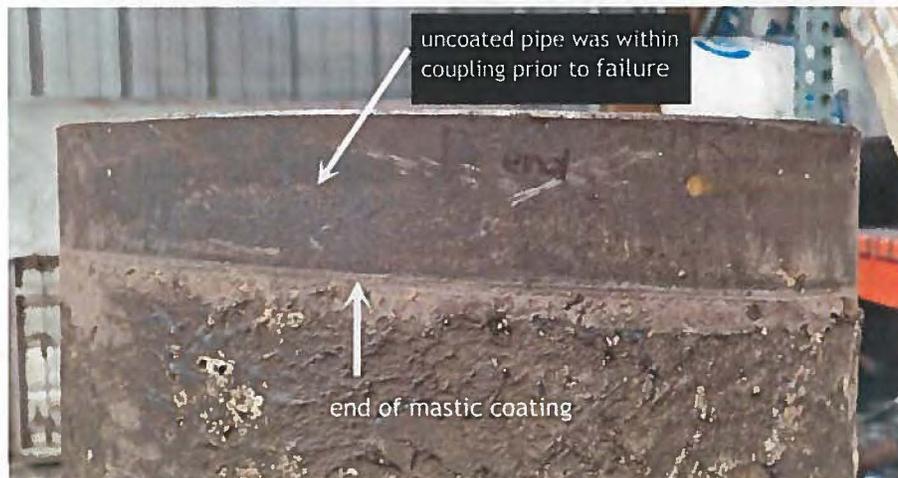
The non-equidistant bracket distances would have produced a bending moment on the lugs rather than axial stress. This is confirmed by the appearance of the D end pipe shown below.

Figure 21. D end of pipe, this end was inserted into coupling

The pipe that was inserted into the coupling was coated after installation. The change in width of the uncoated portion indicates a lack of axial alignment. The width of the uncoated portion varied from 1 ¹¹/₁₆" to 2 ¹/₂".

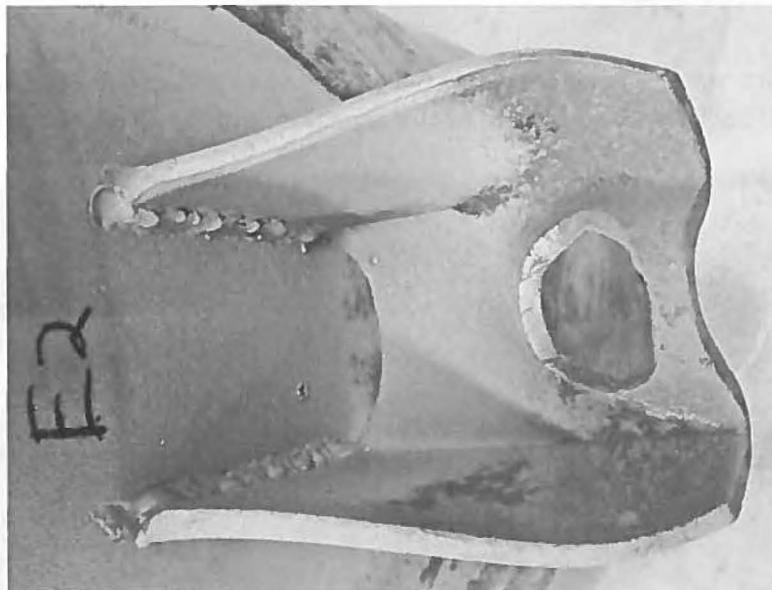
Figure 23. E side bracket #2, severe distortion from compression loading

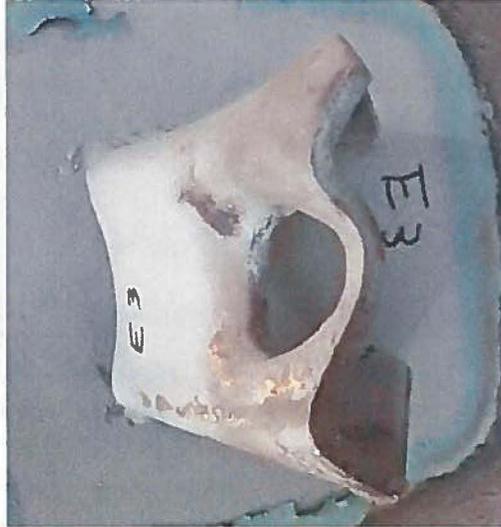
Figure 24. E side bracket #3 compression overload

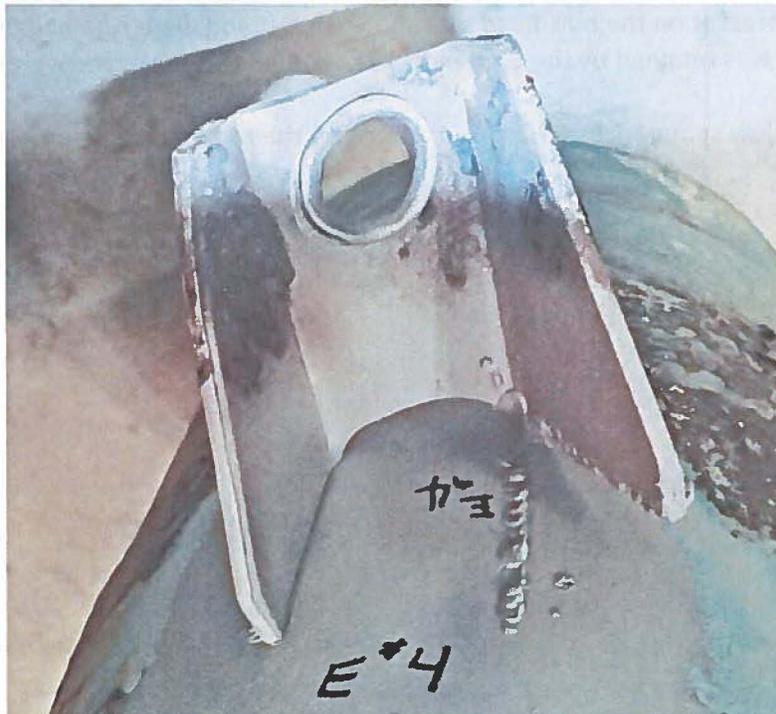
Figure 25. E side bracket #4

A most notable characteristic of the brackets on the D side were the severely deformed and enlarged bracket holes. The threaded rods pulled out of brackets #1 to #3. Rod #4 was still attached to E bracket #4 when GTI received it. It was cut off prior to sending the pipe for blast cleaning. As seen in **Figure 25** bracket #4 appears to have some kind of retaining or reinforcement ring in the bracket hole, this is not seen in the other brackets. Retaining rings may have been present originally on the other brackets, but have pulled out with the rods.

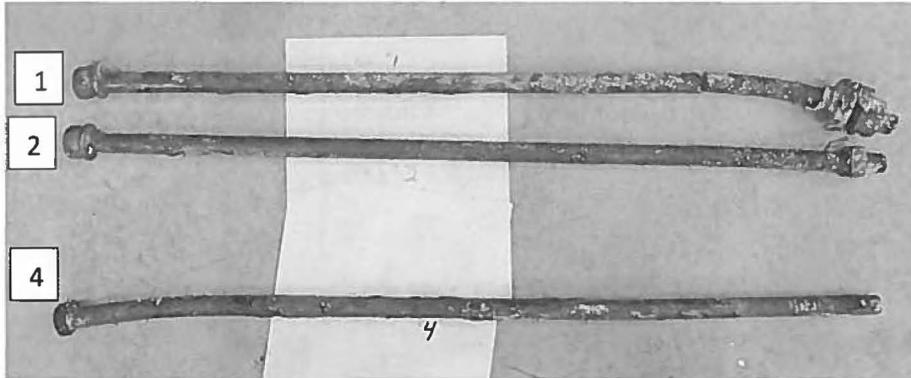
Figure 26. Threaded tensioning rods #1, #2, and #4

GTI received three of the four tensioning rods, as shown above. On the D side the rods were apparently installed with a steel washer and an insulating washer, as seen on the right of rod #1. This is the only rod on which it remained intact. It is not known if the bolt-head sides were installed on the E side with a washer except that none were recovered. Rods #1 and #2 pulled out of the E side bracket on the bolt-head side shown at left and were retained by the D side brackets. Rod #4 was retained by the E side bracket. Rod #3 was never recovered.

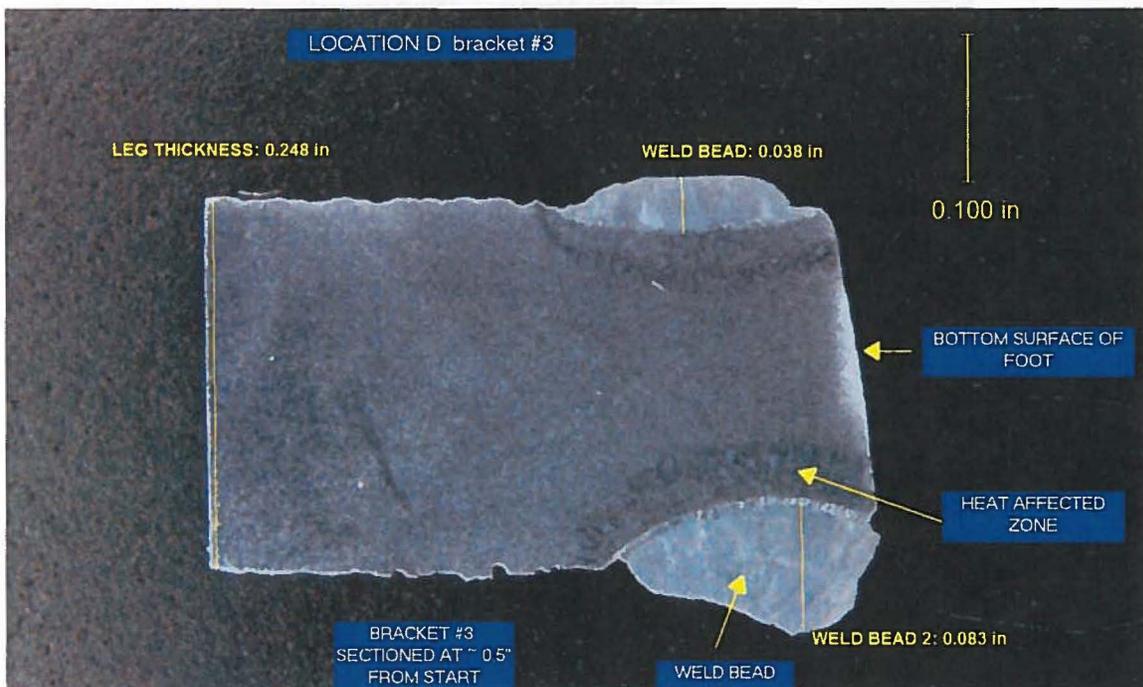
Figure 27. Cross section of bracket #3 leg

As seen in this cross section (Figure 27), beads are present along the sides of the bracket, but the bead is not flush with the bottom of the foot and the weld contact area is low.

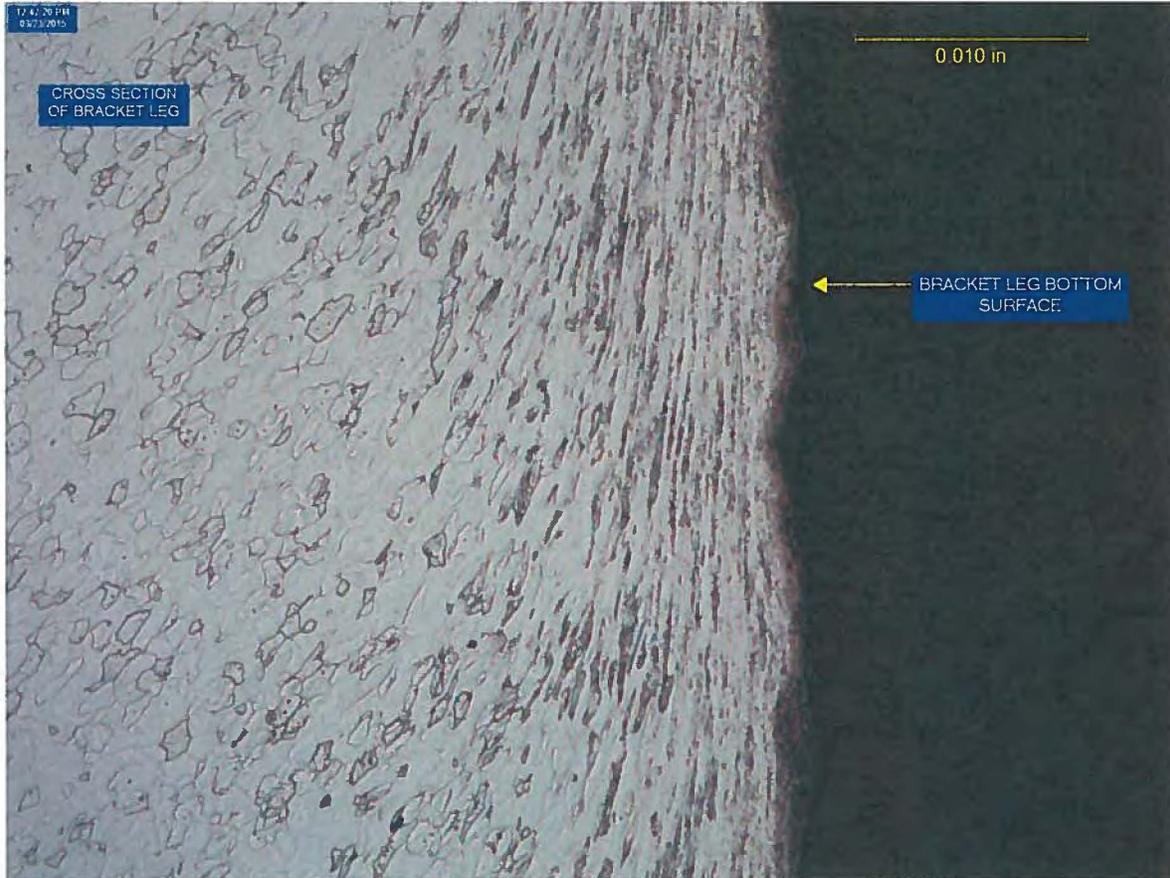
Figure 28. D side bracket #3 cross section of bottom of leg

Figure 28 shows the microstructure at the bottom of one of the bracket's legs. There is no evidence of melting or incipient fusion. Instead what is visible is grain flow and deformation from a shearing operation when the brackets were blanked out from plates.

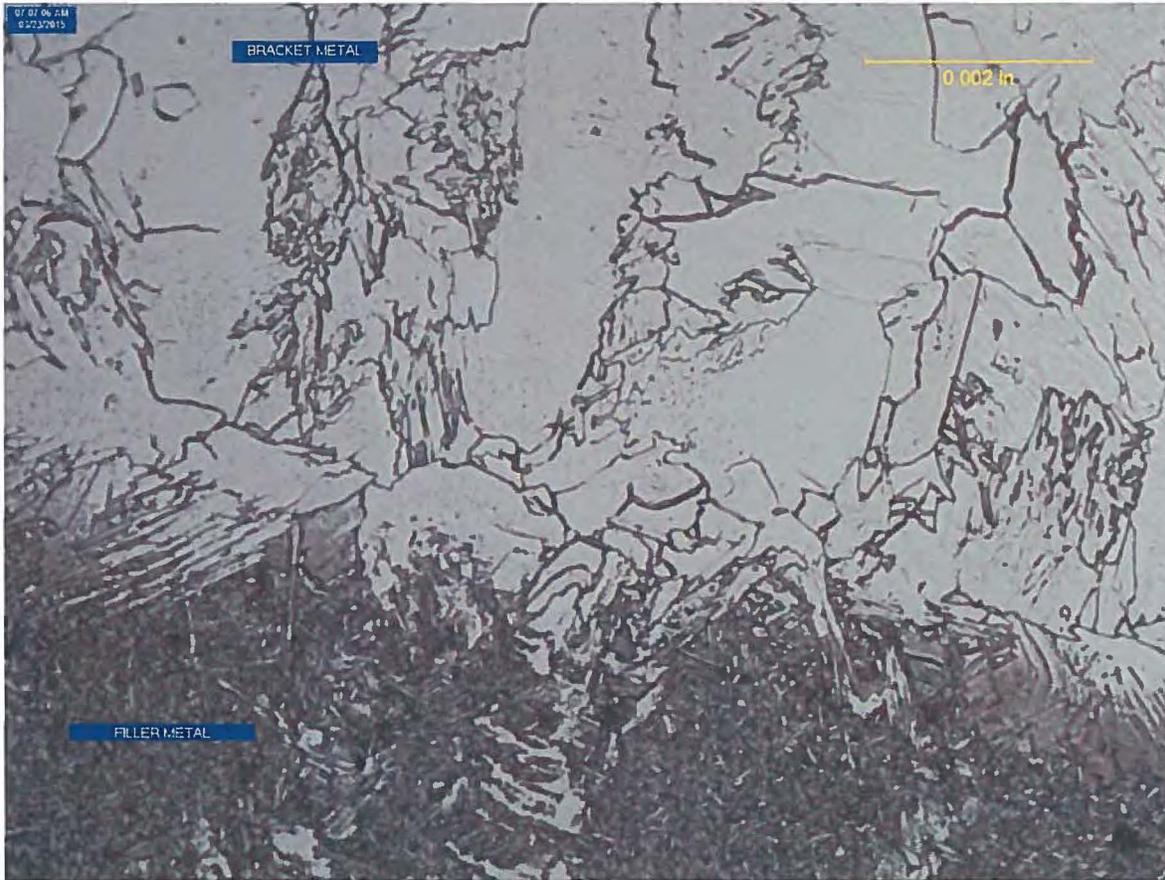
Figure 29. Fusion zone of weld bracket #3, 152148-001

Figure 29 above shows the fusion zone between the bracket metal on top and the darker area on the bottom which is filler rod. The bracket metal near the fusion zone appears to be very low carbon acicular ferrite. The photo below is of the same region at a lower magnification.

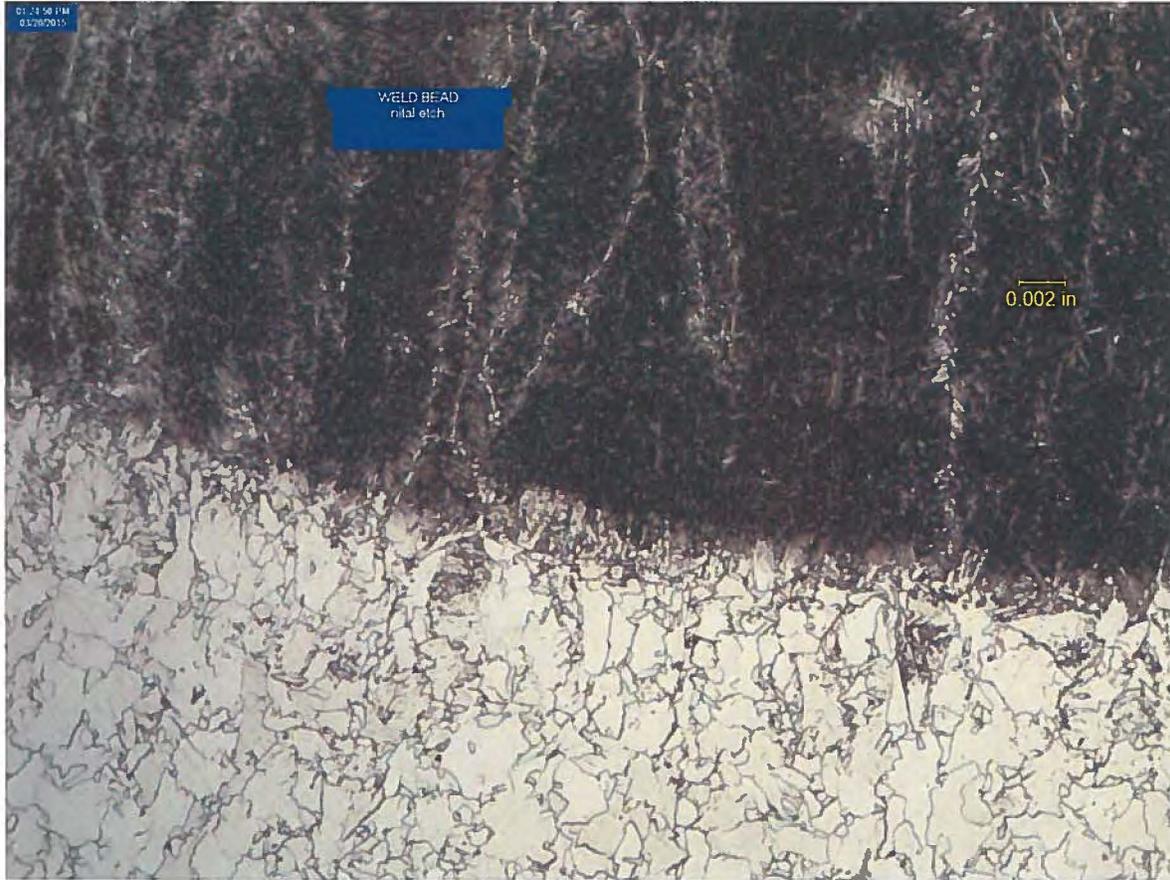
Figure 30. Weld fusion zone nital-etch; filler rod material on top, bracket substrate below

Most unusual is the complete absence of visible carbides in the bracket material. The region of mixture between the filler rod material and substrate is quite low. The structure of the bracket was then examined well away from the weld.

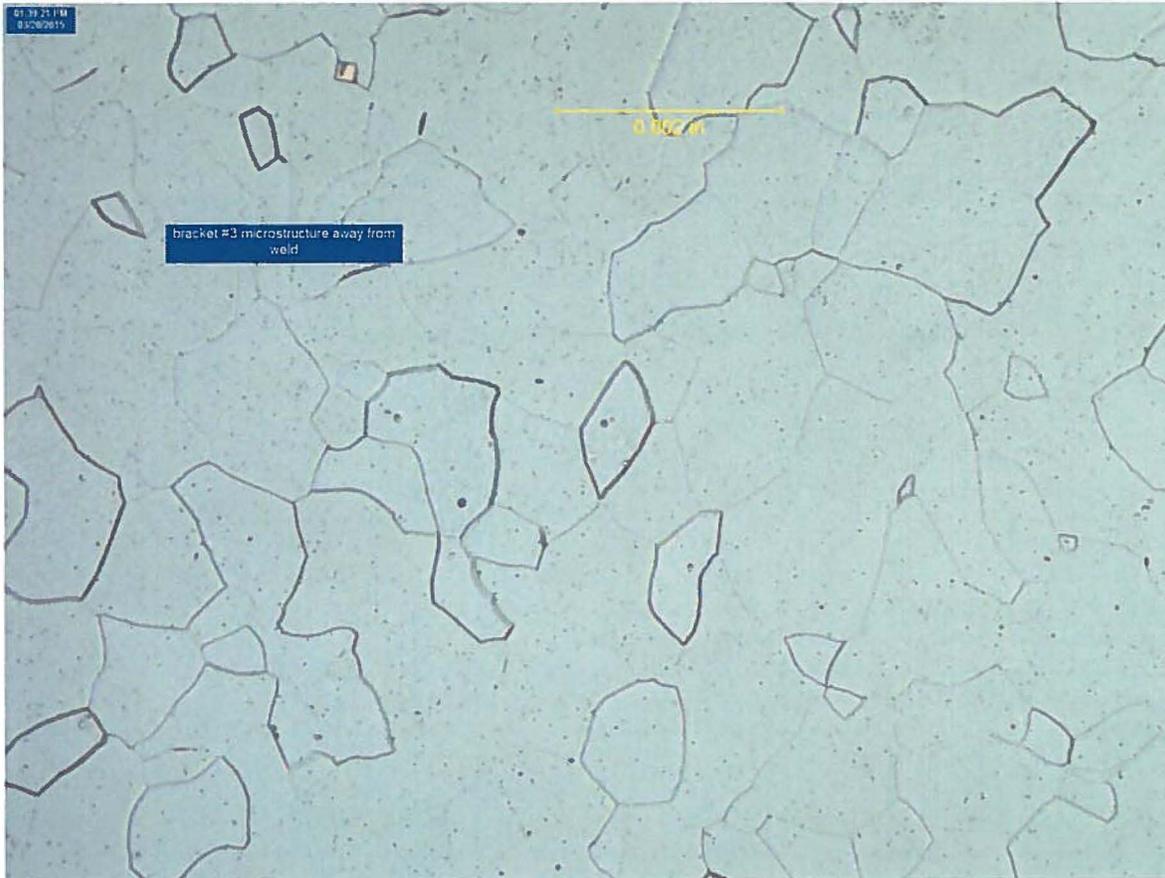
Figure 31. Microstructure of bracket material away from weld

The microstructure seen in **Figure 31** exhibits a complete absence of pearlite ($\text{Fe}_3\text{C}+\text{Fe}$) or cementite (Fe_3C). This structure is typical for what are termed deep drawing quality steels. Chemistry test results listed in **Table 9** confirm the ultra-low carbon level at 0.008 wt. %. The manganese (Mn) level is also exceptionally low at 0.13%. The titanium level of 0.06% indicates the steel was produced as Interstitial Free (IF) steel, which is steel with no interstitial solute atoms to strengthen the iron lattice. Normal steel making processes cannot go below approximately 0.03% carbon. Deep drawing quality steels are vacuum decarburized to go below 0.01% carbon. Such steels have exceptional formability but very low yield and tensile strengths in the hot-rolled state. By design it is steel produced to have the lowest possible yield strength for maximum drawability and therefore not a typical steel choice for a safety-critical structural application. The CSI catalog provides material specifications for all the parts of their couplings, but none for the bracket. Given that there appears to be no material specification, it is possible that the steel supplier received, from the manufacturer, only a very generic order for “mild steel” (i.e., < 0.25% carbon) and provided this material in good faith. . A check of the surface hardness of the bracket found a HRBW hardness of 43.4 (see **Table 13**). Based on this hardness and the chemistry of the bracket we would estimate a yield strength in the range of 20-25 ksi.

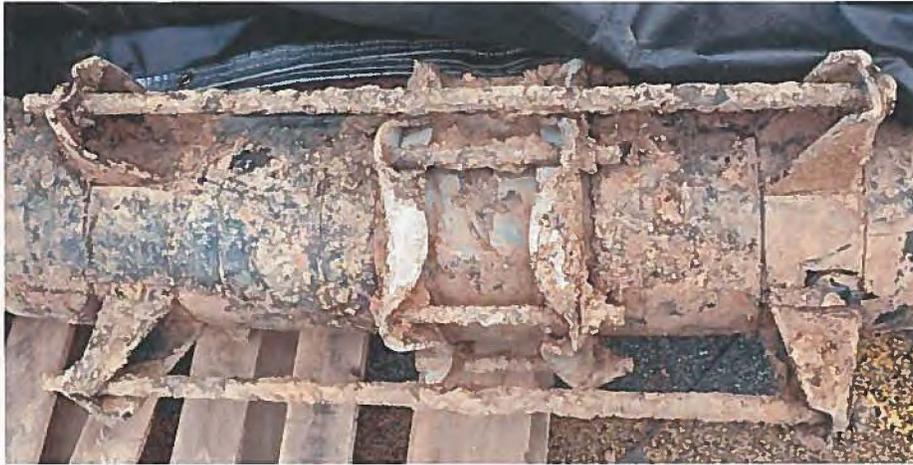
Figure 34. 8" coupling on pipe segment B-C

Due to the large amount of mud on the pipe and the pipe wrap it was not possible to inspect the welds (**Figure 34**). It was possible to see that some of the brackets had begun to yield from compression overloading as shown in **Figure 35**, **Figure 38**, and **Figure 39**.

Due to this fact, it is recommended that LG&E evaluate its high pressure distribution / transmission gas system to identify any mechanical couplings for improper installations and take corrective action to address them.

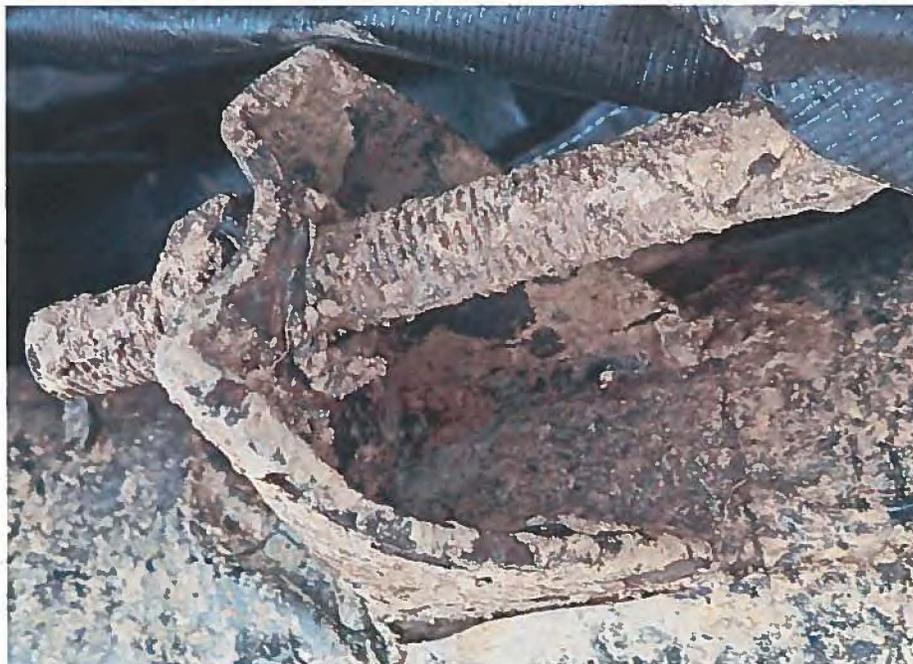
Figure 35. 8" bracket before blast cleaning. Bracket compression surface has deformed under load.
