COMMONWEALTH OF KENTUCKY
BEFORE THE PUBLIC SERVICE COMMISSION

LOUISVILLE GAS & ELECTRIC)
COMPANY)
_____) CASE NO. 2017-00119
)
ALLEGED FAILURE TO COMPLY WITH)
KRS 278.495, 807 KAR 5:022, AND)
49 C.F.R. PART 192)

ORDER

LG&E Natural Gas Pipeline Rupture

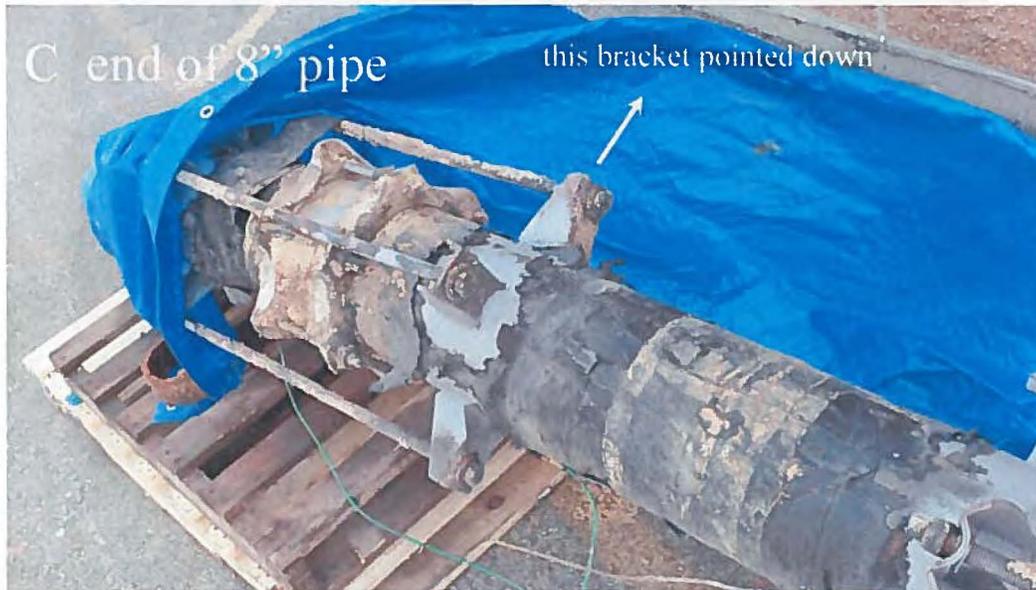
Figure 36. Partial detachment of bracket on 8" pipe

After removal of the pipe wrap it was immediately apparent that one of the rod brackets had partially detached from the pipe (Figure 36 and 37). The coupling was on the C end of the pipe, meaning it was the coupling furthest away from the connection to the 12" pipe. Since no detachment had been observed prior to cleaning, the fracture surface was immediately inspected to see if it was fresh.

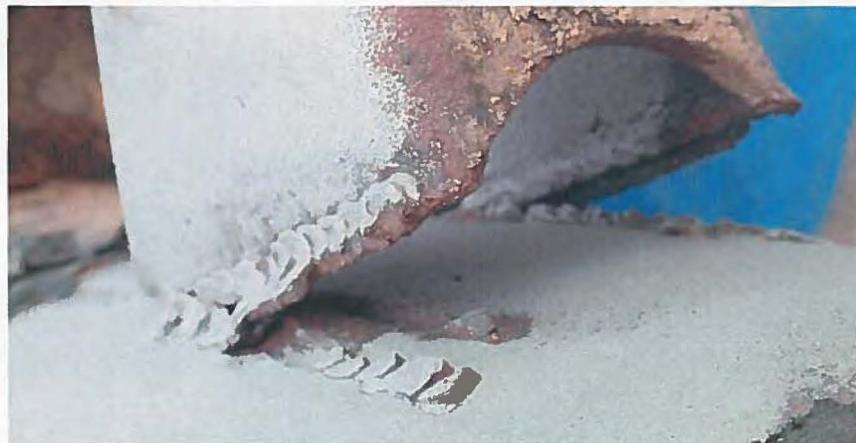
Figure 37. 8" pipe fractured weld bead after cleaning

Fortunately, the weld bead had not been thoroughly cleaned and it was possible to see a significant amount of corrosion on the weld bead. Based on this observation GTI believes that this fracture had existed in the field for some time. Inspection of the weld beads did not reveal any major flaws and all brackets had beads on both the inside and outside of both legs. The amount of contact area however was apparently too small to bear the applied load.

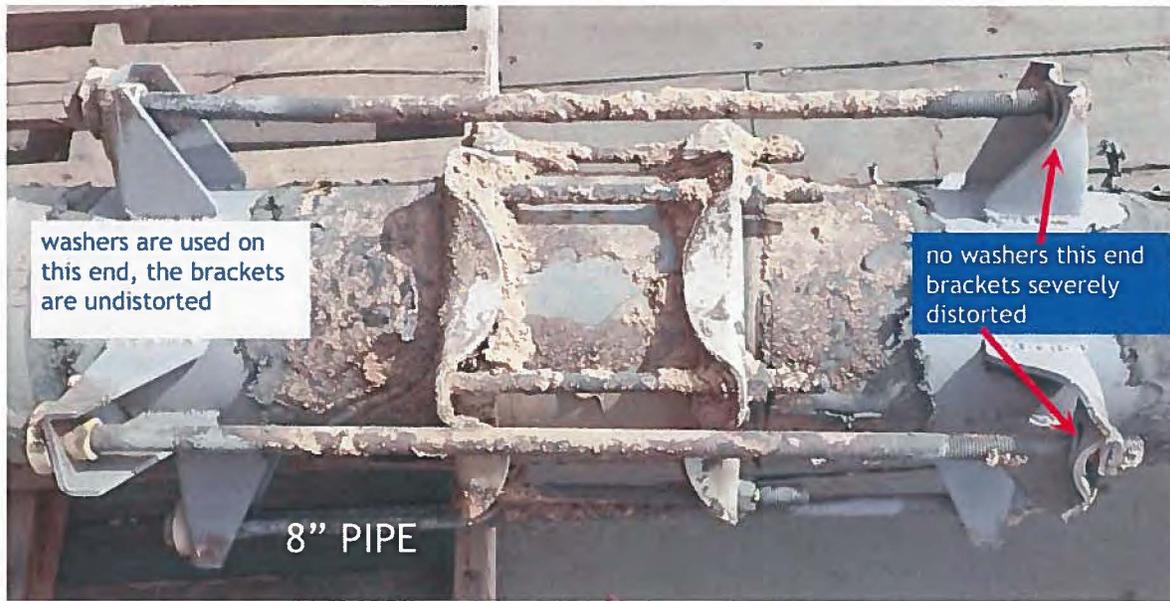
Figure 38. 8" pipe coupling #2 with insulating end

Coupling #1 and Coupling #2 utilized two different rod types. Coupling #1 used a rod that was conductive on both ends, while Coupling #2 used a rod with an insulating washer on one end. The other end on both rod types does not utilize a washer. Instead there appears to be some kind of sleeve insert in the bracket hole. Of the 16 brackets inspected on the 8" pipe, three exhibited medium/heavy distortion from compression overload. In all cases this was on the washer-less side. **Figure 38** shows two of these brackets on the right side. The use of heavy-duty over-sized washers would have spread the load out and might have ameliorated this problem.

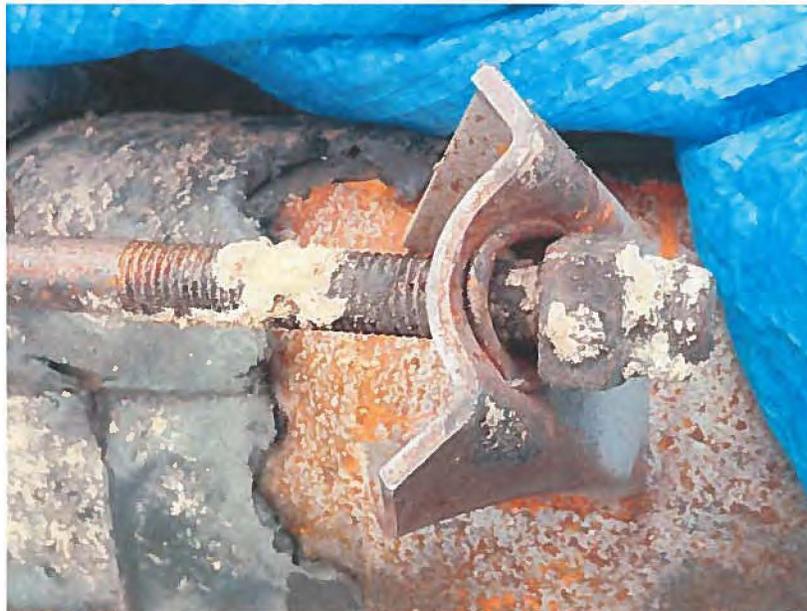
Figure 39. Bracket distortion from compression overload. Note absence of washer
