RE: Notice and Report of an Incident occurring on August 21, 2014, at Campbellsville University, Campbellsville, Taylor County, Kentucky

Re: Campbellsville Fire Department Injury Incident
14-ES-E-024-KU

KPSC INVESTIGATION REPORT

Transmission Line Contact with Injuries

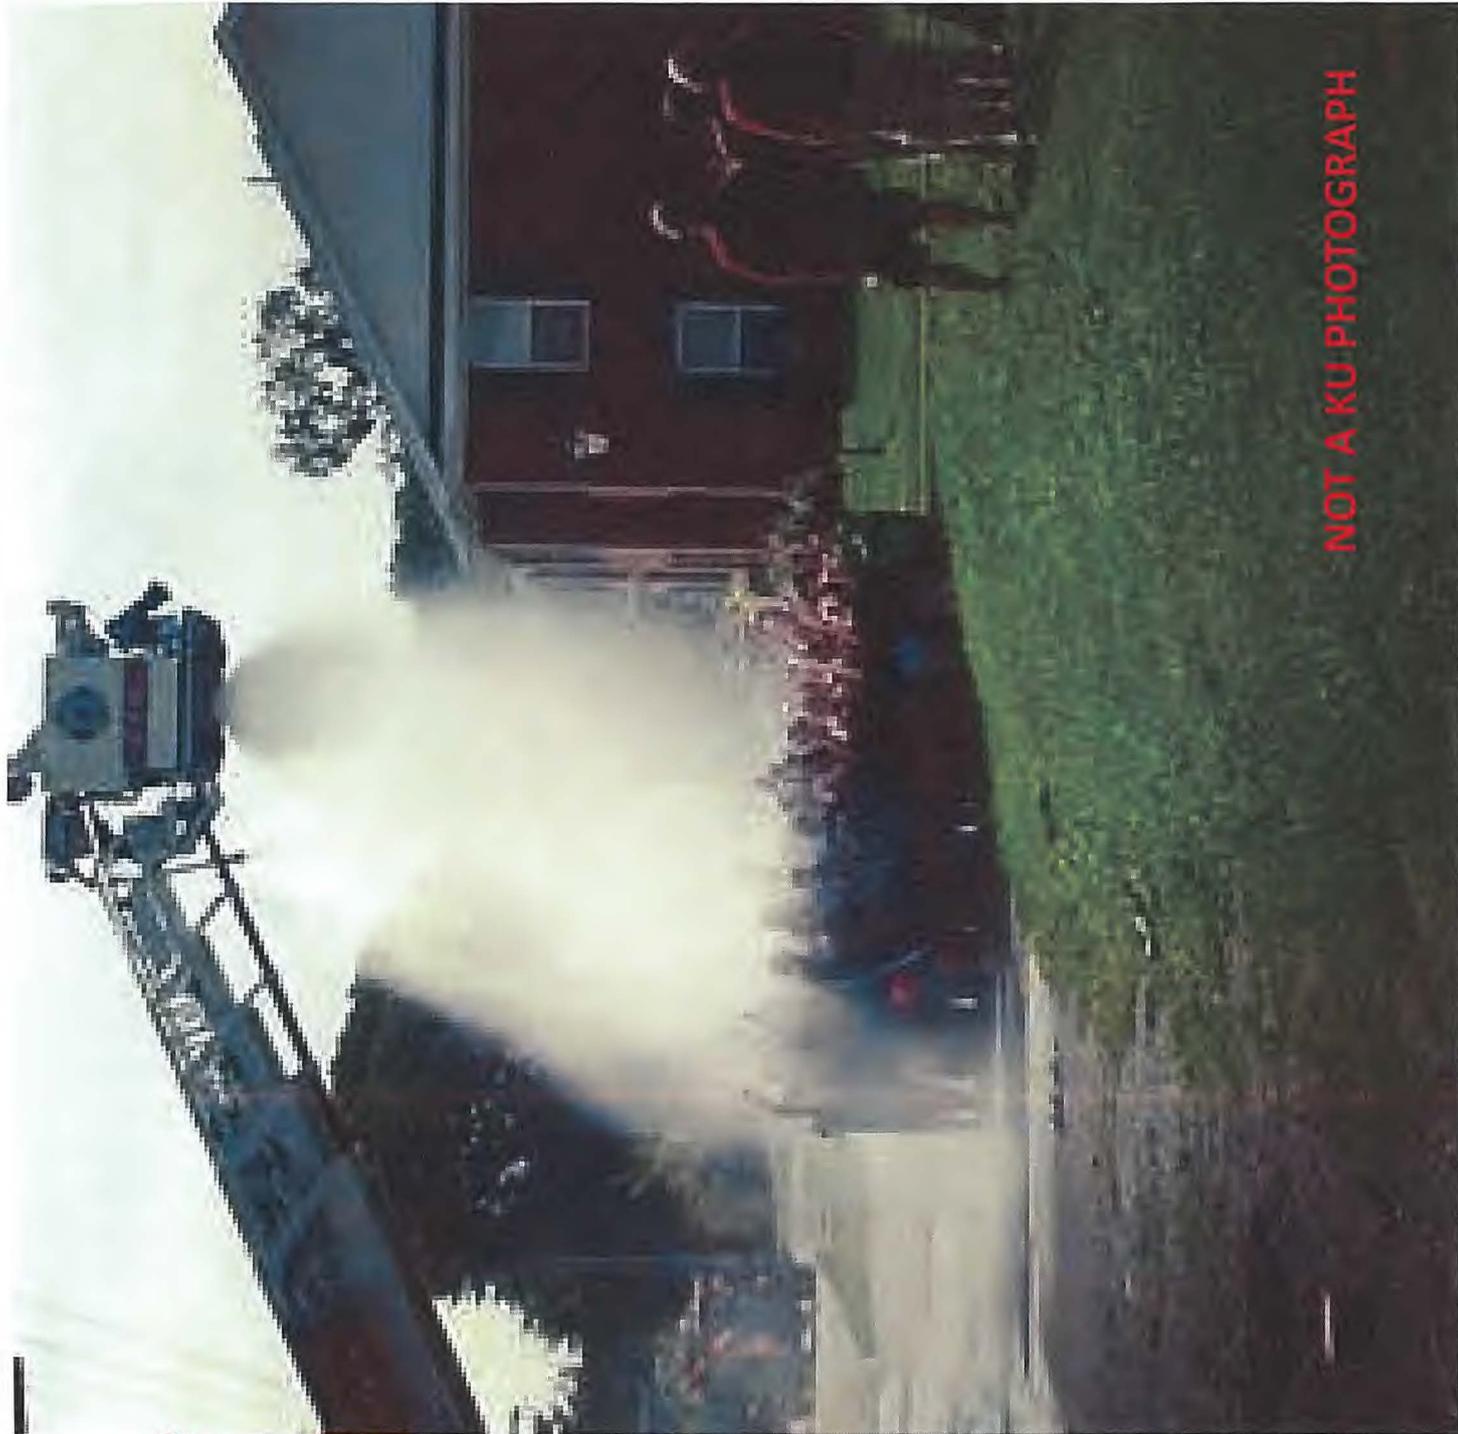
Note location
of 69kV lines
