REPORT  
OF  
INVESTIGATION  
AT  
SIMON KENTON HIGH SCHOOL  
CONCERNING  
NATURAL GAS EXPLOSIONS AND FIRE  
ON  
OCTOBER 9, 1980

January 20, 1981

COMMONWEALTH OF KENTUCKY

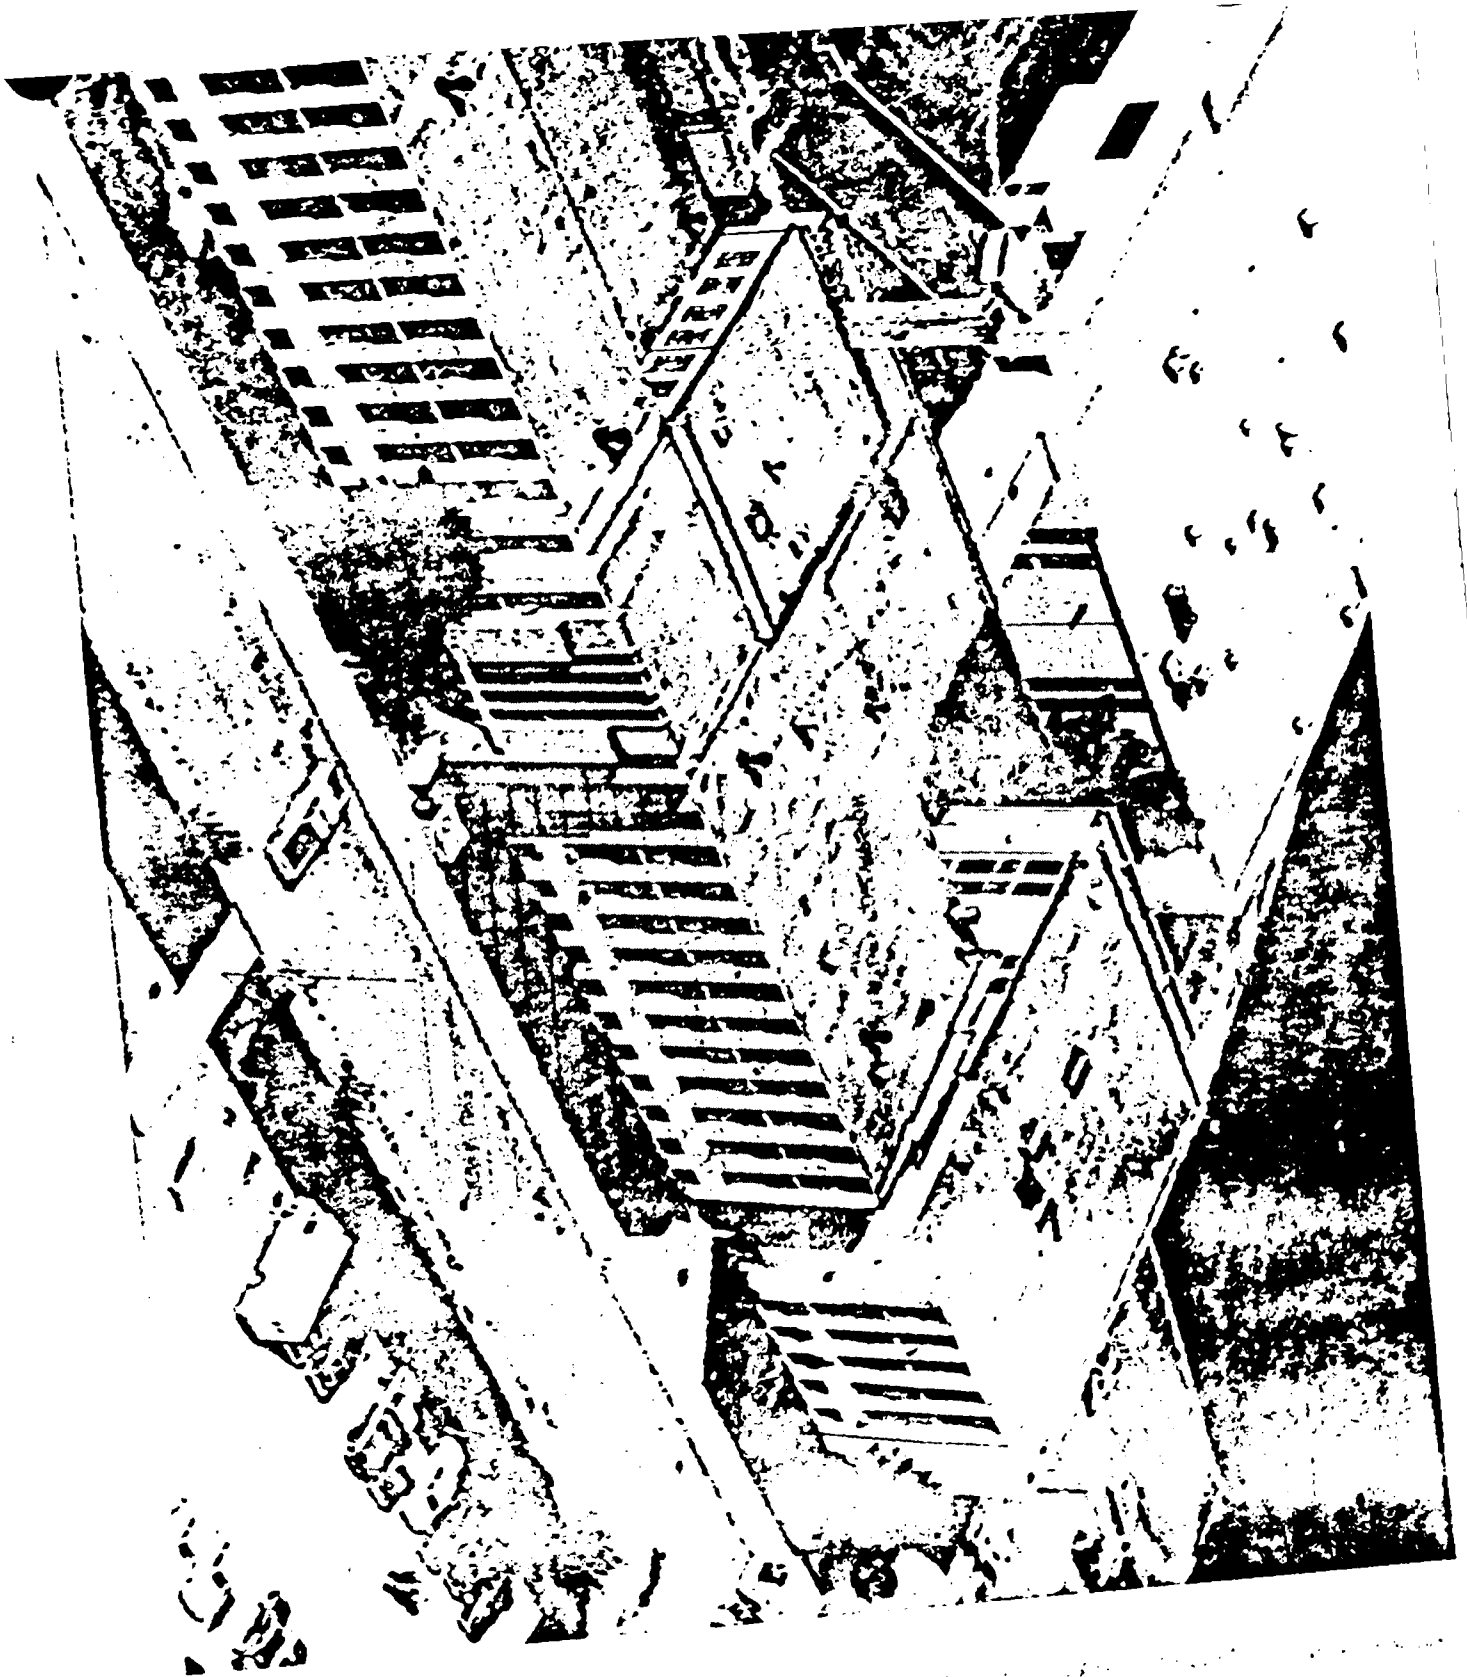
1" = 40' - 12/15/80 - ELL.  
Gas Service Connection  
Simon Kenton High School  
Served by Union Lt. Ht. & P. Co.

Center of Second Explosion

3" Gas Service Line

4" Transm. Ln. f

2" Distribution Ln. f
