COMMONWEALTH OF KENTUCKY
BEFORE THE PUBLIC SERVICE COMMISSION

DELTA NATURAL GAS COMPANY, INC.)	
)	
_____)	CASE NO.
)	90-109
ALLEGED FAILURE TO COMPLY WITH)	
COMMISSION REGULATION 807 KAR 5:022)

ORDER TO SHOW CAUSE

INCIDENT REPORT

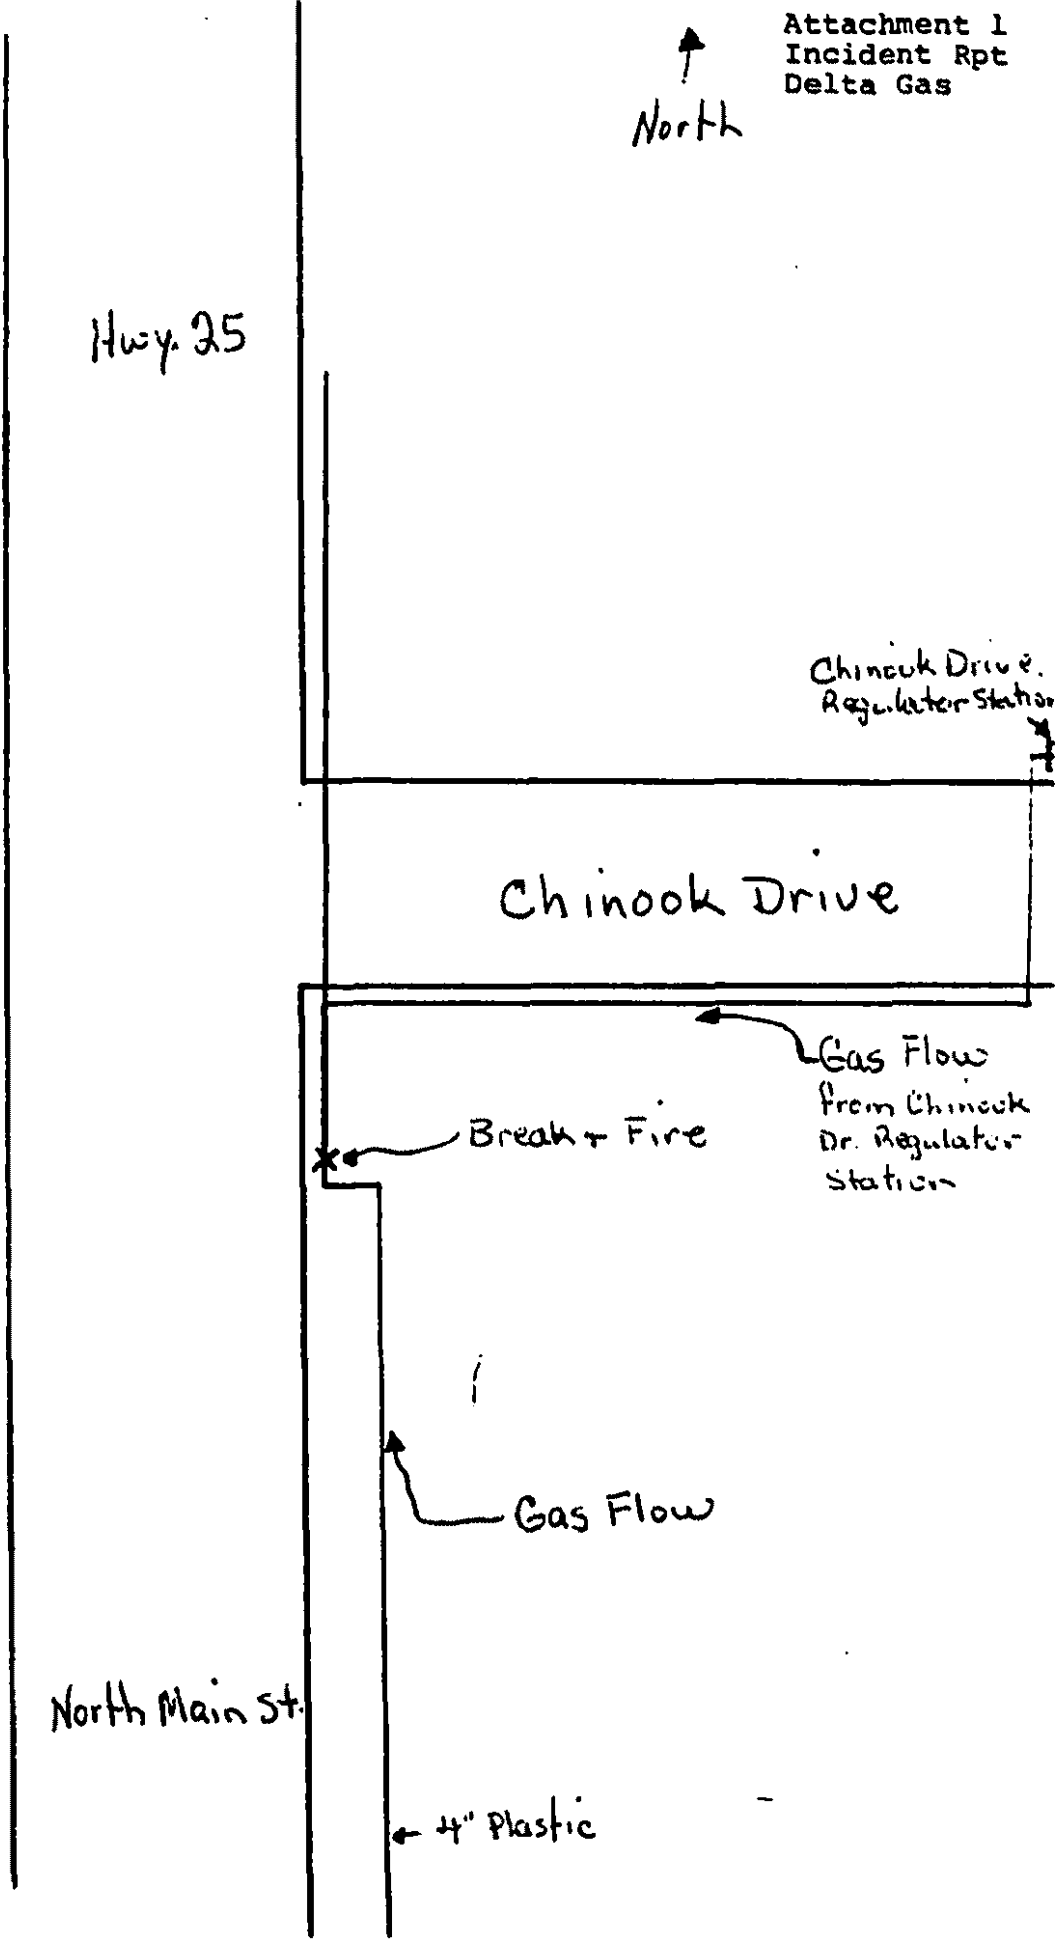
Hwy. 25

* Break + Fire

North Main St.

4" Plastic
