COMMONWEALTH OF KENTUCKY  
BEFORE THE PUBLIC SERVICE COMMISSION

HENDERSON-UNION RURAL ELECTRIC COOPERATIVE CORPORATION, INC.	)	
_____	)	
ALLEGED FAILURE TO COMPLY WITH COMMISSION REGULATIONS	)	CASE NO. 90-260

ORDER TO SHOW CAUSE

ELECTRICAL UTILITY ACCIDENT INVESTIGATION

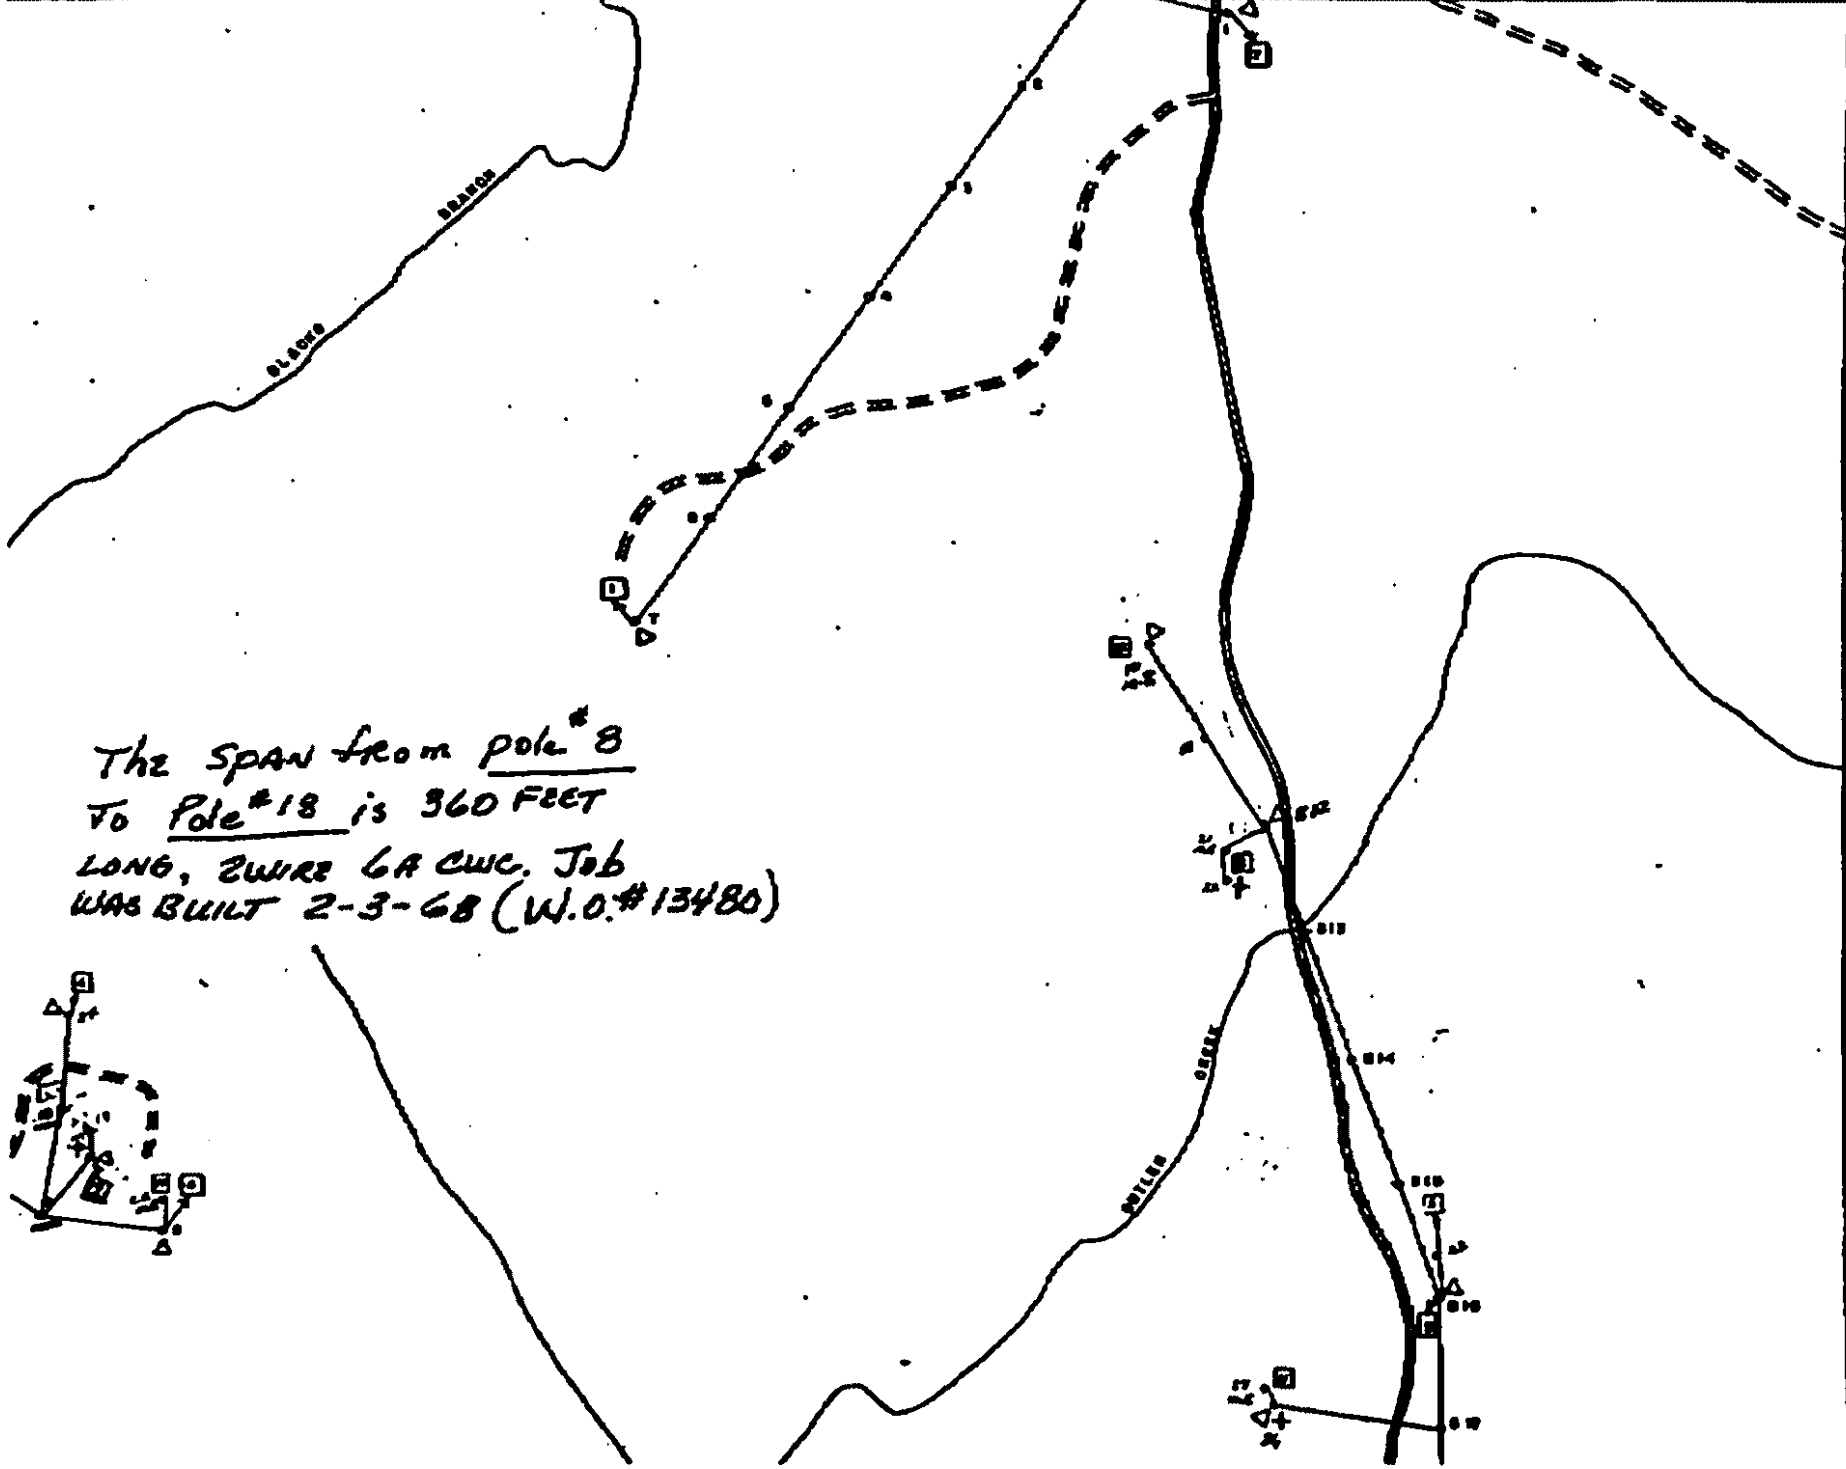
SH	of	JOINT USE	RECC	B	RECC	RECC	DATE	LAST POLE NO.	17	SH	1
SCALE: 1" = 500'				7				LAST CUST NO.	7, B. P. M.	OF	1

The span from pole # 8  
 To Pole # 18 is 360 FEET  
 LONG, 2 WIRE GA CWC. JOB  
 WAS BUILT 2-3-68 (W.O.# 13480)
