COMMONWEALTH OF KENTUCKY

BEFORE THE PUBLIC SERVICE COMMISSION

CASE NO. 91-057

UTILITY INSPECTION REPORT

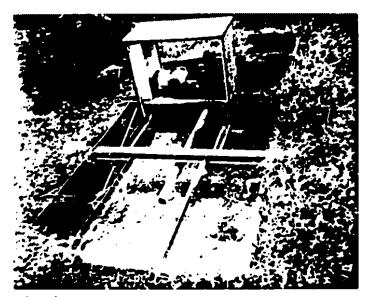
7/31/90 THELMA ACTIVITIES, INC. JIM HUGHS ESTATES S.T.P. AERATION TANK.

- 7. The aeration tank needs to be cleaned out. (807 KAR 5:071, Section 7, 1)
- 8. The pump station at the plant needs to be cleaned out. (807 KAR 5:071, Section 7, 1)
