#### COMMONWEALTH OF KENTUCKY

KENTUCKY UTILITIES COMPANY	) CASE NO. 91-26
ALLEGED FAILURE TO COMPLY WITH	) )
COMMISSION REGULATION 807 KAR 5:006, SECTION 24	) }

### ORDER TO SHOW CAUSE

#### ELECTRIC UTILITY ACCIDENT INVESTIGATION

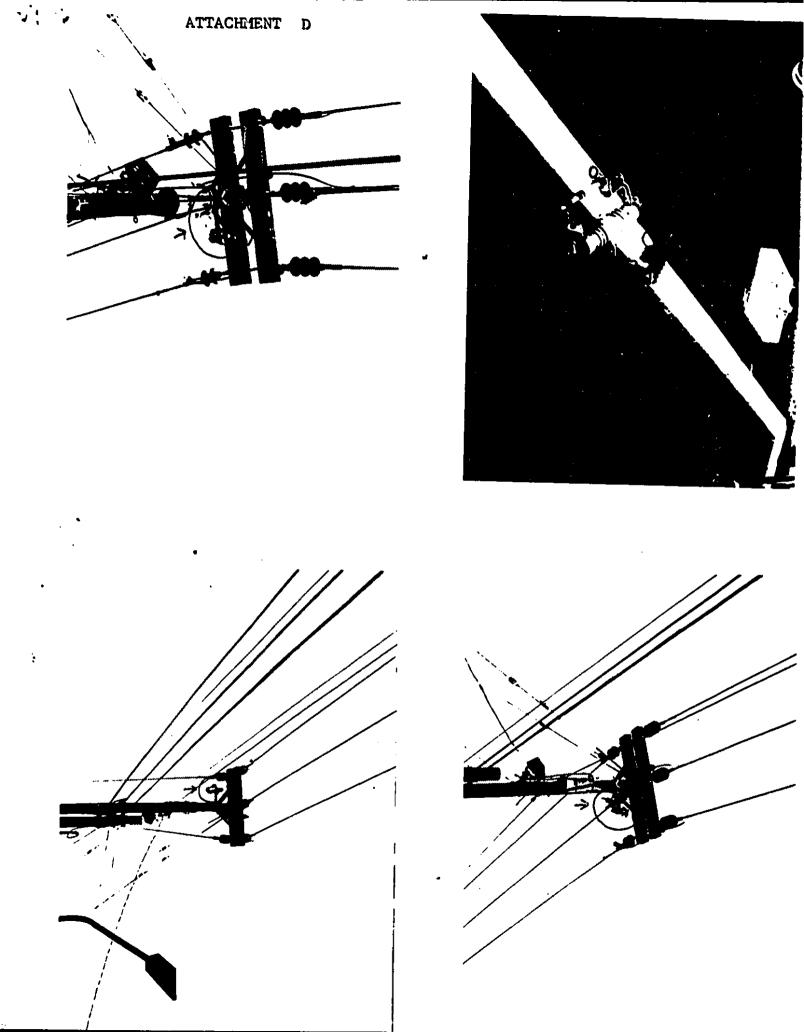
Utility	·	Checked by			
o normalis, <u>esperia <b>e</b>s</u> pue viden esta publica e <del>stado esta</del> pued	Fig	ure 1			
	Primary Temp	avan de la constant d	Lightning Arra	s A fuse	
		1	stormer		
• • • • • • • • • • • • • • • • • • •	man ann an		• • • • • • • •	•	
	••

In order to replace the cutout, a temporary By pass line between the Lightning Heroster and the Transformer are established.

Accident occurred when into at was partially removed from highwing arrestor nobe. and ground his inalvertually connected with Arreston causing phase to grown short with resulting flash.
