APPENDIX TO AN ORDER OF THE KENTUCKY PUBLIC SERVICE COMMISSION IN CASE NO. 2002-00427 DATED February 10, 2003

UTILITY ACCIDENT				
INVESTIGATION REPORT				
Utility:	LG&E Energy Corp. ("LG&E")			
Reported By:	Marty J. Reinert, LG&E			
Accident Occurred:	DATE - September 18, 2002	TIME - Approximately 3:20 PM		
Utility Notified:	DATE - September 18, 2002	TIME - Approximately 3:20 PM		
PSC Notified:	DATE - September 18, 2002	TIME - 3:45 PM		
Investigated:	DATE - September 18, 2002 FOL	LOW-UP - October 1, 2002		
Written Report Revd:	DATE - September 23, 2002			
Location of Accident:	FOX RUN SUBDIVISION – OFF OLD HENRY ROAD, EASTERN JEFFERSON COUNTY (New construction – no known address)			
Description of Accident:	("Pike") Companies had been assigned to do, Pike Foreman, Dominick Simms, and Fishel Foreman, Chad Best, did not recognize that they would need a grounding elbow. LG&E supervising personnel discovered this and stated that a grounding elbow was furnished to the job site. During the initial investigation of the accident, LG&E personnel discovered that a grounding elbow was found on a Pike electrical truck. When the underground ("UG") system was energized, the morning of the acci

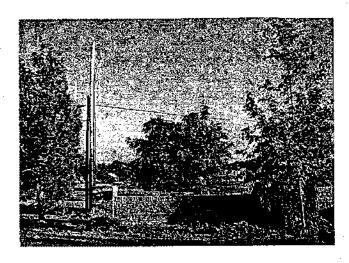
View from drop pole to accident sight (behind house)

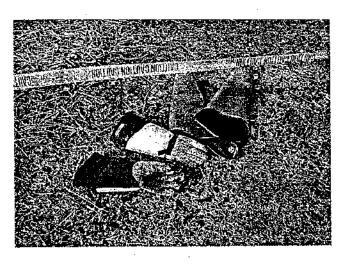
Accident area with PPE on-sight

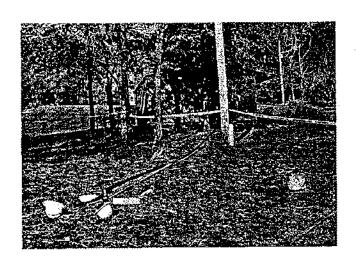
Accident area with PPE on-sight

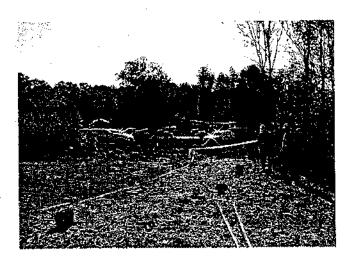
View from accident area toward pad mount transformer

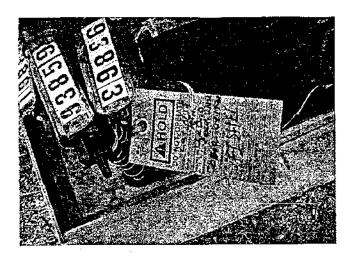
Fishel Foreman Best had attached a red Hold Card to the elbow on the double feed-through bushing on the URD transformer. The red Hold Card was visible to Pike Foreman Simms and other personnel at the site. Best improperly used a red Hold Card as a message card, instead of a white Message Card. LG&E's normal practice is to use a white message card for information or instruction (during subsequent interviews). Best said. "I did not know to use a white card for messages, but I do now."

Pad Mount Transformer showing installed card and cable terminations

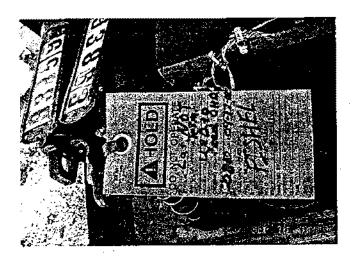
Wording on installed "Card"

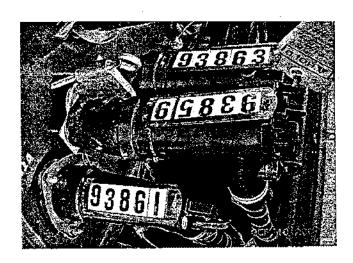
The URD transformer involved in this accident had a double feed-through bushing. The other URD cable, coming from the first transformer and feeding the new subdivision, was plugged into the other side of the same double feed-through bushing. When the feed from the first URD transformer was energized, it energized a portion of the UG system, including the lateral cable that was being worked on. Best and Simms failed to recognize the need for, and failed to install the necessary grounding elbow prior to energizing this UG eyetom.

Transformer/Cable Terminations

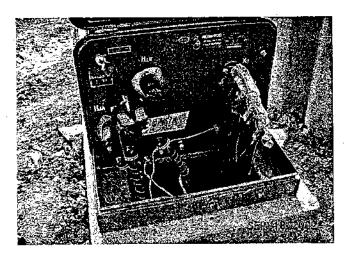
Transformer ~ source for lateral

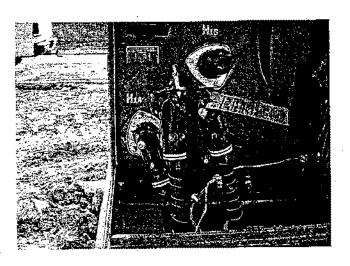
Transformer - source for lateral

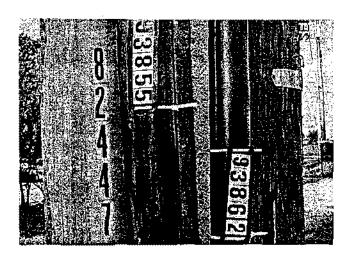
Cable Tags at Drop Pole

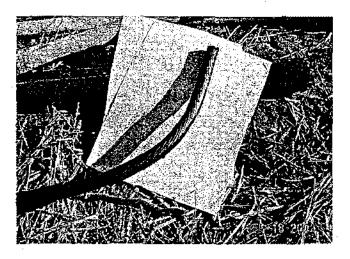
Cable End ~ Accident Contact Burn/Arc Marks

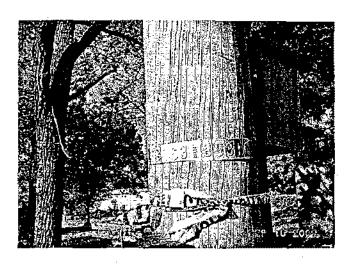
Lateral Pole At Accident Site

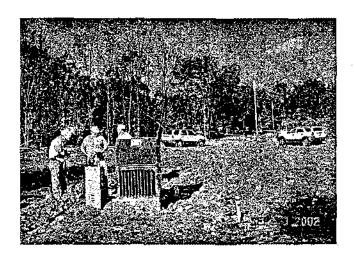
View From Pad Transformer Toward Accident Site

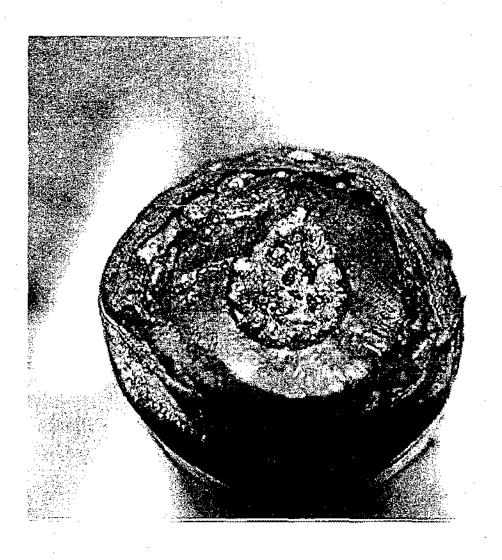
LG&E ACCIDENT ~ 09/18/2002

This section of cable is the portion apparently removed from the underground lateral by Mr. Walker prior to the accident that resulted in his fatility.

The cable shows results of arcing that was apparently due to the initial fault.
