Electric Utility Accident Report

**RE: Contractor Shock and Burn
LG&E Beargrass Creek Switching Station
Louisville, KY**

INVESTIGATION REPORT

Accident investigation report
Beargrass - Northside 138kV OPGW Installation for Insight Communications
LG&E Project # 114159

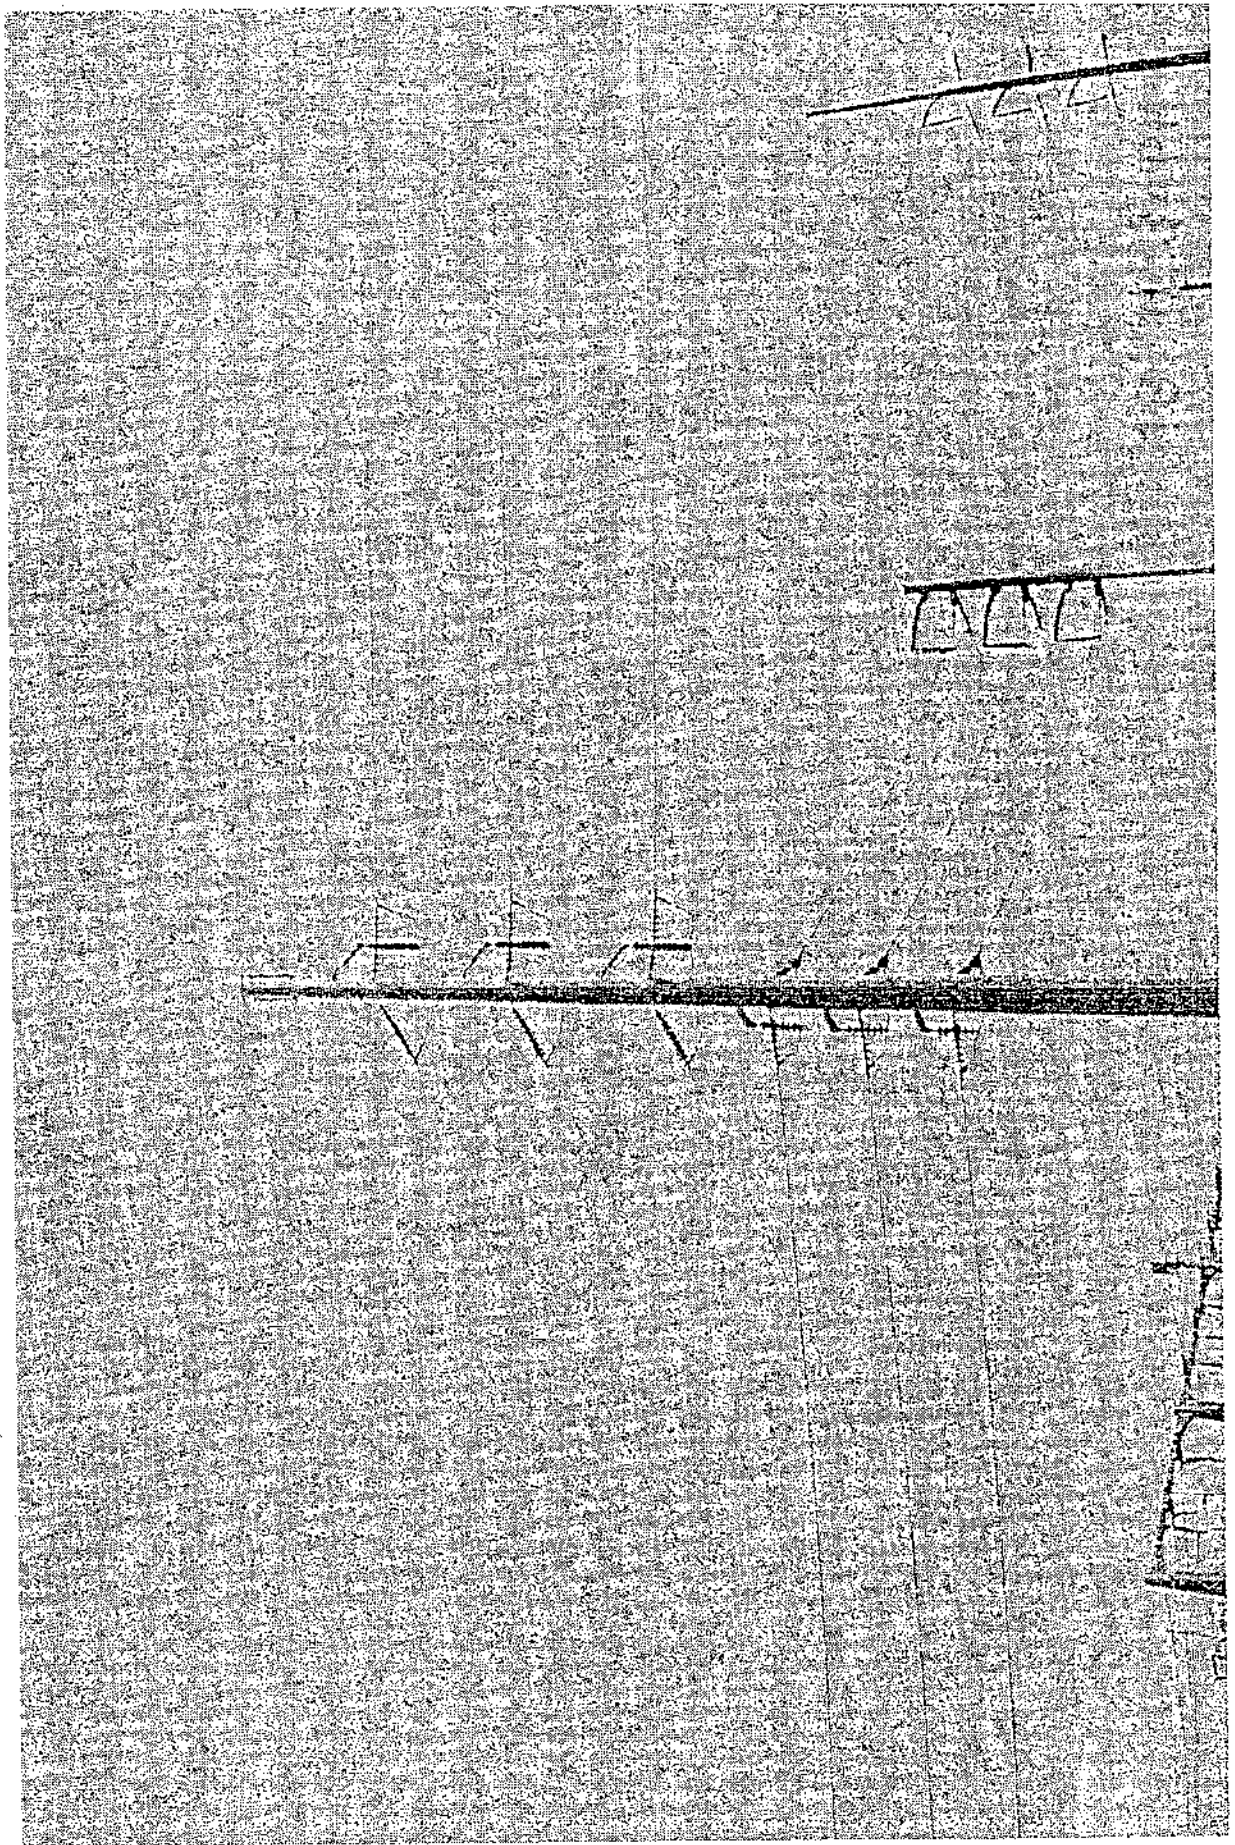
Structure 1E

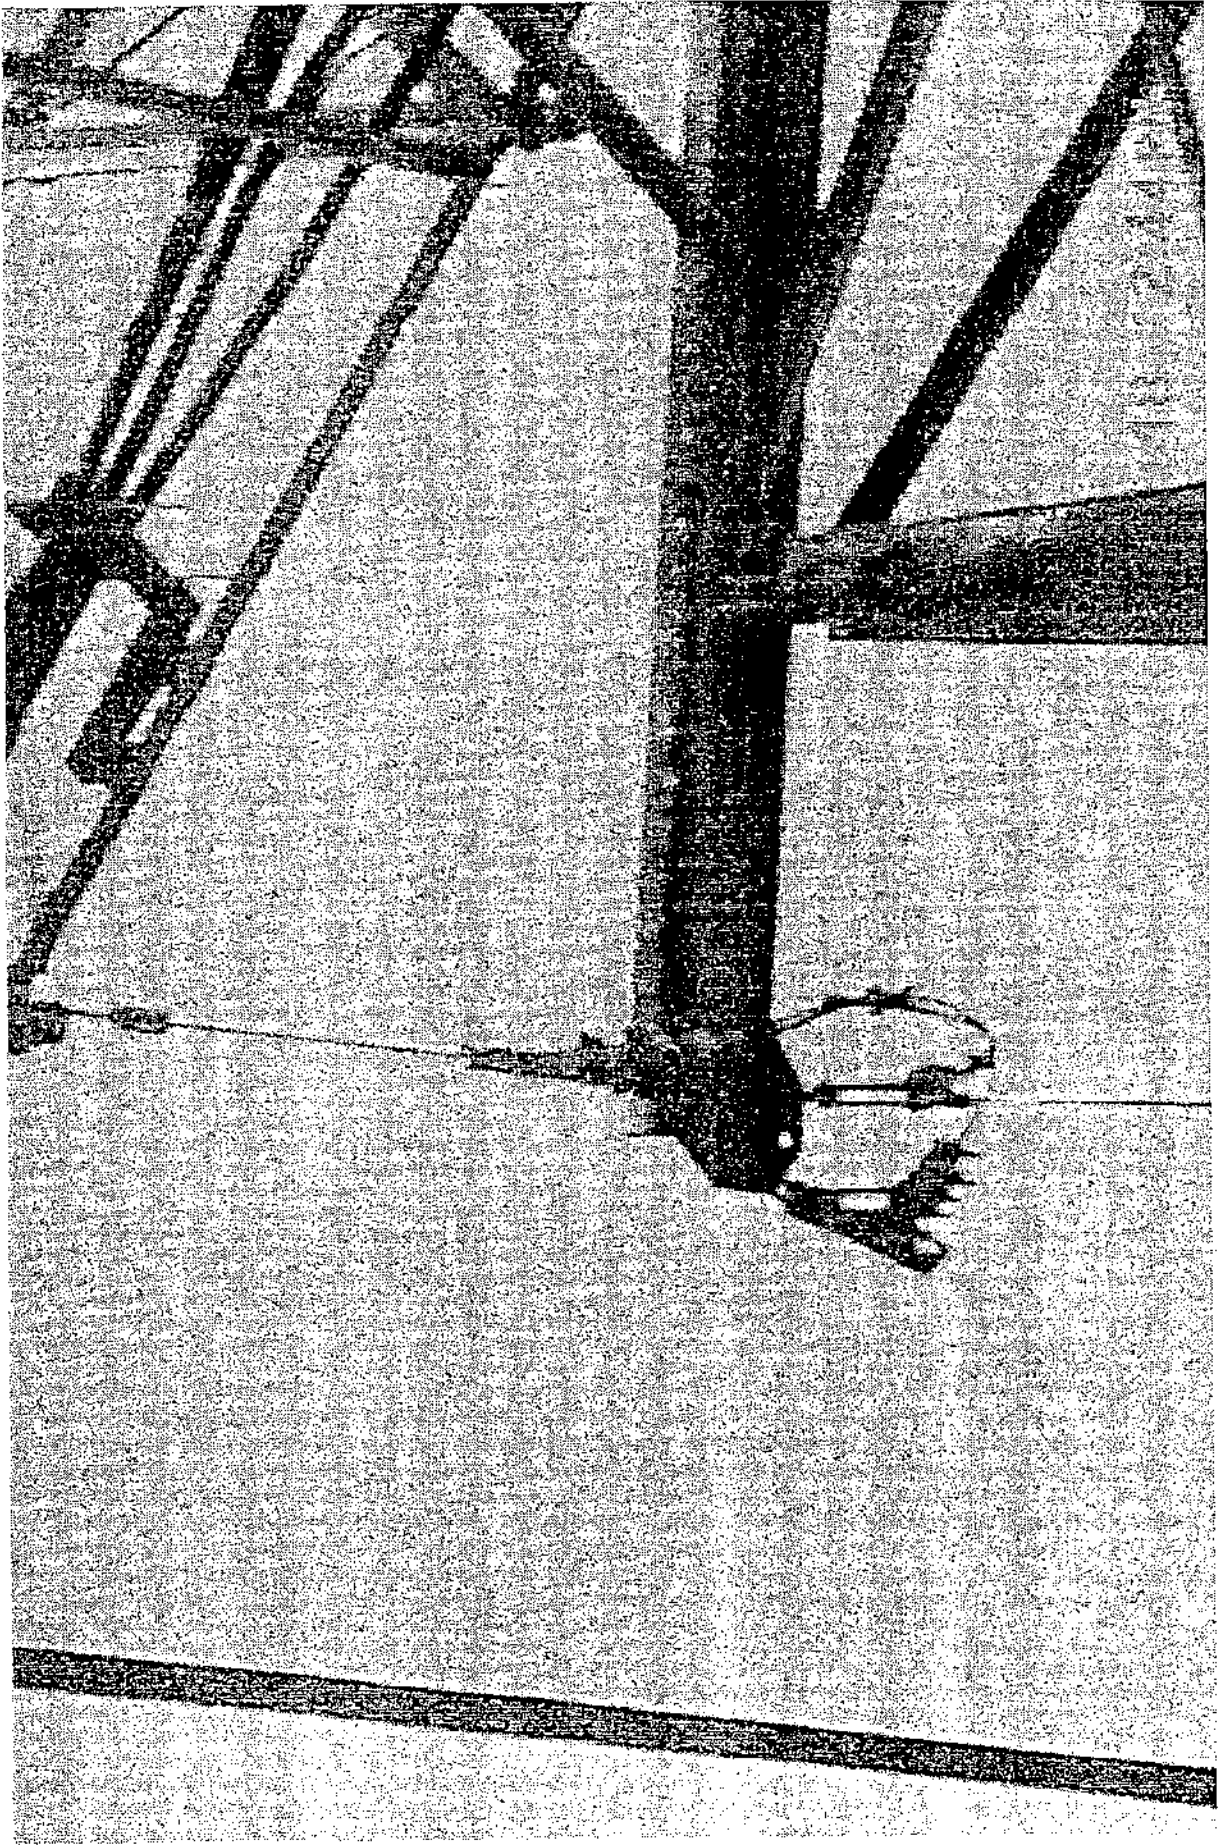
Inspection of the static wire that was being replaced has found that only the end of the wire has been damaged by an electrical arc. This has led to the assumption that the static wire came out of or broke at the connection shoe on the top of the tower. There were no other marks on the old static wire. Based on current information, it is not possible to conclusively rule out that the static wire was lowered into contact with the 69KV line before falling.

Shoe on structure 1F

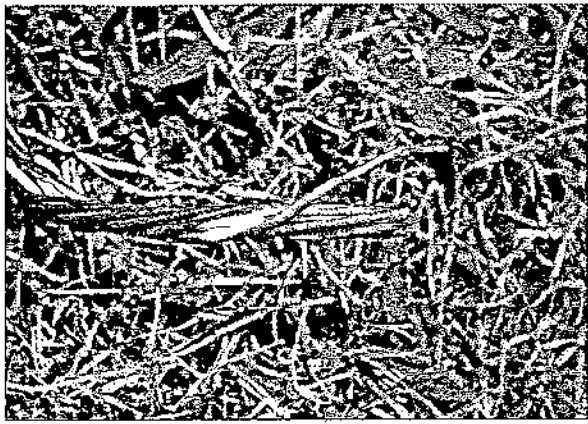
As the end of the static wire being replaced fell, it made contact with an energized 69KV line that was on the tower. This energized the static wire. It appears that Mr. Hudson at that time came into contact with the energized static wire. Mr. Hudson received a shock and entry burn to his right side in the hip area. The exit points were each located on the fifth digit (small toe) of each foot.

Static Wire after contacting 69kV

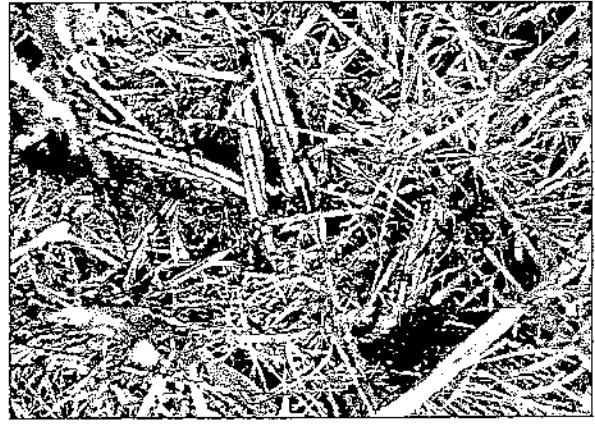
Pieces of static wire after contacting 69kV

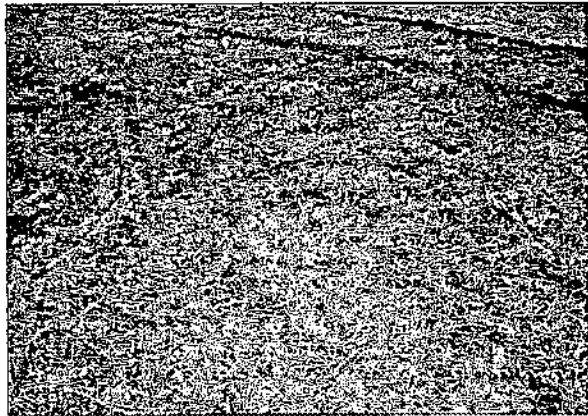
Chain hoist (red item on right) used in lowering static wire

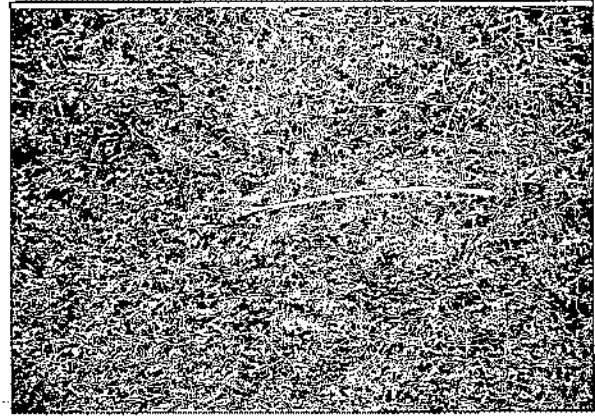
Static wire burned off after contacting 69kV

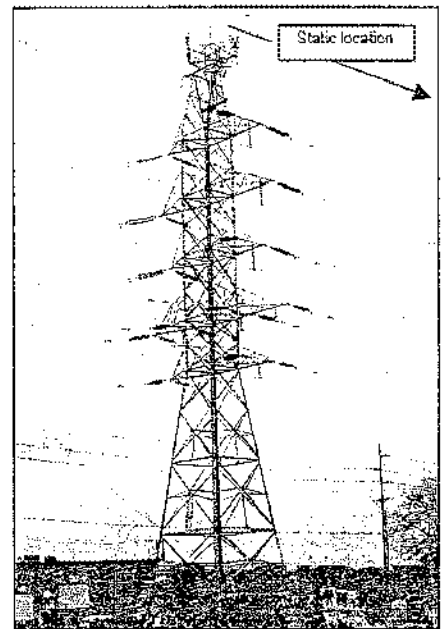
Structure #1-F ~ Transmission tower southeast of #1-E

Once on scene, I found that there were no protective grounds on the 69KV circuit that was located on the tower. All personnel interviewed corroborated that there had been no testing nor grounding of the 69KV circuit.

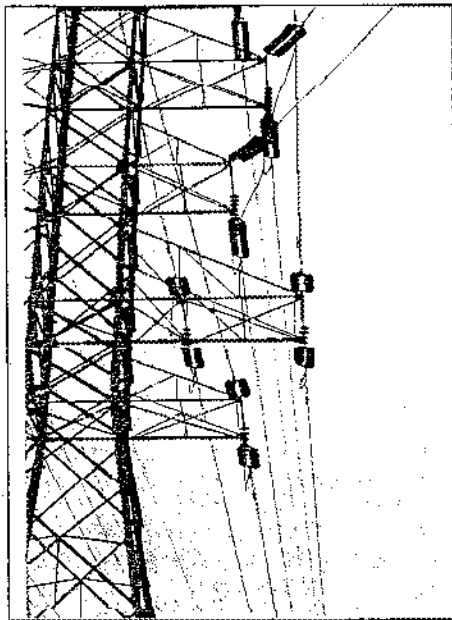
Structure # 1-F ~ Circuit to right was being worked

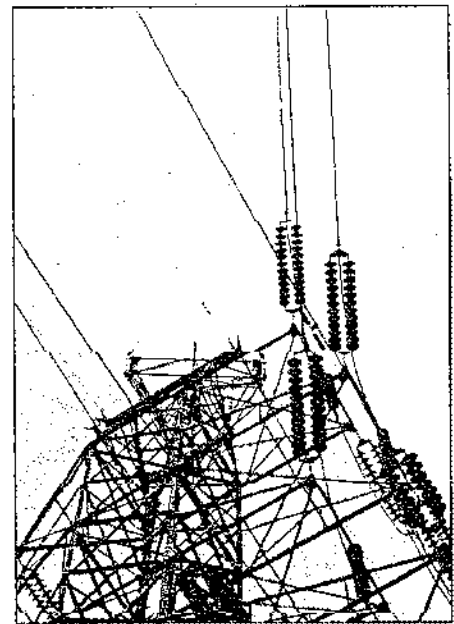
Structure # 1-F ~ Circuit to right was being worked

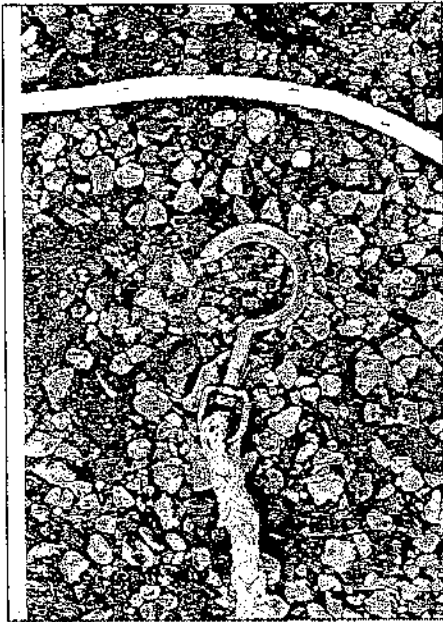
Handline hook used to pull static wire

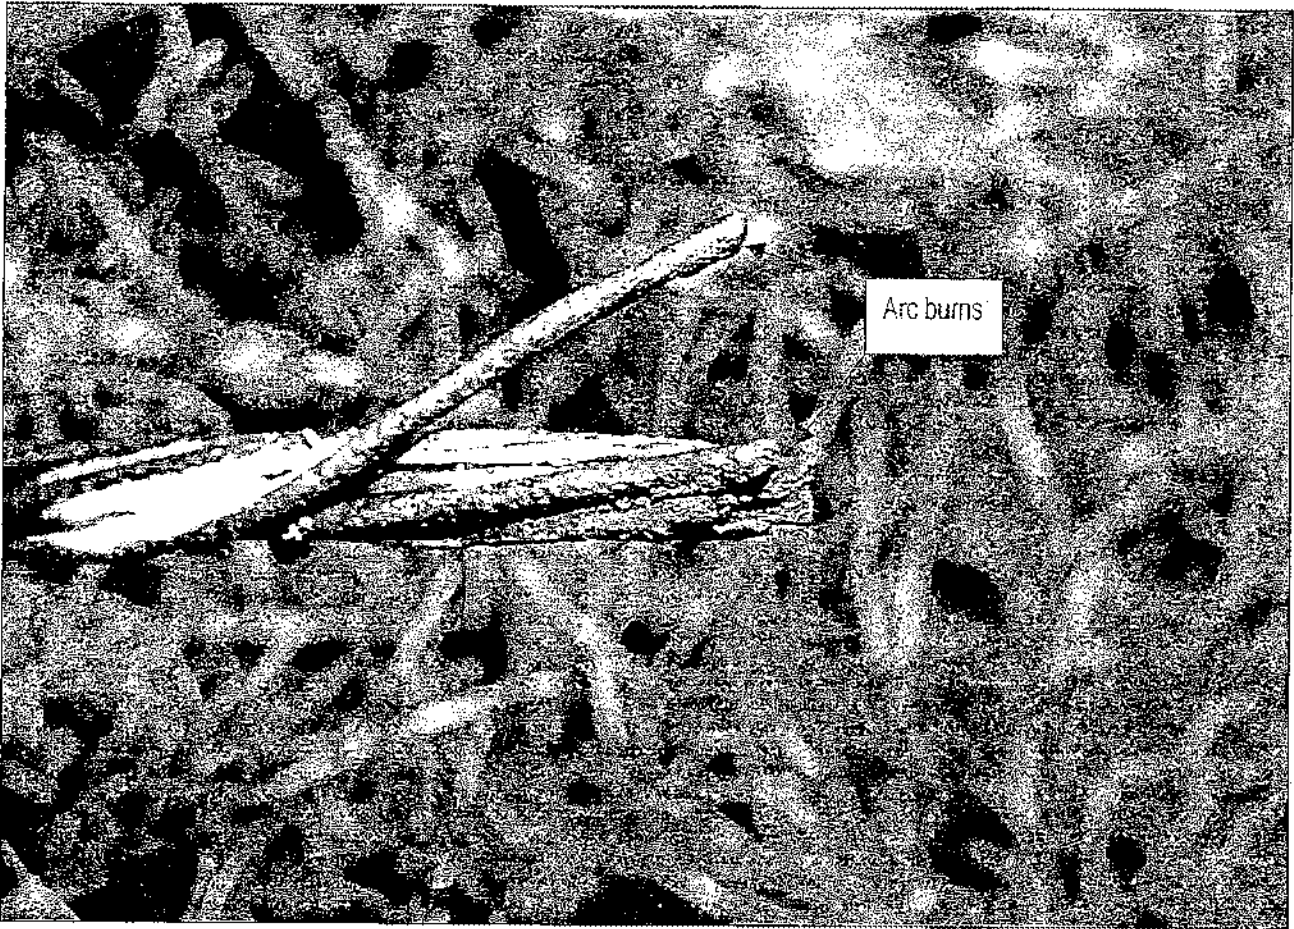
Static Wire after contacting 69Kv

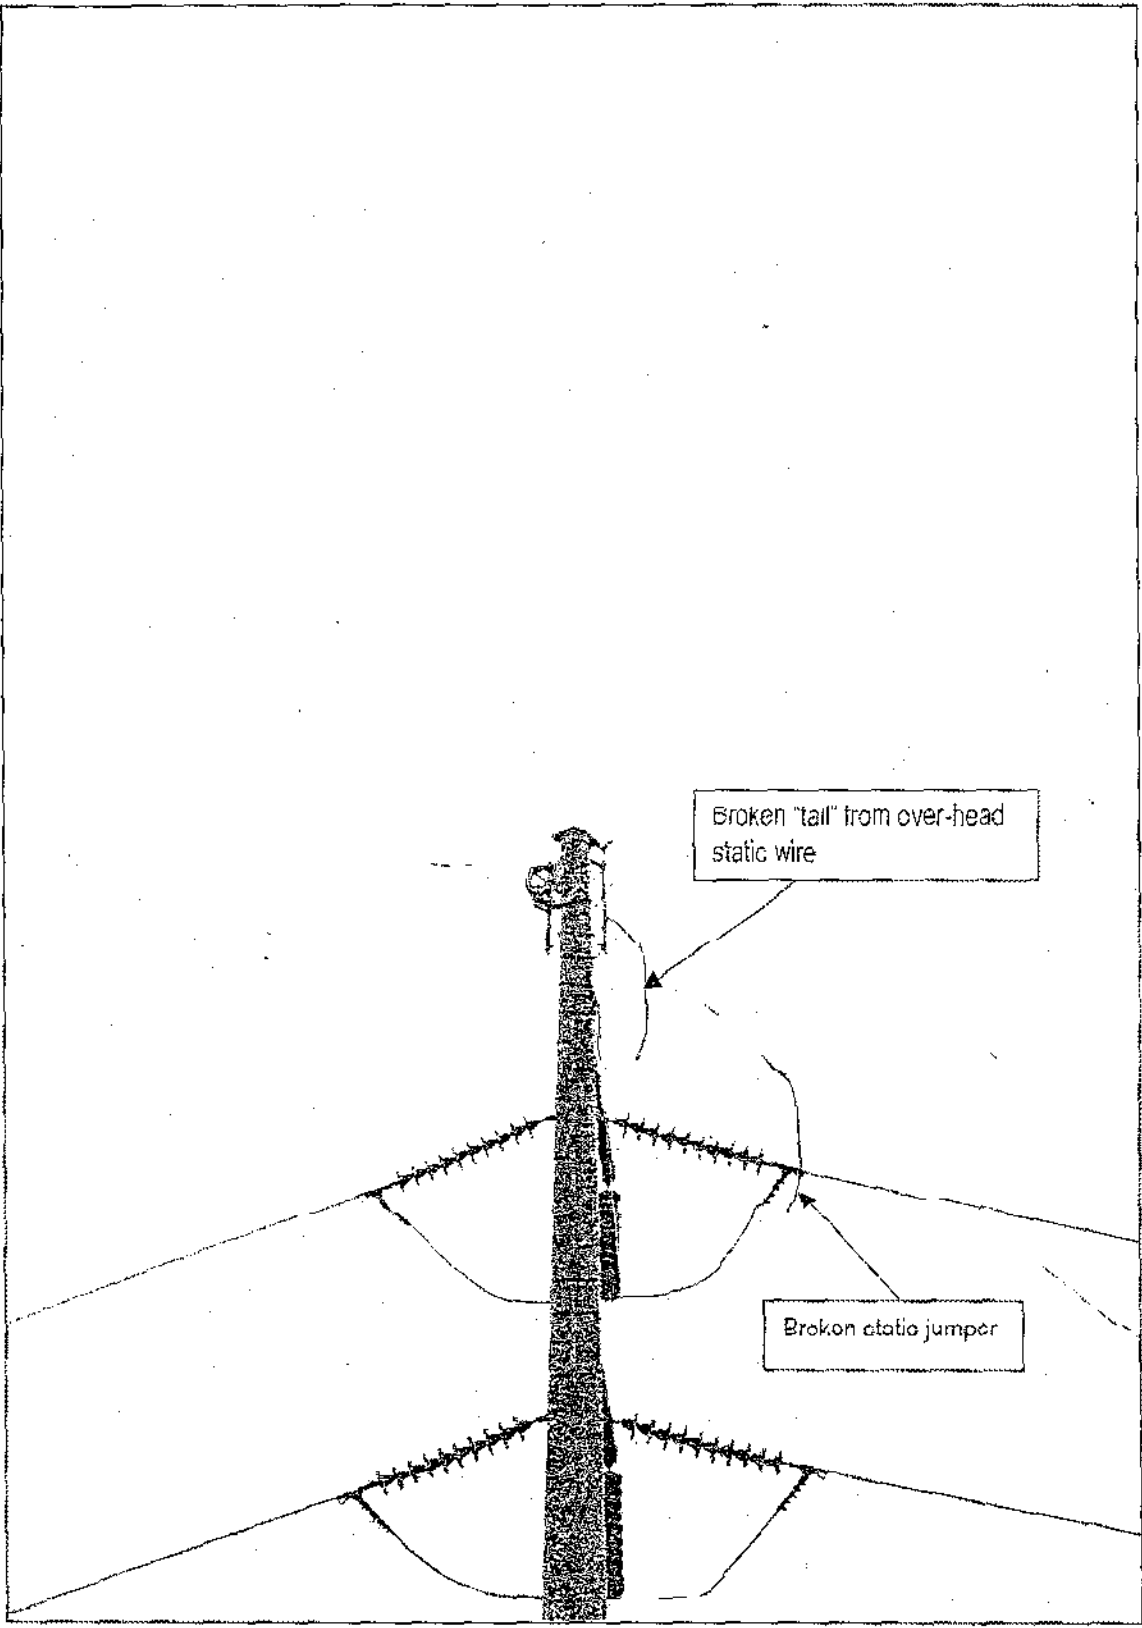
The static wire being replaced was disconnected at the pole and was being let down using a rope hand line and pulley. The hand line was being operated from the ground. The static line being replaced was still connected to the tower (structure 1-F). Mr. Hudson was on the ground and was to release the old static from the rope hand line. When the static wire was on the ground Mr. Hudson approached the static wire and removed a chain jack that was also on the end of the rope. As Mr. Hudson was taking the old static wire off of the rope it appears that the other end that was connected at the top of the tower (structure 1-F), either broke at the connection shoe or came loose at the connection and fell.

Structure # 1-E ~ Close up showing Static "tail" after breaking
