COMMONWEALTH OF KENTUCKY  
BEFORE THE PUBLIC SERVICE COMMISSION

SOUTH KENTUCKY RURAL ELECTRIC	)	
COOPERATIVE CORPORATION	)	CASE NO.
_____	)	2009-00015
	)	
ALLEGED FAILURE TO COMPLY WITH	)	
KRS 278.042	)

**INCIDENT INVESTIGATION ~ Staff Report**

**Incident Date ~ August 5, 2008**

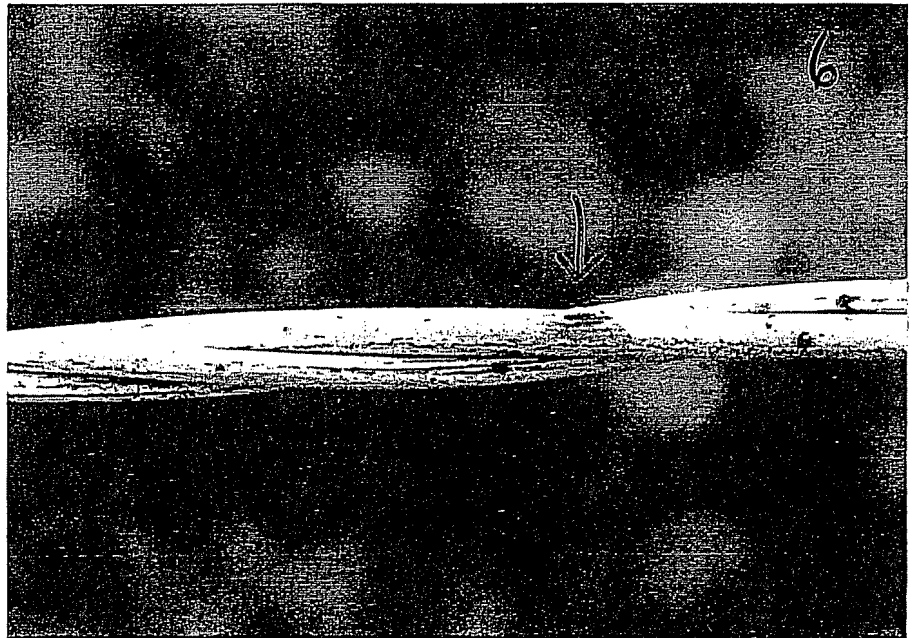
# 6 6 A CWC conductor where # 2 ACSR made contact in span between pole # 128161 and pole # 128162 approximately 120 feet out from pole # 128161.

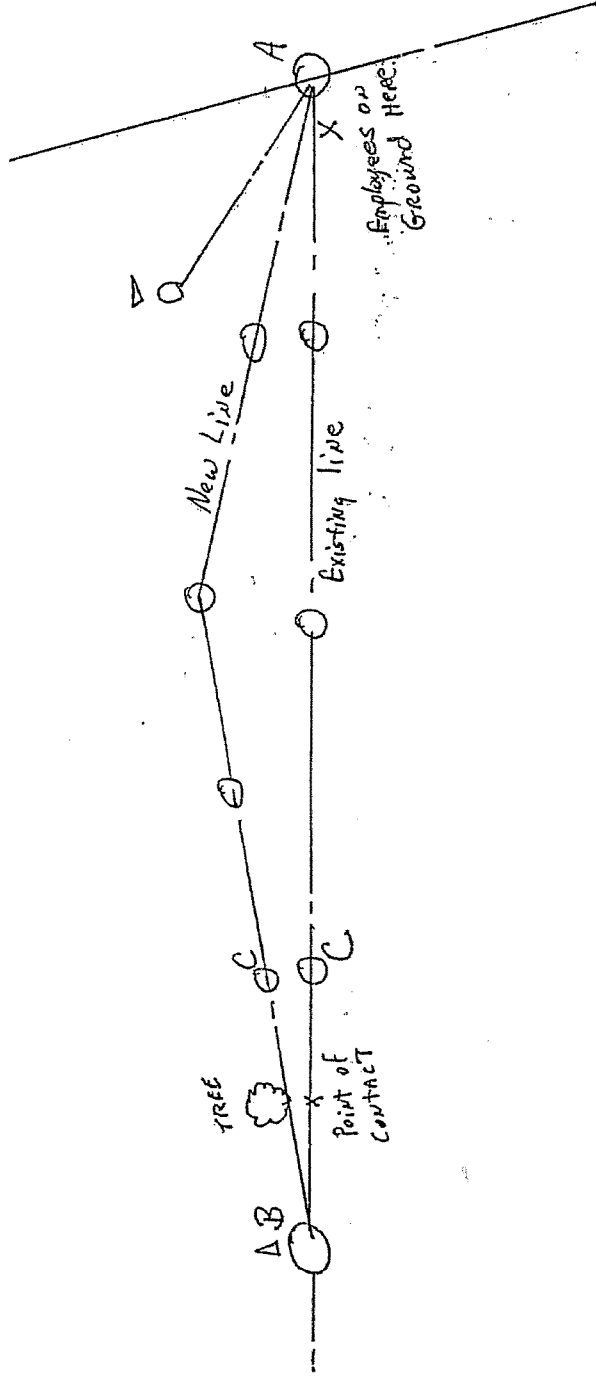
See drawing on back of incident form for reference to points A,B and C

All energized parts near where the new wire would be placed were covered. A new wire was pulled out and deadended at pole C. The wire was then temporary tied on the pole tops to allow for sagging. A preform and rope were attached to the wire near pole A. Scotty Hurst and Donnie Lainhart were using the rope to pull excess slack out of the wire. Policy 6.24 Blue section of hand book permits using dry rope to raise and lower wires on poles. Carl Gilbert was standing by to place a grip on the wire for raising the wire into position for sagging. Carl was wearing all required PPE for placing the grip on the wire. Gloves Sleeves and Insulated Boots.

As Scotty and Donnie were pulling the wire up, it became snagged in a tree limb. Due to the amount of wire they were pulling, they were not concerned that it was a hard pull. They could not see the area where the wire was snagged in the tree. As they pulled harder the wire dislodged from the tree limb. The resulting jerk caused the new wire to contact the energized old wire. When this contact occurred, both Scotty and Donnie experienced an electrical shock. Both employees had exit wounds on one foot. Due to the nature and extent of the injuries, we have determined that the electrical shock was a result of a Step Potential condition caused when excess wire laying on the ground, near the employees became energized.

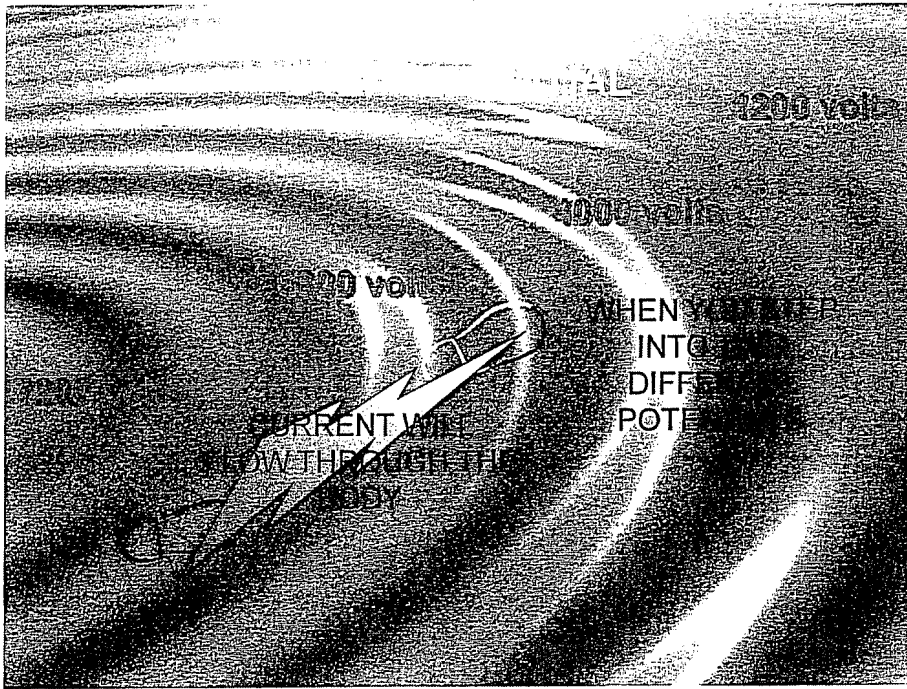
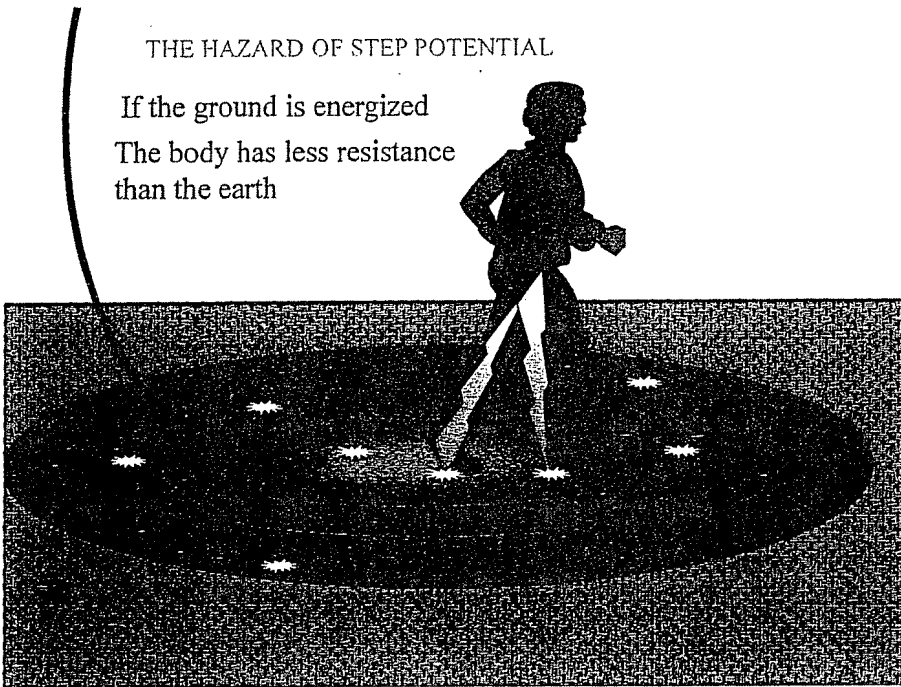
#### THE HAZARD OF STEP POTENTIAL

If the ground is energized  
The body has less resistance  
than the earth
