COMMONWEALTH OF KENTUCKY
BEFORE THE PUBLIC SERVICE COMMISSION

KENERGY CORPORATION)	
_____)	
ALLEGED FAILURE TO COMPLY WITH)	CASE NO. 2009-00431
KRS 278.042)	
)

ORDER

INCIDENT INVESTIGATION ~ Staff Report

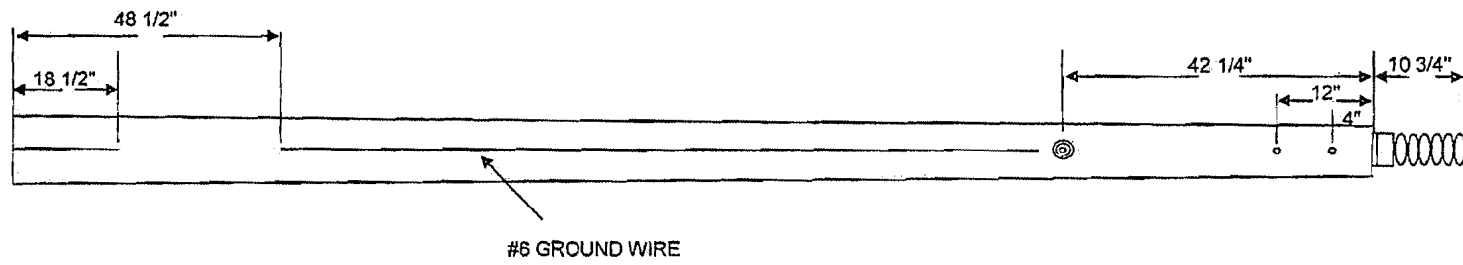
LYON COUNTY
KNIGHT ROAD

40 FOOT POLE
