COMMONWEALTH OF KENTUCKY  
BEFORE THE PUBLIC SERVICE COMMISSION

DUKE ENERGY KENTUCKY, INC.

\_\_\_\_\_  
ALLEGED FAILURE TO COMPLY WITH  
KRS 278.042

)  
) CASE NO.  
) 2010-00248  
)  
)

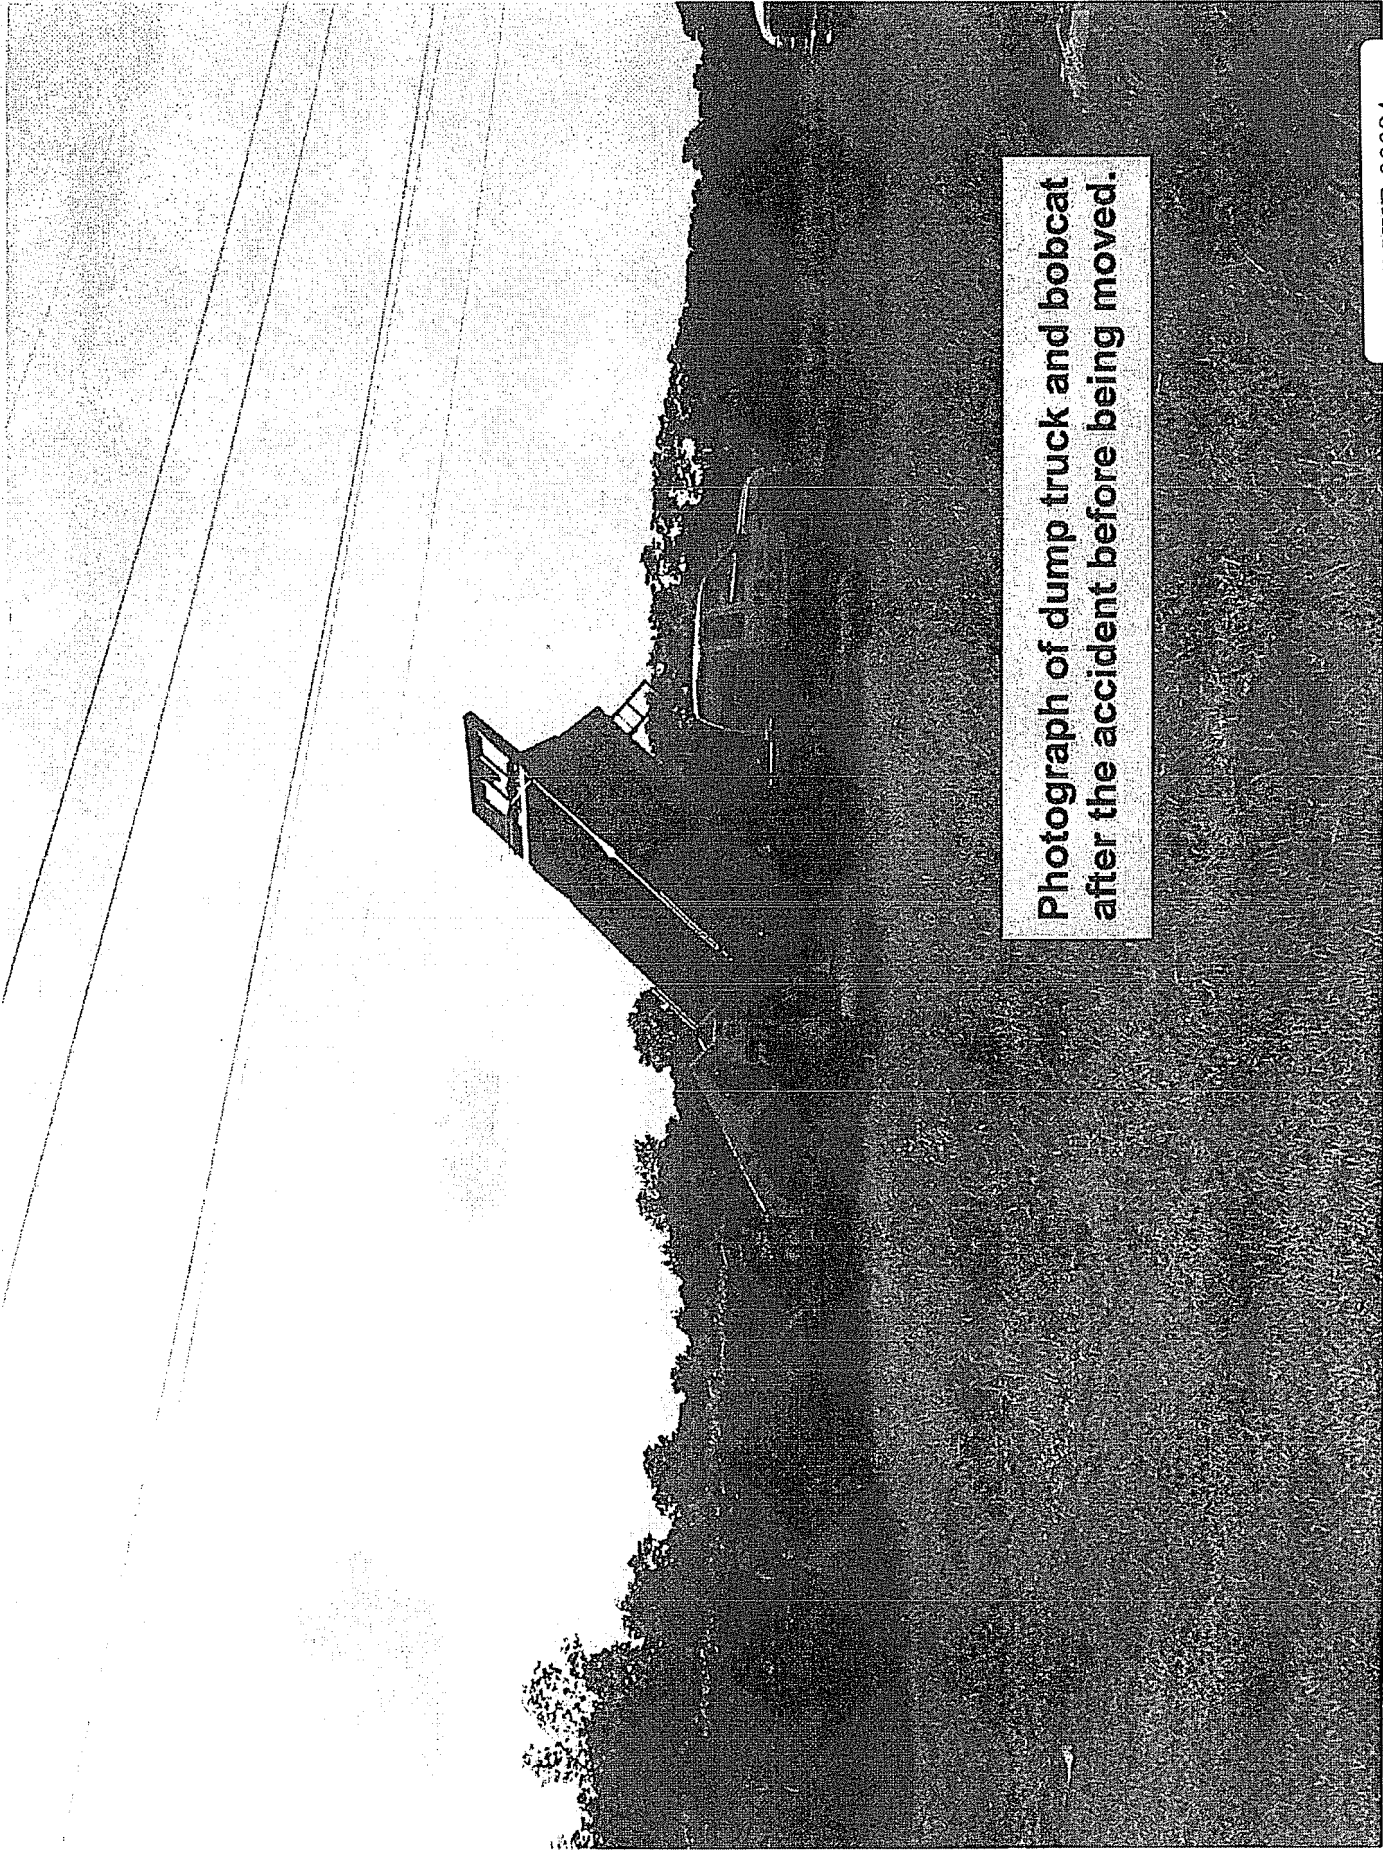
Photograph of dump truck and bobcat  
after the accident before being moved.

Incident site located between  
poles 10G-85E and 10G-86E

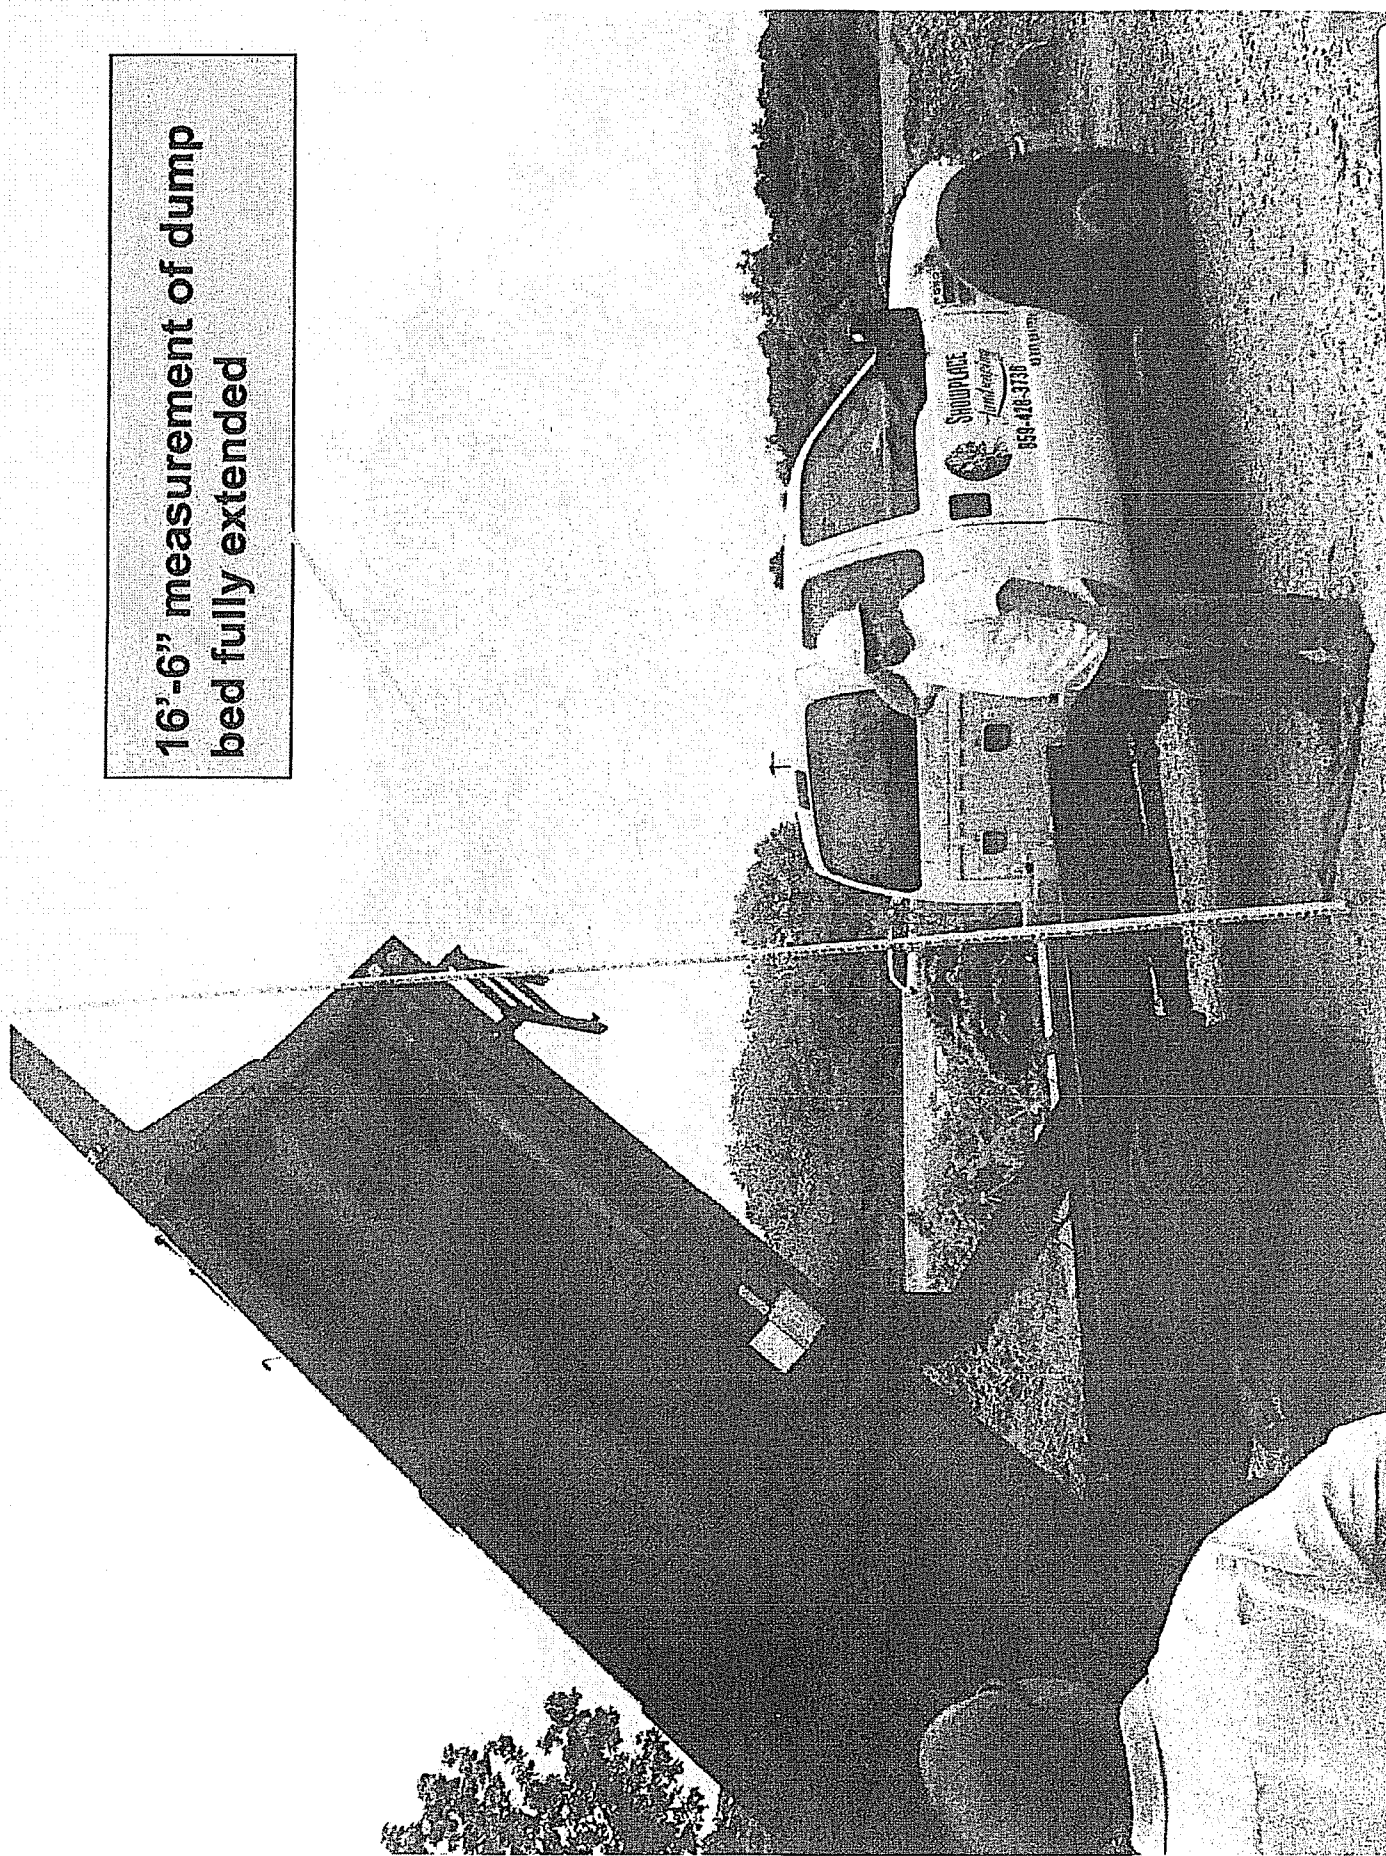
DUKE-00098  
CONFIDENTIAL

With the dump truck bed measuring sixteen feet, six inches, and both the top of the bed and conductors showing contact points, the supply conductor must have been less than sixteen feet, six inches when the bed of the dump truck made contact. This is a probable violation of the National Electric Safety Code (NESC).

16'-6" measurement of dump  
bed fully extended

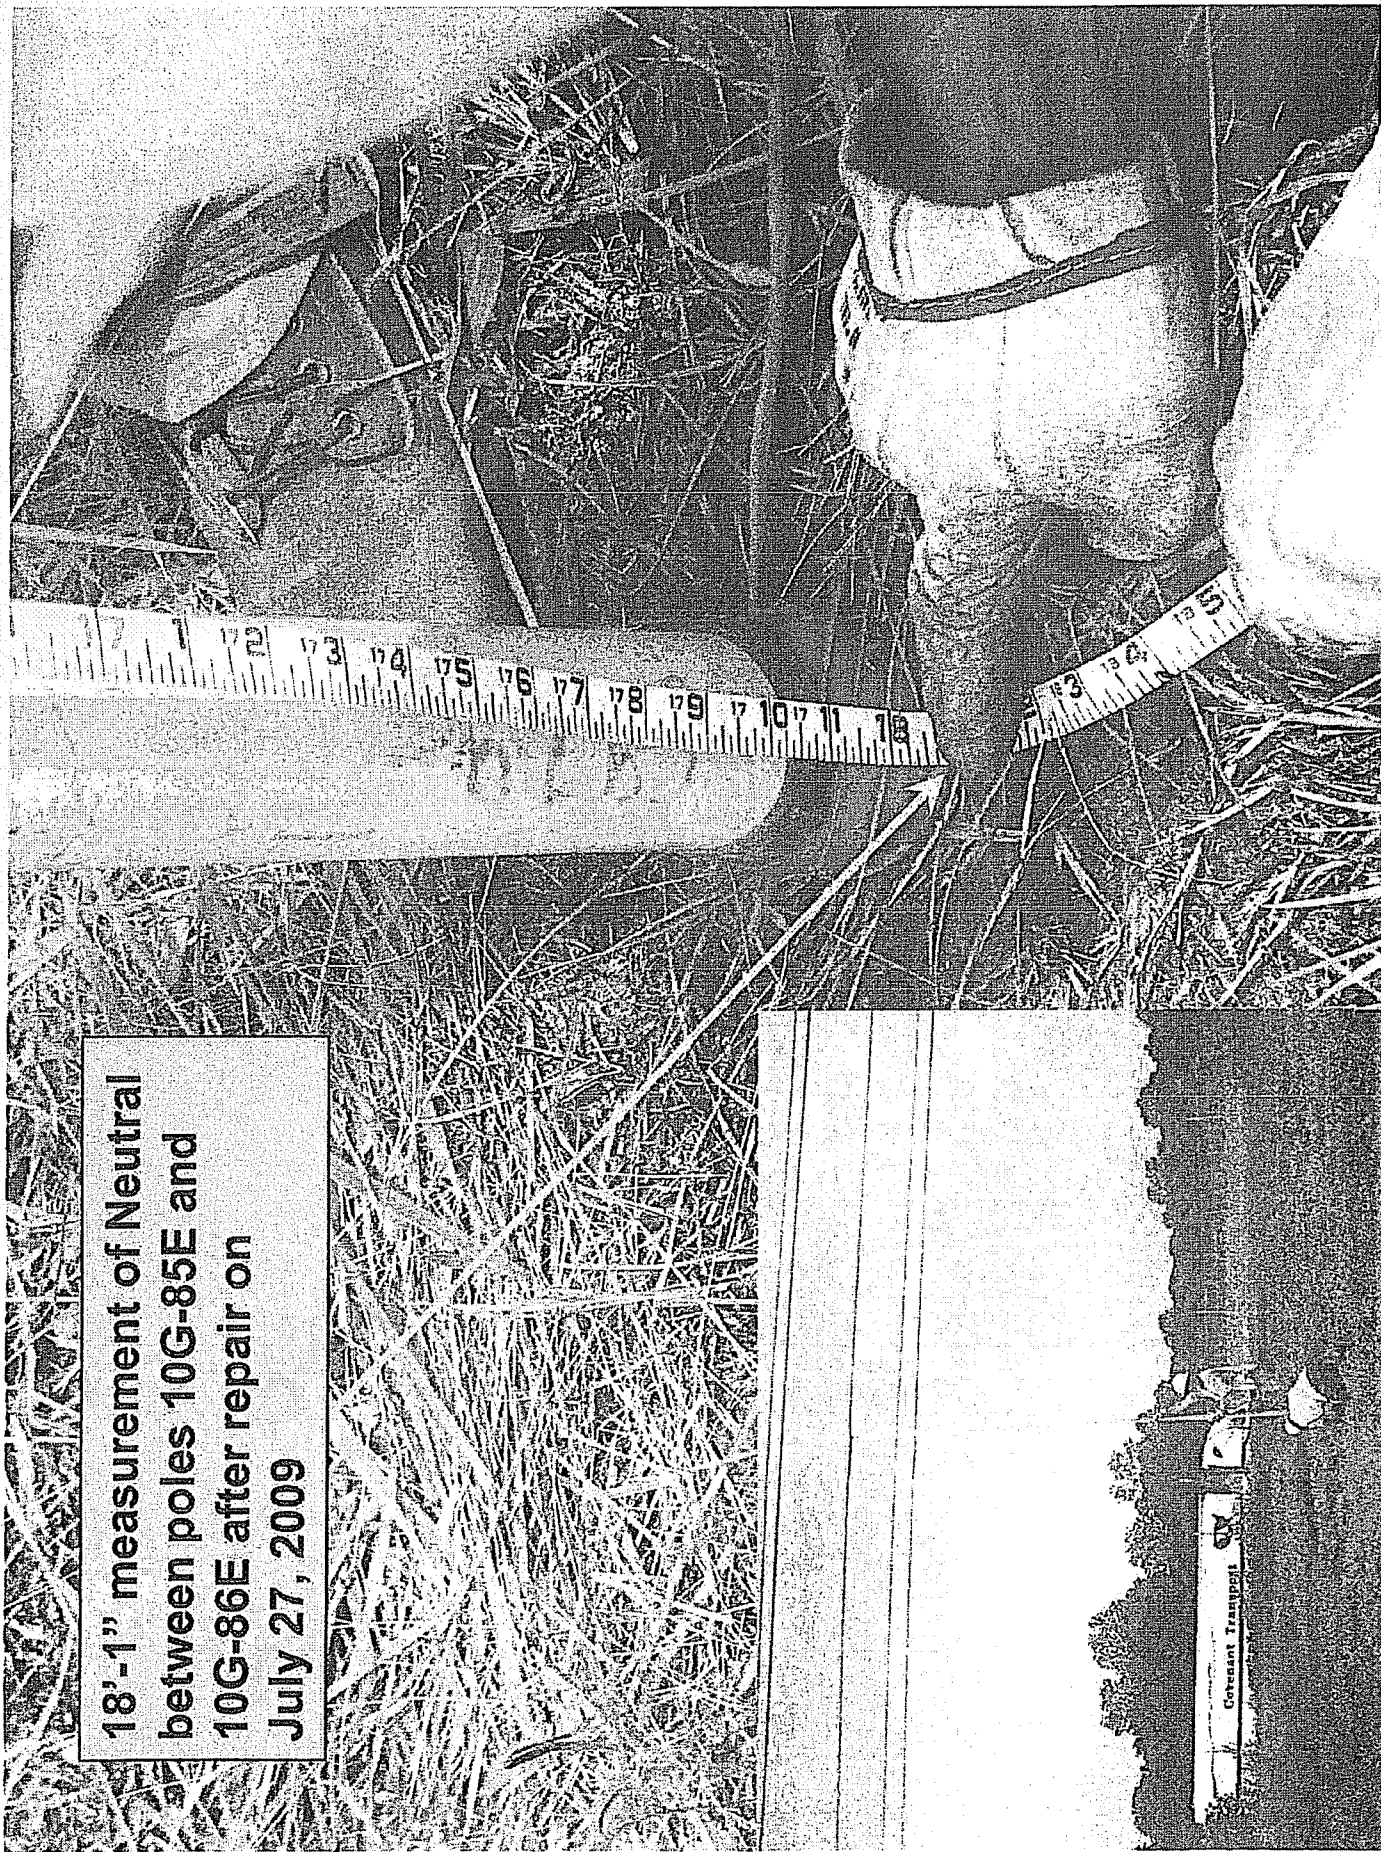
**18'-1" measurement of Neutral  
between poles 10G-85E and  
10G-86E after repair on  
July 27, 2009**

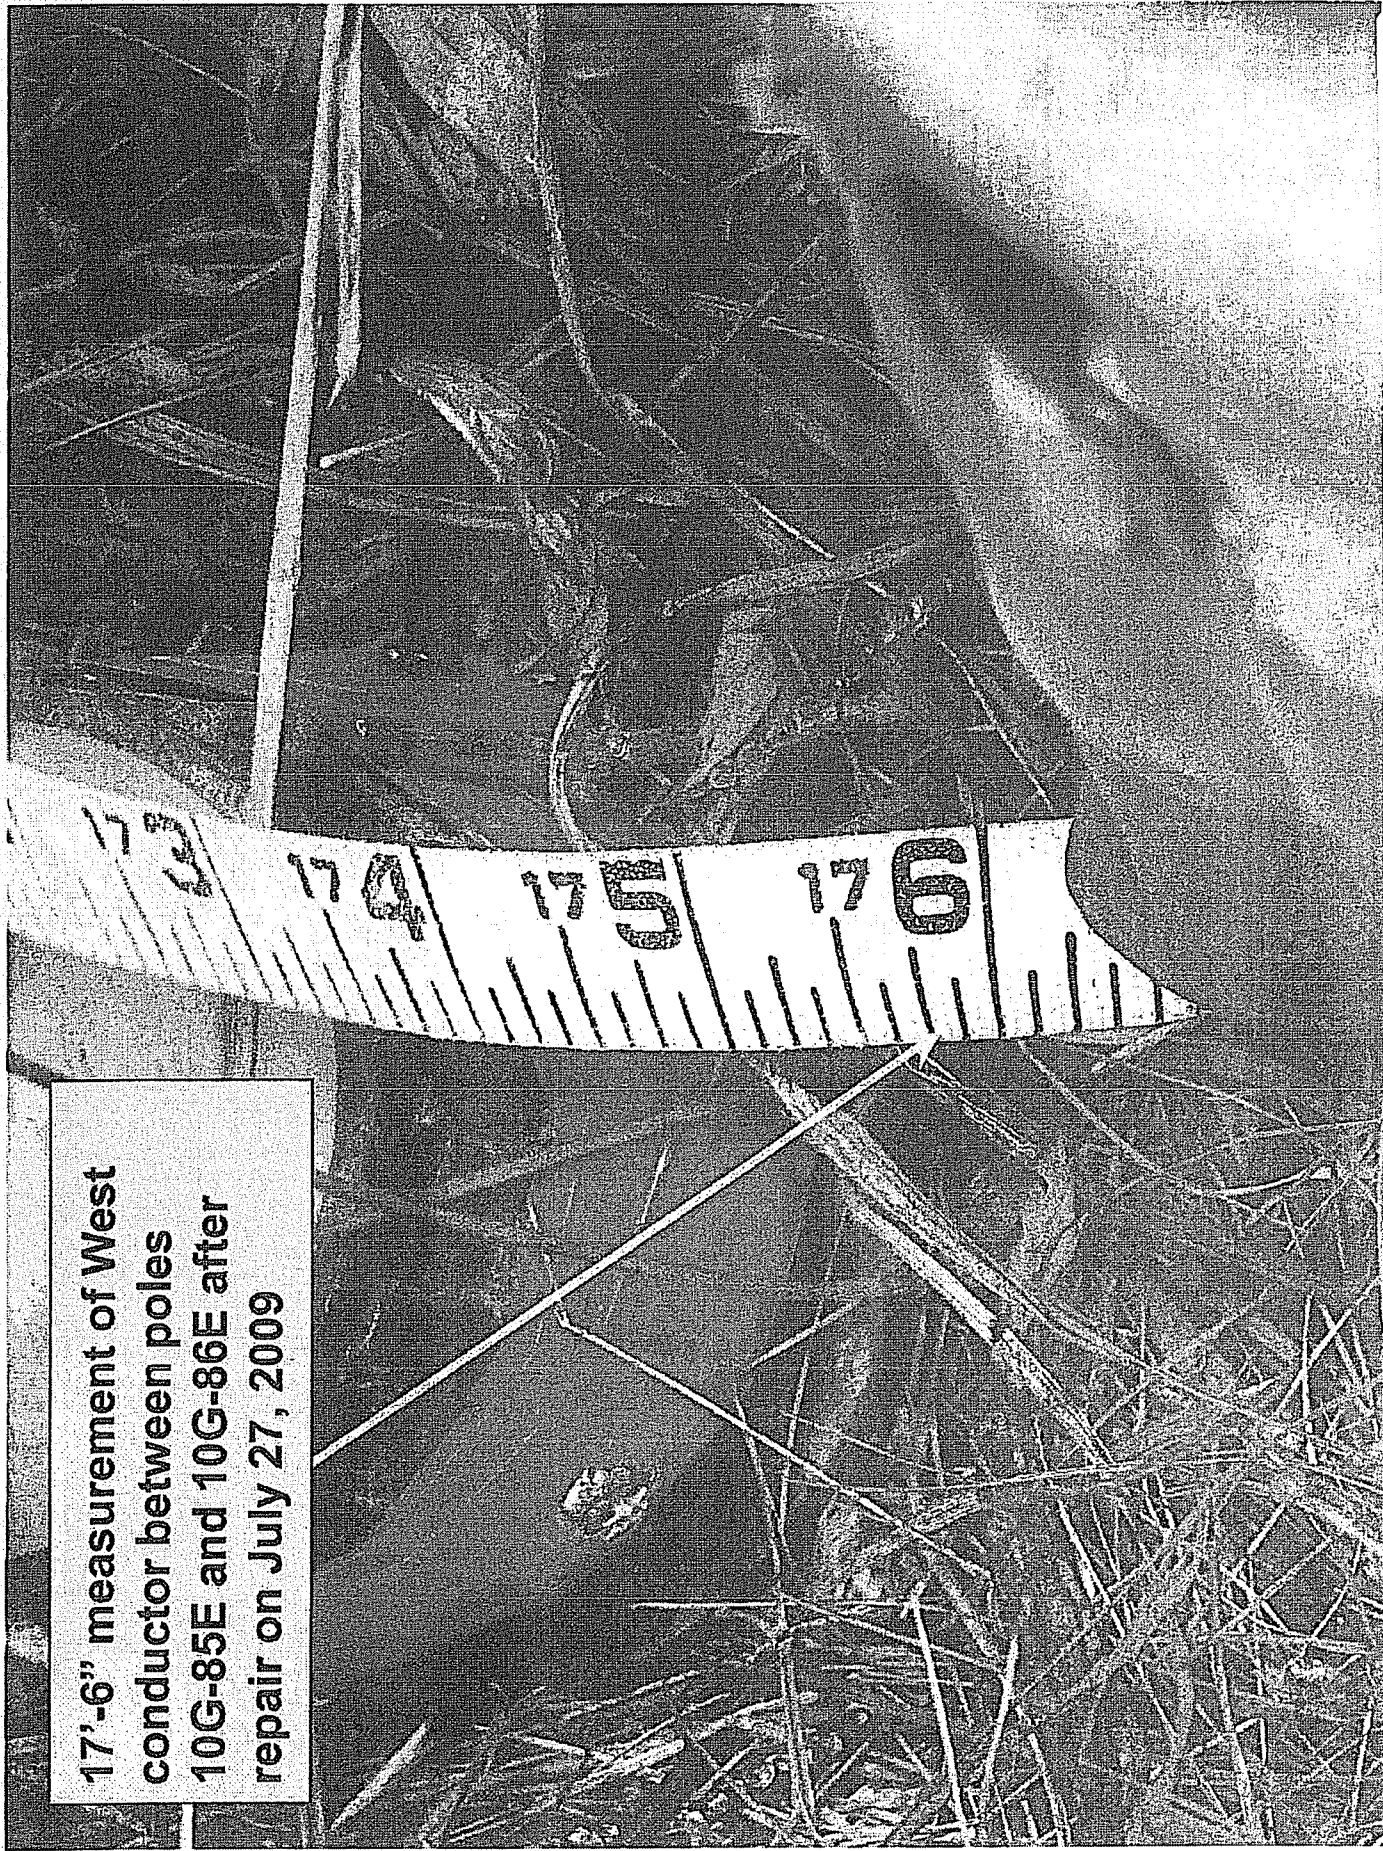
Attachment A shows the ground clearance of the west supply conductor at seventeen feet, six inches after repairs. This is still a probable violation of the NESC, section 20, table 232-1.

After receiving the documents in Attachment A (date stamped November 20, 2009) showing the conductors height at seventeen feet, six inches after the repairs had been made, it was discovered that Duke Energy Kentucky facilities at the incident site had been changed, new structures installed, and the conductor height changed. I contacted Duke Energy Kentucky and asked if they would like to amend the seven-day report showing the height of the conductors after the changes mentioned above. They sent an amended document for Duke Energy Kentucky's seven-day report on January 14, 2010 documenting changes made to the facilities at the incident site. The photograph in Attachment A, DUKE-00112 shows the supply conductor at thirty two feet, six inches, compared to photograph DUKE-00101 which shows the supply conductor at seventeen feet, six inches.

**17'-6" measurement of West  
conductor between poles  
10G-85E and 10G-86E after  
repair on July 27, 2009**

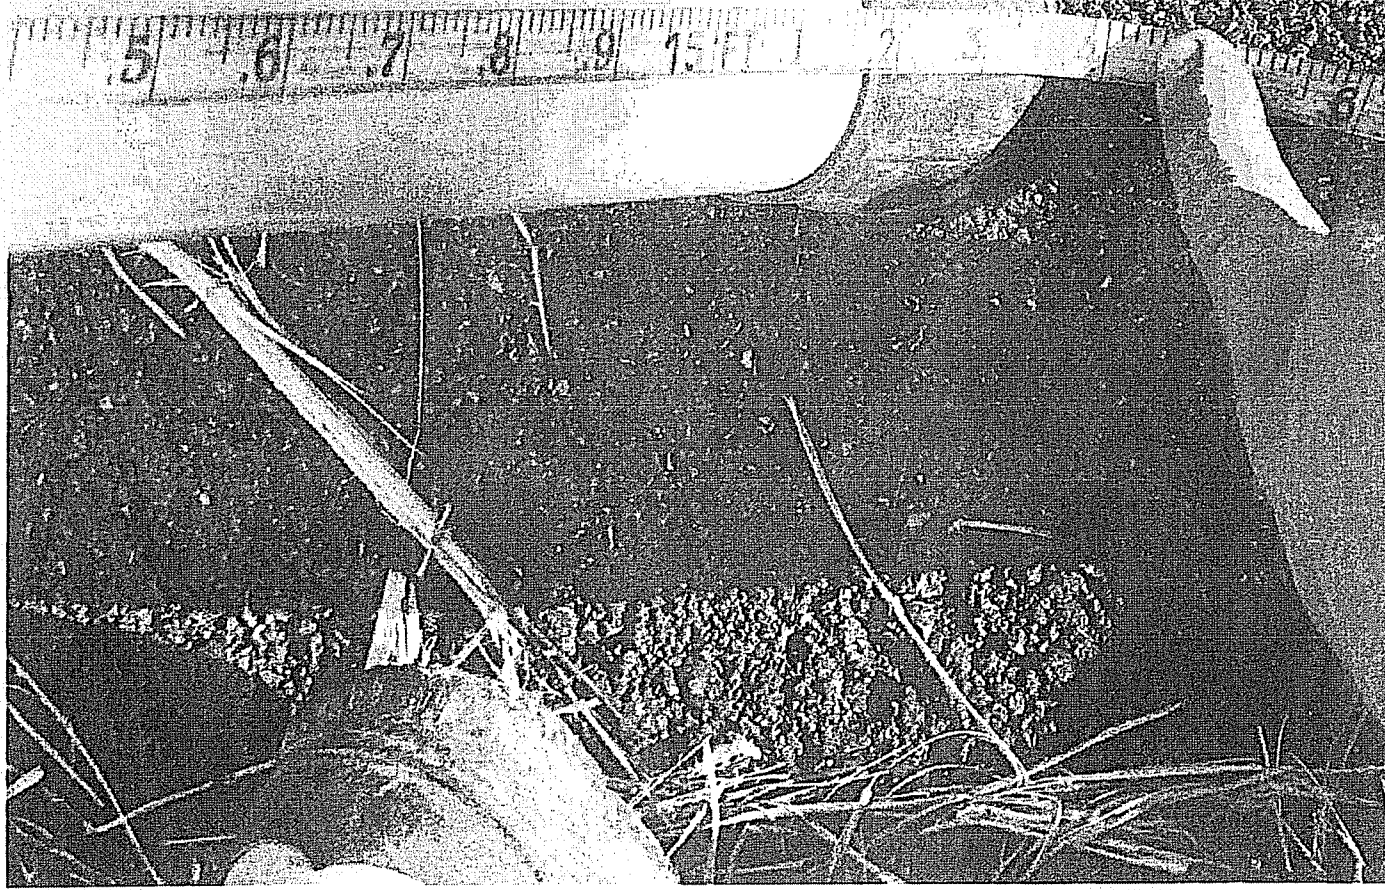
In addition, you notified us of potential clearance violations involving the height requirements on a 7.2kV phase conductor (west line) located along U.S. 25 easement located between pole numbers 10G-85E and 10G-86E, and 5G-345E and 5G346E crossing Route 2942.

15'-3" measurement of Neutral  
between poles 5G-345E and  
5G-346E prior to raising on  
July 31, 2009

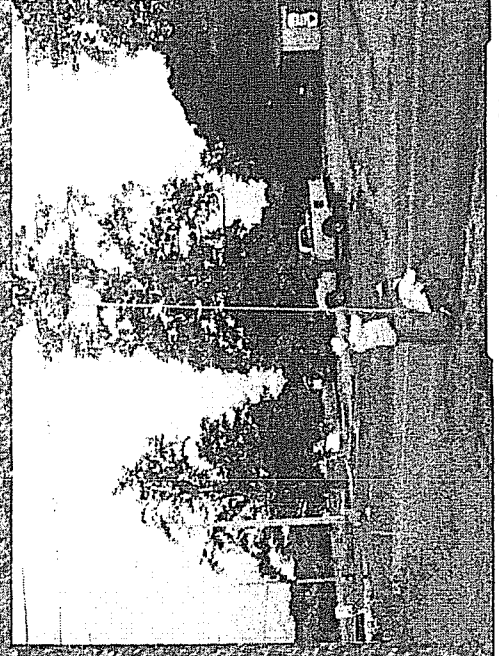
17'-6" measurement of Neutral  
between poles 5G-345E and  
5G-346E after raising on  
July 31, 2009

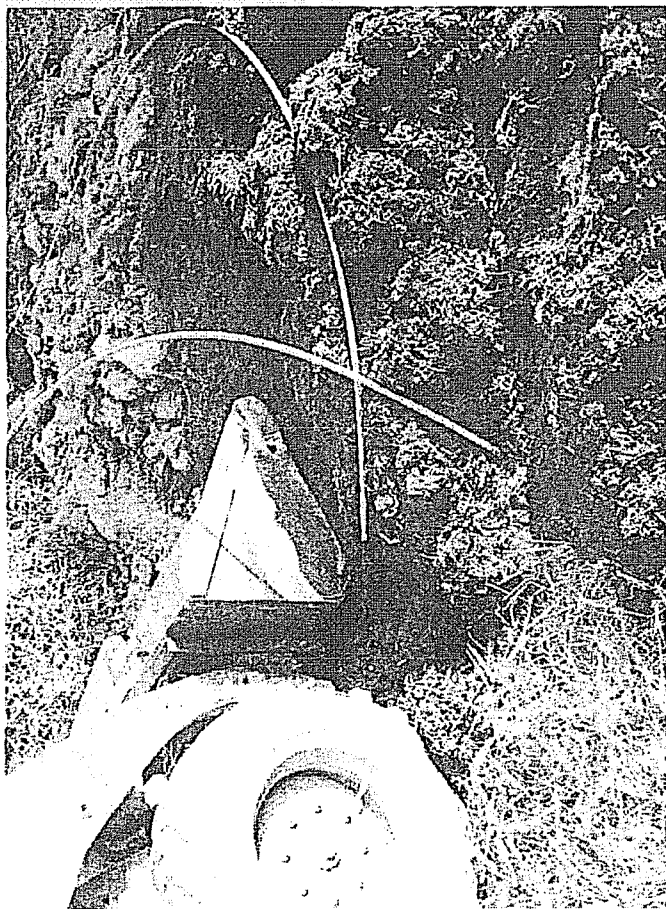
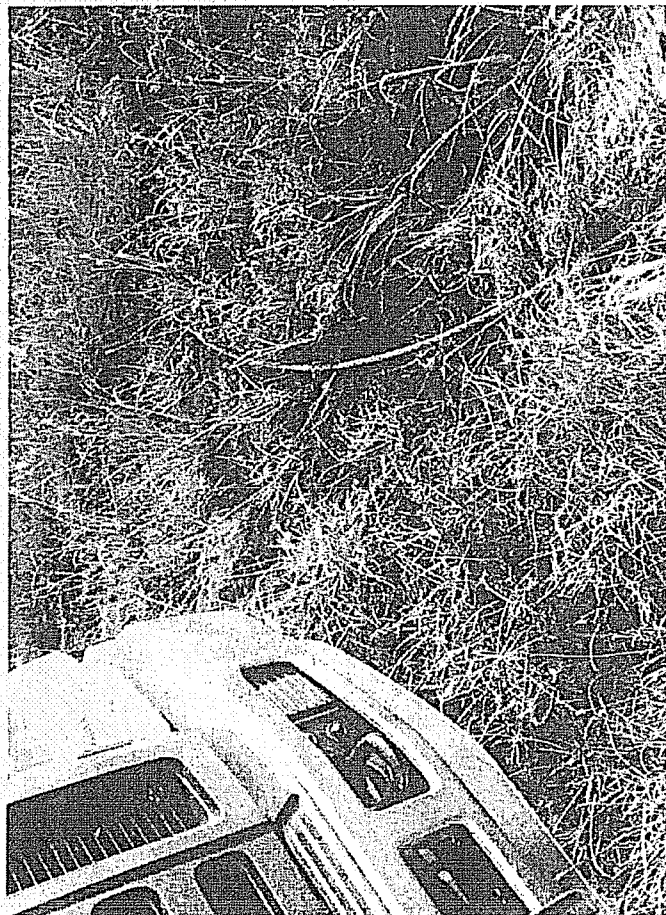
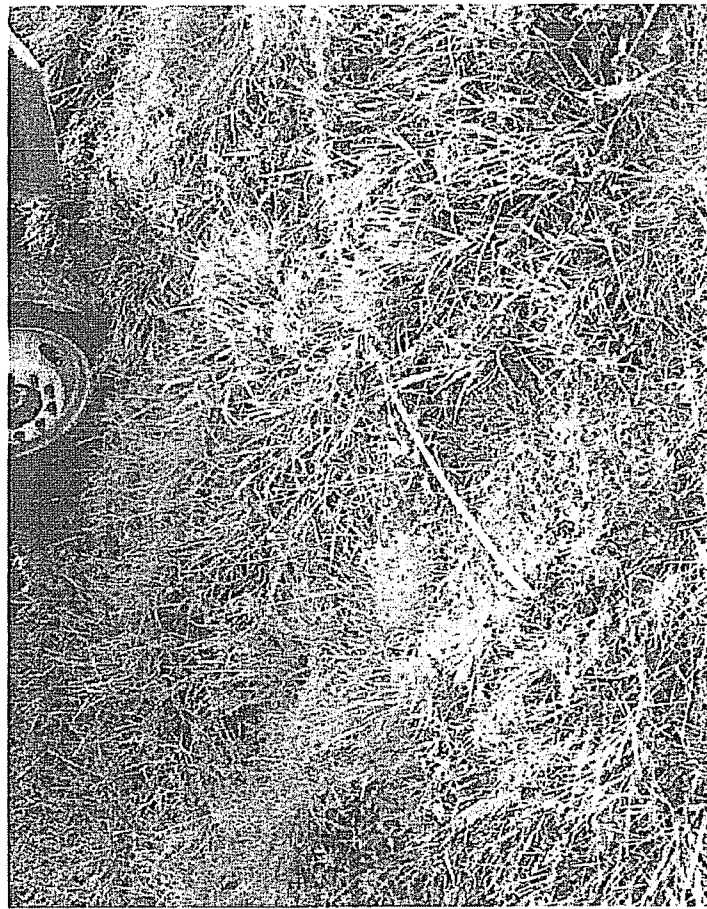
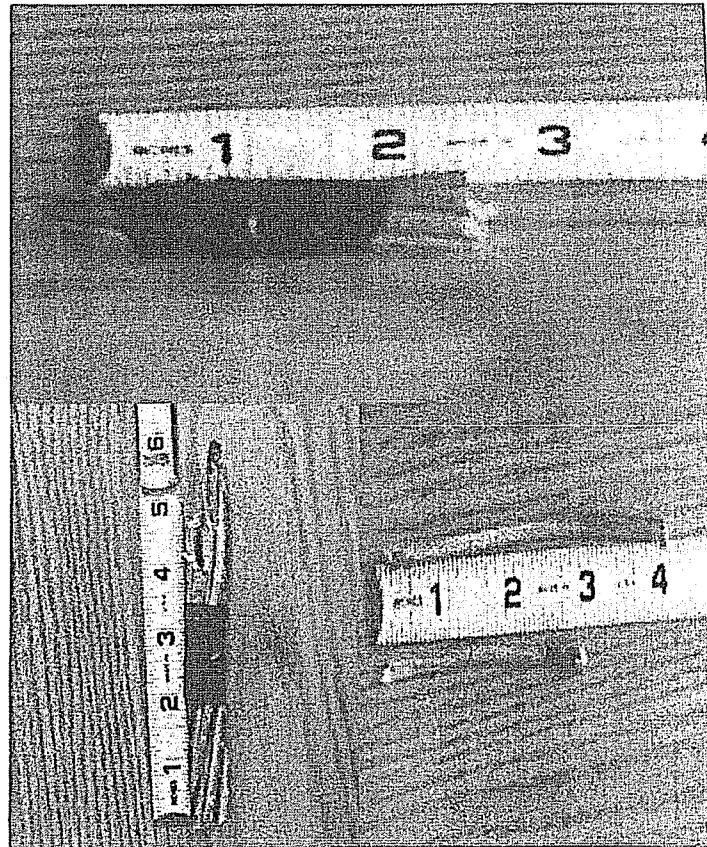
Non-Conductive Stick of 8'-6" in length was added to each total measurement to determine final height

19'-4"

19'-1"

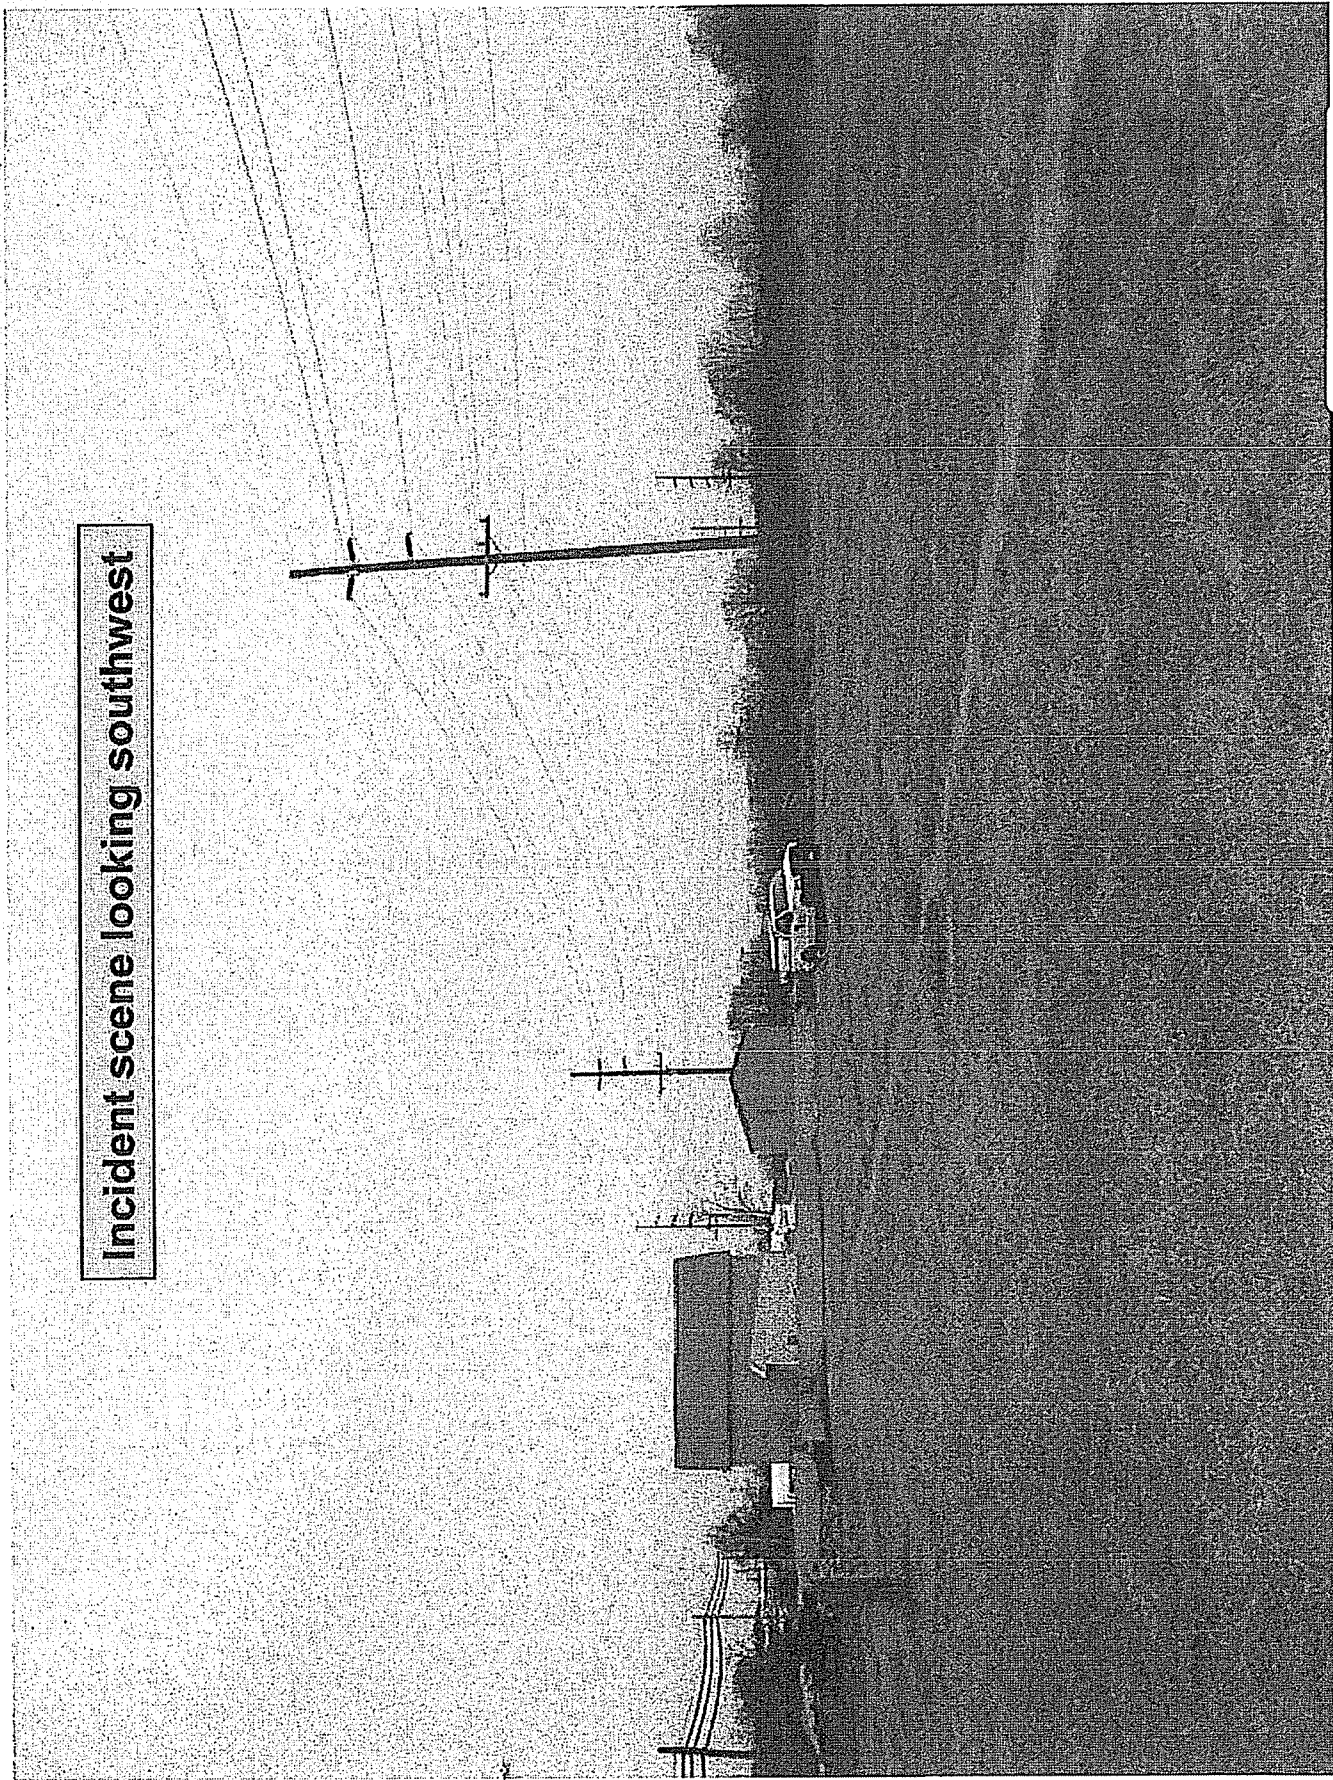
Incident scene looking southwest

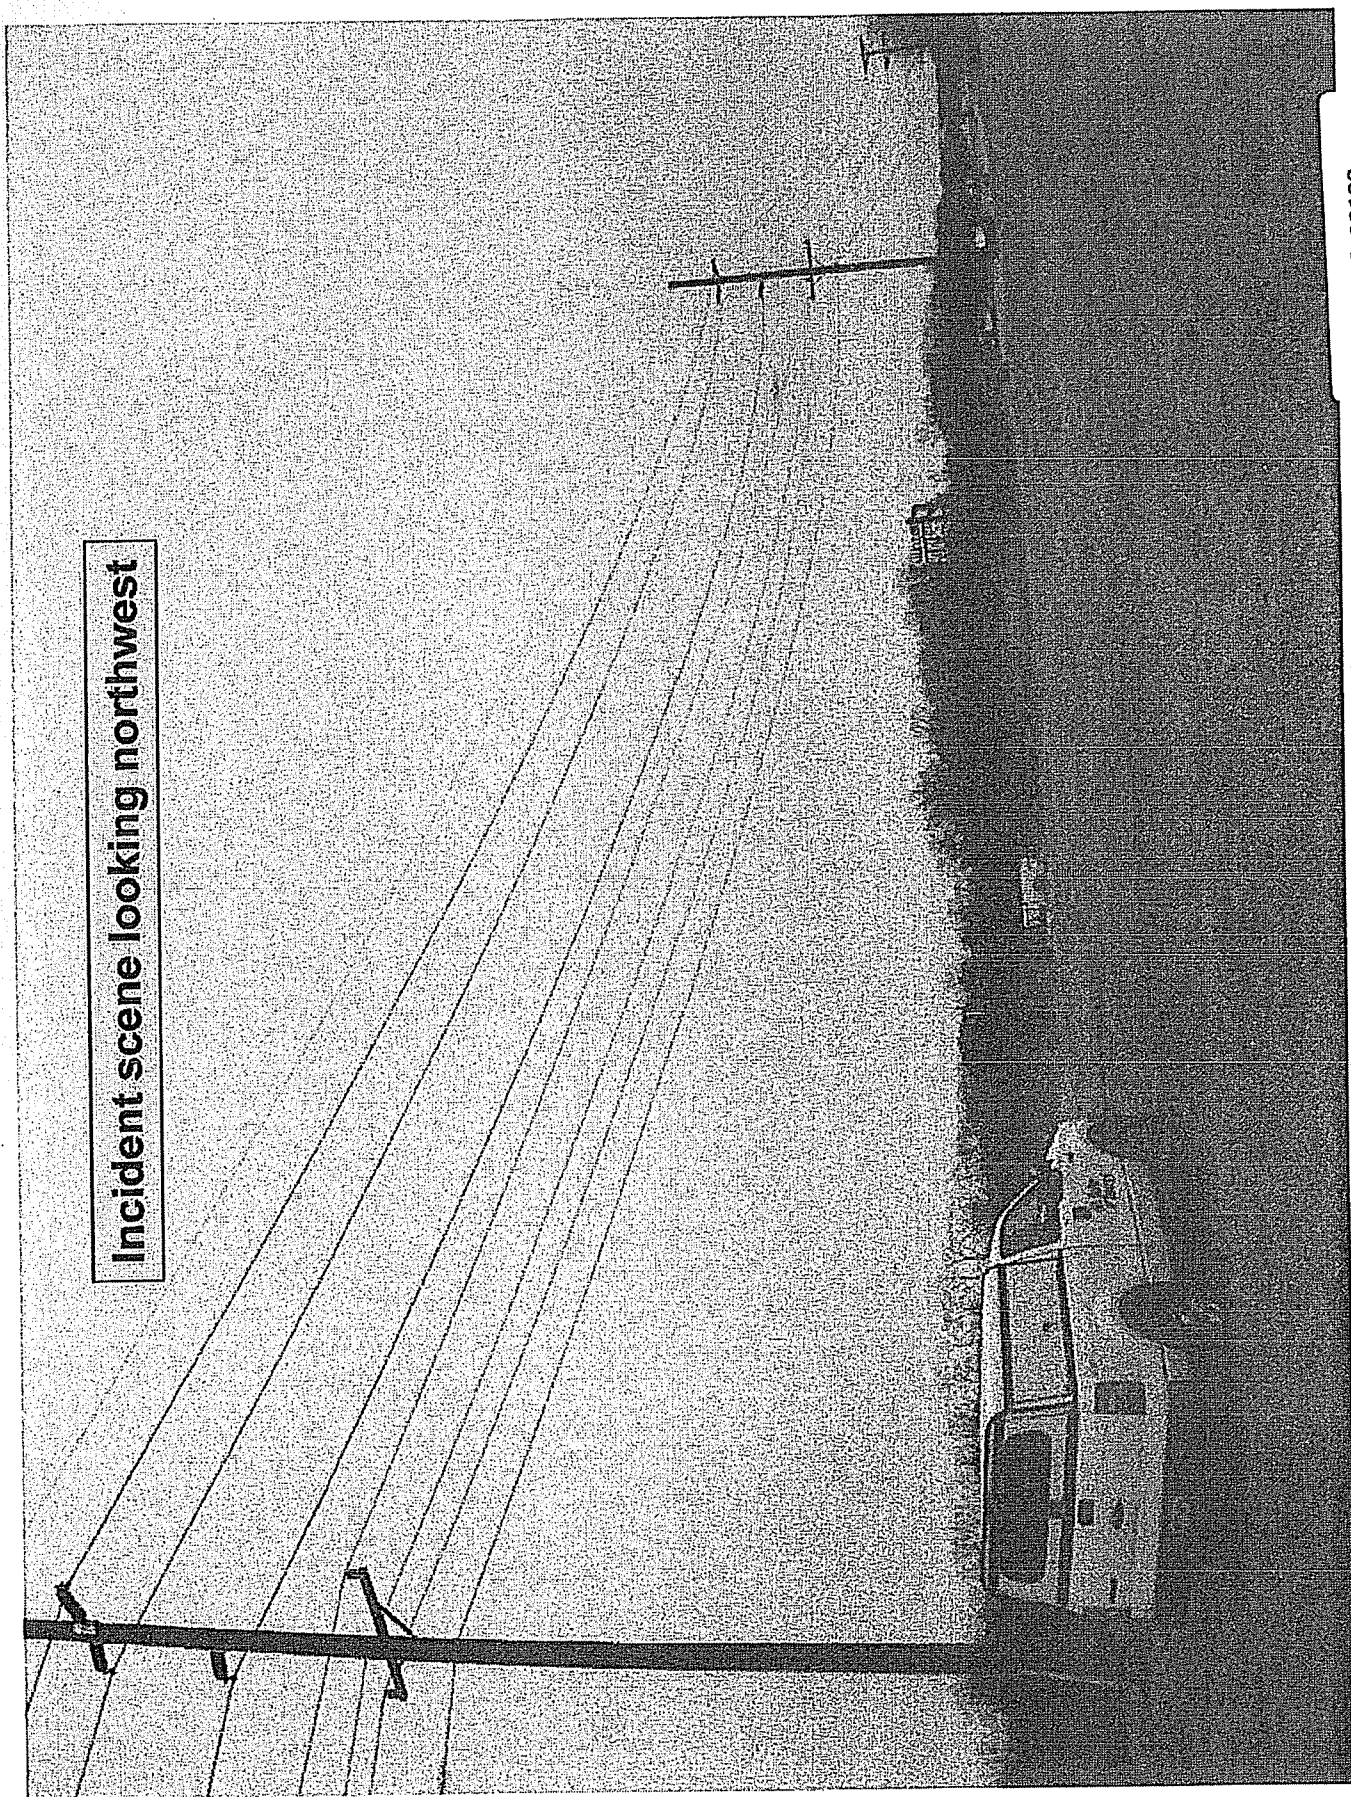
Incident scene looking northwest

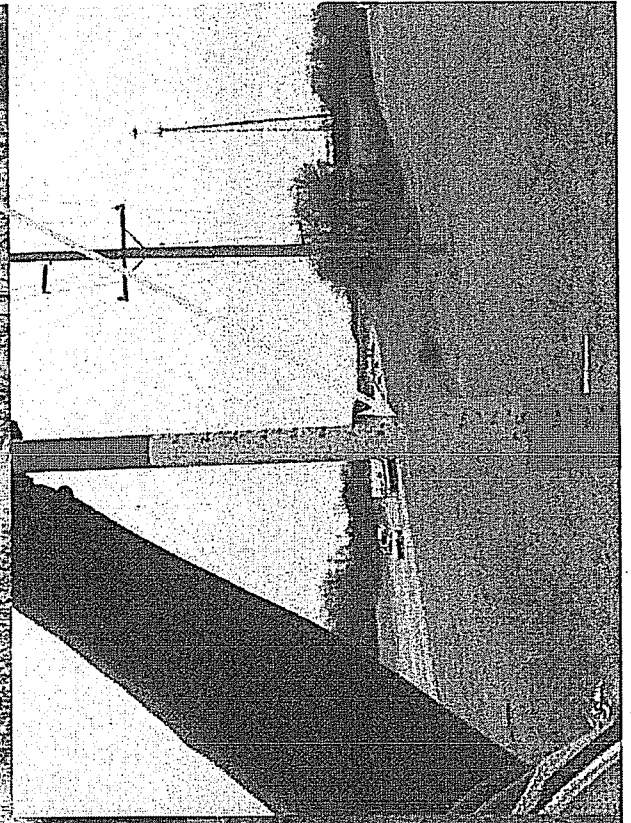
The neutral at the lowest point in the span is 22 feet, 9 inches from the ground.

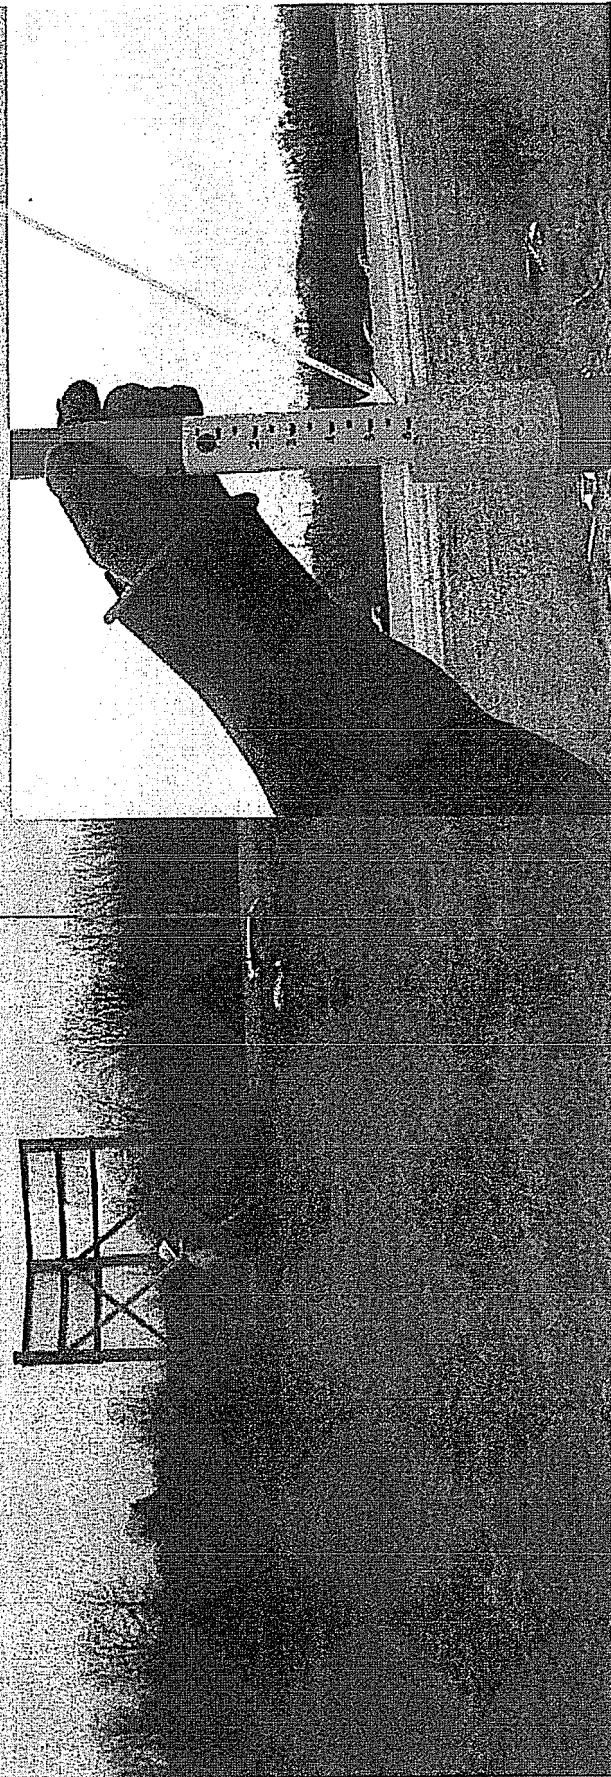
The phase at the lowest point in the span is 32 feet, 6 inches from the ground.
