MOUNTAIN RURAL TELEPHONE COOPERATIVE CORPORATION, INC.)))	CASE NO. 2012-00370
ALLEGED FAILURE TO COMPLY WITH 807 KAR 5:006 and 807 KAR 5:061)))

ORDER

ACCIDENT INVESTIGATION - Staff Report

Incident Investigation Report

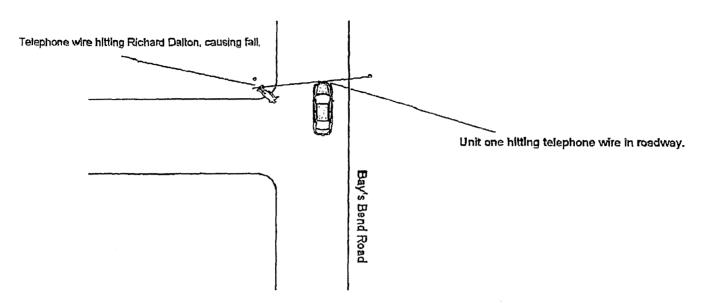
Unit one was traveling north on Bay's Bend Road, in Morgan County. Richard Dalton, an employee of Mountain Telephone, was working along the roadway of Bays Bend Road. Dalton and other employee's of Mountain Telephone were stretching telephone wire from a pole along the north bound side of Bay's Bend Road, across Bay's Bend Road. The wire was lying on the roadway. Dalton was standing at the south bound edge of Bay's Bend Road, directly across from the pole from which the wire was extended. Unit One hit the telephone wire in the roadway, causing tension, in the wire. The telephone wire then hit Richard Dalton, causing him to fall partially into roadway.

Operator of Unit One advised that as he was approaching the work site, he observed a worker on a telephone pole along the south bound shoulder of roadway, and Mr. Dalton standing at the base of the pole. The operator of Unit One advised that as he approached the location of the work site, he observed a loop in the wire, just as the impact with the wire occurred. The operator of Unit One stated that he immediately looked in his side mirror, and observed Dalton lying on the ground.

Perry Lacy, employee of Mountain Telephone and witness to the collision, stated that he had arrived at the scene just prior to the accident. Lacy said that he observed Dalton standing at the base of a telephone pole, on the south bound shoulder of Bay's Bend Road. Lacy stated that he observed Unit One just prior to hitting the telephone wire in the roadway. Lacy stated that the telephone wire appeared to be slightly suspended above the roadway. Lacy said that when Unit One hit the telephone wire, he saw Dalton fall to the ground.

Traffic control was not present at the time of the collision.
