COMMONWEALTH OF KENTUCKY
BEFORE THE PUBLIC SERVICE COMMISSION

KENTUCKY POWER COMPANY)	
_____)	
ALLEGED FAILURE TO COMPLY)	CASE NO. 2016-00279
WITH KRS 278.042)

ORDER

Incident Investigation Staff Report

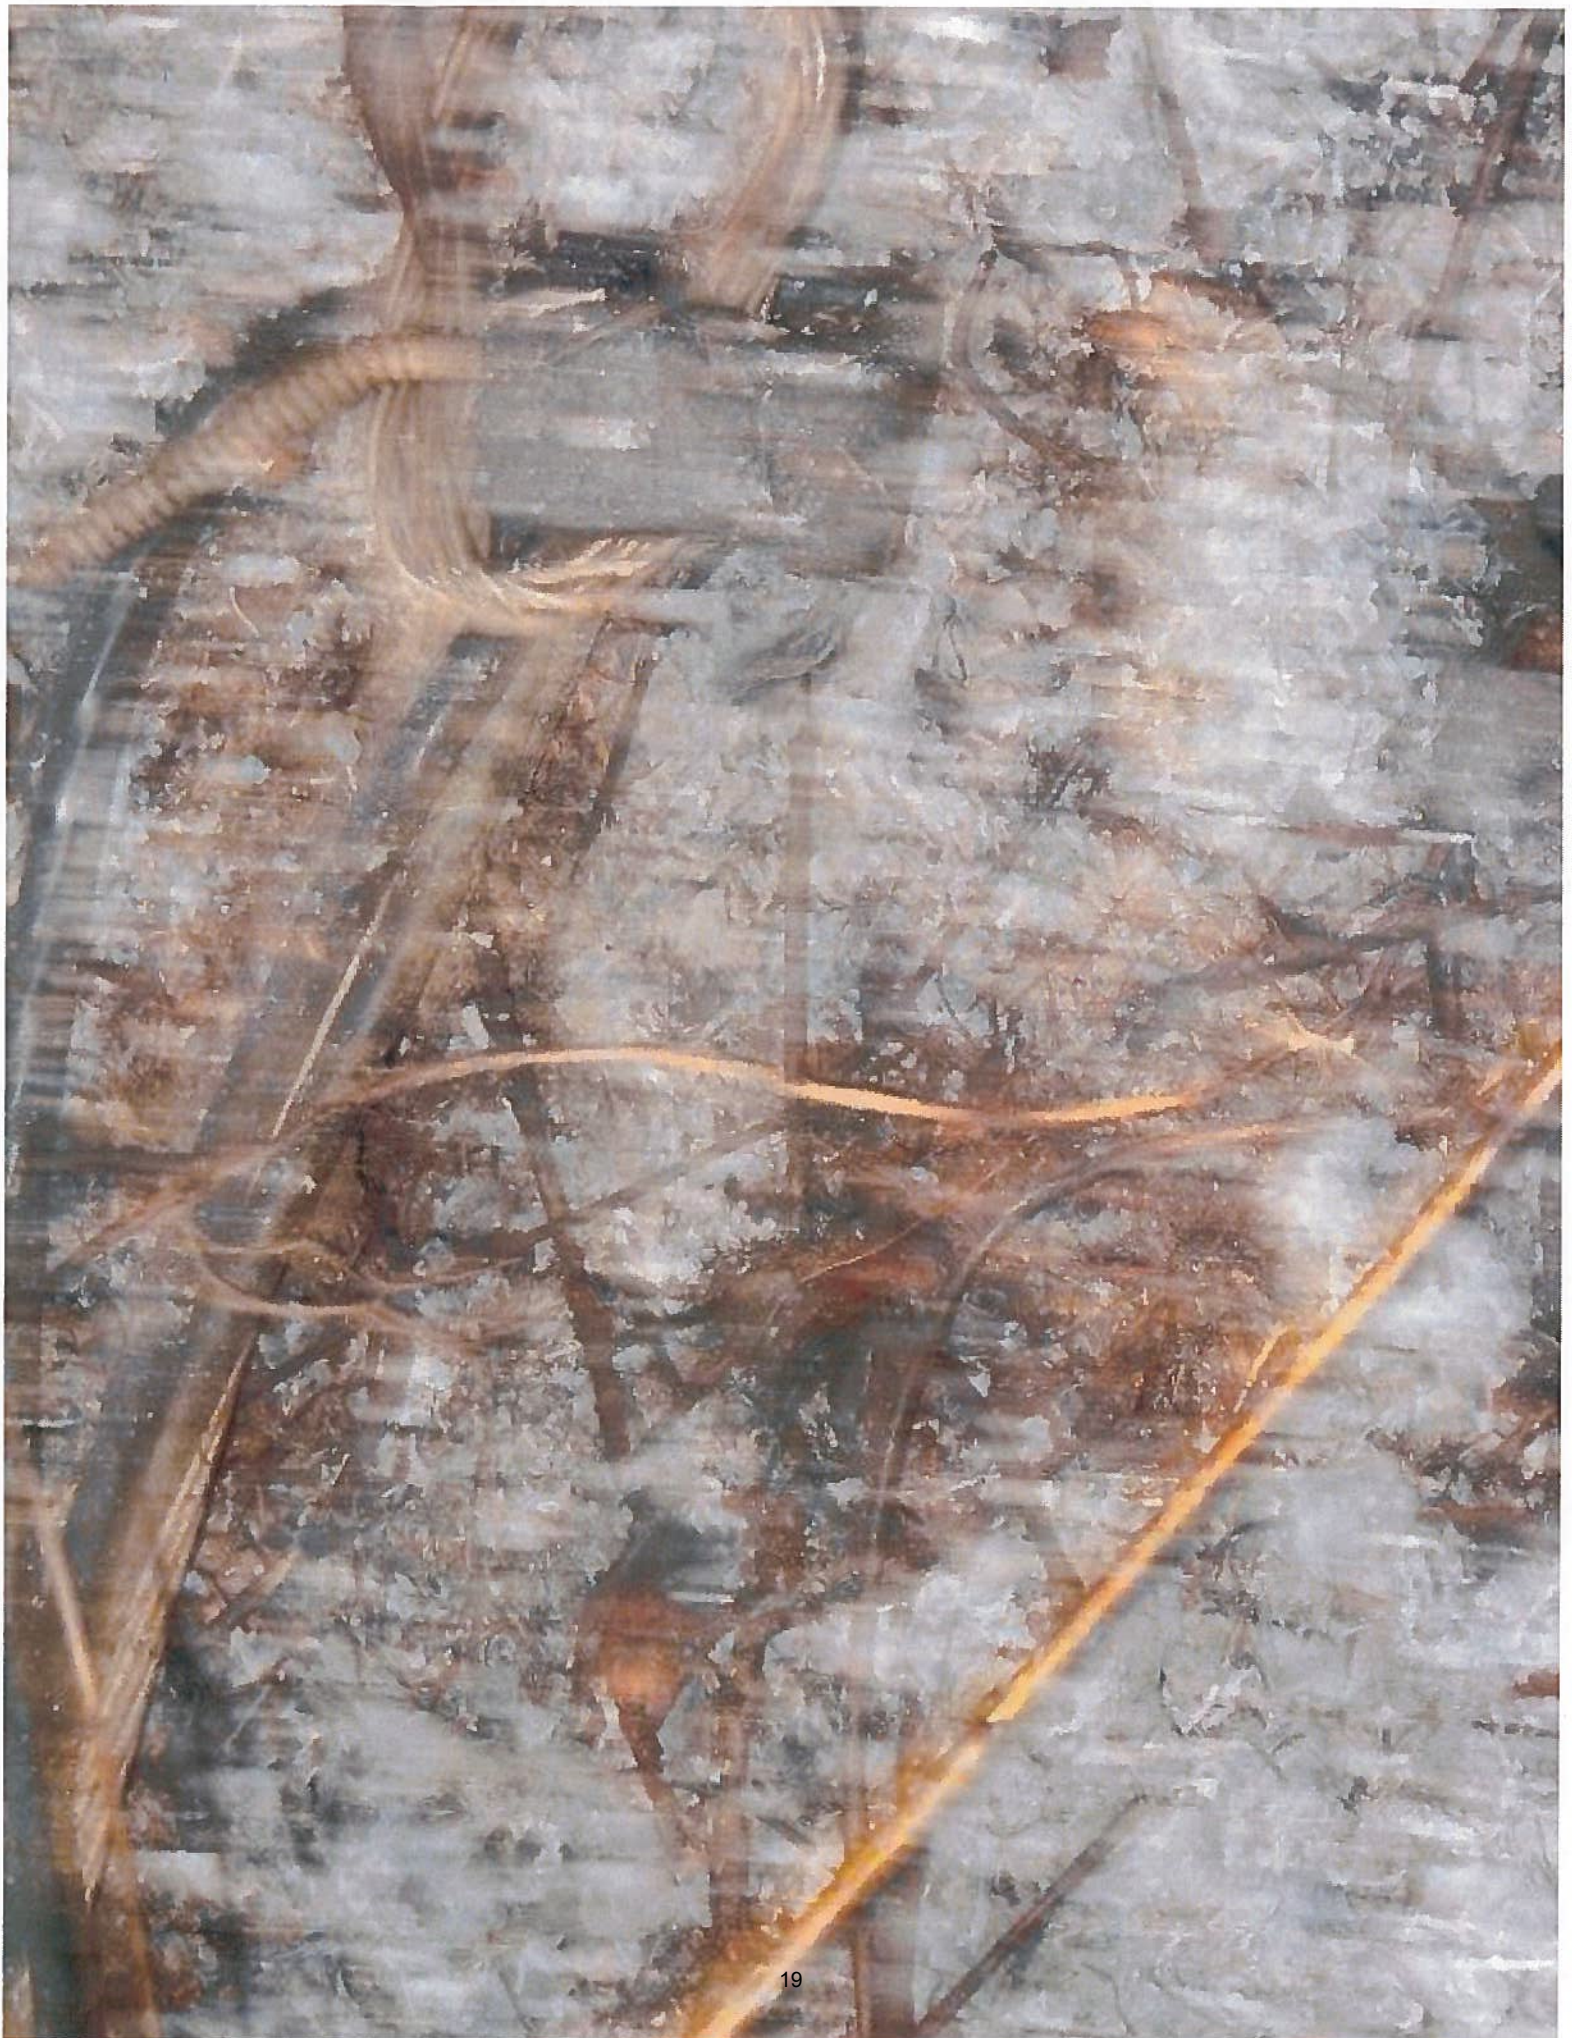
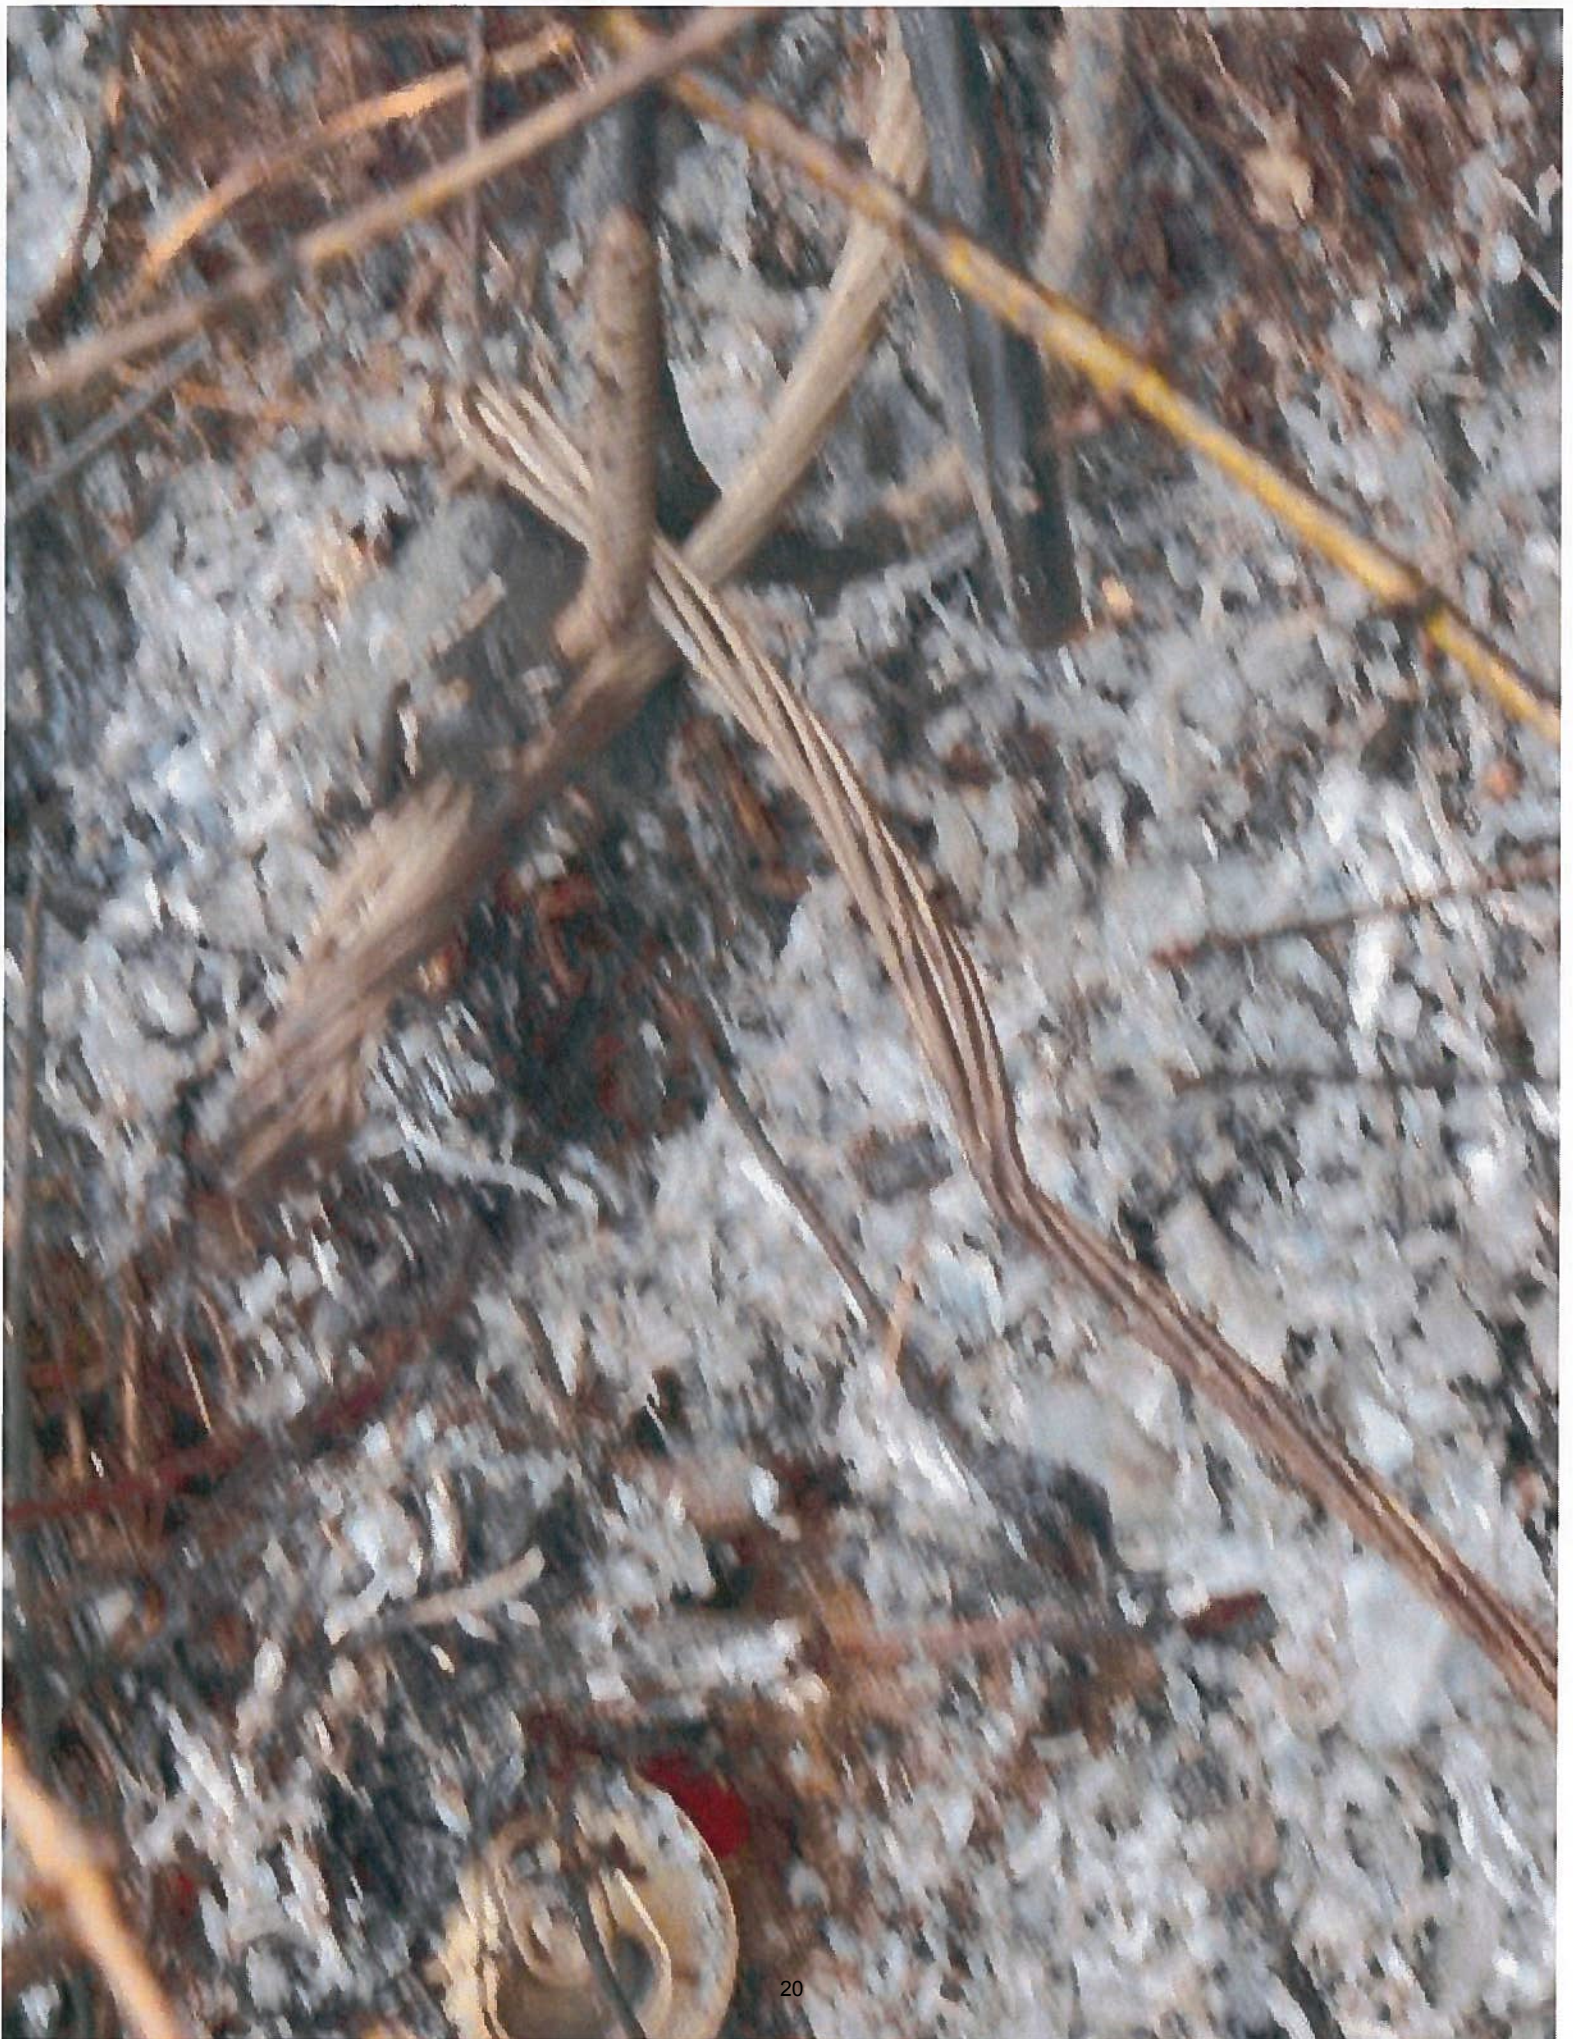
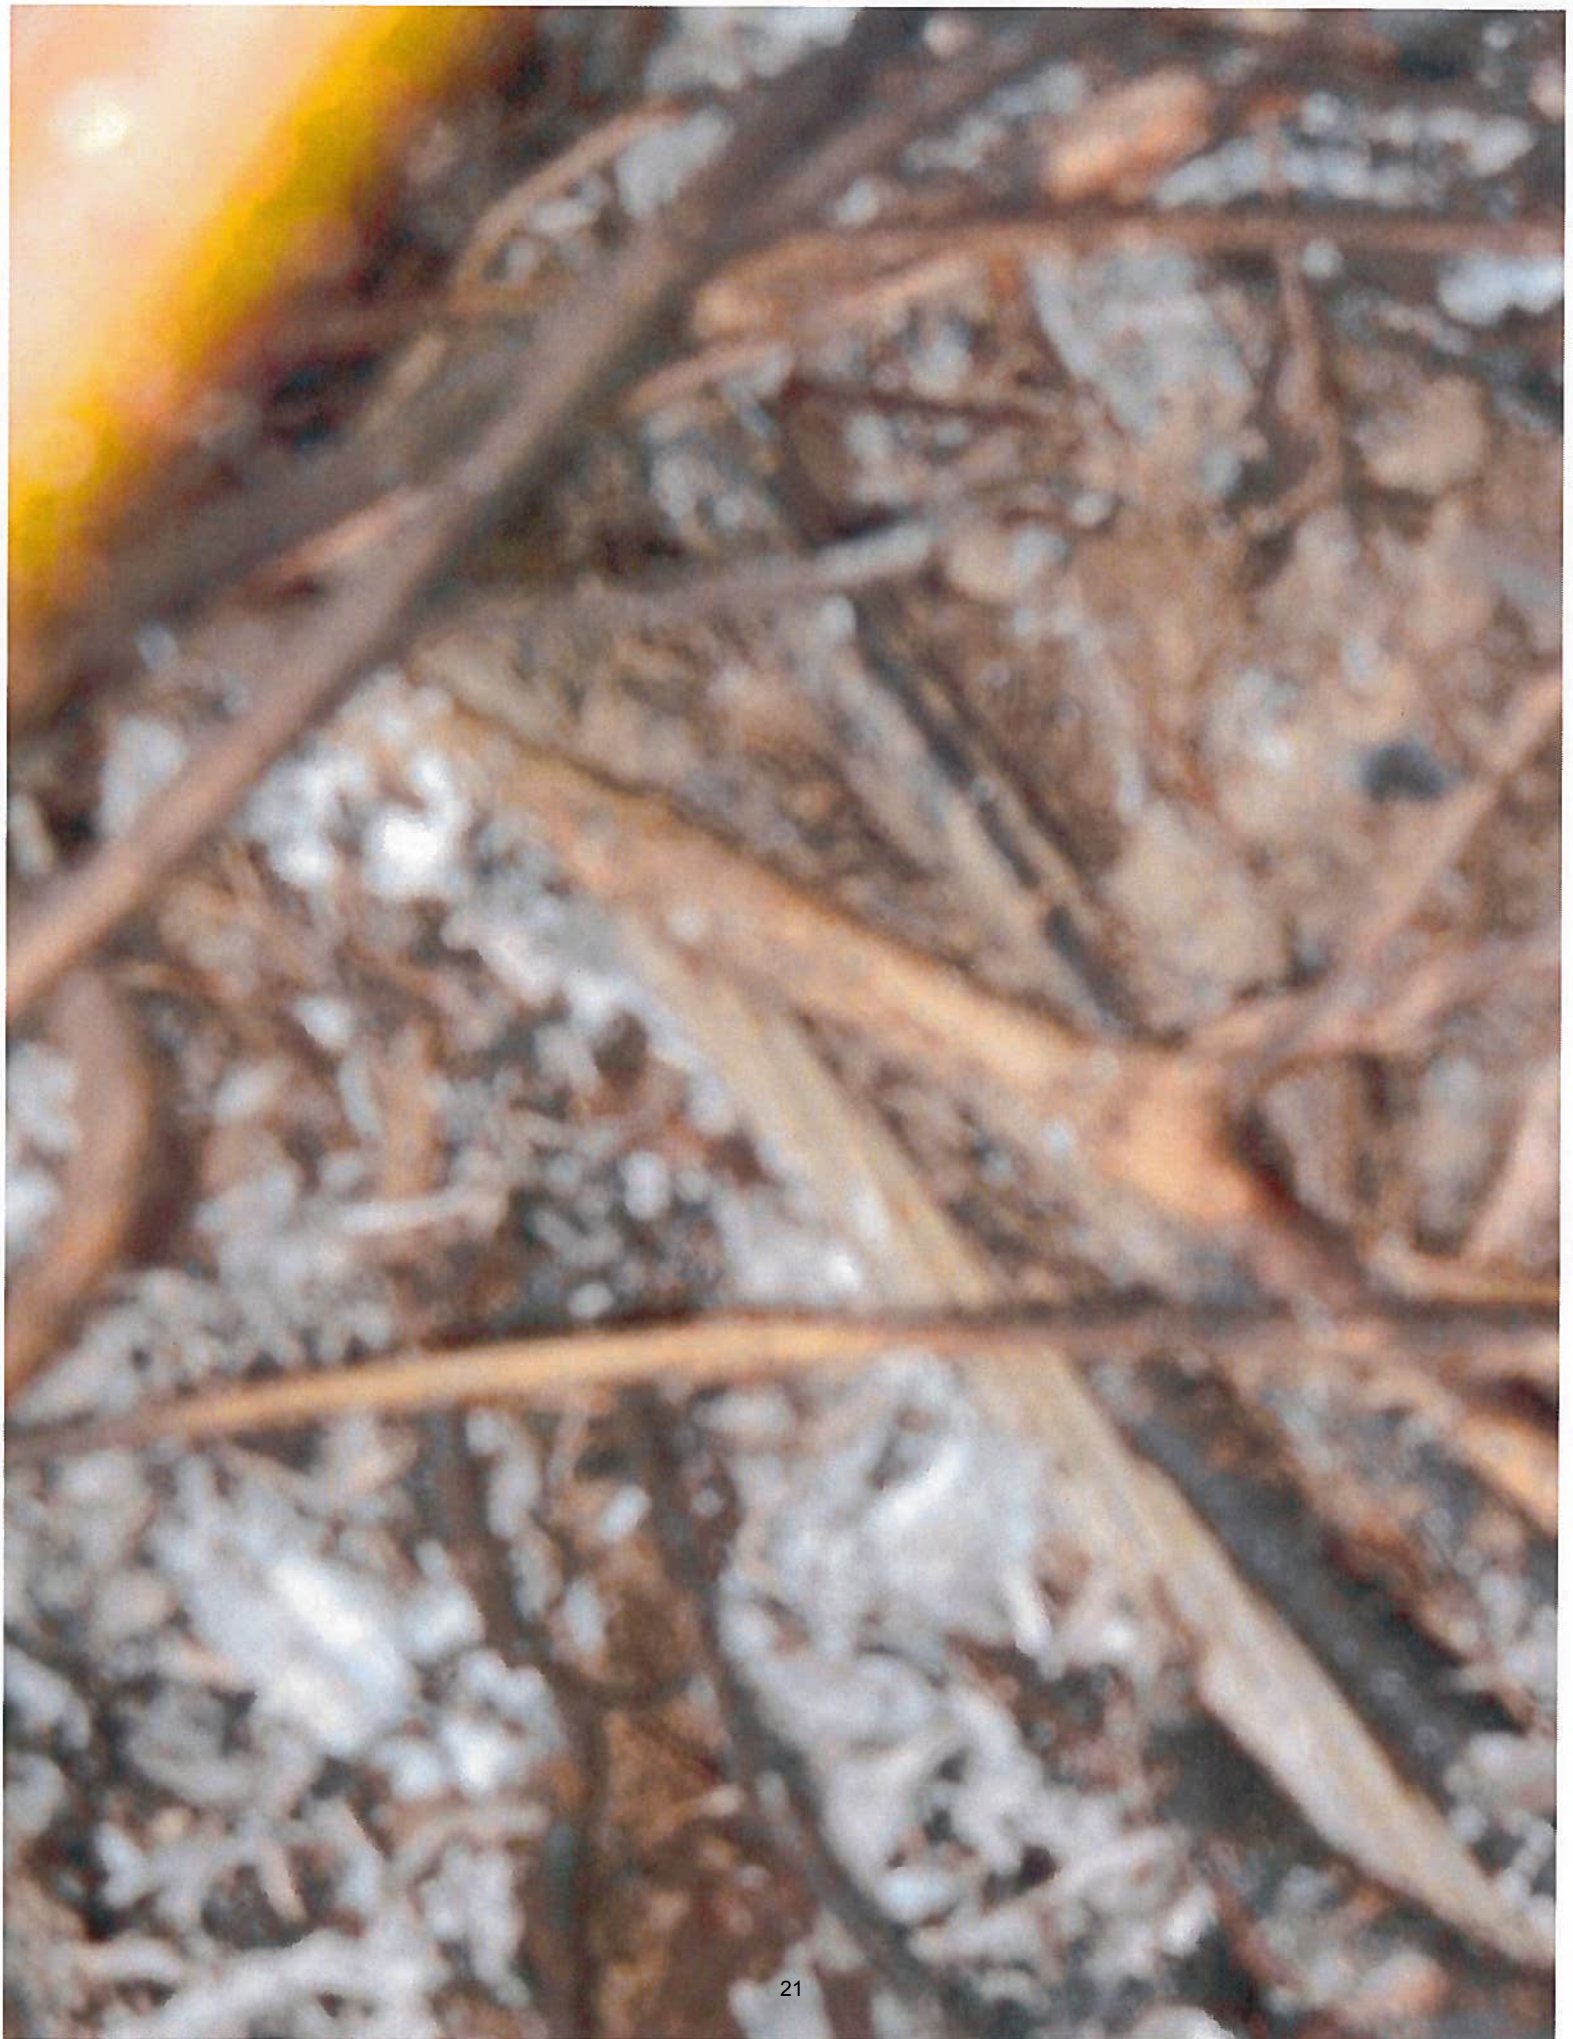
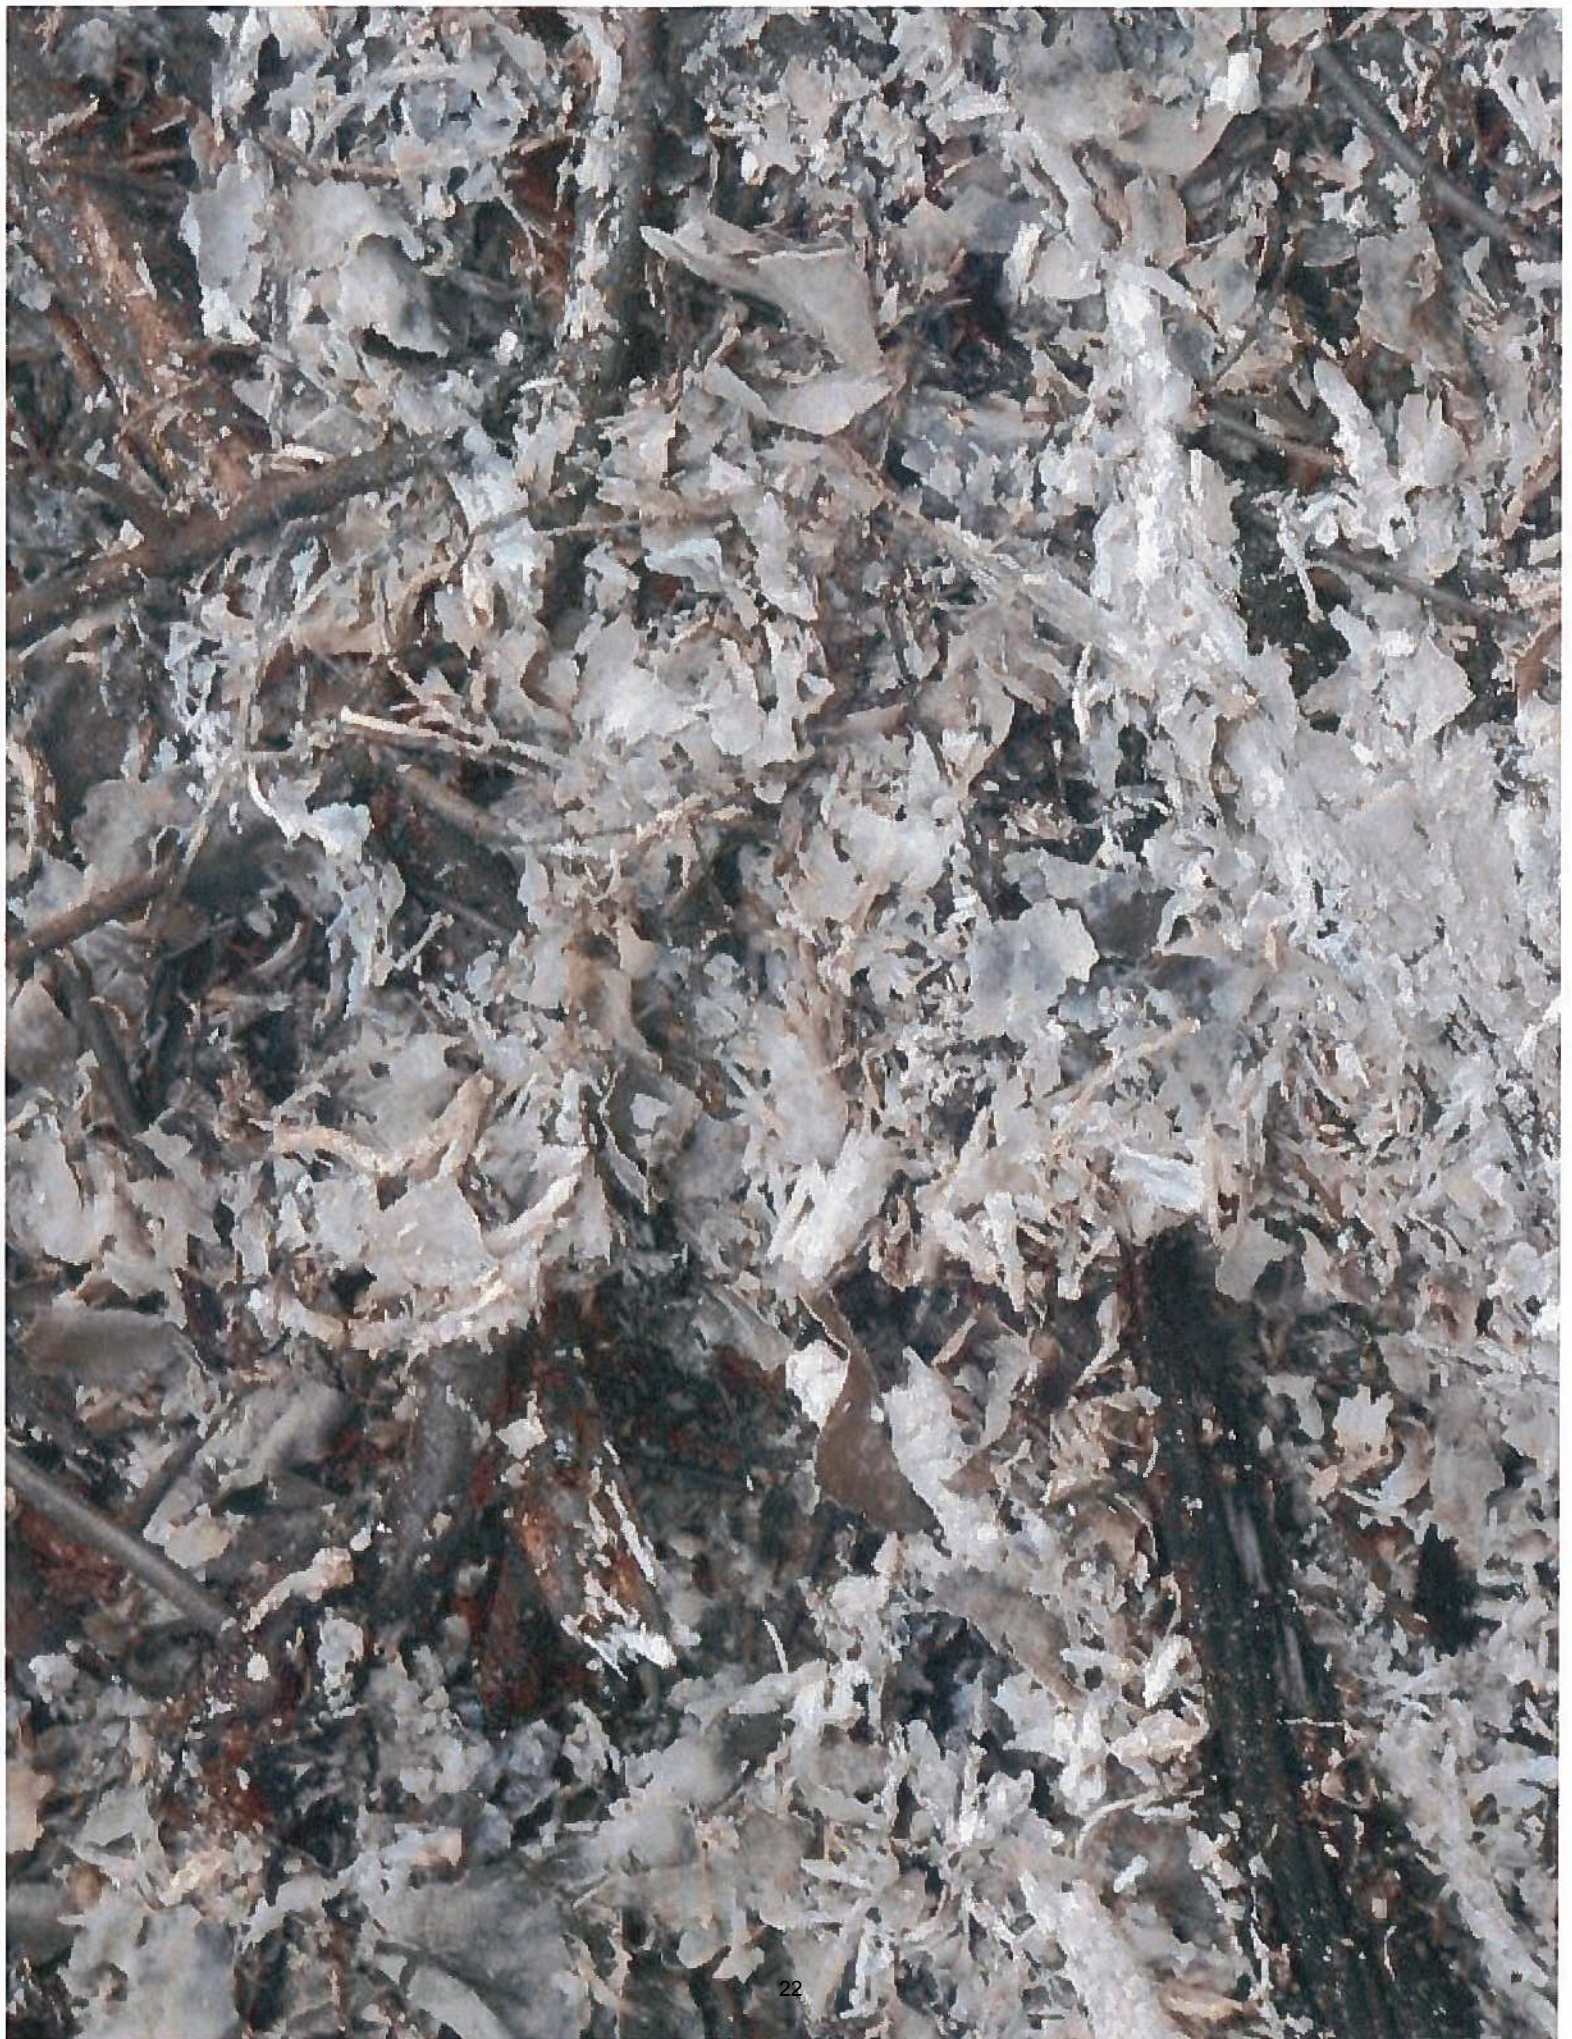
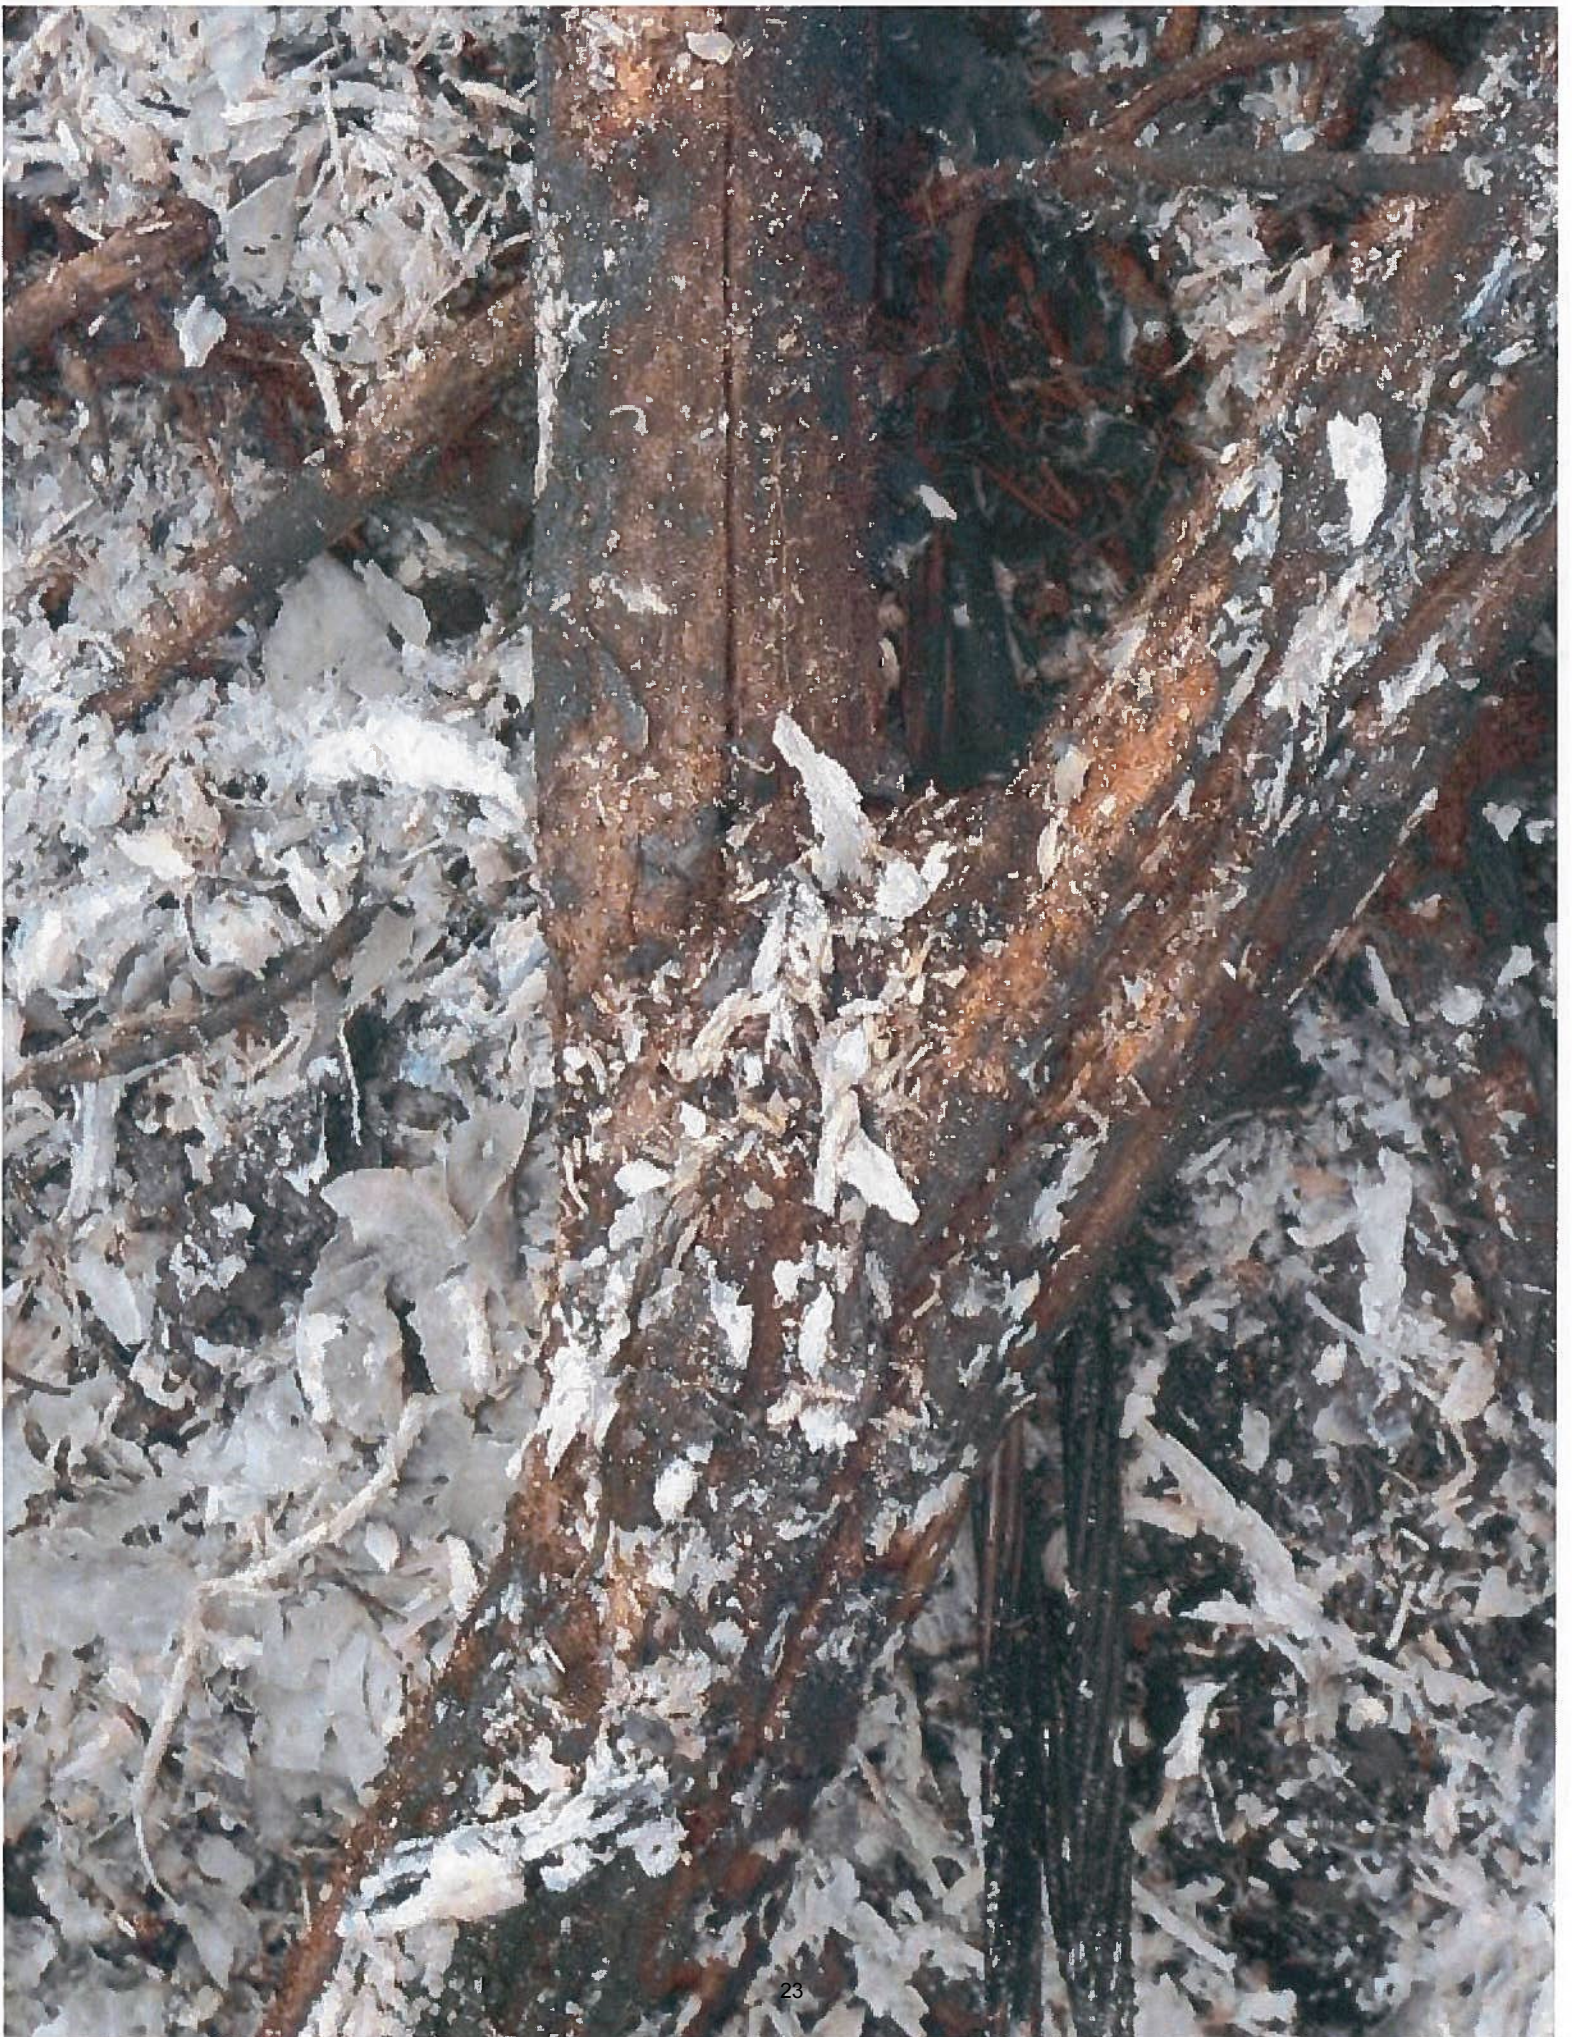
Pictures was taken at the site by Dennis R. Massey LCSNE Pikeville Dist.

According to information from the utility investigation (Attachment C), the energized triplex conductor that was attached to the pole measured approximately 47.5 feet in length, and was lying on the ground covered in tall heavy brush, vines, and weeds. At the time of the PSC investigation there were not any structures located within 47.6 feet of the pole, and the energized triplex conductor had been disconnected and removed from the pole by the utility.

Jason Michal Grace was helping to clear property that was recently purchased by Wilson Page. Property location (Stafford Cemetery Road at the Mouth of Little Mud Lick). The injured was using a weed eater that had a blade to cut brush down, when he came in contact with a 2/3 service drop that lying on the ground. Injured had possible flash burns to hands and started feeling sick after contact was made. Injured did go to Paul B. Hall Medical Center for treatment. The servicer drop that he contacted showed to be approximately 47 feet and 6 inches in length. The service drop was covered in tall heavy brush, vines and tall weeds. When responder arrived at site, he was informed of this contact by Jason Hammonds (contact number 606-534-1183) who was helping the injured clear the property. The responder notified DDC and Robert Shurtleff about the contact. DDC and Robert Shurtleff contacted me to respond. Jason Hammonds returned to the site just before we was finished investigating, I asked him was they aware of or did they see the service drop lying on the ground. His reply was that the property was so grown up by the vegetation they did not see the service drop on the ground. He was going back by the medical center to check on the injured person.
