COMMONWEALTH OF KENTUCKY
BEFORE THE PUBLIC SERVICE COMMISSION

KENTUCKY POWER COMPANY)	
_____)	
ALLEGED FAILURE TO COMPLY)	CASE NO. 2016-00279
WITH KRS 278.042)

ORDER

Incident Investigation Staff Report

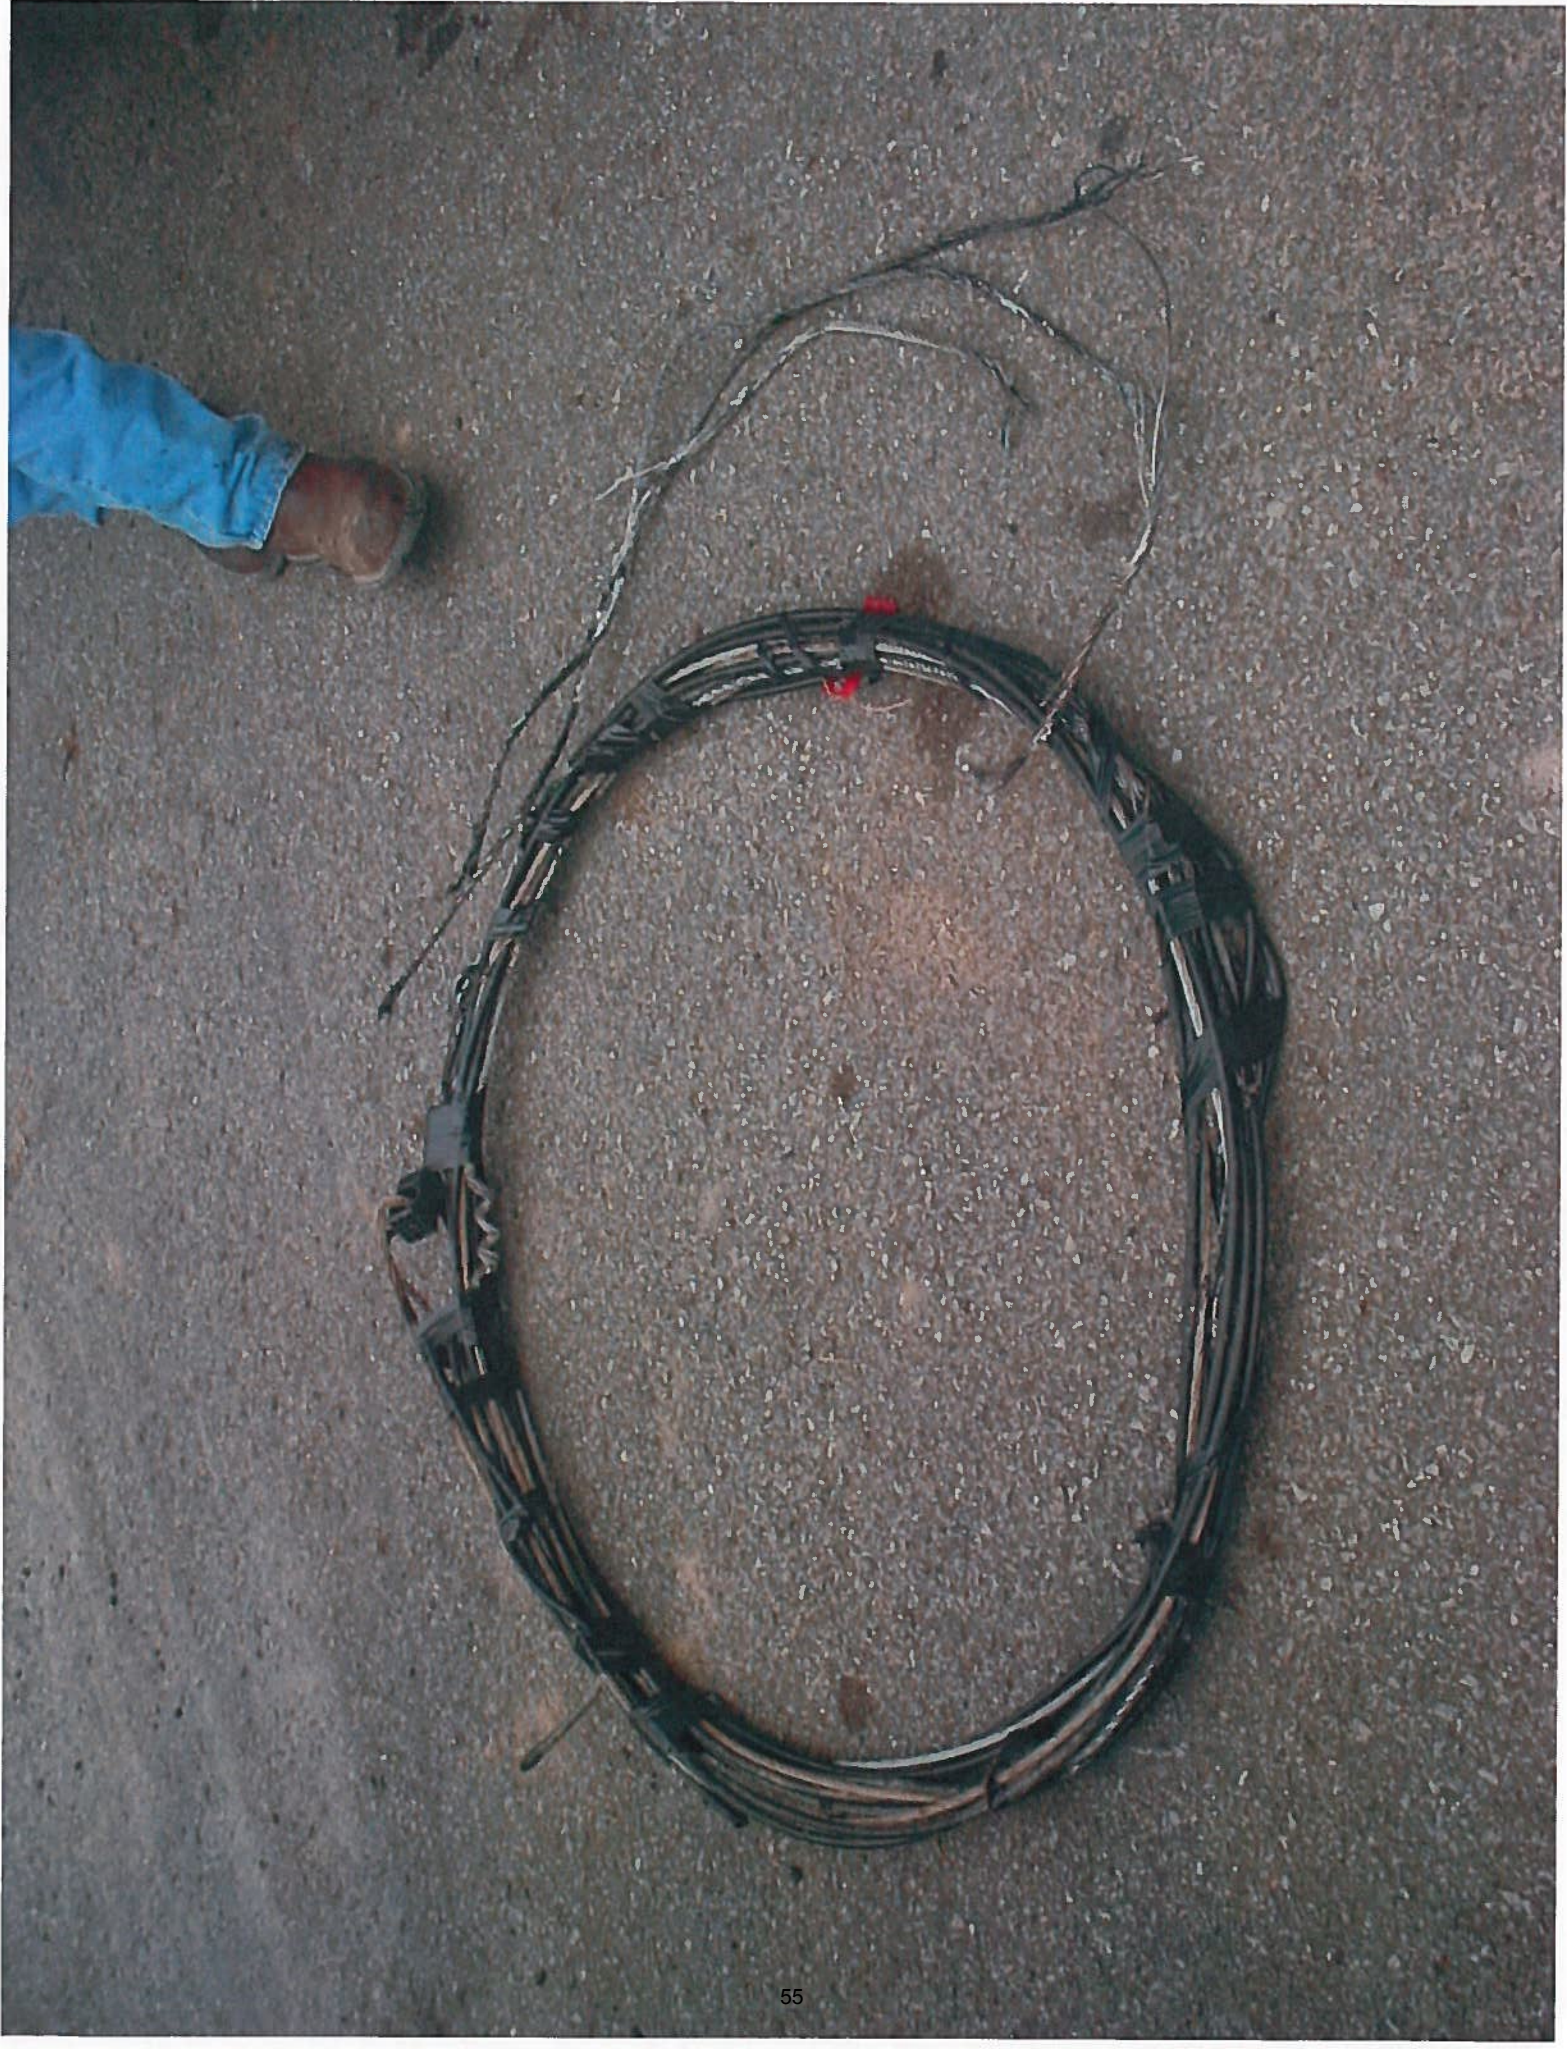
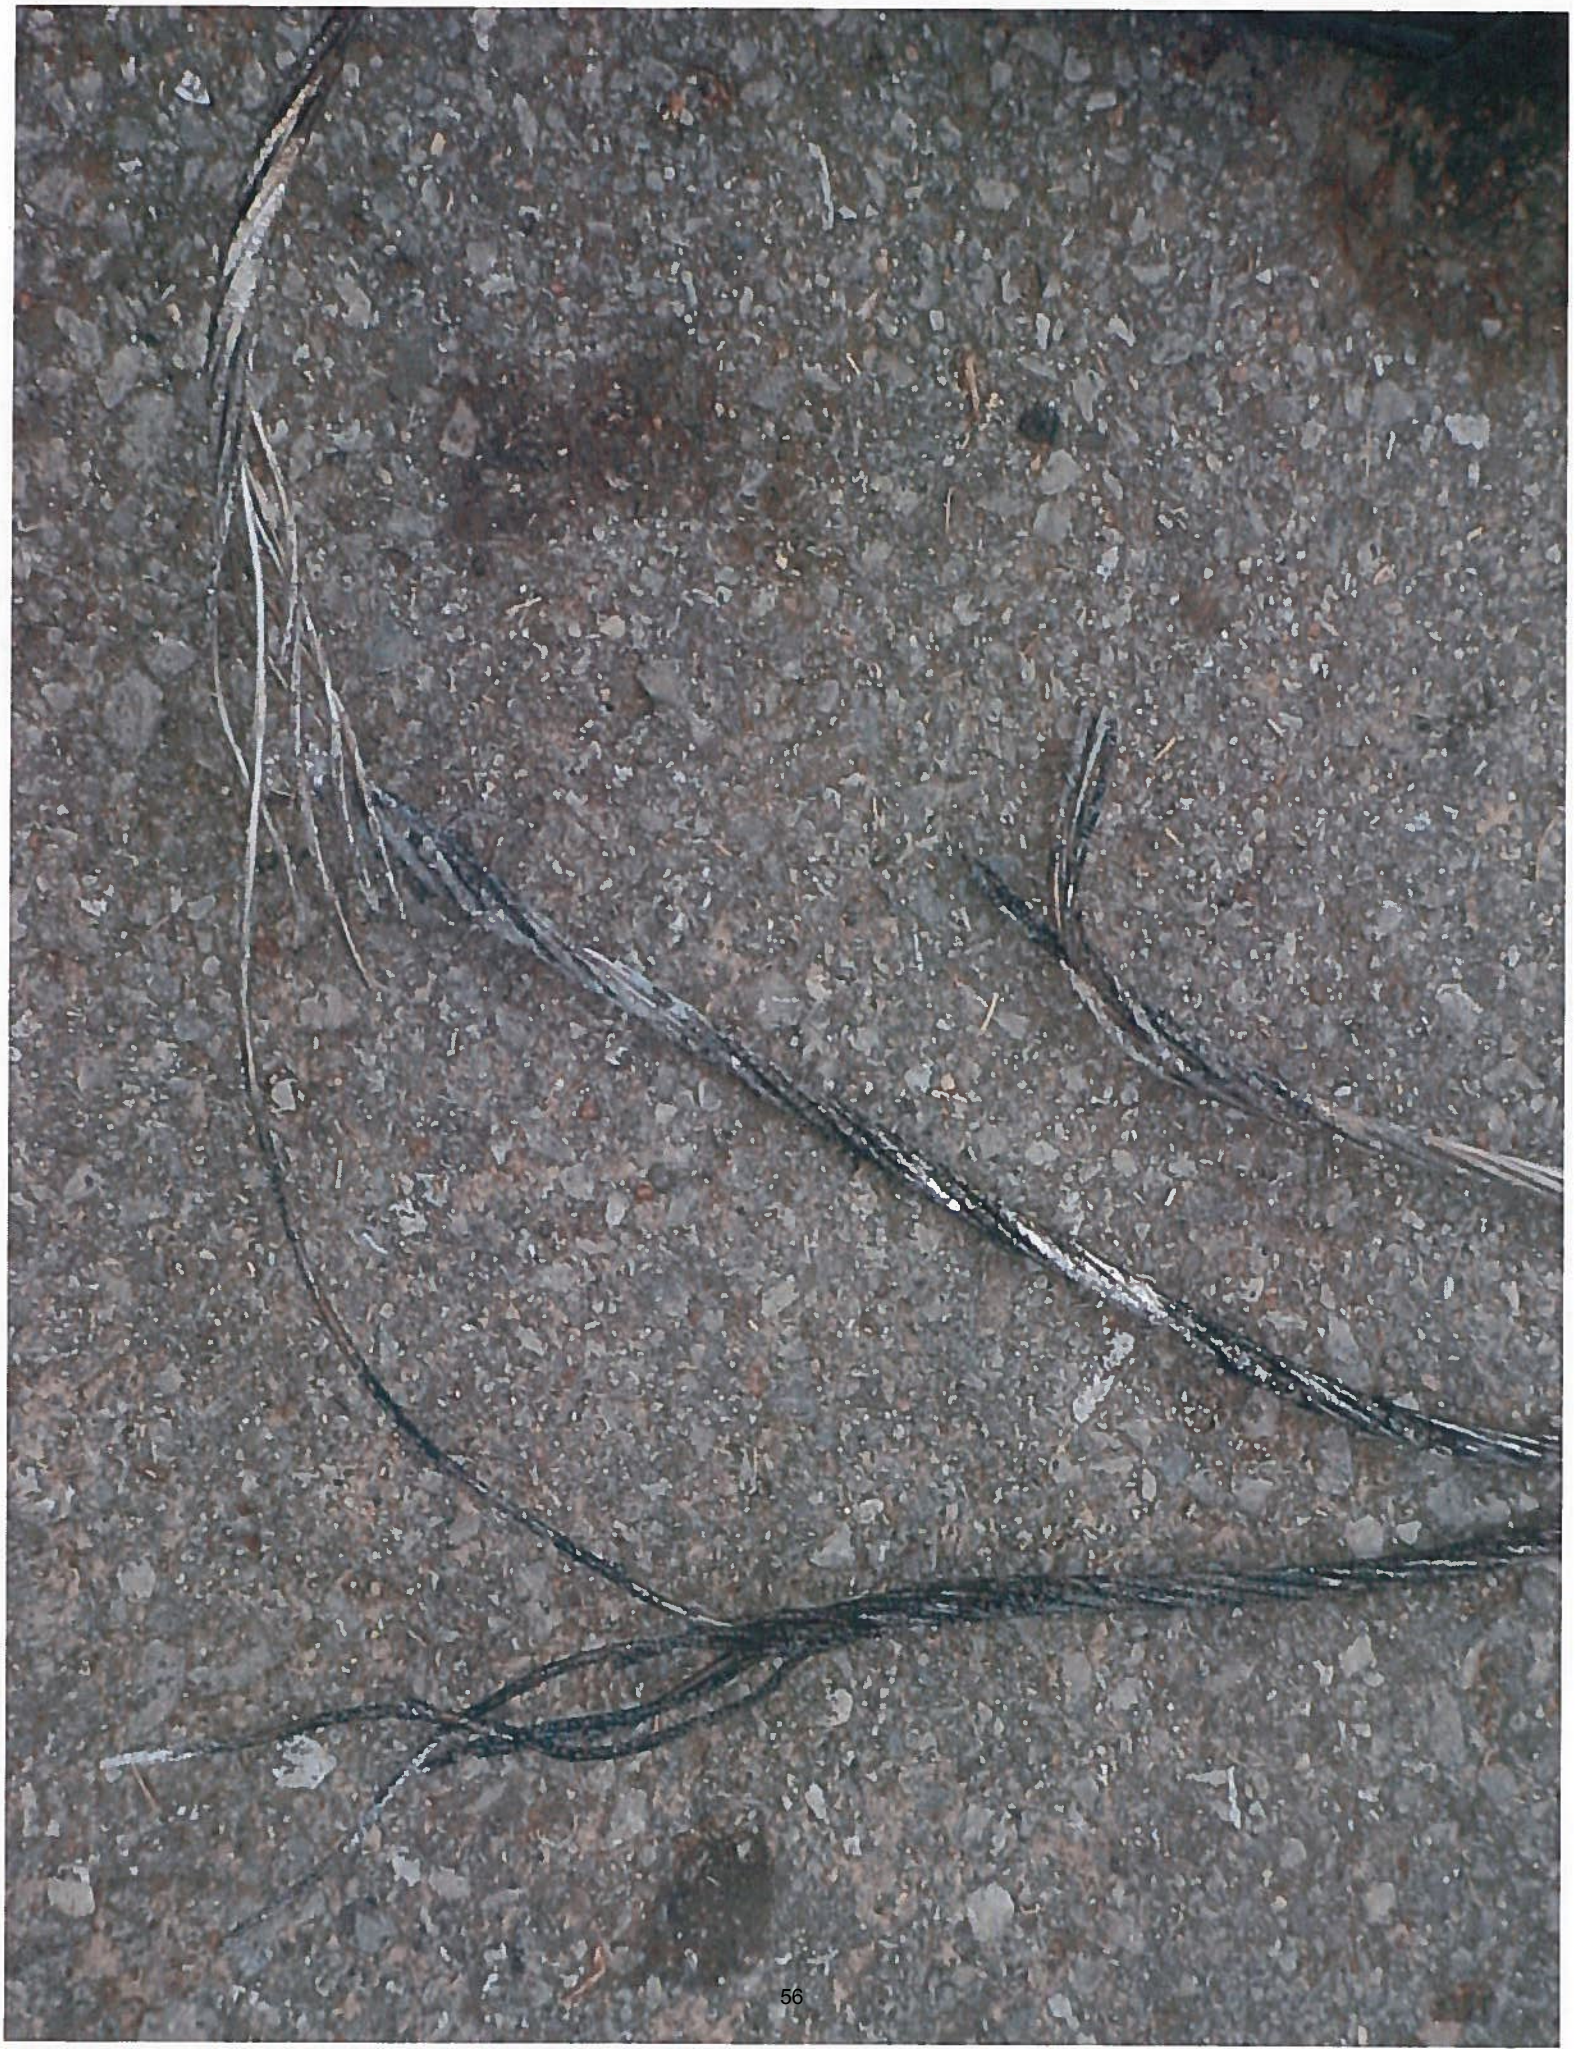
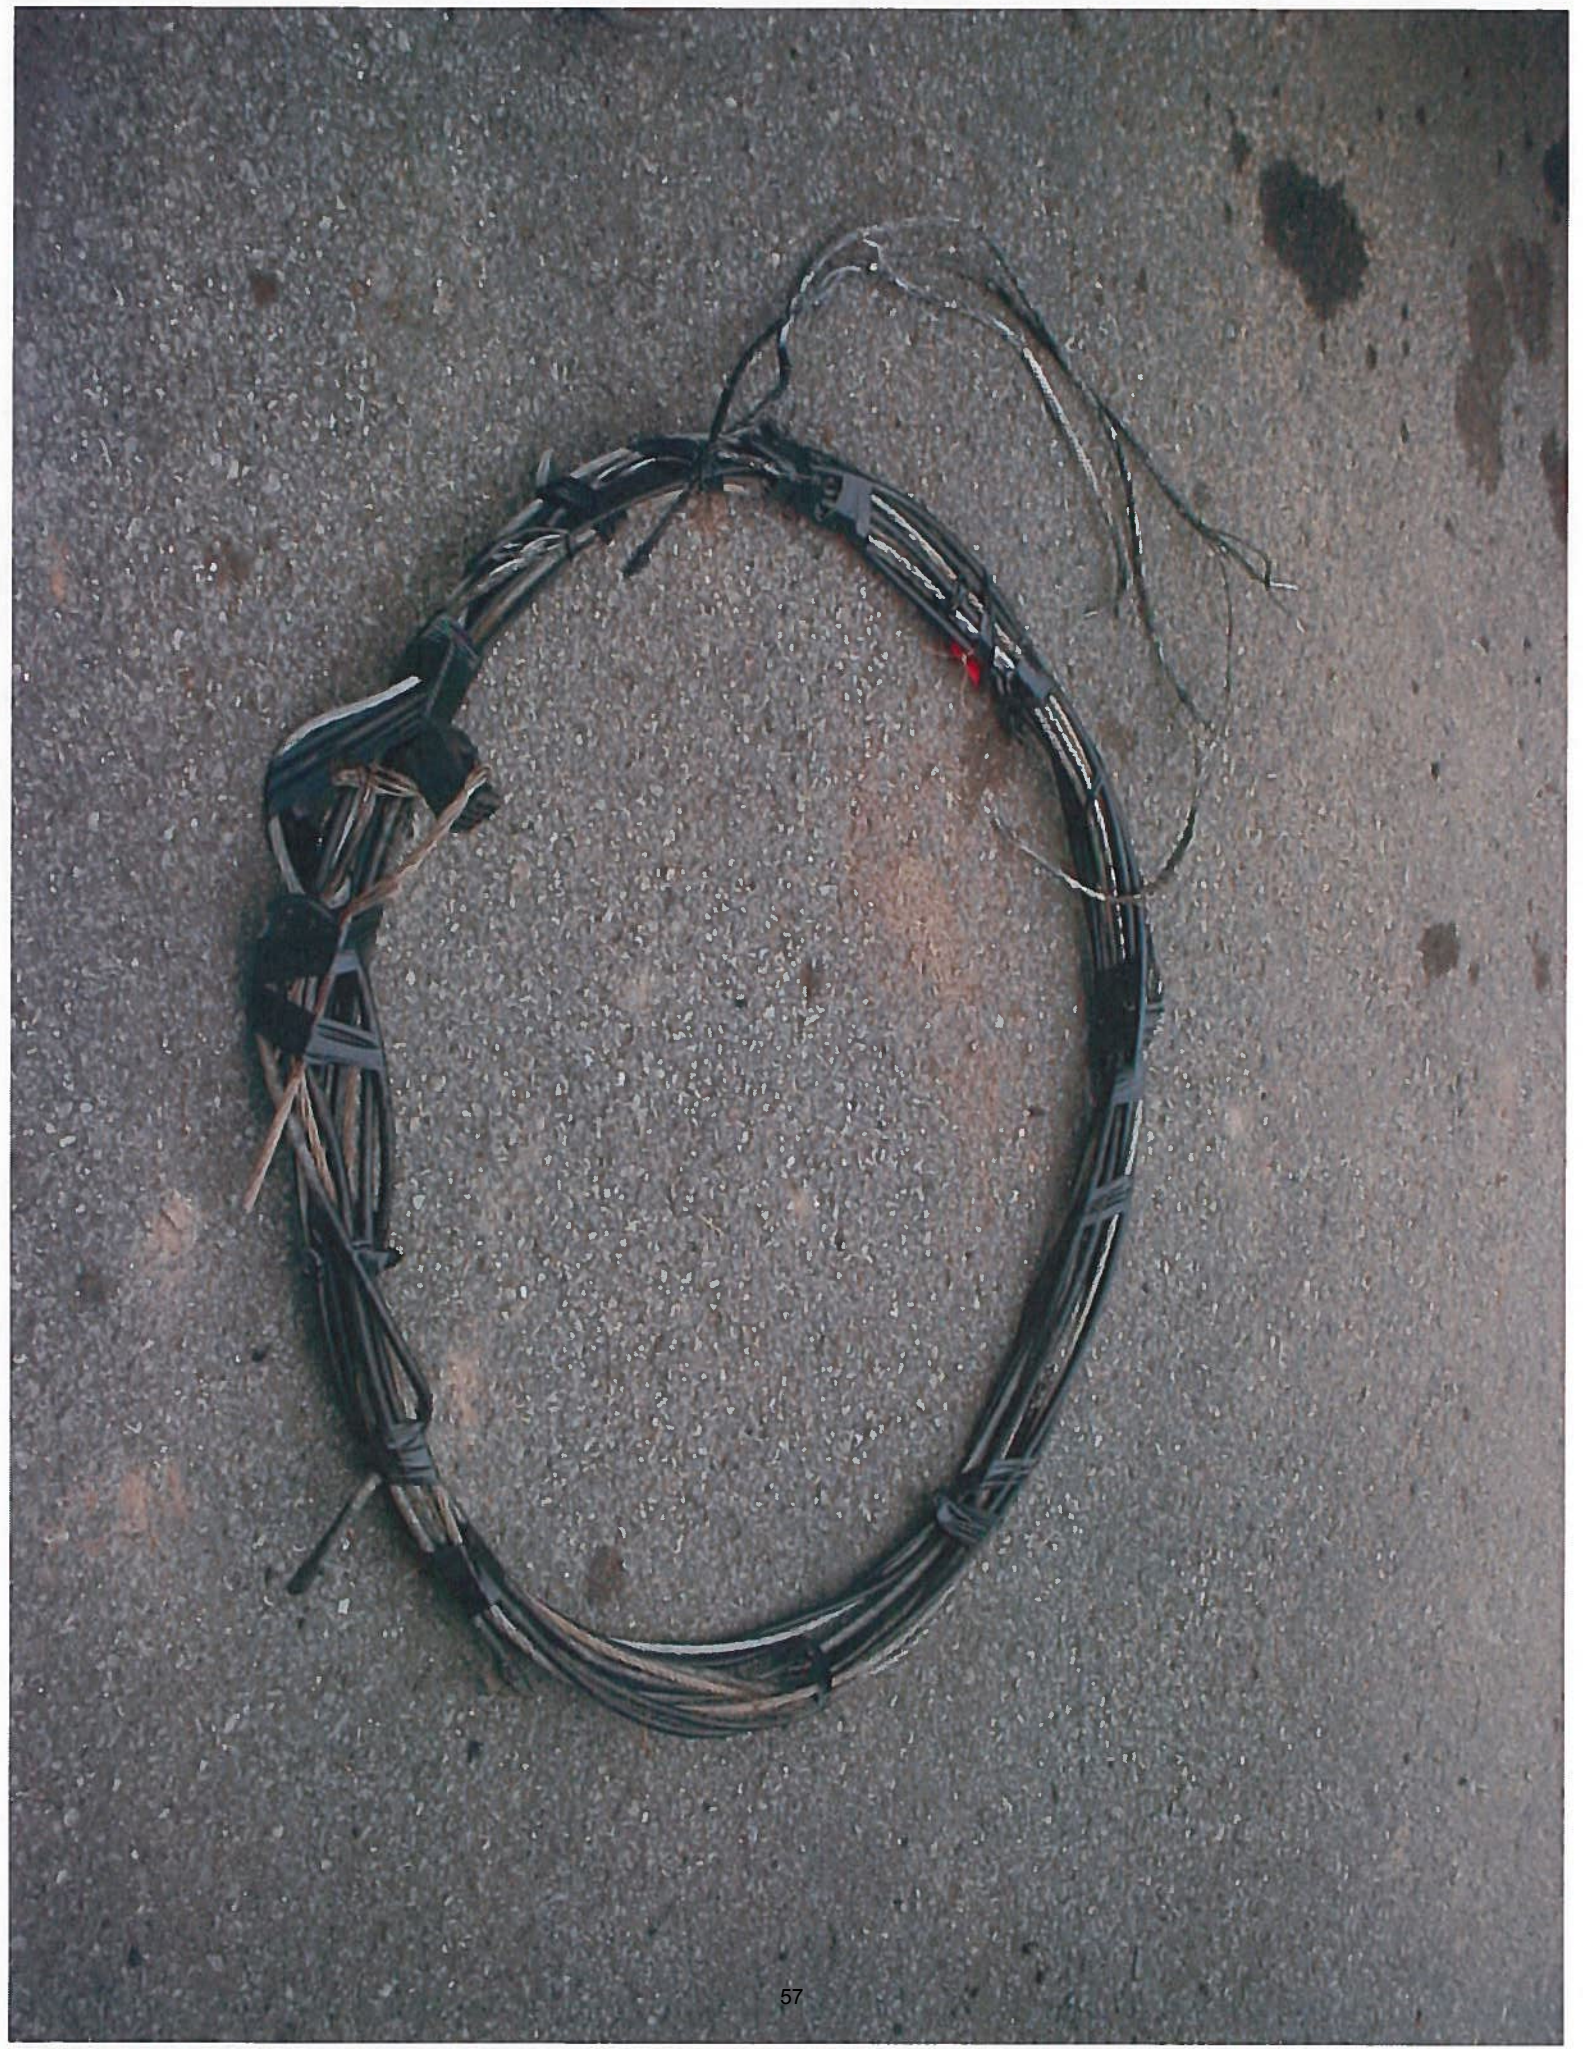
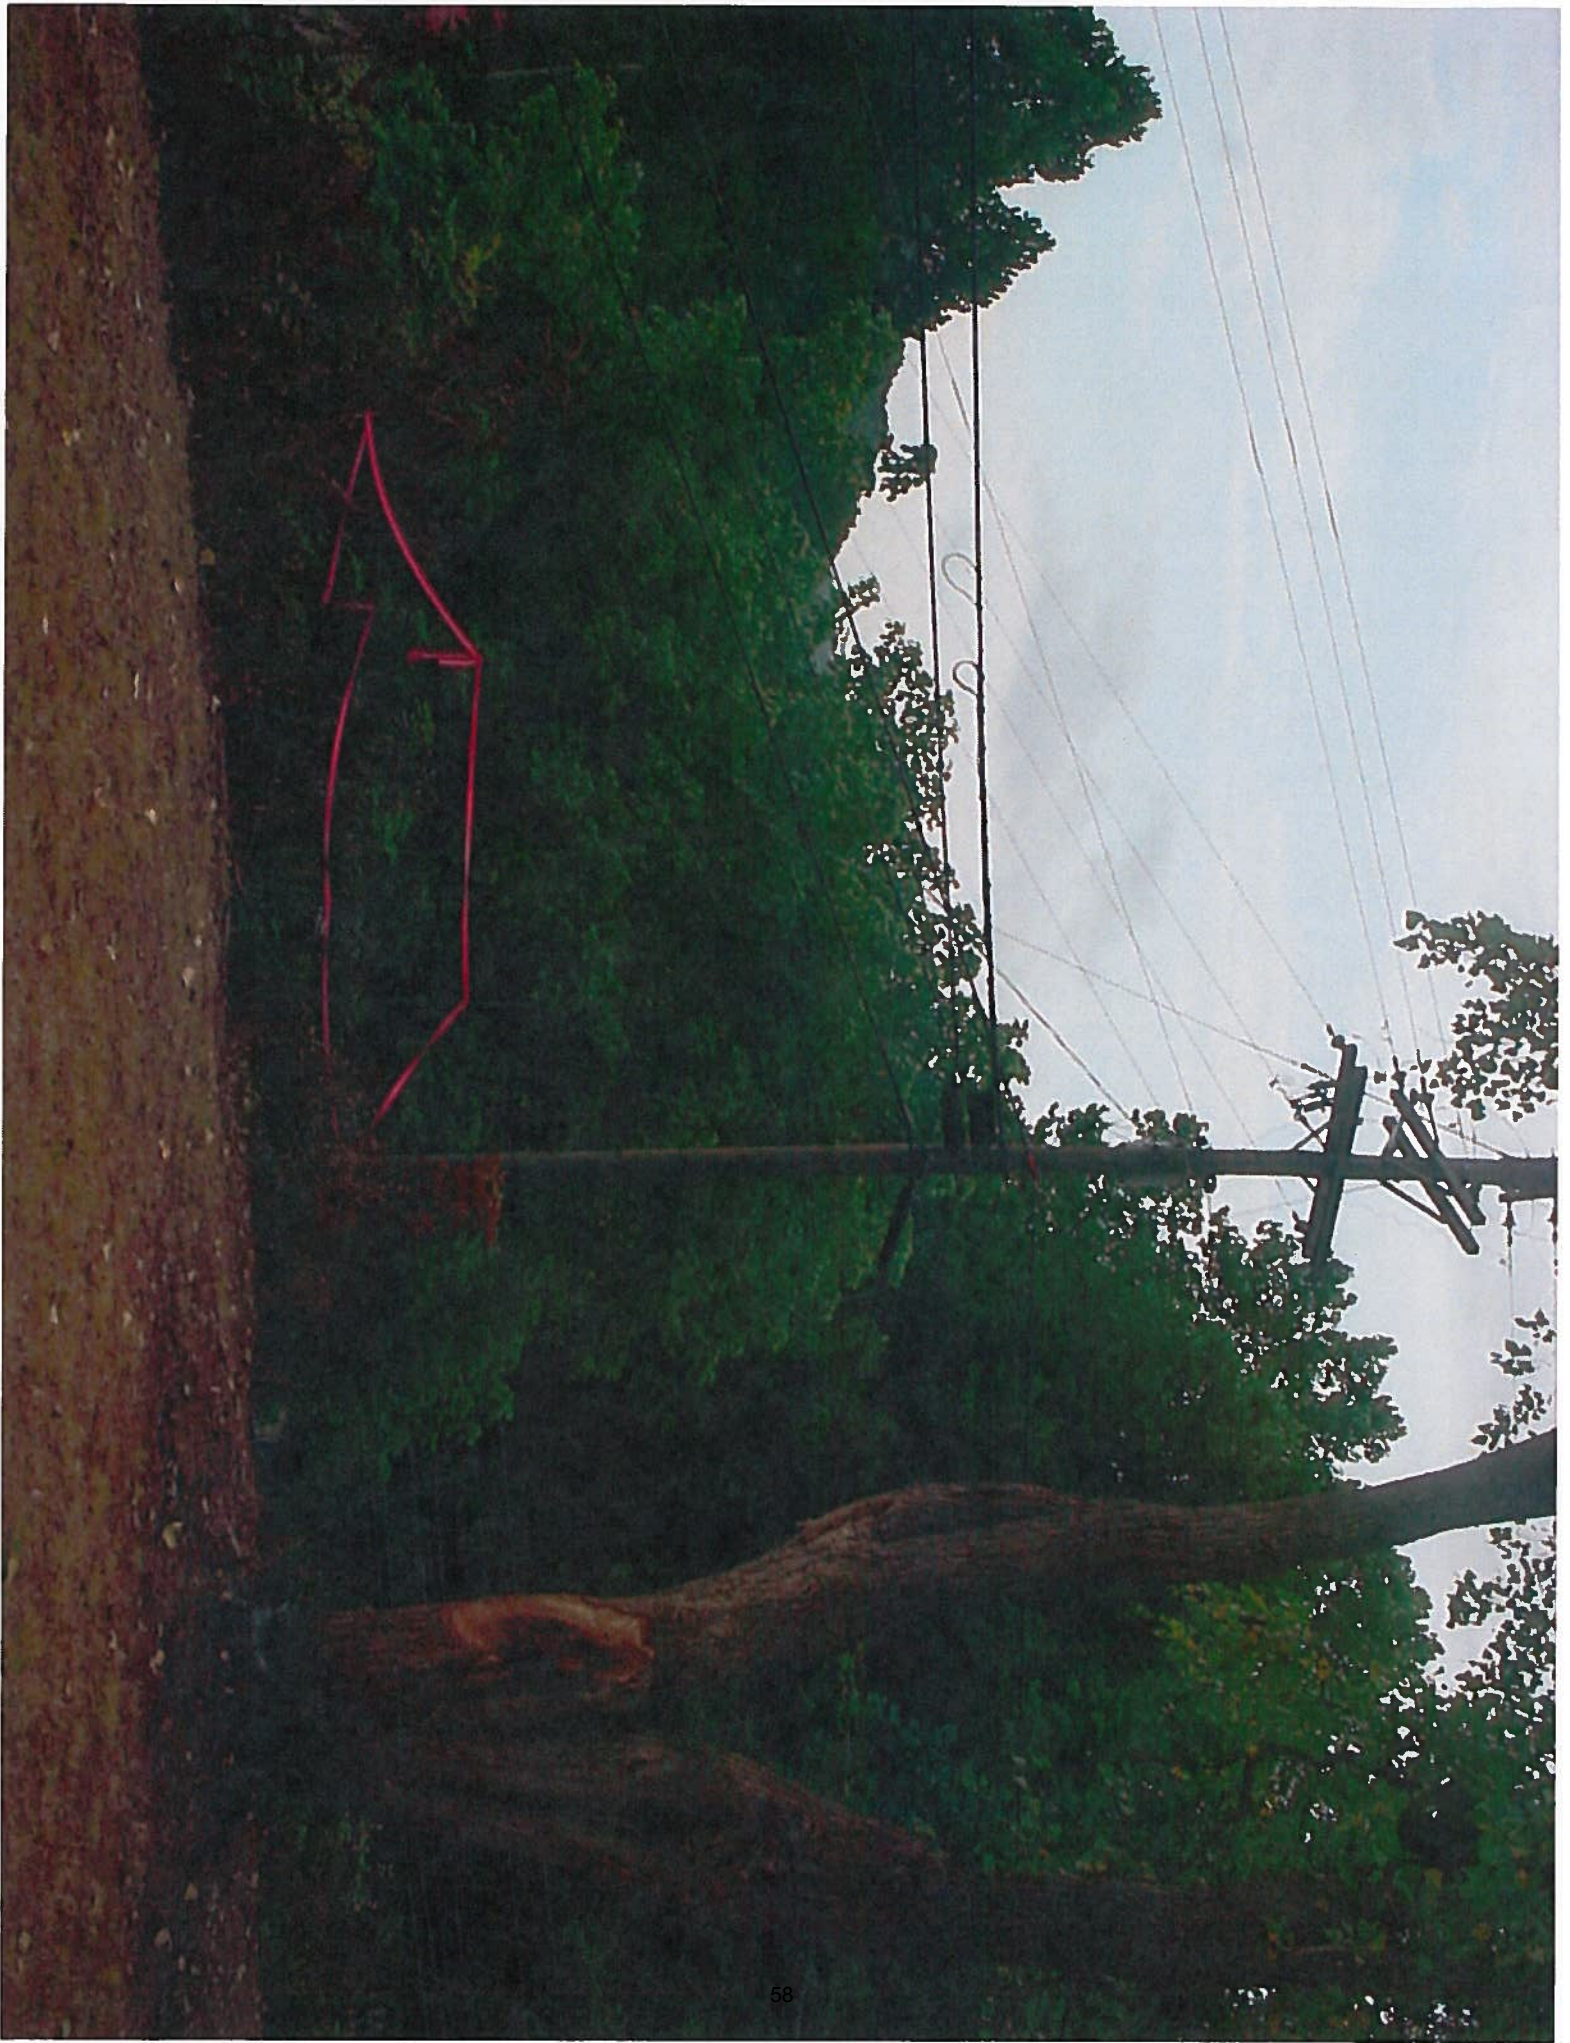
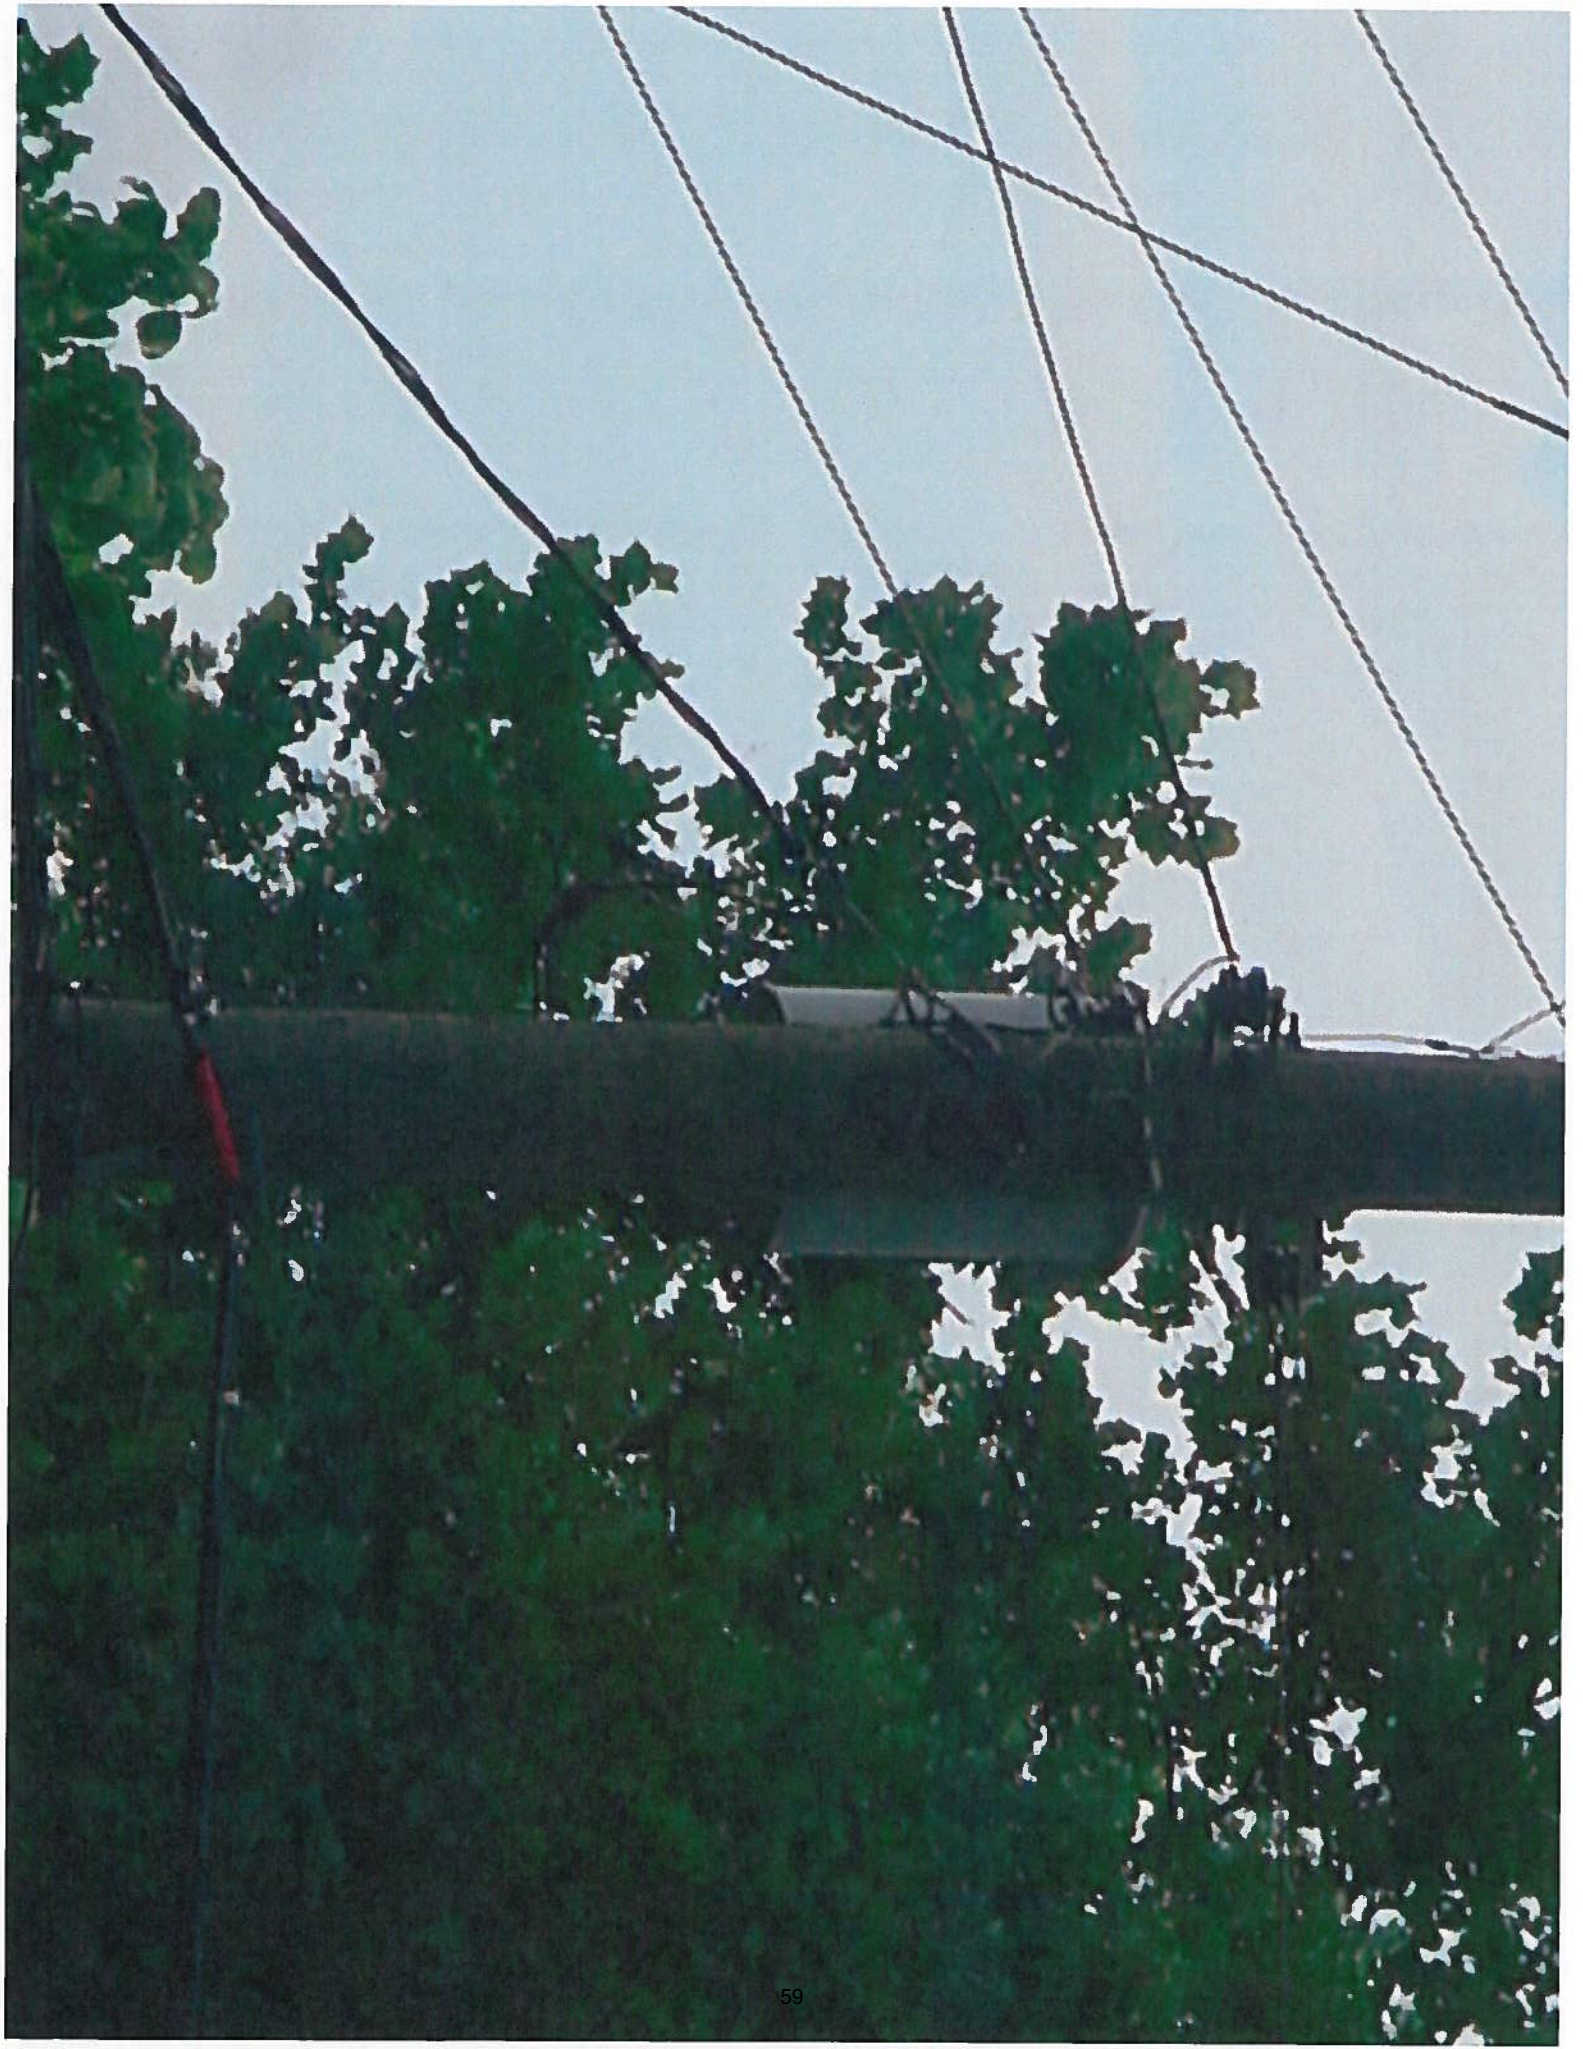
PSC Investigator's Photographs

PSC Investigators Scott Morris and Jeff Moore met with Robert Shurtleff at the incident location to conduct an on-site investigation on the afternoon of July 14, 2014. Mr. Shurtleff brought with him the disconnected triplex conductor, which had been previously removed from the pole by the utility. Mr. Shurtleff was asked to provide photographs of the weed eater used by Mr. Grace, records for the last two system inspections of this circuit (Attachment A), and any records for the name of the customer served at this location and the last known meter at this location, including when the meter was removed.

Line Clearances At Point of Incident	Measured:	Minimum Allowed by NESC	Applicable NESC Edition 2012*:	Voltage	Construct Date:
Triplex Service	Drop reported lying on ground	12'	2012 Edition	120/240	Unknown
