| CLOSURE OF INVESTIGATION OF |) | CASE NO |
| SEPTEMBER 9, 2019 INCIDENT – EAST |) | 2020-00075 |

ORDER

ACCIDENT INVESTIGATION STAFF REPORT

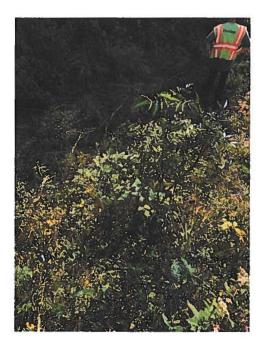
Looking into gully from approach
