**RE: AN EXAMINATION OF THE APPLICATION OF THE FUEL  
ADJUSTMENT CLAUSE OF KENTUCKY UTILITIES COMPANY  
FROM MAY 1, 2005 THROUGH OCTOBER 31, 2005  
CASE NO. 2005-00496**

**E.W. Brown**  
**Units 8,9,10,11**  
**Alstom GT11N2**  
**CIB 20050511**

# CUSTOMER INFORMATION BULLETIN

<b>Editor:</b> Stefano Tartoni <b>Phone:</b> +41-56-205 72 74 <b>Fax:</b> +41-56-205 72 13	<b>Subject:</b> <b>GT11N2 Turbine Vane 4 Finding</b>
--	---

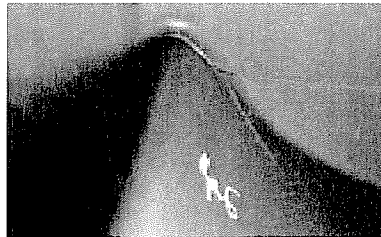
During disassembly on May 6, 2005 a displaced vane of row 4 was found. Visual inspection revealed a crack around the leading edge propagating towards the airfoil pressure side.

Crack

The component in question has accumulated 3'831 OH, 631 starts and 17'271 EOH.

- ALSTOM recommends to boroscope inspect the five units concerned prior to the next run and to immediately report the findings to ALSTOM
- ALSTOM further recommends implementing the current row 4 vane design as soon as possible

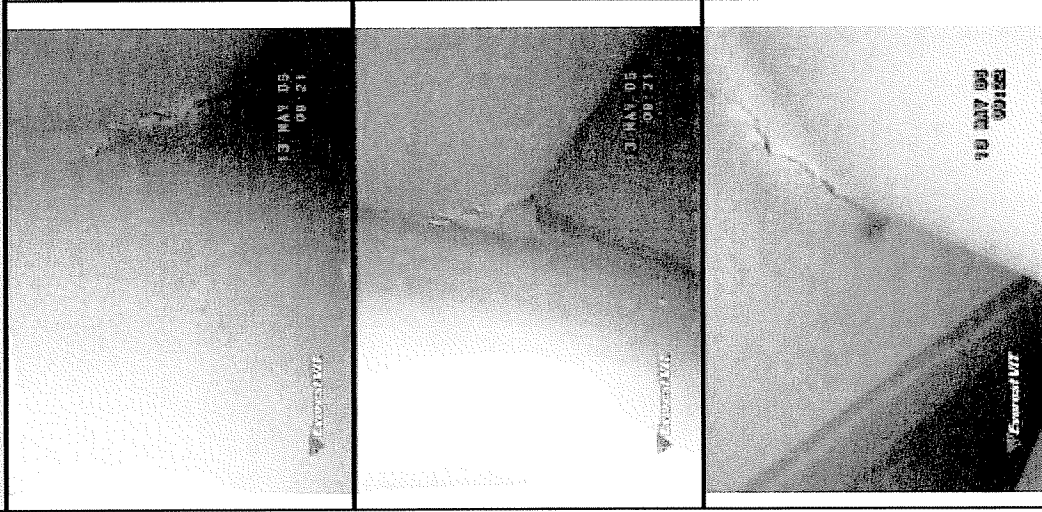
### CT8

Air foil #48. (1 O'clock Position in the flow direction)

Crack on leading edge between route fillet and air foil.

Crack is propagated and spreading apart.

Cracks are visible to the naked eye and the material is splitting at the crack.

Failure is considered imminent by ALSTOM.

- Alstom recommends immediate replacement of all 4 units row-4 vane prior to returning the units to service
- Repair time per unit 30 days (sequential)

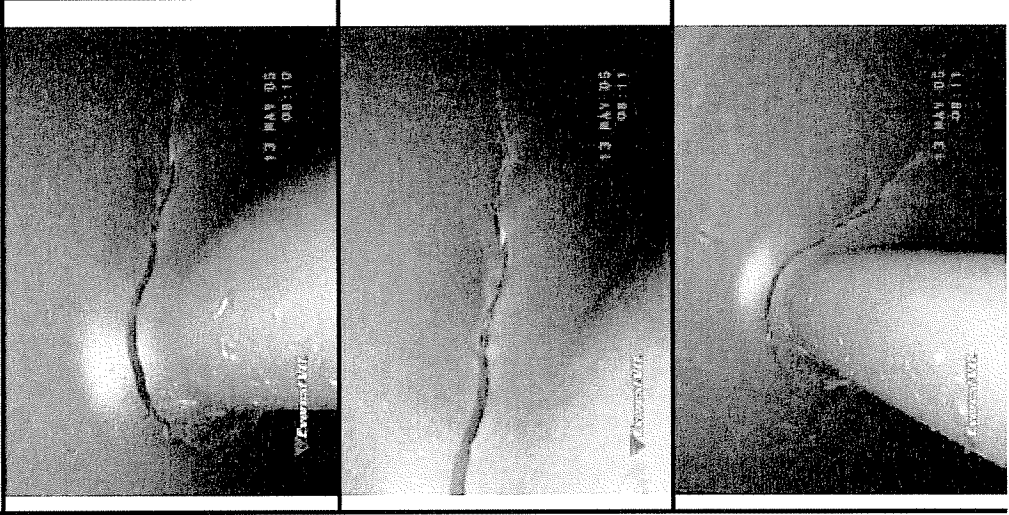
### CT9

Air foil #48. (1 O'clock Position in the flow direction)  
Crack on leading edge between route fillet and air foil.  
Crack is propagated and spreading apart.  
Cracks are visible to the naked eye and the material is splitting at the crack.  
Failure is considered imminent by ALSTOM.

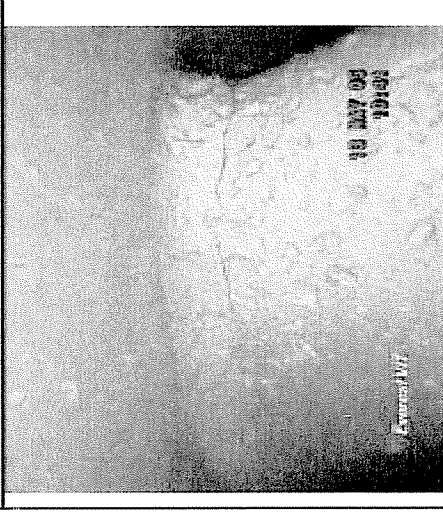
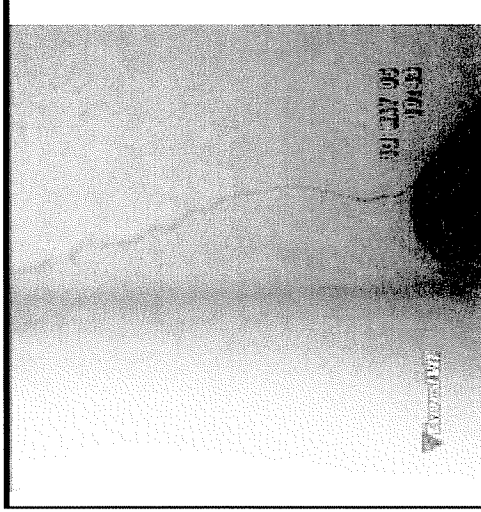
### CT10

Air foil #49. (1 O'clock Position in the flow direction)  
Crack on leading edge between route fillet and air foil.  
Crack is propagated but is not spreading.  
Slightly less damage than CT8 and CT9.  
Cracks are visible to the naked eye but the material is not splitting.

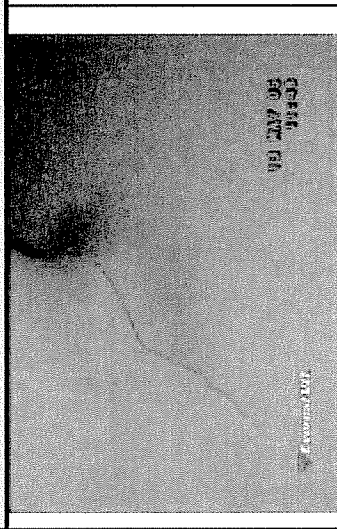
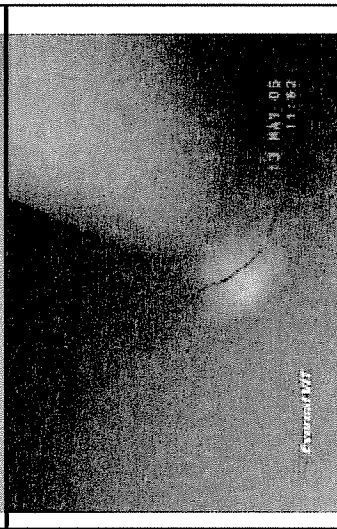
<i>CT11</i>

<p>Air foil #50. (1 O'clock Position in the flow direction) Crack on leading edge between route fillet and air foil. Crack is propagated but is not spreading. Cracks are visible to the naked eye but the material is not splitting. This unit displays the least amount of damage.</p>
