**RE: An Examination of the Application of the Fuel Adjustment Clause of
Kentucky Utilities Company From November 1, 2004 to October 31,
2006 - Case No. 2006-00509**

Life Assessment Study: Kentucky Utilities Tyrone Units 1 and 2

February 2007

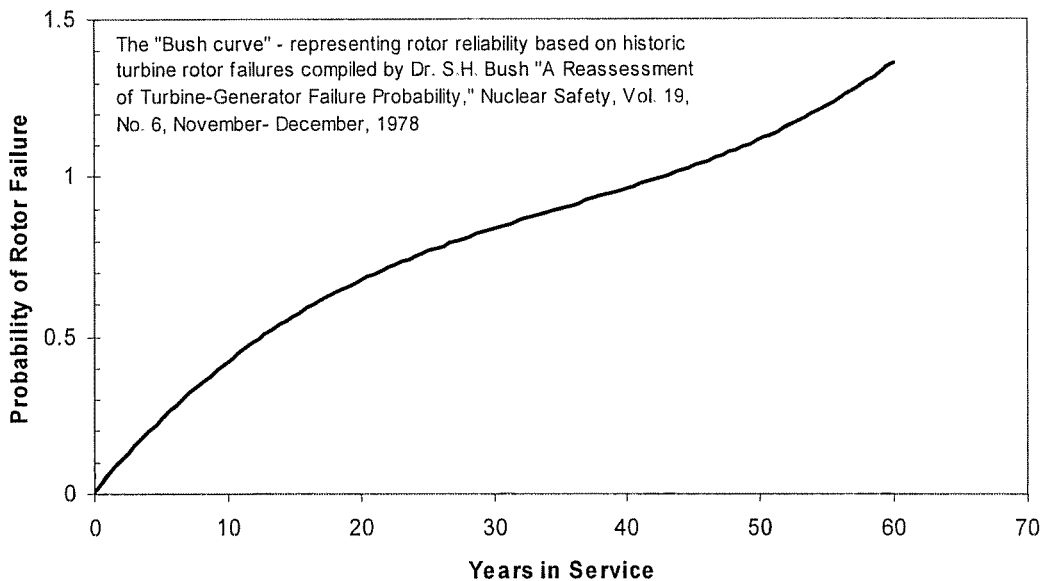
Figure 4-1 — Probability of Turbine Rotor Failure versus Time

Regardless of the degree of sophistication employed in calculating or measuring stresses (or strains); there remains a considerable amount of uncertainty about their actual magnitude in service under different operating conditions. Similarly, one cannot assume a single value of strength (or strain capability). Heat-to-heat variations and even variations within a single large component, such as a rotor forging or turbine shell, introduce unavoidable uncertainties in material capability. Thus, it has become necessary to treat the problem statistically. The “permissible” probability of failure, or failure rate, depends on many factors, including the consequences of failure. While there is no definitive rotor end-of-life based on the number of service hours, the probability of rotor failure begins to increase significantly at 40 years of service, as depicted below. The graph in Figure 4-1 shows the probability of failure, expressed as percentage, as a function of years of operation. This curve was based on historic turbine rotor failures compiled by Dr. S. Bush. The Bush curve represents the cumulative hazard or probability of failure in percent versus operating time. The curve indicates that at 40 years in service the risk of rotor failure is 10 times greater than during the first couple of years in service.

Since the rotor is the most expensive component of the steam turbine, failure will effectively be the end-of-life for the steam turbine. The installed replacement cost for a new rotor is estimated at \$1,500,000. The risk of rotor failure estimated by NDE testing and remaining life assessment is as previously discussed.

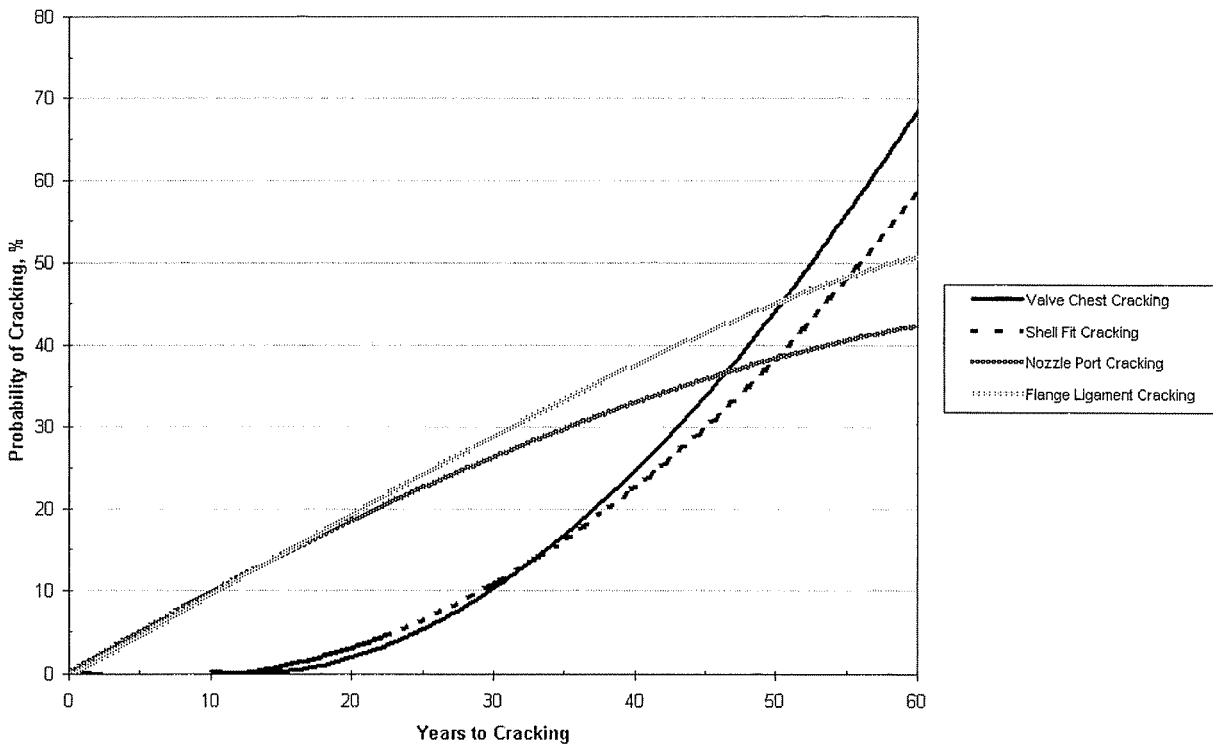
Figure 4-2 — Steam Turbine Body Cracking Probability

Valve chest, shell, nozzle ports, and flange ligament cracking can be expected as the units age, as depicted in Figure 4-2. The Unit 1 1961 inspection report indicated cracks were found in the high-pressure base and cover cylinders.

Based on the vintage of the equipment, the length of inspection intervals, and the historical cracking susceptibility, there is a high probability that stress corrosion exists and major repairs will be necessary. For each steam turbine, the estimated cost of repairs is \$125,000.

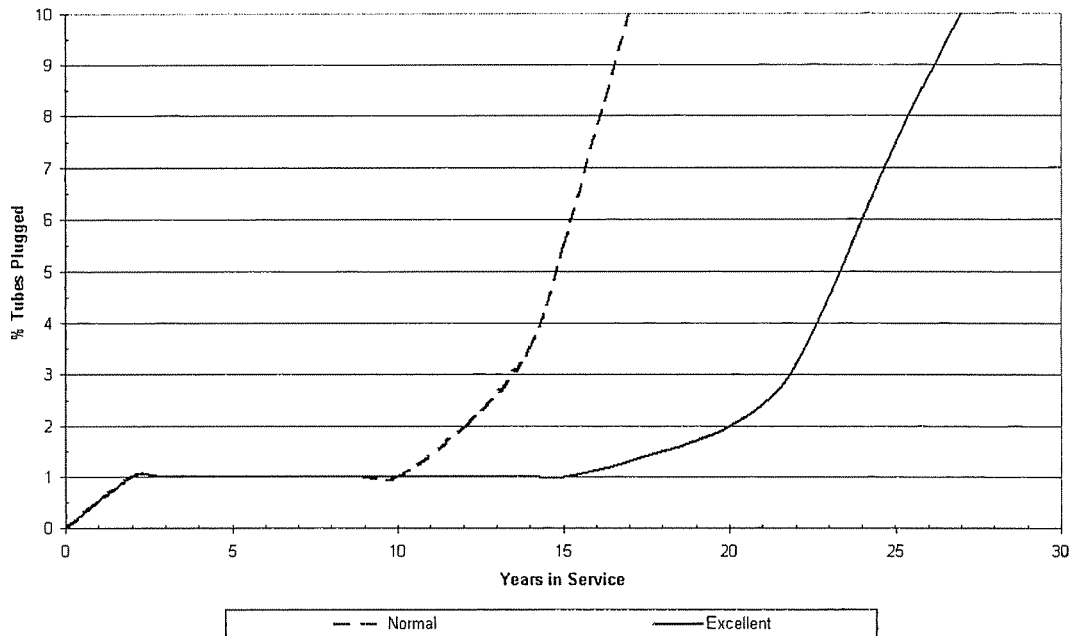
Figure 4-3 — Life Cycle of Heat Exchanger Tubing

Typically, plugged tubes do not become a concern with respect to thermal performance until the pluggage rate approaches 10%. This typically occurs after 15 to 25 years in service, as depicted in the following life cycle curve.

There is no record of any heater or heater tube replacements. Based on the vintage of the equipment, there is a high probability that feedwater heater tube replacements will be necessary to maintain the thermal efficiency of

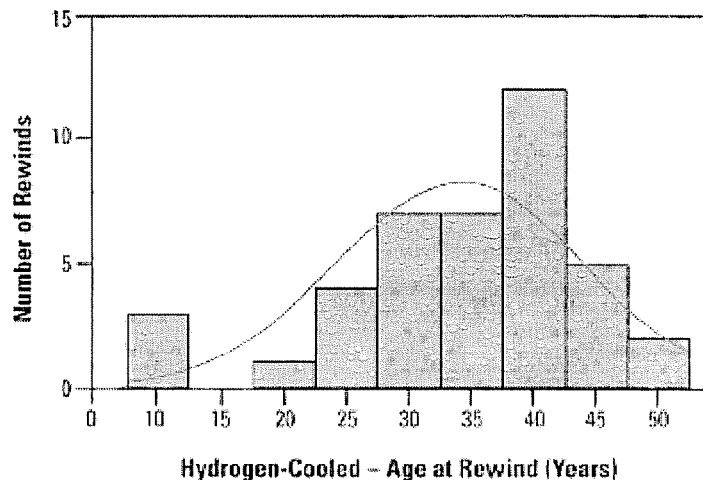
Figure 4-4 — Stator Rewinds

The biggest cost item that could result from the testing of the generator would be the rewinding of the rotor and stator. Stator rewinds for hydrogen-cooled generators are usually required between the 30- and 40-year age of the machine. Rotor rewinds usually occur several years sooner.

Without testing the machines, the integrity of the insulation is not known; however, given the age and time of the last inspection, it is reasonable to expect insulation deterioration to the point that a rewind would be required.

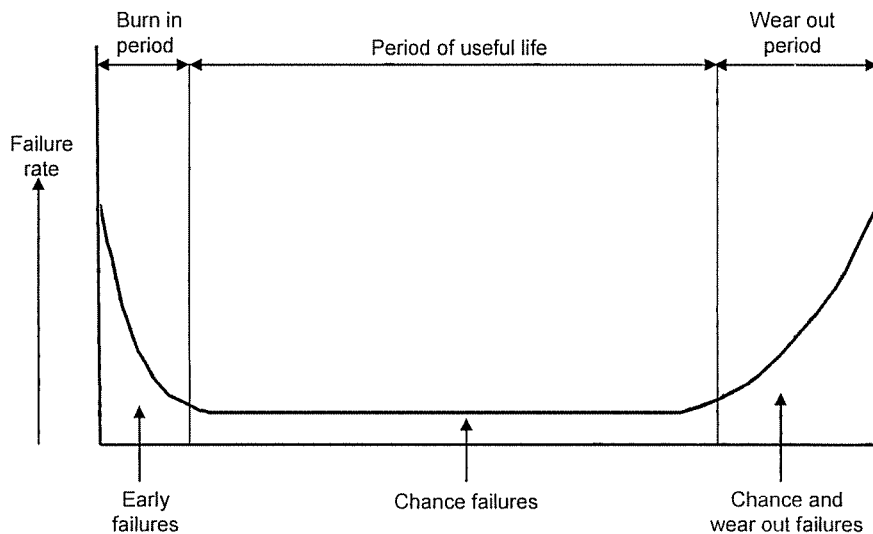
Figure 4-5 — Typical Mortality Curve for I&C System Hardware

During the last 50 years, the instrumentation and control (I&C) systems evolved from the pneumatic in the 1950s, to analog in the 1960s, and finally to microprocessor-based and programmable logic controller (PLC) based systems beginning in the 1970s. The use of microprocessor-based or PLC-based depended on the type and scope of the application. Whenever a new generation of I&C systems is produced, spare parts of the preceding generations have limited availability and are expensive, if available. As such, many utilities have opted to replace I&C systems when they become obsolete. Another factor that affects the utility's decision is the life of the I&C systems. The typical mortality curve (Figure 4-5) for I&C system hardware indicates that their useful life is between 15 and 20 years. After that time, the hardware starts having high failure rates, which result in poor availability and high maintenance cost.

The existing pneumatic systems for the boiler controls and monitoring are obsolete and have not been in service for a long time. It is likely that the many of the seals will need replacing and that internal controller parts will also need to be replaced. In many cases, these parts are not available from suppliers and must be manufactured in-house or through contracting to local machine shops. Therefore, to achieve the objective of returning the units to reliable service, the additions and/or upgrades discussed in the following subsections are recommended.
