LG&E/KU – Mill Creek Station

Phase II Air Quality Control Study

Scrubber Support Structure Steel Refurbishment Cost Estimate

March 11, 2011
Revision B – Issued For Client Review

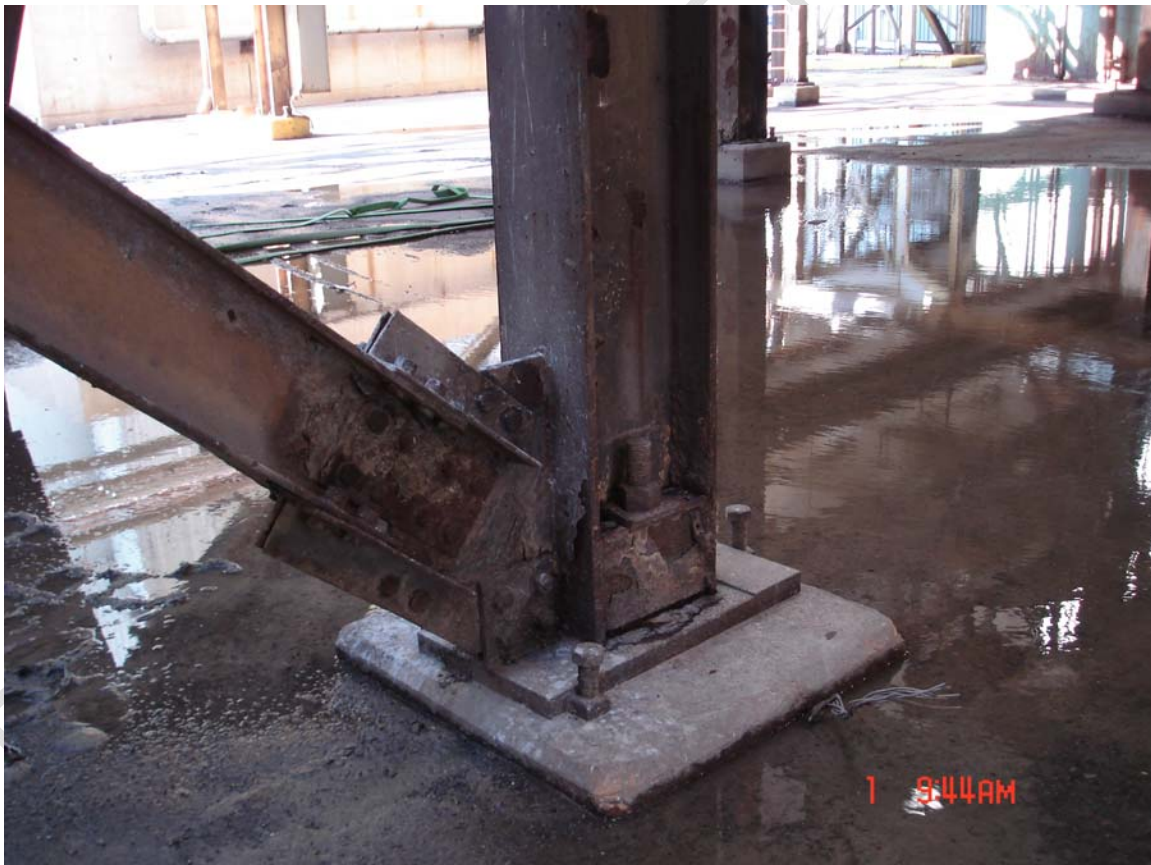
Unit 1 Column Line D-6

1. The protective coating on the structural steel is corroded away in large areas. Some of the corroded areas have significant loss of steel cross section.
2. The columns have lost steel section from the steel delaminating and falling off. In most cases, the brace connections are also damaged leaving a thinner gusset plate and deteriorated connection angles, bolts, and nuts. In some locations the bolts and nuts are corroded to the point of rounding the hexagon surface and having no thread. This is typical for the main support columns and bracing.

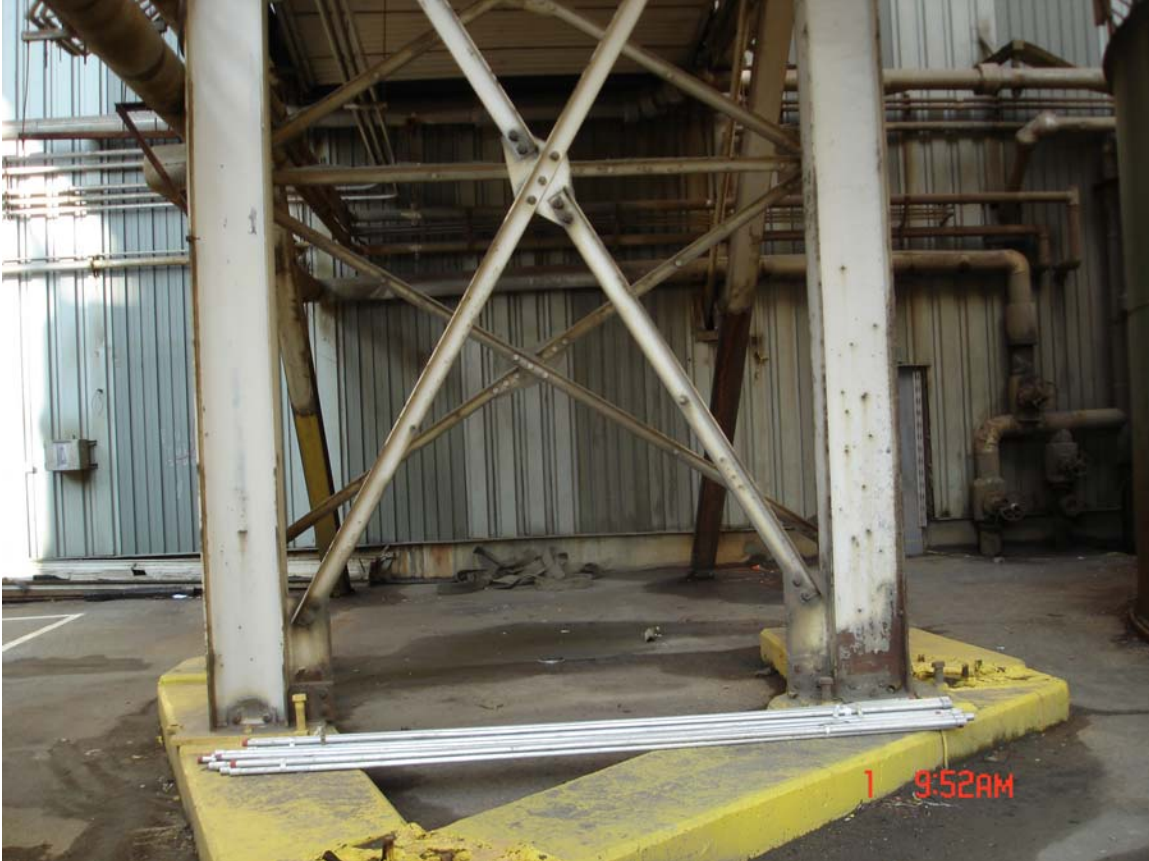
Unit 1 Column Line A-0.1 and A-0.2

3. Some of the columns at column lines A through C could be cleaned, repaired, and coated, but the columns at column lines D through H will need to be replaced.

Take down the existing structure and replace it with new structure between Column Lines D through H and Column Lines 1 through 10. The existing duct support structure at Column Lines A through C can be cleaned, repaired, and coated.

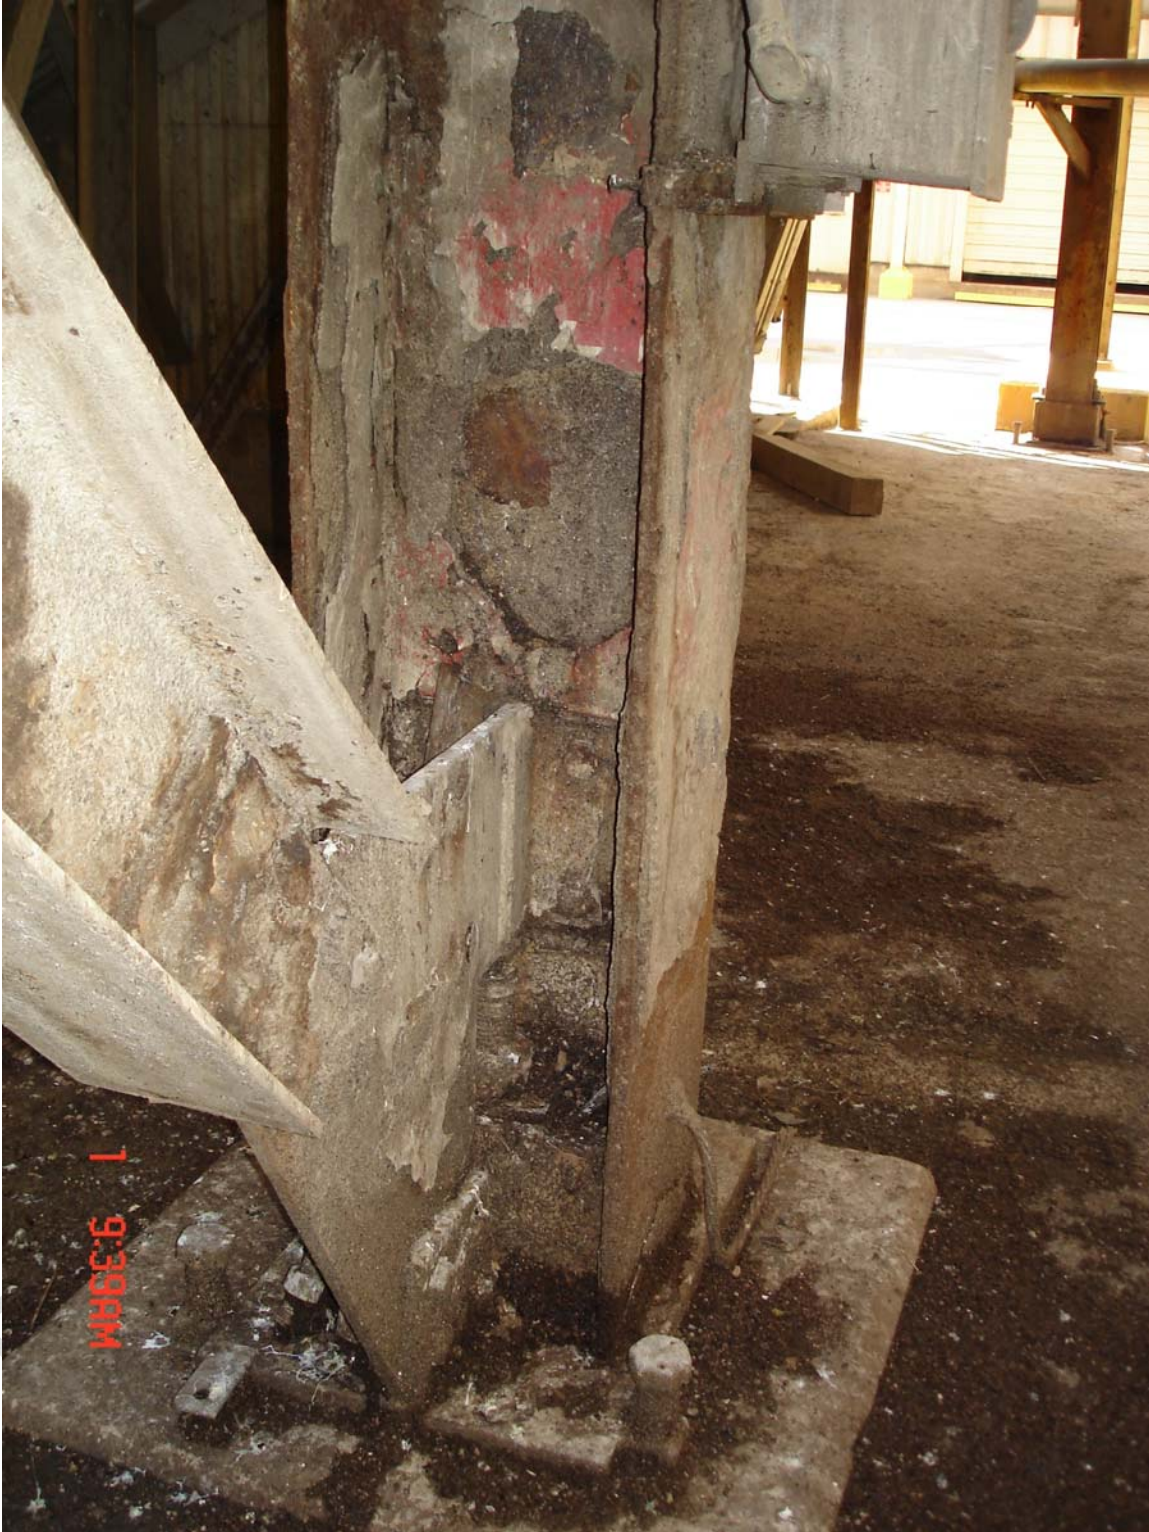
Unit 1 Column Line E-5

4. The columns are corroded and have lost section in the webs, flanges, and connections.

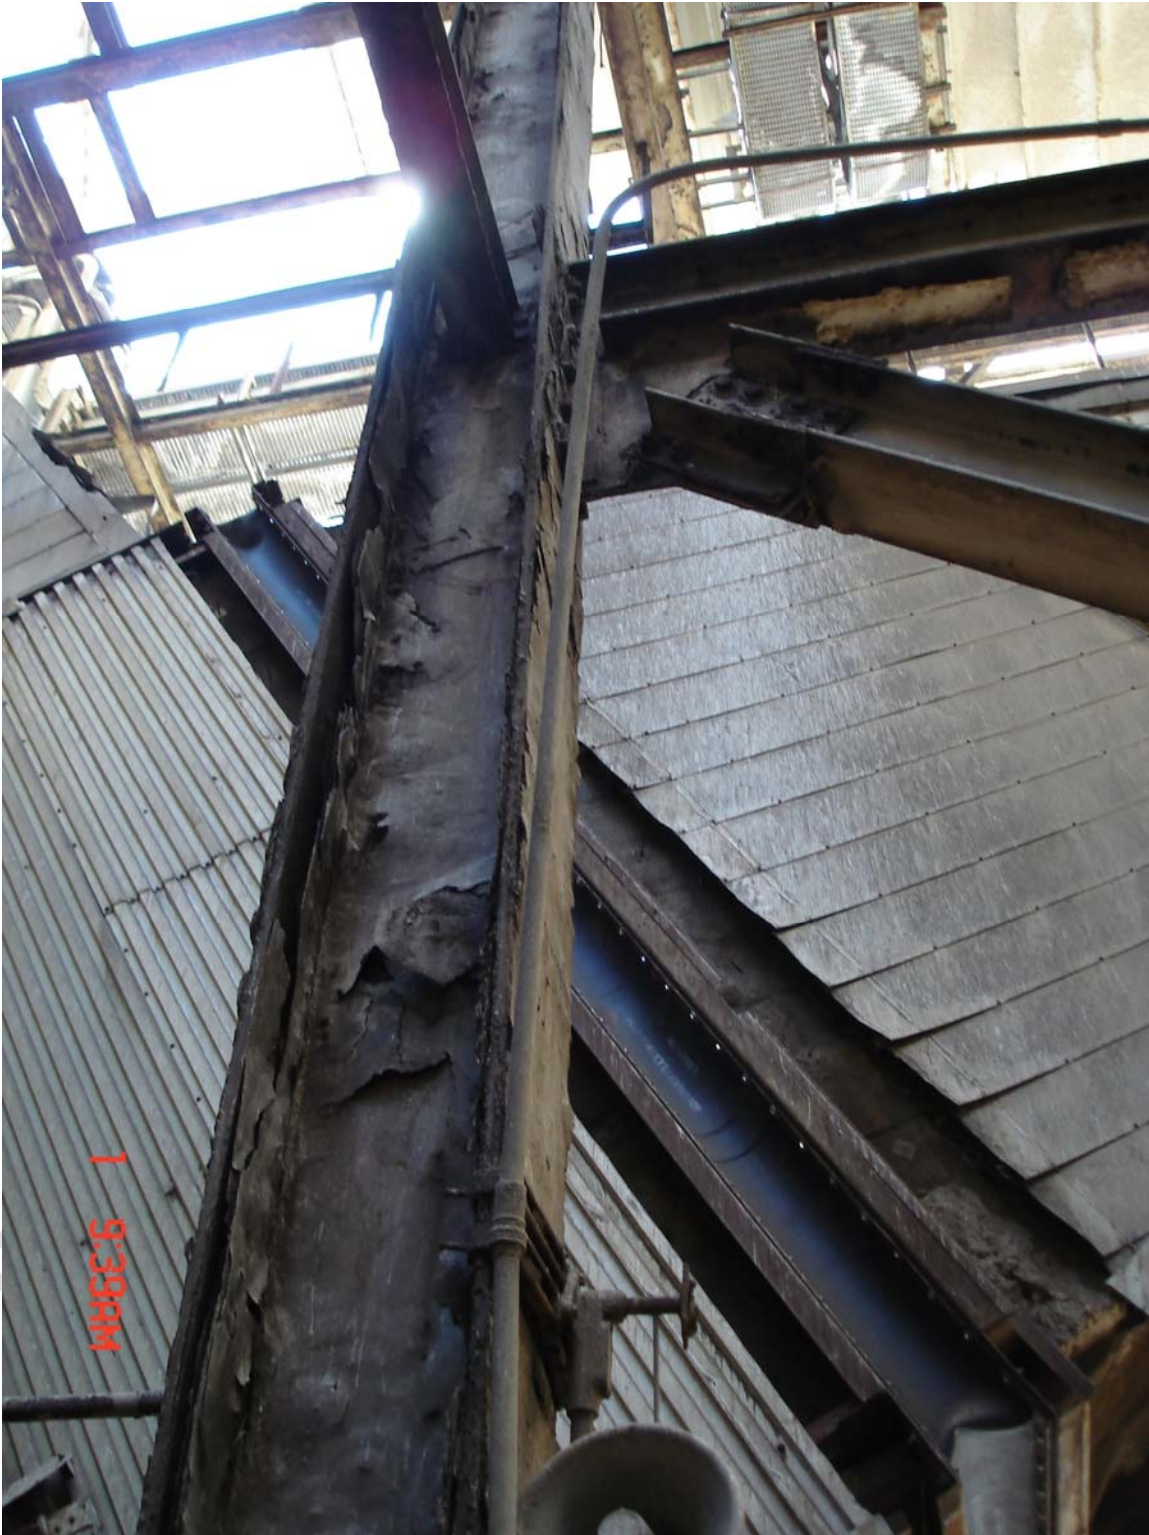
Unit 1 Column Line E-5

5. Steel is delaminating from the flanges and web as shown in the following picture.

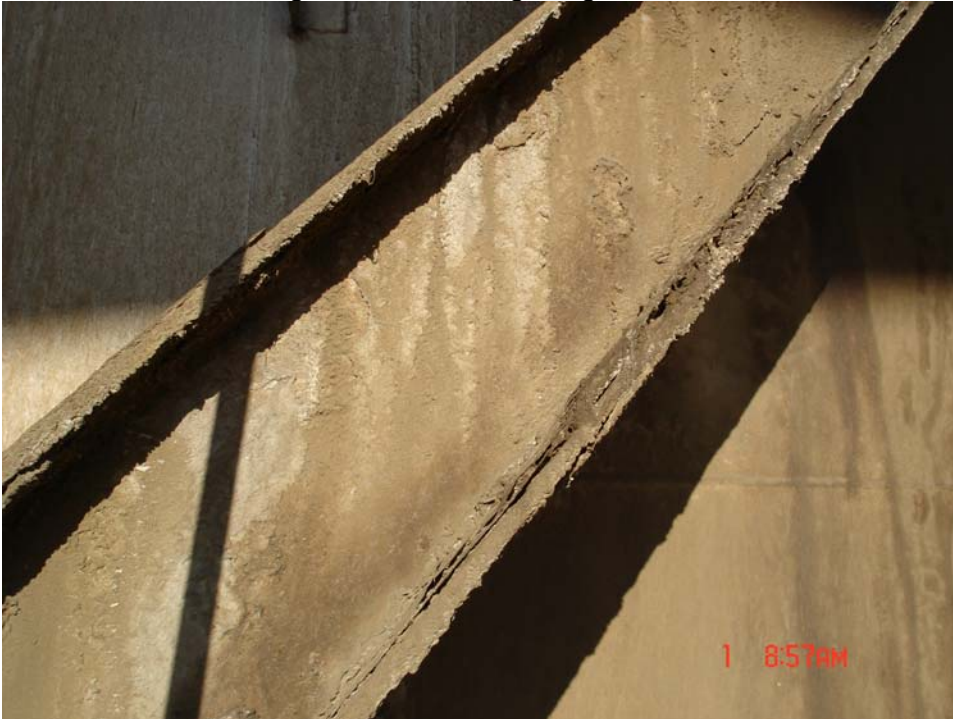
Unit 1 Main Bracing between Column Line H-3 and H-7

6. Steel is delaminating from the bracing flanges.

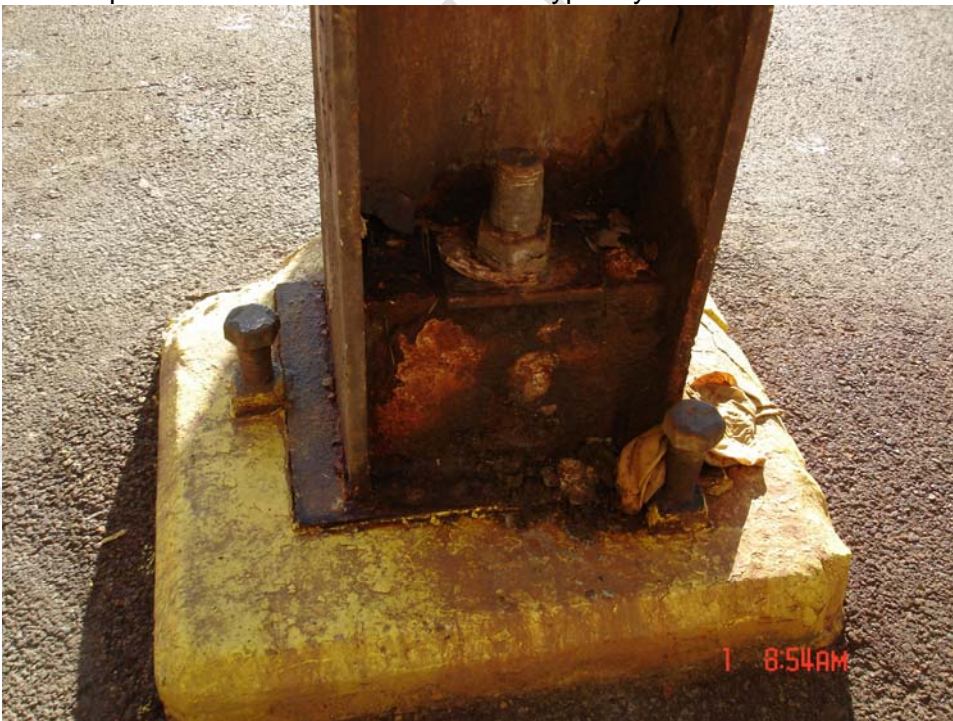
Unit 1 Column Line H-2

7. Base plates and anchor bolt chairs are typically corroded.

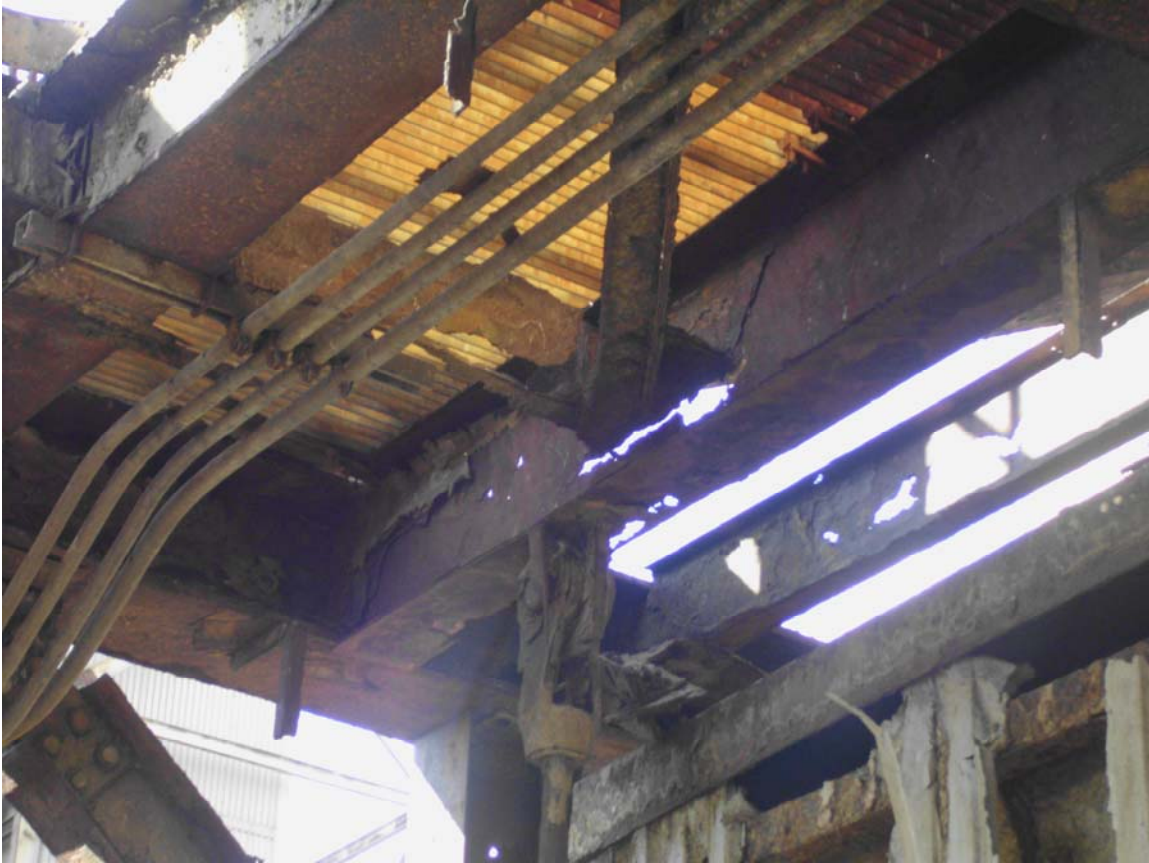
8. The duct support hanger is attached to a beam that has been corroded away. The loading is no longer supporting by the beam and has transferred elsewhere in the structure. This is in danger of collapse.

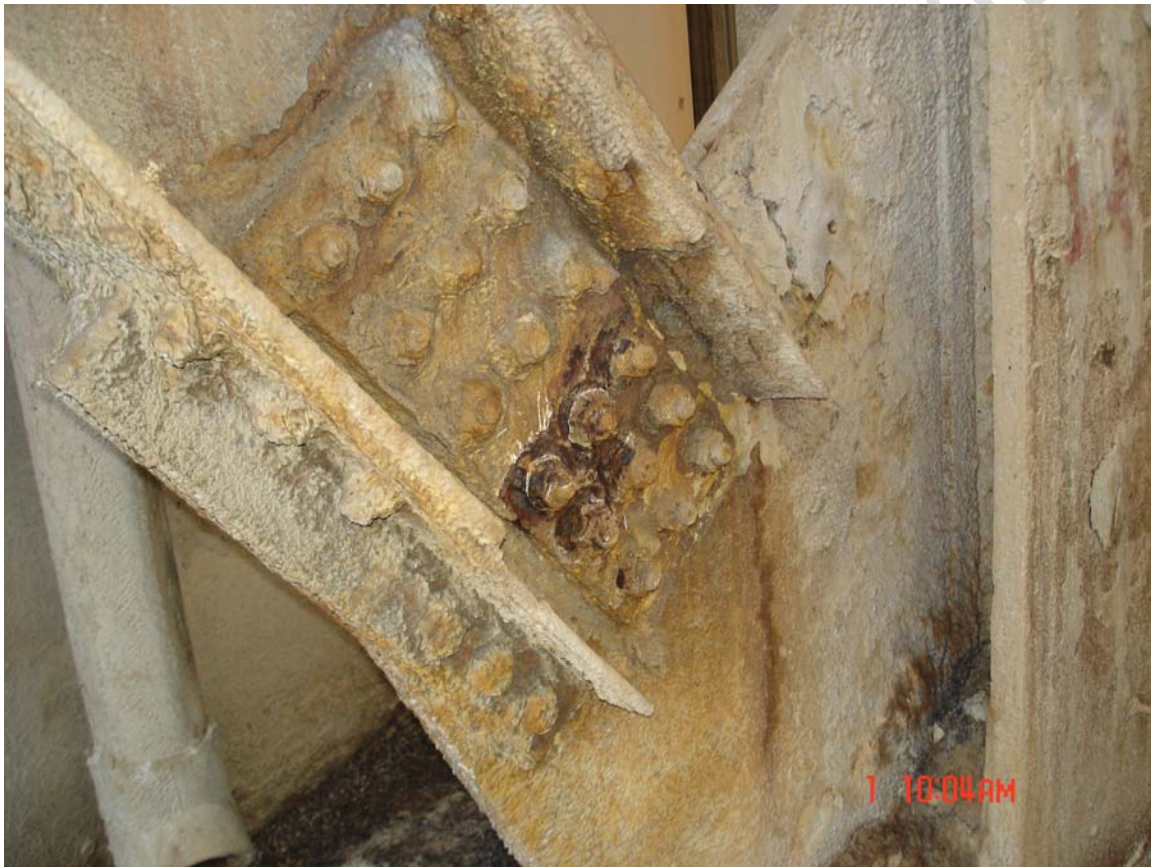
Unit 2 Column Line Ec-19

2. The bottom of the column has lost steel section from the steel delaminating and falling off. In most cases the brace connection is also damaged leaving a thinner gusset plate and deteriorated connection angles, bolts, and nuts. In some locations the bolts and nuts are corroded to the point of rounding the hexagon surface and having no thread. This is typical for the main support columns and bracing.

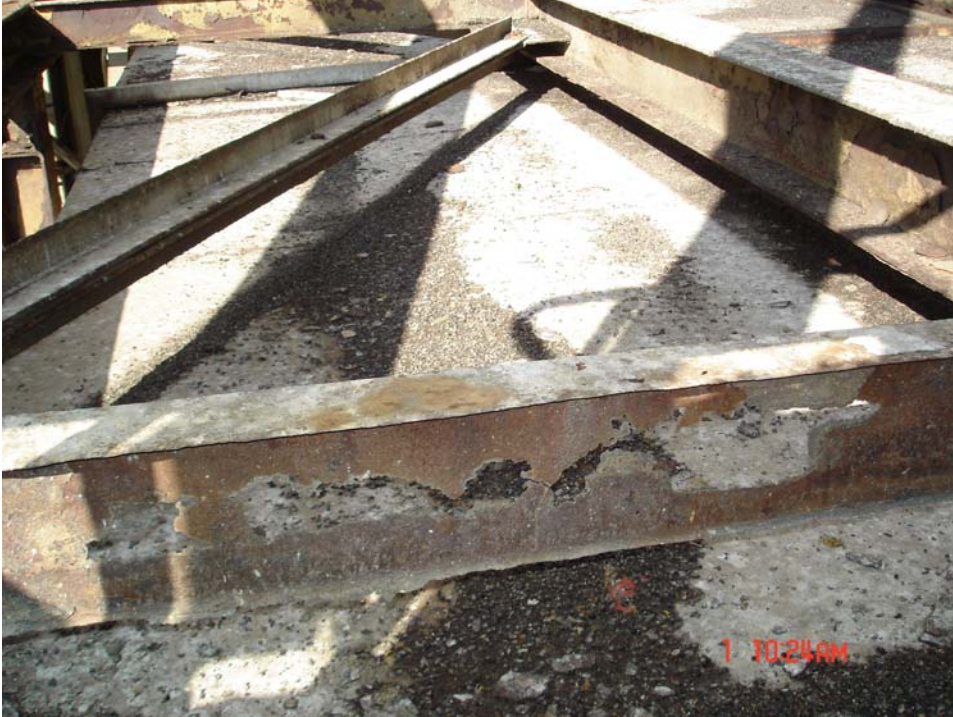
Unit 2 About Elevation 500

5. The horizontal bracing is damaged. The beam in the foreground has lost the web and the bottom flange. Some of the angle bracing has been completely corroded away.

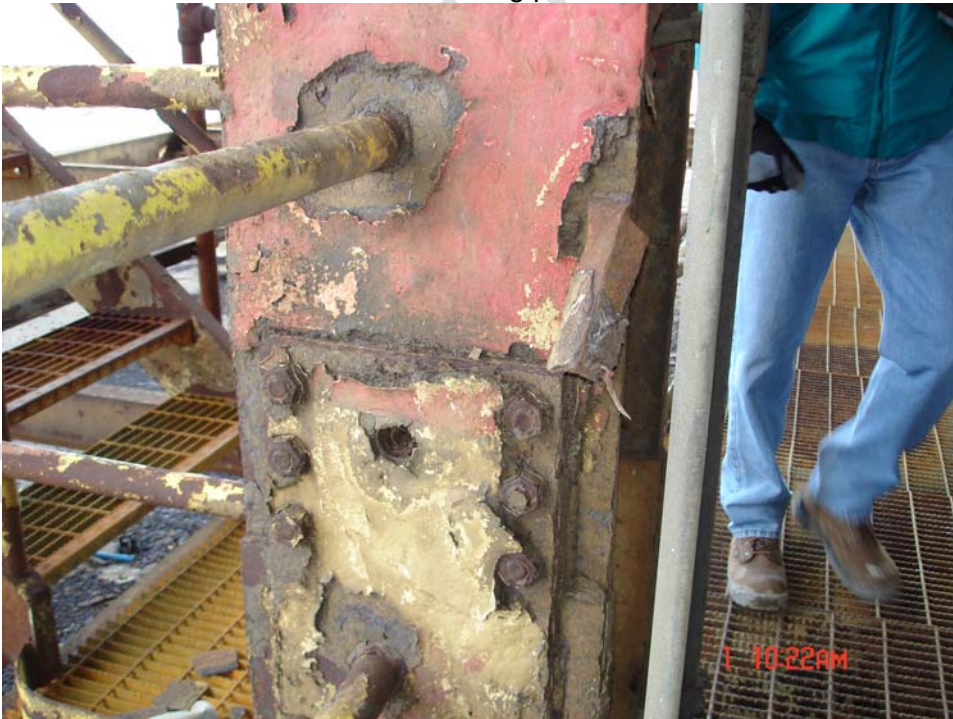
Unit 2 About Elevation 515

6. Steel is delaminating from the column splice plates and the shim/filler plates have been corroded as shown in the following picture.

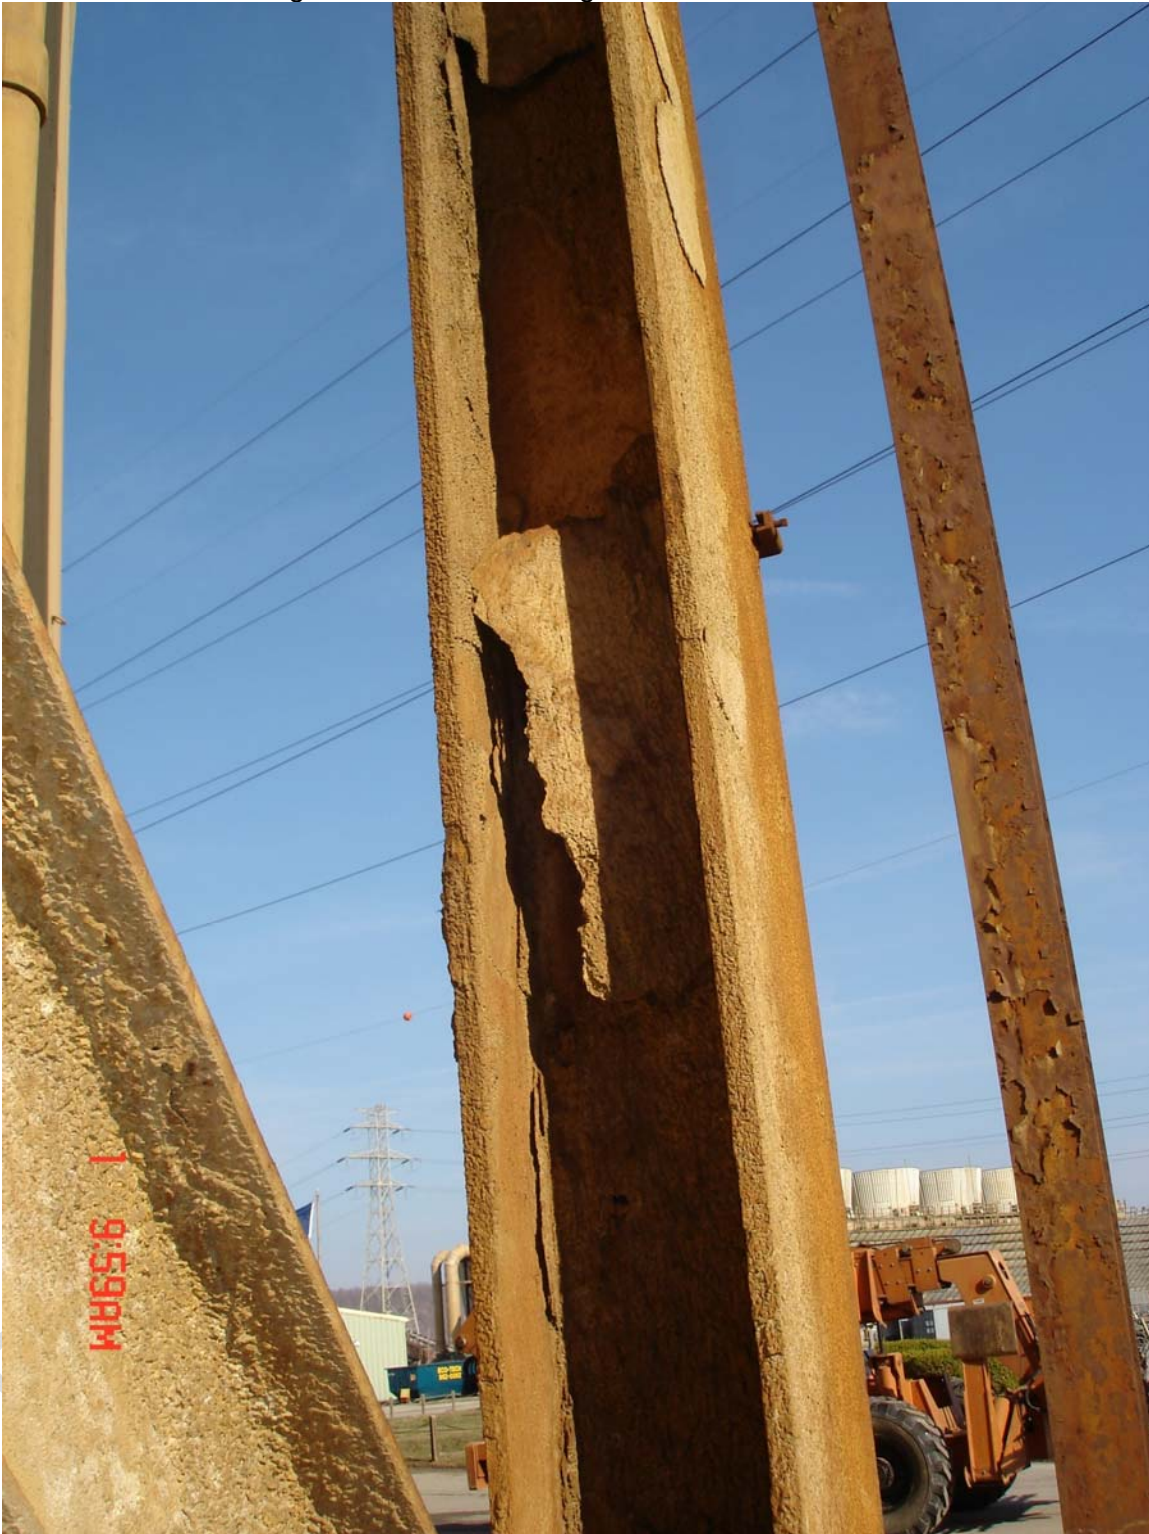
Unit 2 Column Line Gc-24

7. Steel is delaminating from the column flanges and web.

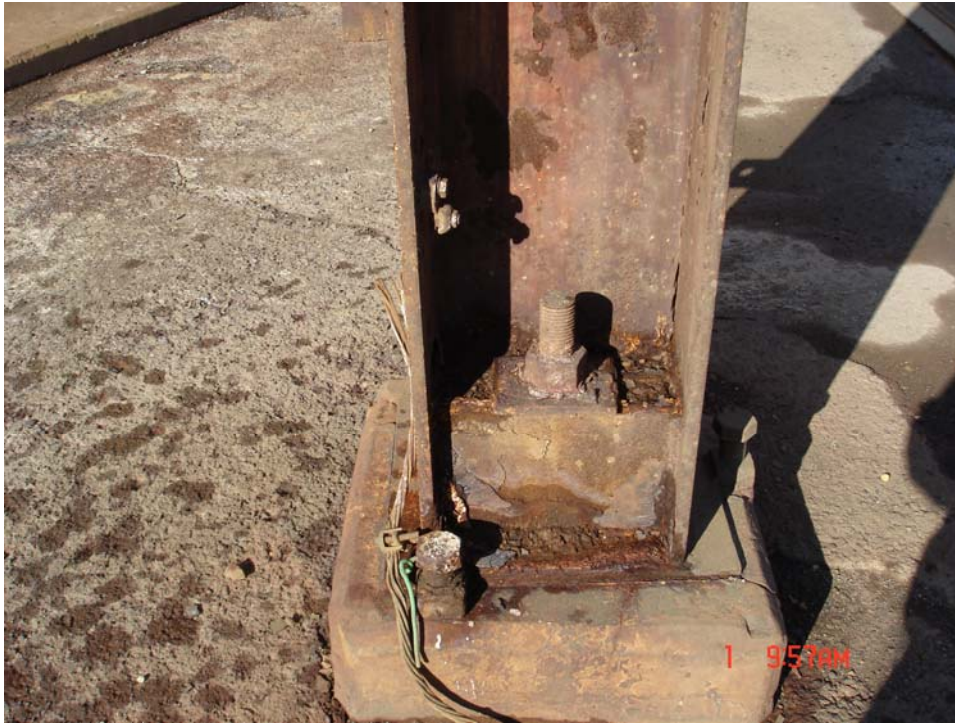
Unit 2 Column Line Gc-25

8. Base plates and anchor bolt chairs are typically corroded.

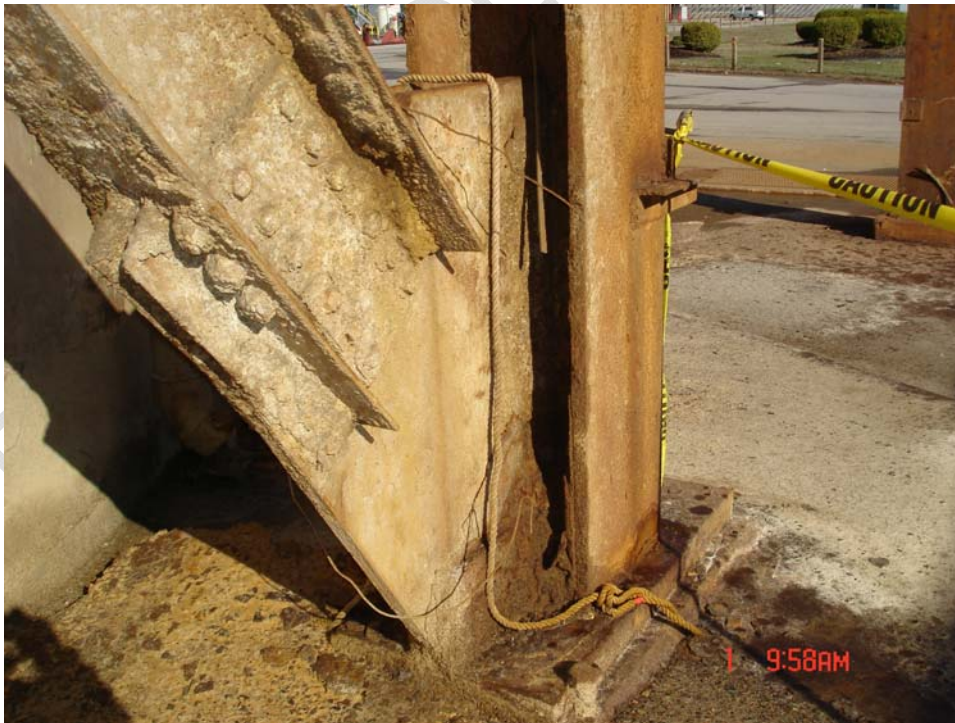
Unit 2 Column Line Gc-24

9. Some base plates, connection plates/angles, and connection bolts and nuts, are corroded and have lost significant section.

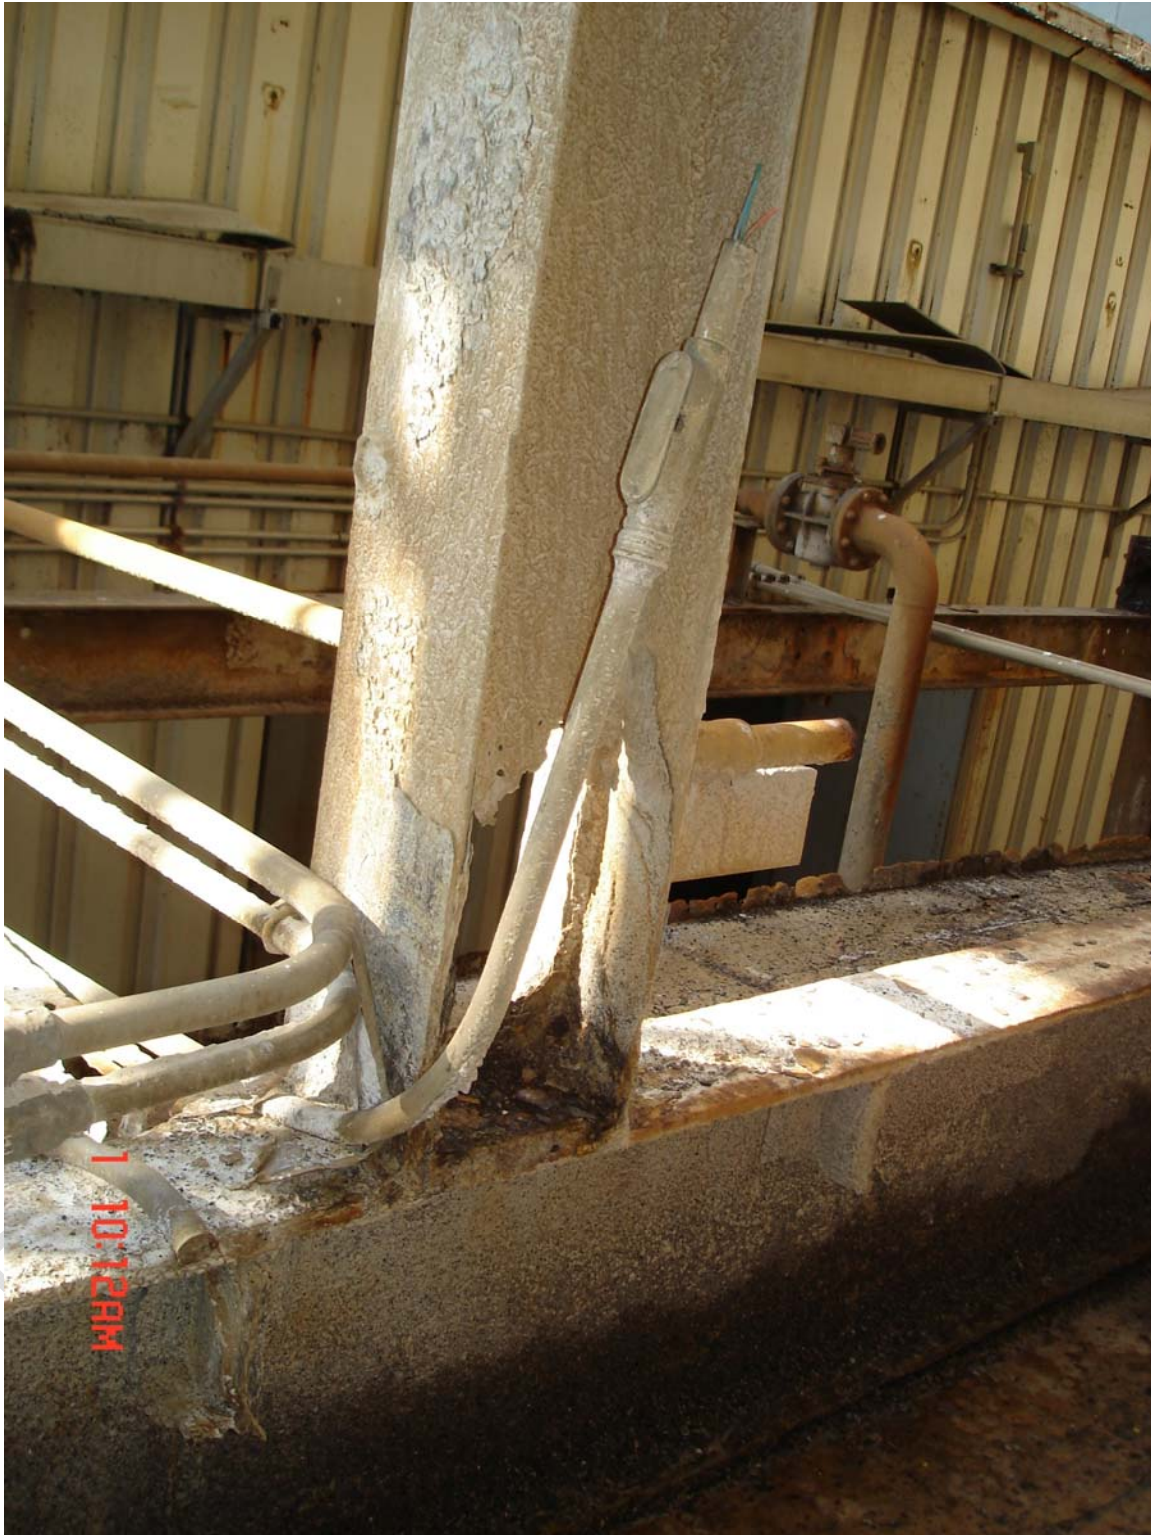
Unit 2 About Elevation 500

10. There are several beams and posts at the upper elevations that have been corroded through the webs and/or flanges.

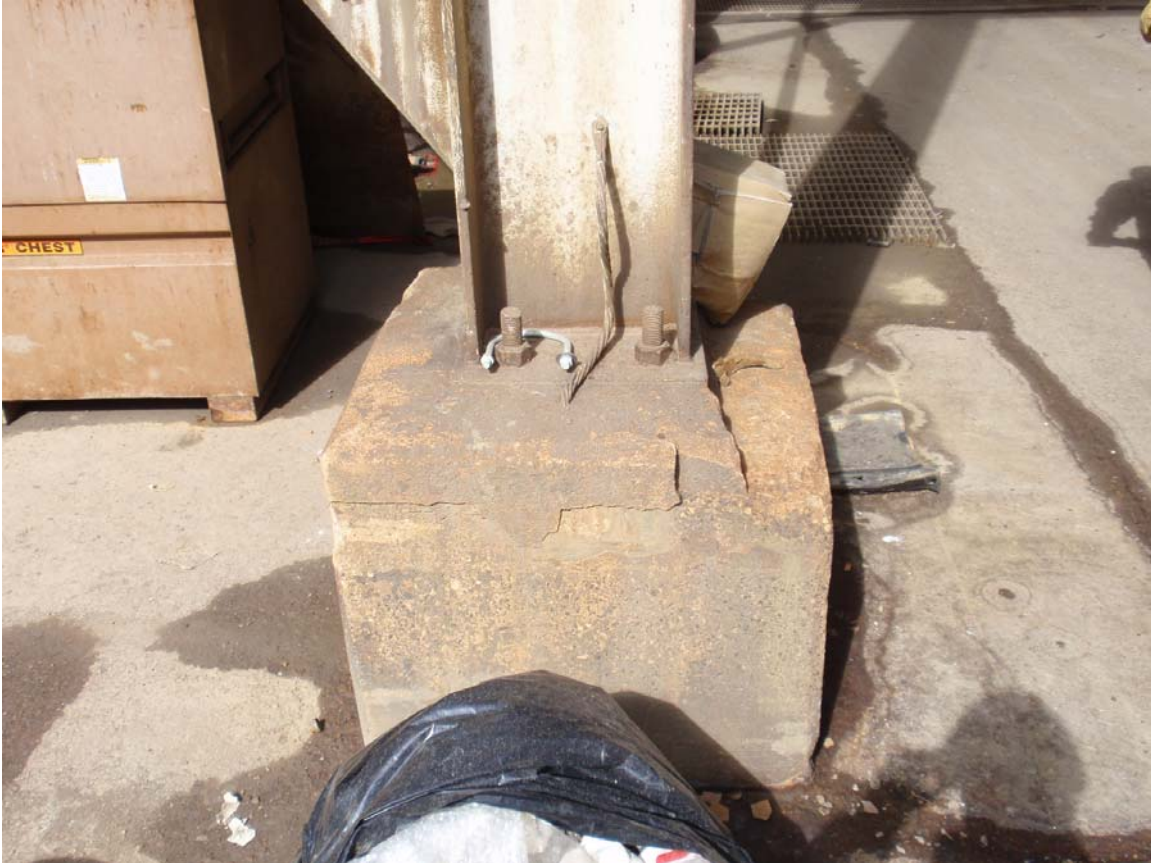
Unit 4 Typical of column bases at column lines L, M, N, and P

1. Several of the column bases have been damaged and need to have the broken and missing grout repaired. The base plates and bottom of the columns should be cleaned and coated to prevent corrosion damage. Some base plates will need to be repaired.

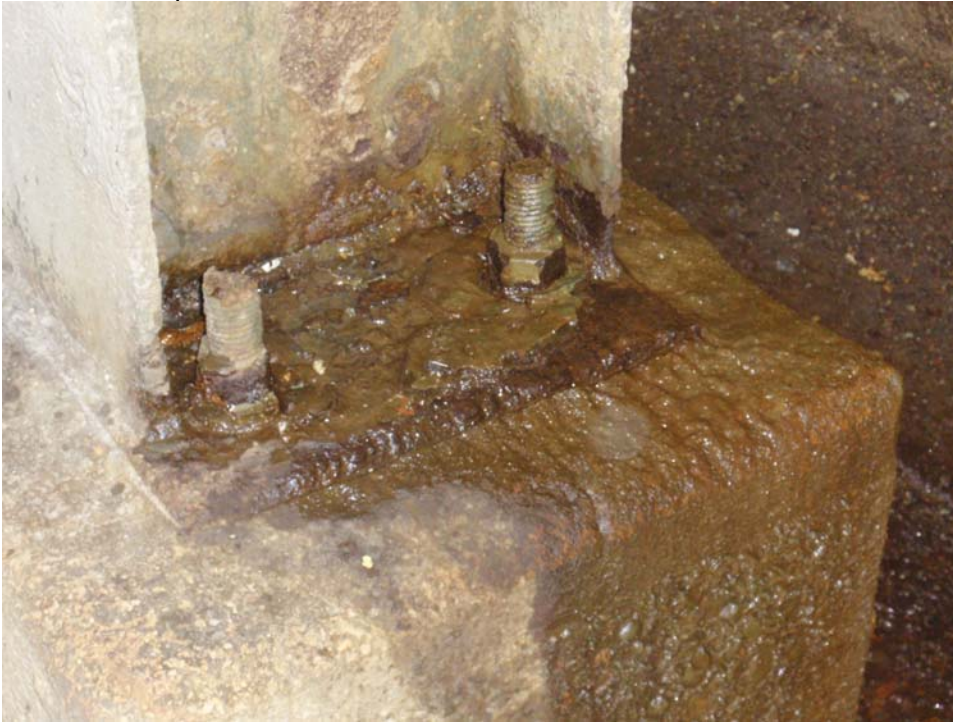
Unit 4 Column Line N-6B

2. The ductwork at Unit 4 is leaking flue gas and the acidic condensate is dripping on the structure. The base plate and column at column line N-6B has been damaged and will need to be repaired.

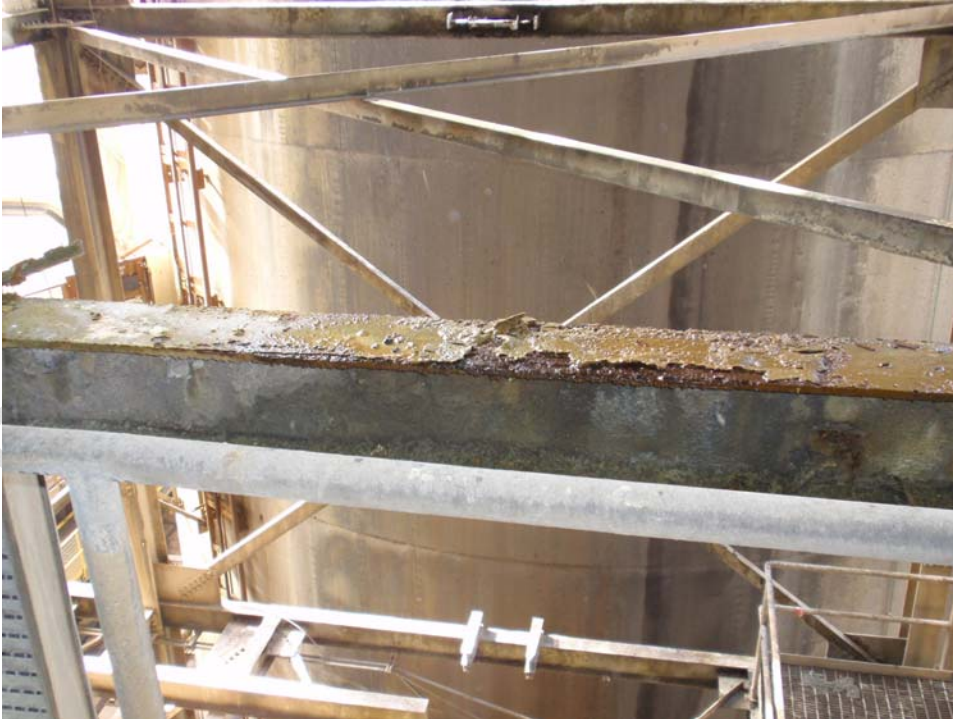
Unit 4 Column Line N about elevation 500

3. Beam on Column Line N between Column 4A and 6B at about elevation 500 where the acidic condensate is dripping. All levels of steel under this drip need to be repaired.

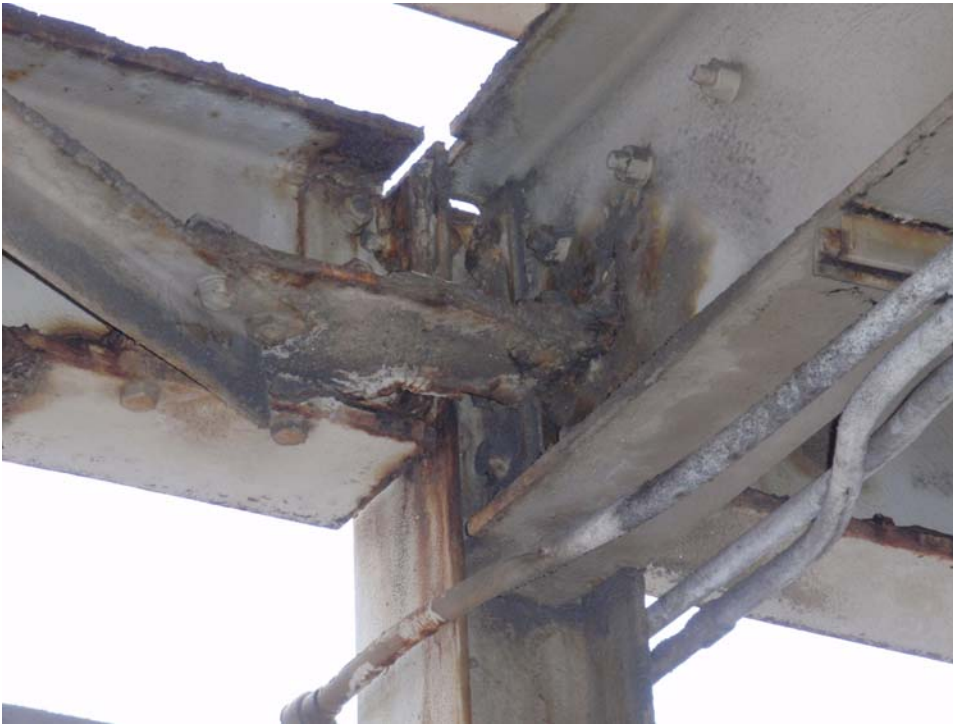
Unit 4

4. The structural steel will need to be cleaned, repaired, and coated in locations where the flue gas is leaking from the duct and acidic condensate is dripping on the steel.

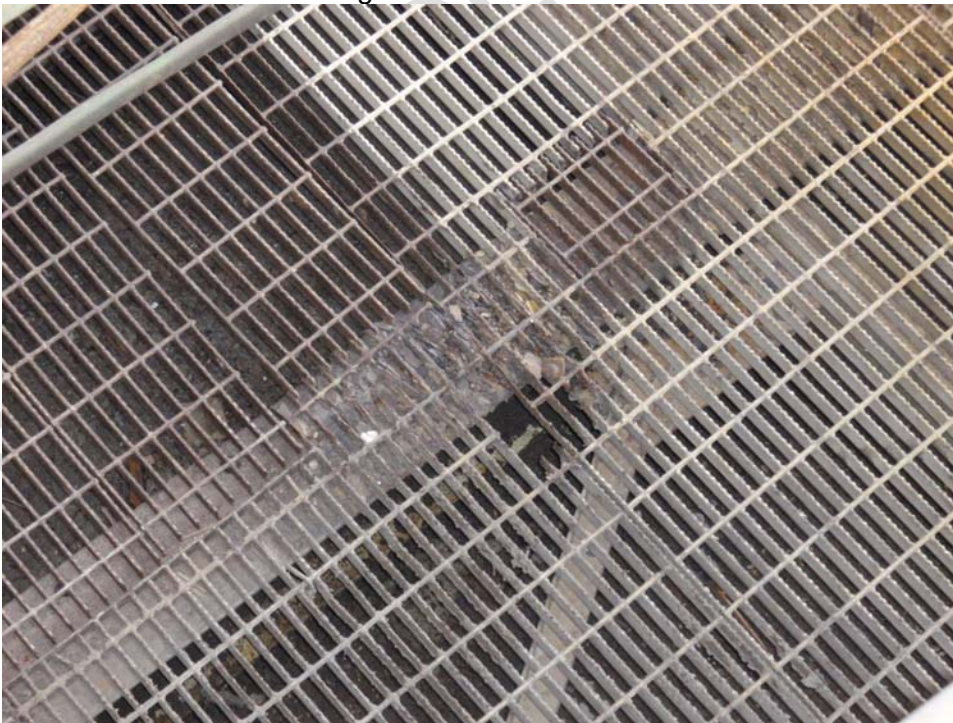
Unit 4 Grating platform

5. The grating above the tank is corroding and will need to be replaced where it is thin and where holes are forming.

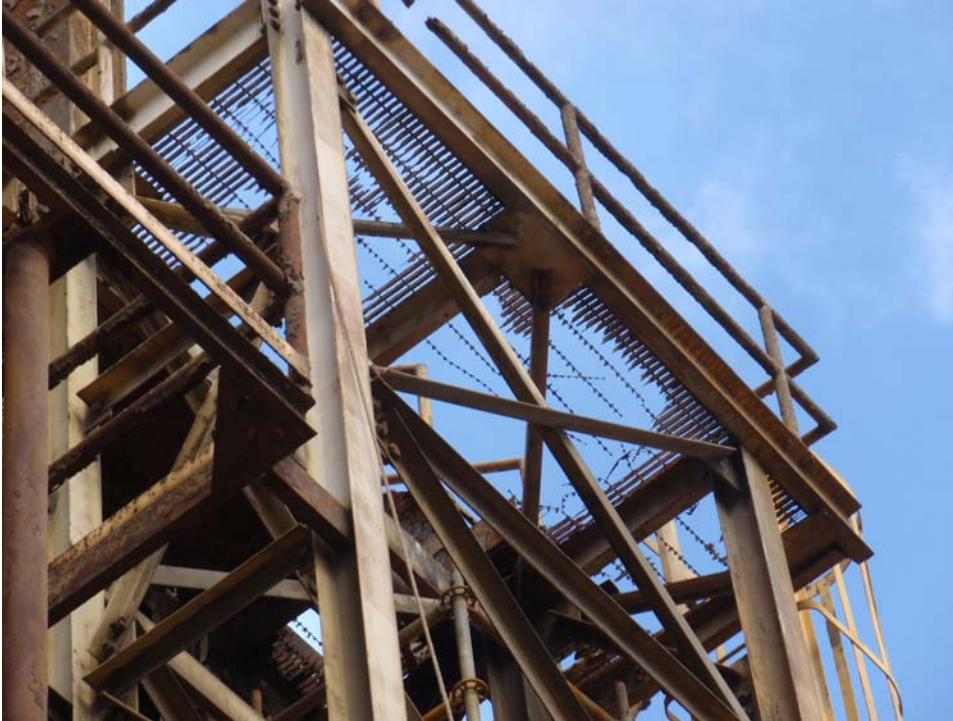
Unit 4 Upper level grating platform.

6. Grating in the upper level platforms can be seen to have holes corroded through.

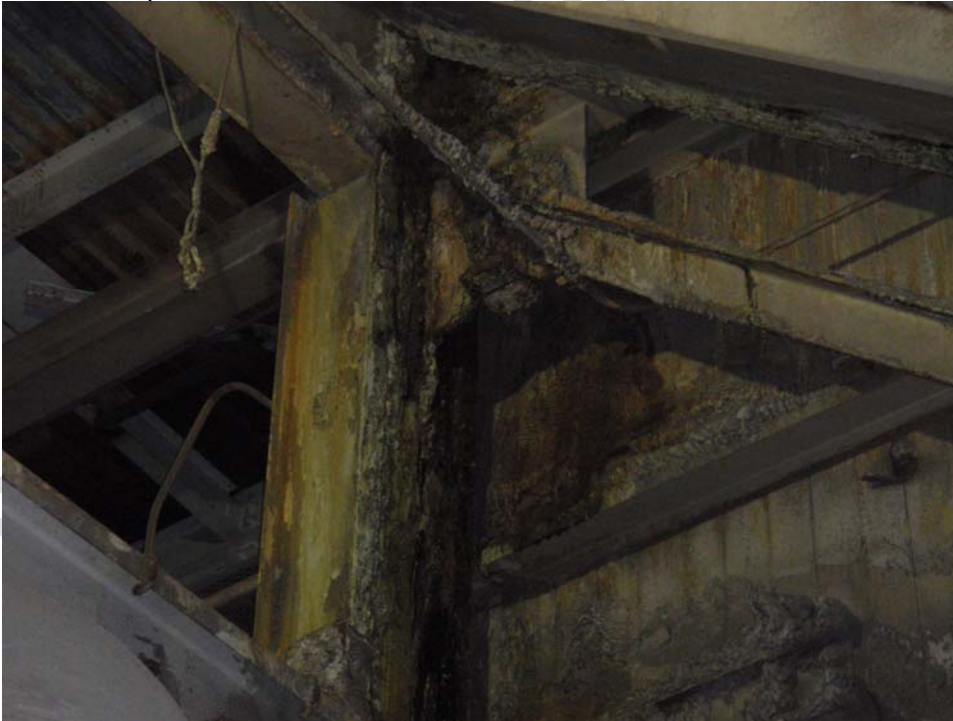
Unit 4 Inside Building are leaking duct.

7. The ductwork is leaking inside the Unit 4 building at the corners. The steel should be cleaned, repaired, and coated.
