Re: Kenergy Corp.
Marion, Ky., office
Application for Certificate of Convenience
and Necessity

TESTIMONY OF TIM SKINNER

**INSPECTION
OF
EXISTING OFFICE / SERVICE FACILITY
KENERGY CORP
MARION, KENTUCKY
703 S. Main Street**

SKINNER EXHIBIT A

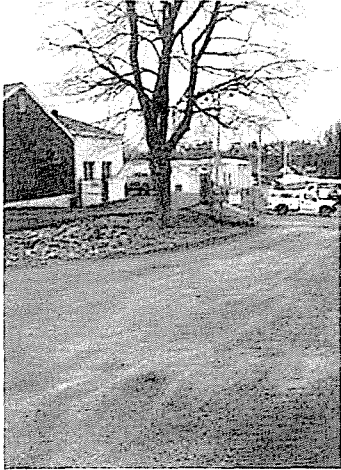
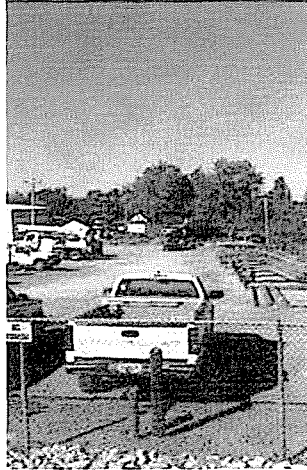
The Marion facility consist of three (3) separate building structures, a pole storage yard, transformer storage areas and associated vehicle parking areas. The entire site is enclosed with chain-link fencing. The site slopes severely from 703 S. Main Street (Main Entry) down to

Moore Avenue (along the rear of the property). This change in elevation causes problems in storm water site drainage onto adjacent properties. With the current site area restrictions, any improvement in material or equipment storage (ex: paved areas or new storage buildings)

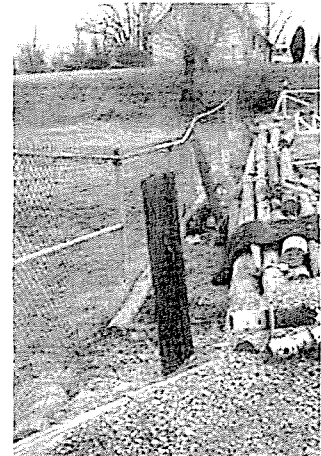
would only exacerbate the storm water drainage conditions. Within the boundaries of the property, most of the various service areas of the facility area are on different elevations, making efficient work operations difficult. Movement of service vehicles is tight and most service vehicles must be stored outside, without cover in inclement weather. This lack of cover for the service vehicles necessitates that field technicians remove snow and ice from truck mounted equipment before they begin service runs. This becomes a

constant safety hazard as well as the inefficient use of service

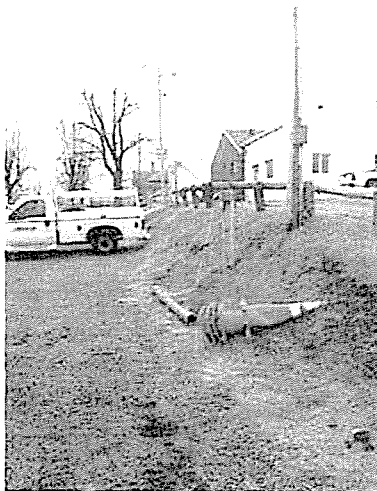
time. This also increases the wear on equipment leading to earlier replacement times. Exterior storage areas for transformers and other service materials are separated due to the lack of proper site space. This lack of proper storage space and site mobility limits the overall efficiency of the complex. The change in site elevations requires the use of retaining barriers requiring ongoing maintenance.

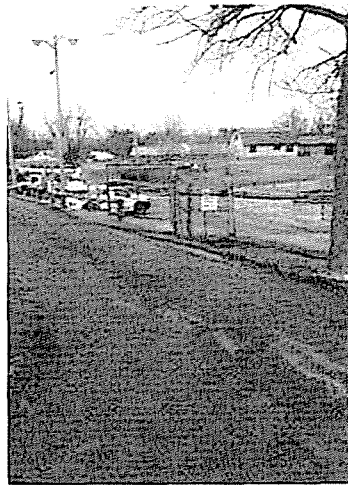
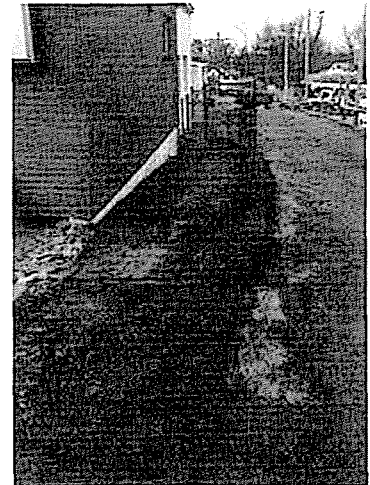
The facility has a serious problem with exterior water infiltration due to building construction problems and the building location. The lower level of the structure has had water in the building on numerous occasions. This water is caused by storm water that enters the building through various locations. Water is

entering thru cracks in the foundation wall system, roof system and under existing doorways. This is due to poor site grading. To correct these issues would require extensive site excavation and re-contouring of the existing grades. Exact repair requirements of the building could not be

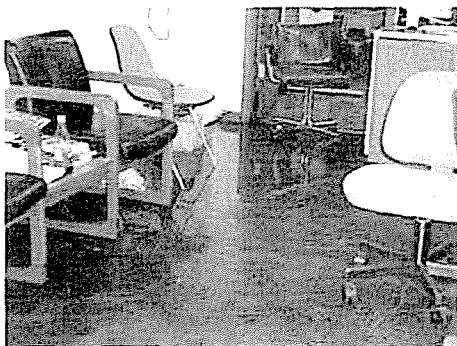
determined until excavation takes place. This water infiltration has caused building deterioration and created some areas that contain active mold and mildew. Remediation of these areas would be required.

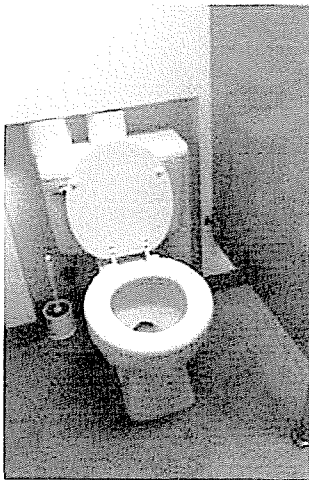
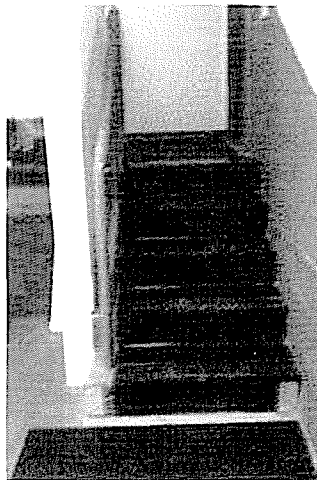
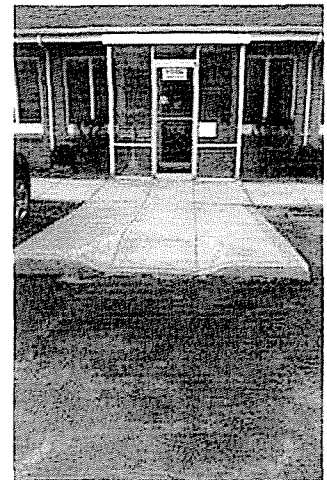
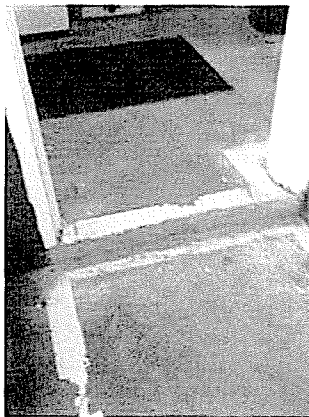
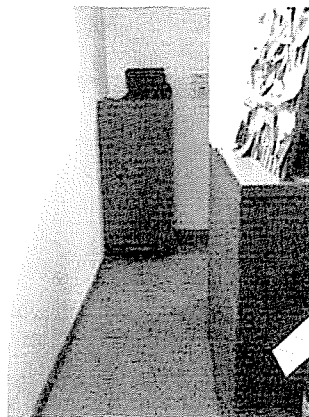
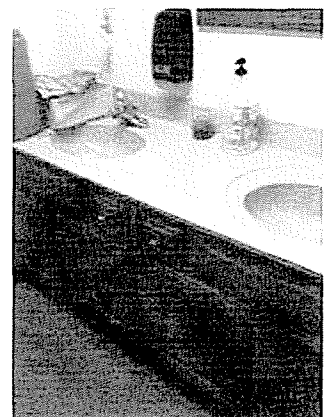
The current facility does not meet current ADA requirements.

- 1.) Door openings are not of adequate width.
All doors must be a minimum of 3'-0" wide
- 2.) The door hardware does not meet ADA requirements. All door hardware must be operable without having to grasp handle. Lever handles are required.
- 3.) The existing restroom facilities do not meet accessibility standards. The size and required approaches to fixtures will not meet federal requirements.
- 4.) There are different floor levels that are not accessible. There are no means of traversing these level changes. (ex: elevators or lifts)
- 5.) Existing hallway clearances do not meet ADA requirements.
- 6.) Existing building entry curb cut and disabled parking areas do not meet required standards.

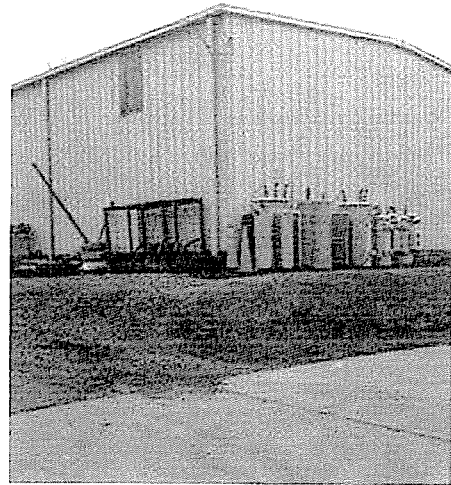
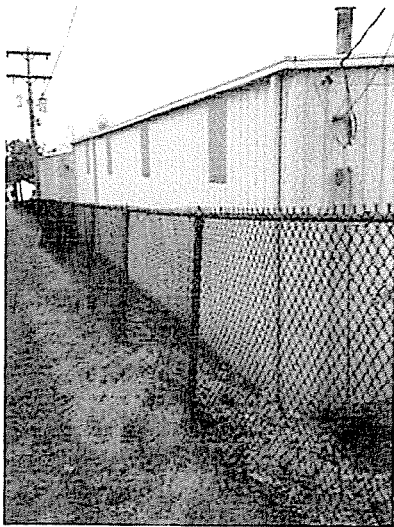
There are two (2) pre-engineered metal service buildings located on the site. These buildings are on different floor elevations from the main office buildings and on different elevations from each other. One building is approximately 3,200 sq. ft. and the other facility is 2,400 sq. ft. They are primarily used for material storage and equipment maintenance. These areas which provide for the protection of service vehicles are inadequate.

This causes services crews to spend time removing snow and ice from the equipment of the vehicles before leaving to begin field operations. The buildings appear to be in good shape structurally. However due to the change in site grade the efficiency of operations is compromised.

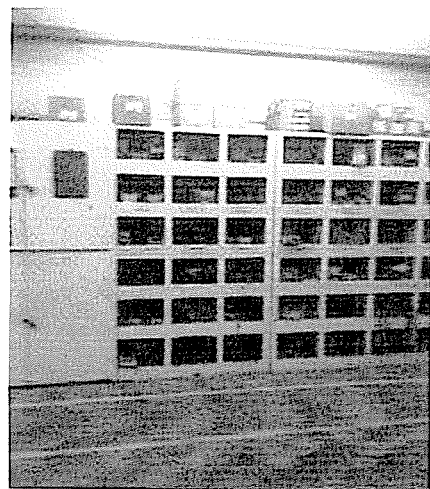
While some of the storage racking system is adequate, other storage systems have been built over the years by Kenergy personnel and need to be updated. Material storage areas would function better if housed in a single structure instead of various buildings around the site. This would allow for increased inventory control and security.

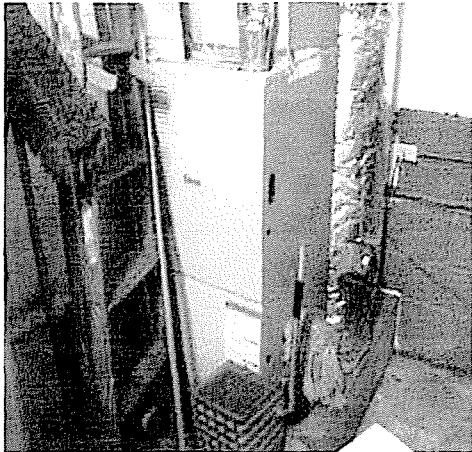
The split system does not meet building code requirements. The return air plenum box is wood (this is a natural gas unit) attaching at the bottom of the furnace which places wood material in very close proximity to open flames inside of the furnace. There is no dedicated outside combustion air intake as required for commercial HVAC systems. The combustion air is pulled from the

interior space. This would be fine if the unit was located in the maintenance garage area but the unit is located in a make-shift closet/office area with no direct access to outside air.

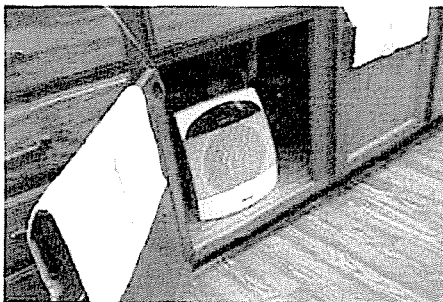
The unit's flue piping is installed incorrectly and allows rain water to drain back into the furnace causing both rusting of the furnace and build-up of mold (visible mold was found at the base of the unit and inside of the unit). The natural gas piping is not installed in compliance with NFPA 54 (fuel gas code). The area around the furnace is used for storage; materials stored are of combustible composition. There was not any outside fresh

air intake duct system found for the HVAC unit as required by code. There are several electric unit heaters (installed in wall as part of the building and individual personnel units) that are used to augment heating. The individual units pose potential fire hazards

when left un-attended. The electric unit heaters in connection with the portable fans indicate under sizing of the HVAC system and poor air distribution.

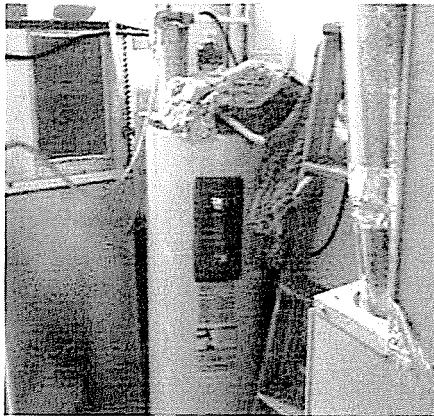
The hot water heater is under sized and is improperly installed. It is very difficult to

work on the unit and the material stored on and around the unit poses a hazard. The hot water system piping distribution system (as with the cold water piping distribution system) is without any insulation. The piping systems often freeze during the winter months. The ice maker/storage unit is improperly installed too close to the hot water heating unit.

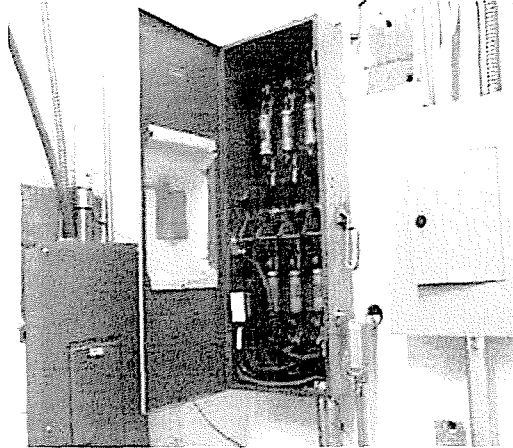
The electrical system is a complete hodge-podge of electrical installation from the early 1950's to the present, almost none of which meets code. The facility is served with power from both Kentucky Utility and Kenergy terminating in a combined, fused master

disconnect. The power supply originally was attached to the exterior of the building, but was later incorporated into the interior of the building when the maintenance garage was added. The power is distributed from the master disconnect to a series of panels and sub-panels located throughout the facility. Many of the panels and sub-panels were found open and all sorts of combustibile material around the

panels were observed. Some panels had cut-off conduit and conductors exposed and not capped/sealed as required by code. Several panels had unmarked breakers.

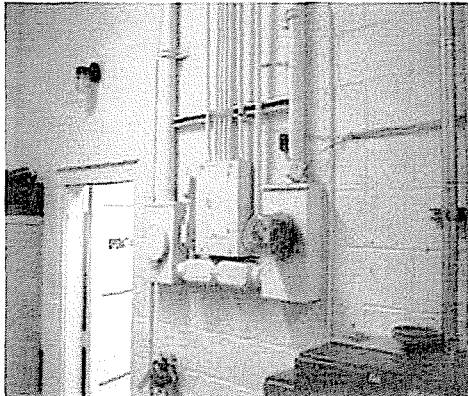
The office/maintenance building is lacking in wall receptacles, causing office personnel to use numerous extension cords. These cords are taxing the breakers and panels and

creating trip hazards and potential fire hazards due to electrical overheating. Some of the wall receptacles have been and continue to be compromised when heavy rain water backs up into the building and in the walls. Additionally, the lack of proper power distribution for the office equipment and computers has and does cause interruption and computer failure.

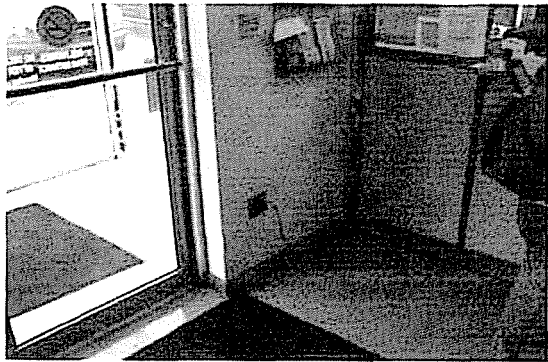
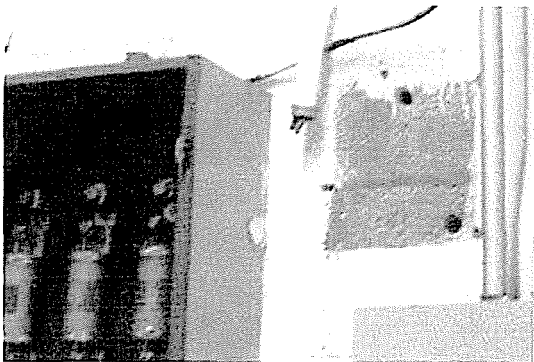
The electrical systems need to be completely removed and installed in compliance with current electrical codes. Much of the facility's electrical systems were done under what is loosely known as the "grandfather clause". The electrical system is literally held together with tape and wire.
