**SECOND SUPPLEMENT TO ANSWERS OF BULLITT UTILITIES INC., TO THE
ATTORNEY GENERAL'S SECOND REQUEST FOR INFORMATION**

**SUBJECT: Hunters Hollow Treatment Plant
Field Inspection for Steel Tank
Bullitt County, Kentucky**

**SUBJECT: Hunters Hollow Treatment Plant
Field Inspection & Analysis for Structural Slab/Foundation
Bullitt County, Kentucky**

**SUBJECT: Hunters Hollow Treatment Plant
 Addendum for Field Inspection & Analysis for
 Structural Slab/Foundation
 Bullitt County, Kentucky**

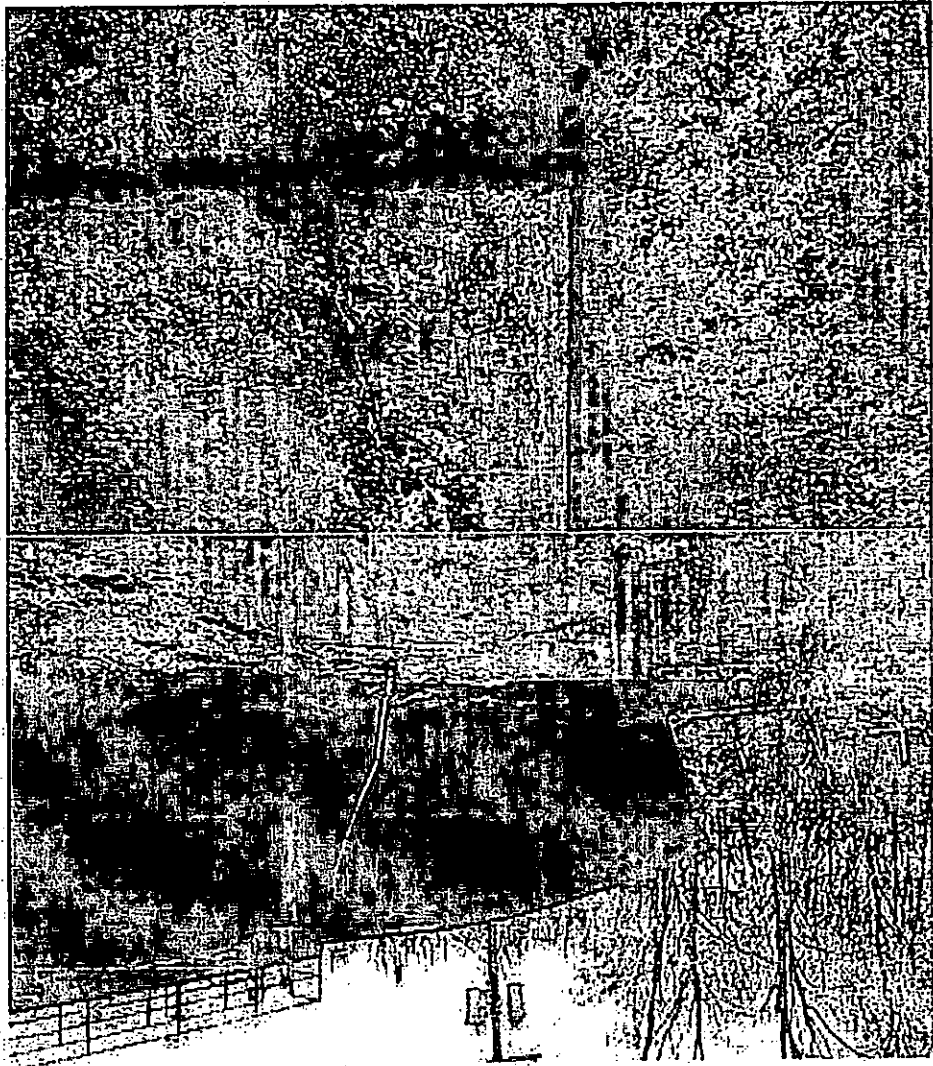
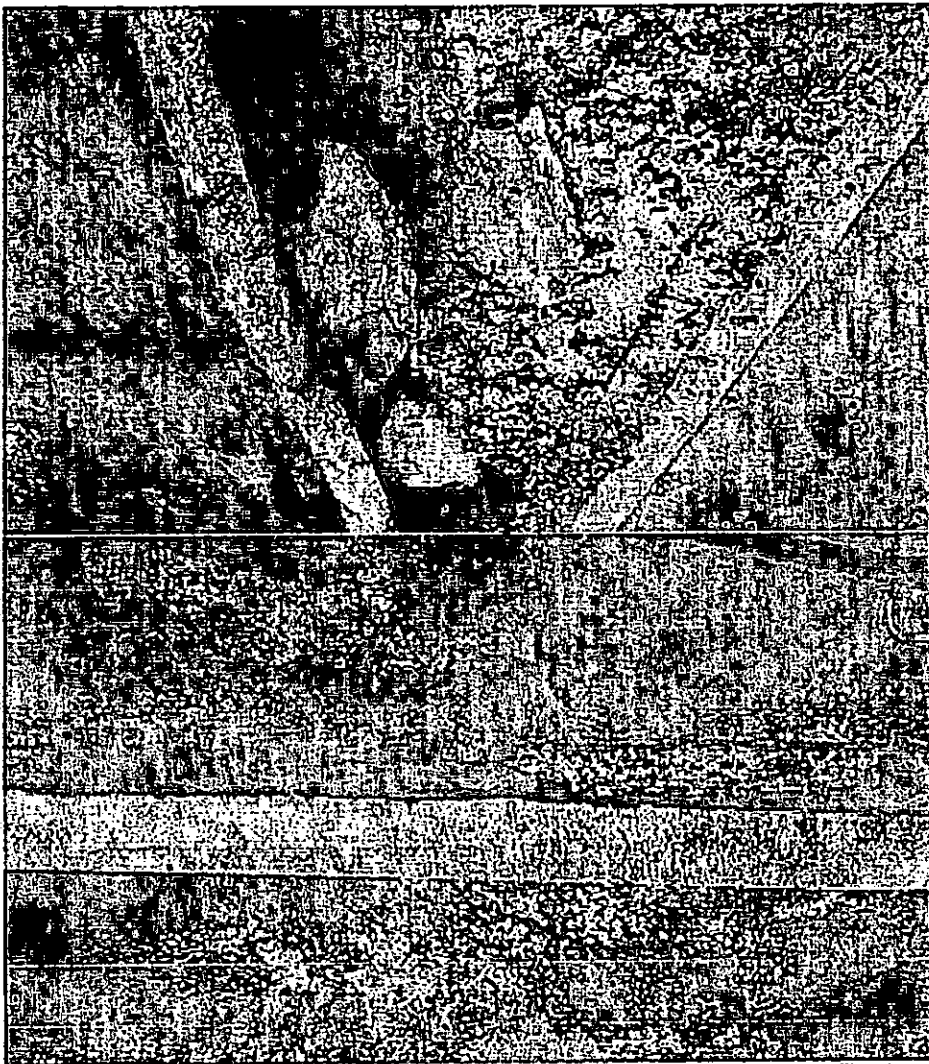
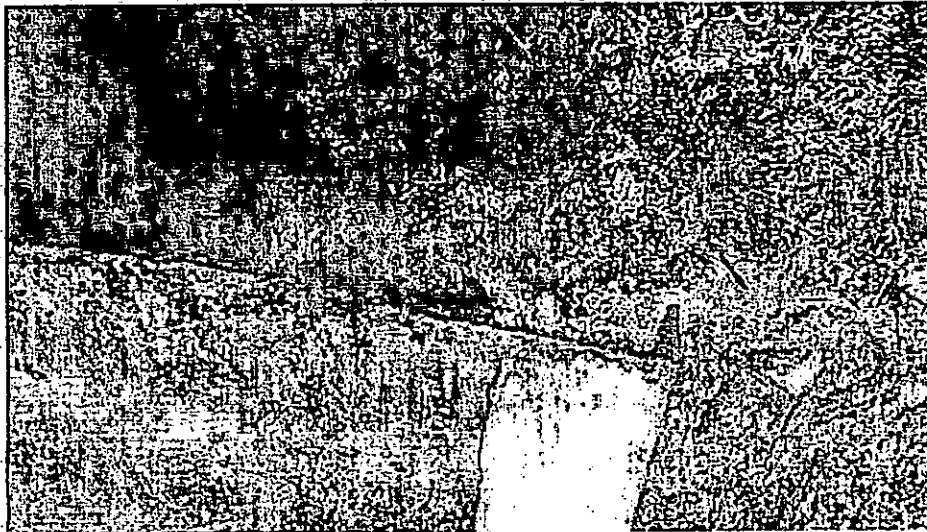
Inspection of the existing welds did not identify that structural tank failure occurred at these weld joints, as can be seen in the attached photographs. The steel tank pieces were welded to a piece of 8" channel to join the tank that was originally set in a concrete foundation about 4" deep (on the channel). These steel tank pieces and channel were observed to have been ripped out of the concrete foundation of the tank. Additionally, large chunks of concrete foundation were scattered about the site and around the steel tank pieces that had been stacked.

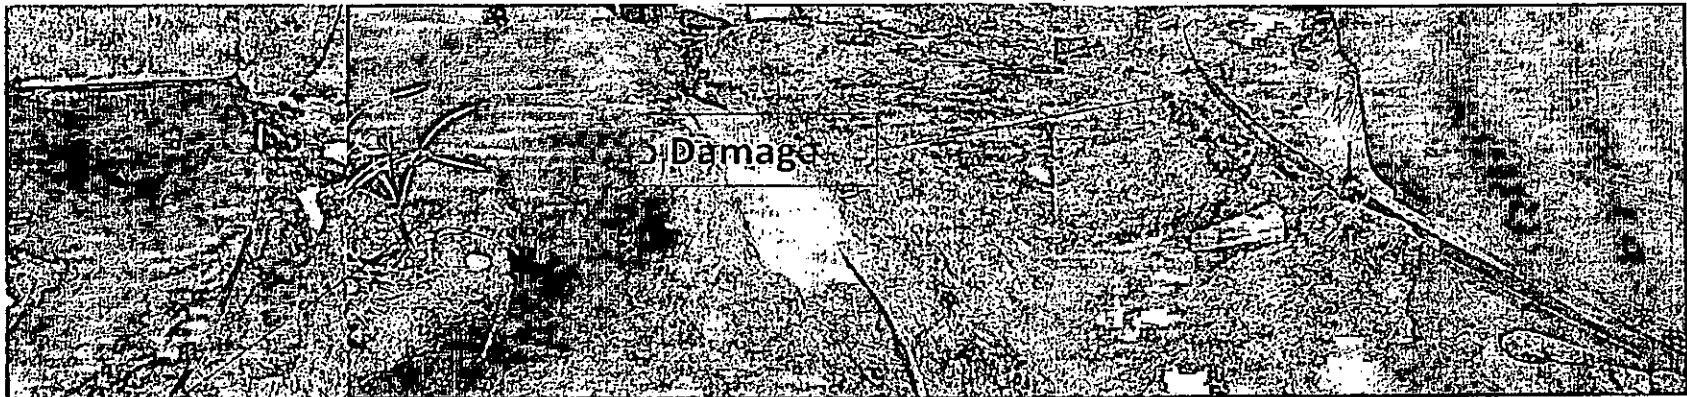
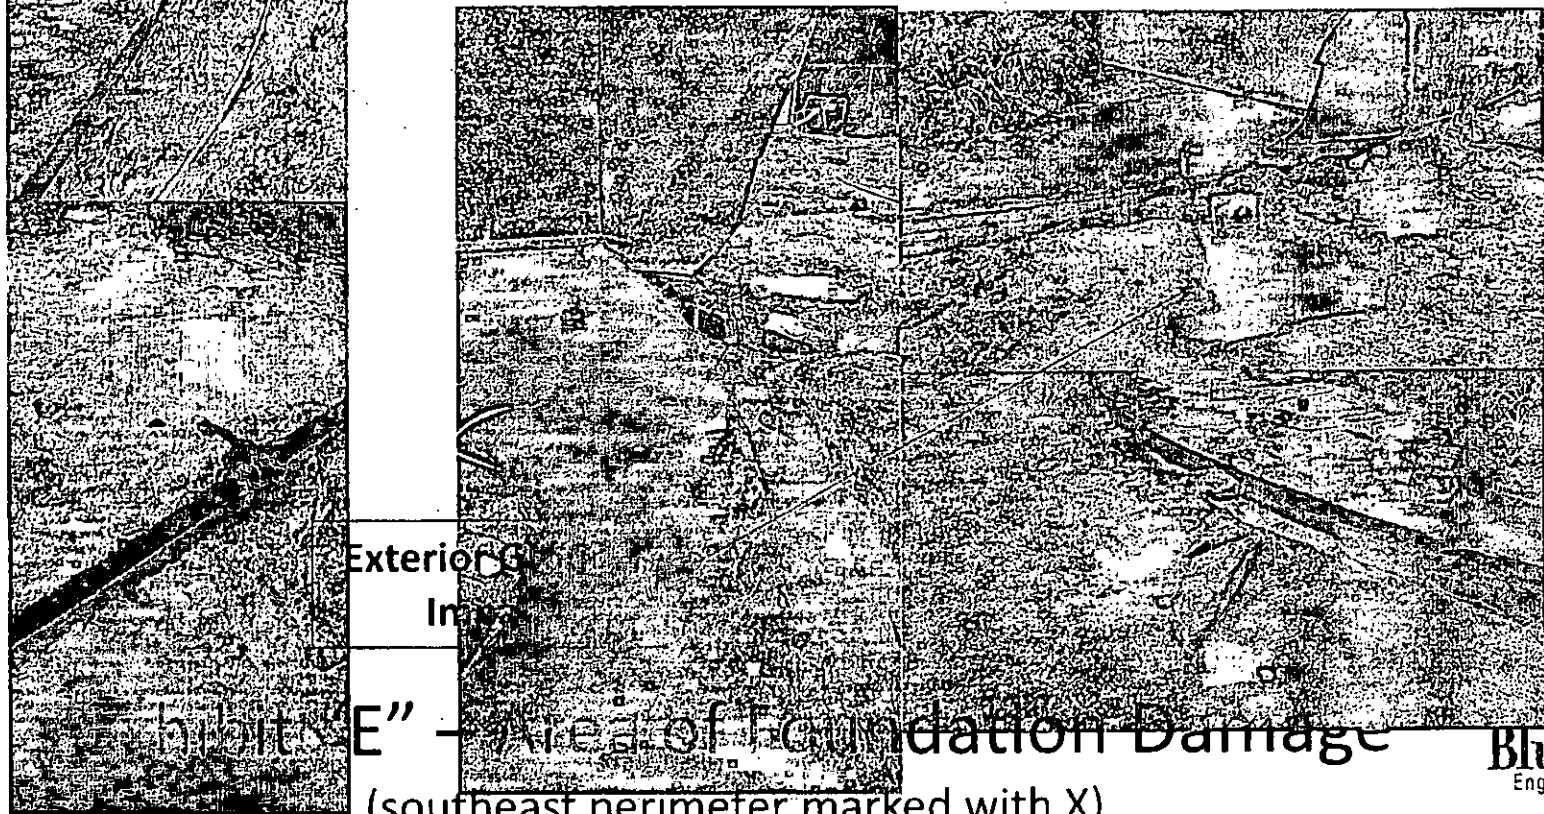
The most notable area of damage is shown in the southeast quadrant of the tankage -- this area looks to have received the most damage along the exterior foundation as compared to rest of the perimeter foundation -- this can be seen in Exhibit "E".

Exterior Ground Inspection
"Exhibit E" - Area of Foundation Damage
(southeast perimeter marked with X)

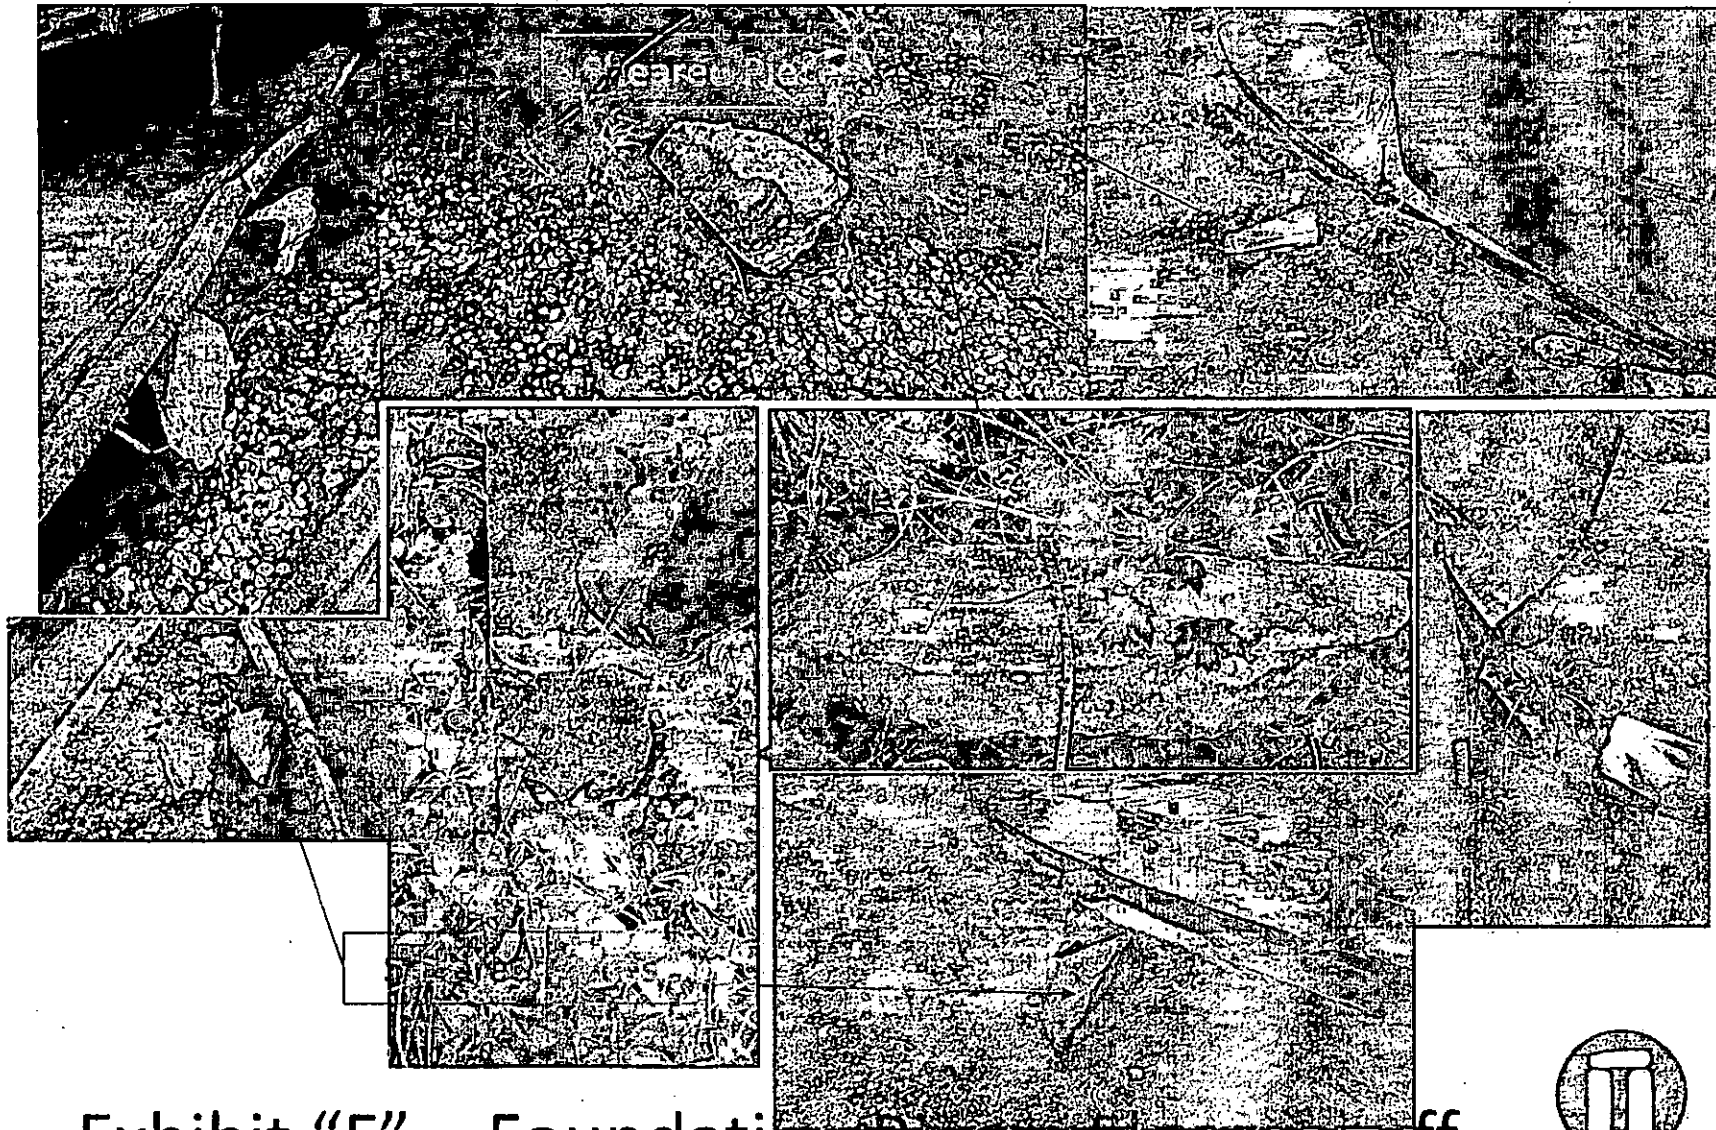
Most important to note is that none of the exterior portion of the concrete foundation that held the steel channel in place includes structural steel reinforcement. Upon failure of the tank and foundation, when the steel channel was pulled from the foundation, these exterior pieces of concrete slab separated into typical 3' and smaller sections that are scattered around the site. Examples of some of these exterior foundation slab pieces are shown in Exhibit "F". These exterior slab pieces were found as far as 100 feet away from the tank foundation site.

Exhibit "F" – Foundation Pieces Sheared off
(no steel reinforcement)

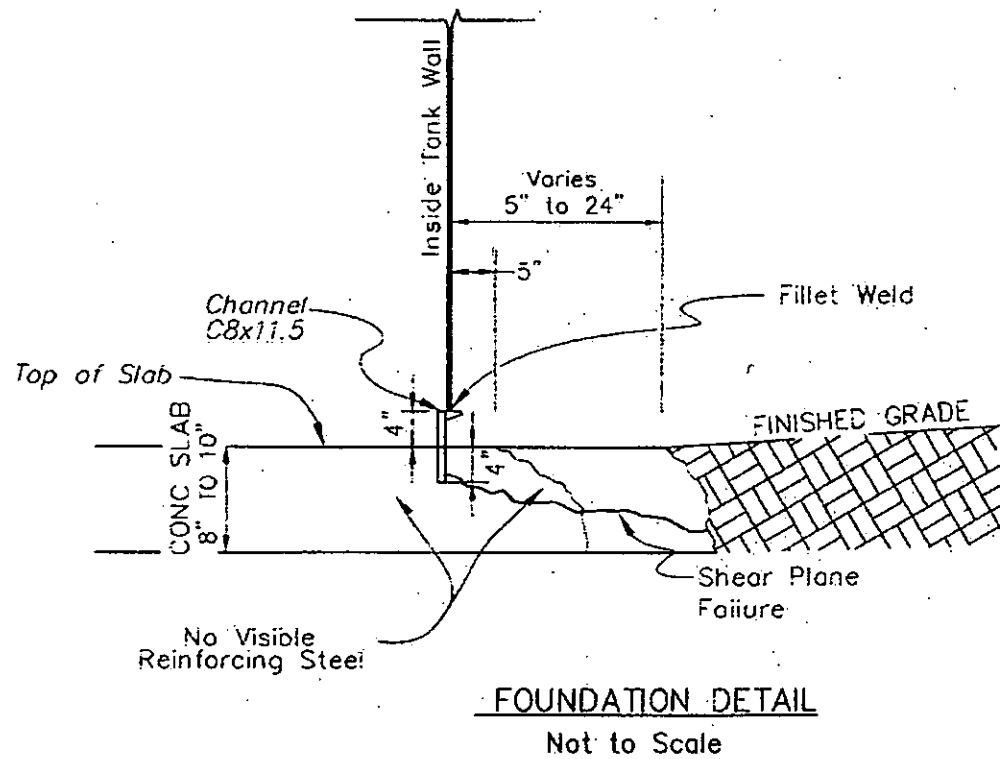
From inspection of the interior slab condition (very good), as well as inspection of the exterior of the foundation section (pieces that have broken off from the foundation and are scattered about the site) this is indicative of a shear failure of the concrete foundation between the interior and exterior sections of the foundation where the steel channel was installed, see Exhibit "G" for typical detail. Since the exterior portion of the concrete foundation did not include any additional steel reinforcement, the section of foundation from the steel channel outward separated along the shear plane and pulled free from the interior foundation and slab during the failure of the plant. Most likely this occurred at the exterior foundation's weakest point along the perimeter, which from the review of the perimeter damage seems to be at location "X" as seen in Exhibit "A" and "B", and as shown on Exhibit "E". Pictures of the exterior foundation pieces showing the shear plane are shown on Exhibit "F".

Exhibit "G" – Foundation Section
(shear plane failure)
