APPLICATION OF BULLITT UTILITIES, INC.)
FOR A CERTIFICATE OF CONVENIENCE AND) CASE NO 2014-00255
NECESSITY AND SURCHARGE FOR SAME)

PRE-FILED TESTIMONY OF CHRIS CRUMPTON

SUBJECT: Hunters Hollow Treatment Plant
Field Inspection for Steel Tank
Bullitt County, Kentucky

SUBJECT: Hunters Hollow Treatment Plant
Field Inspection & Analysis for Structural Slab/Foundation
Bullitt County, Kentucky

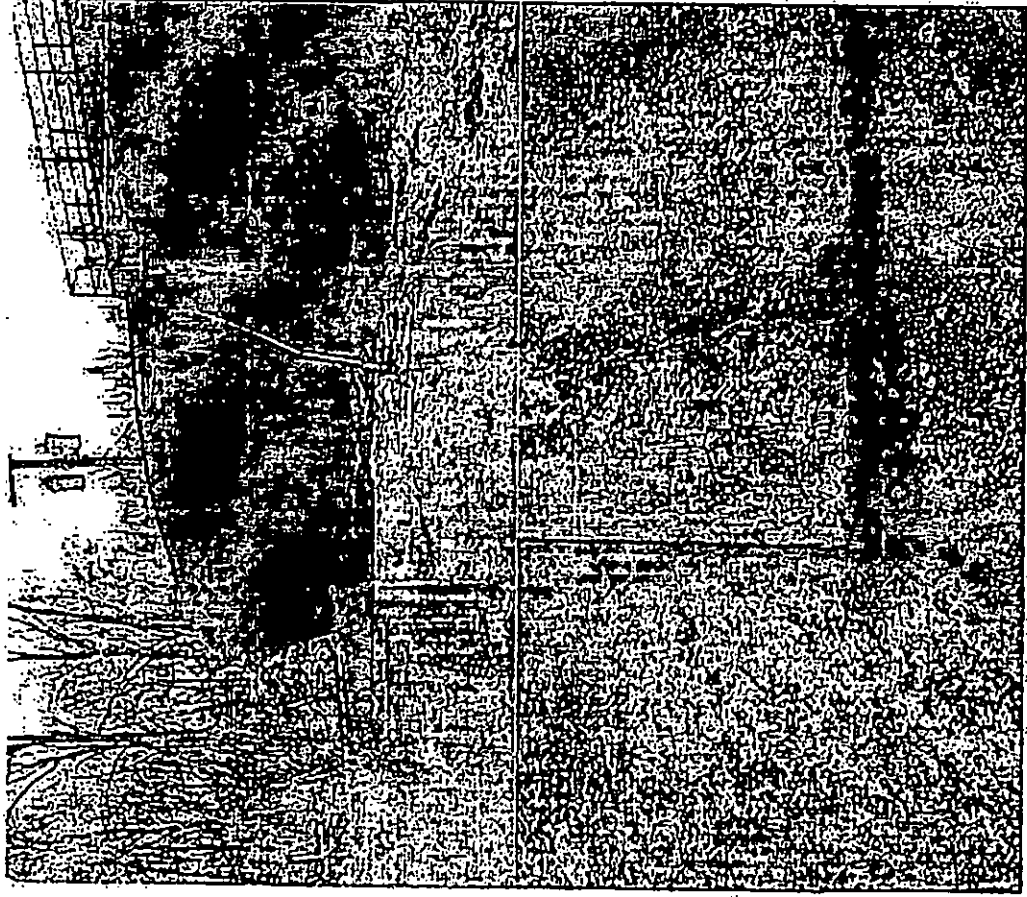
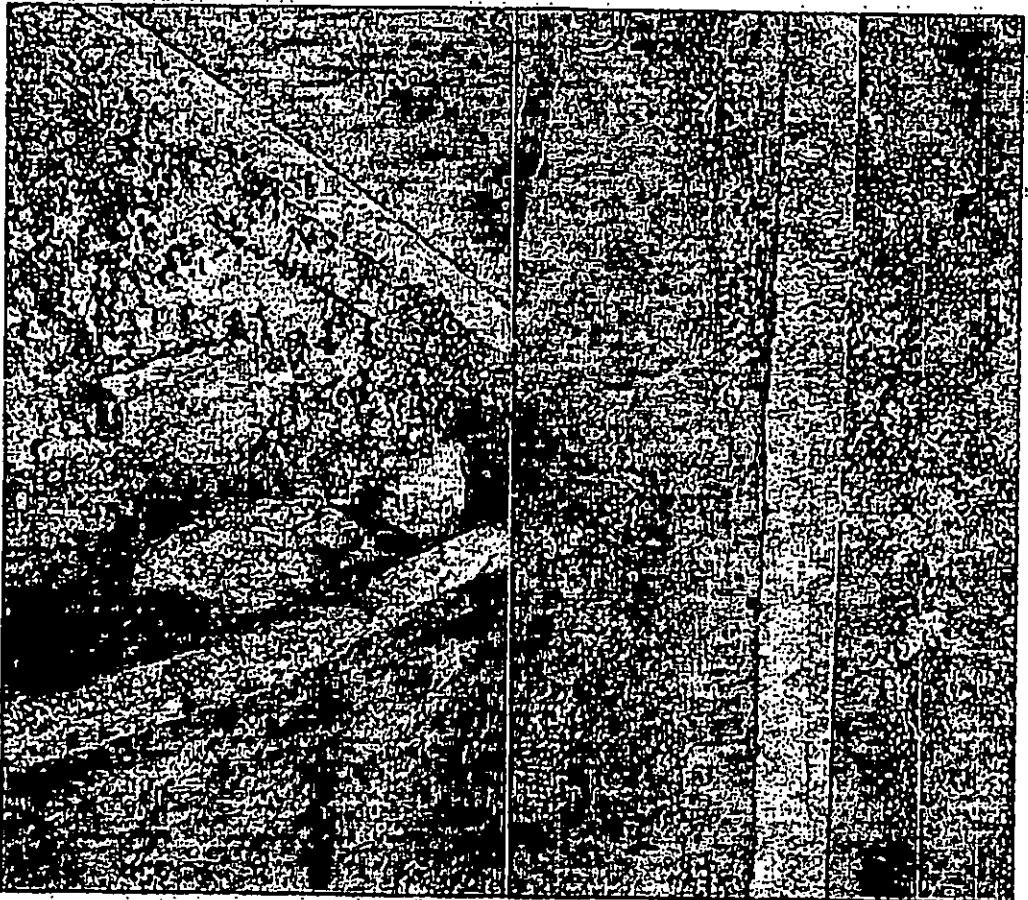
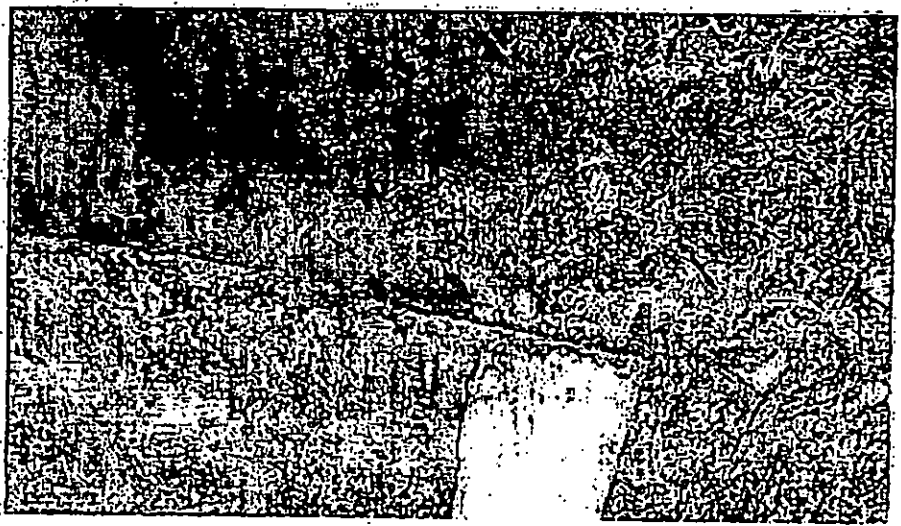
Inspection of the existing welds did not identify that structural tank failure occurred at these weld joints, as can be seen in the attached photographs. The steel tank pieces were welded to a piece of 8" channel to join the tank that was originally set in a concrete foundation about 4" deep (on the channel). These steel tank pieces and channel were observed to have been ripped out of the concrete foundation of the tank. Additionally, large chunks of concrete foundation were scattered about the site and around the steel tank pieces that had been stacked.

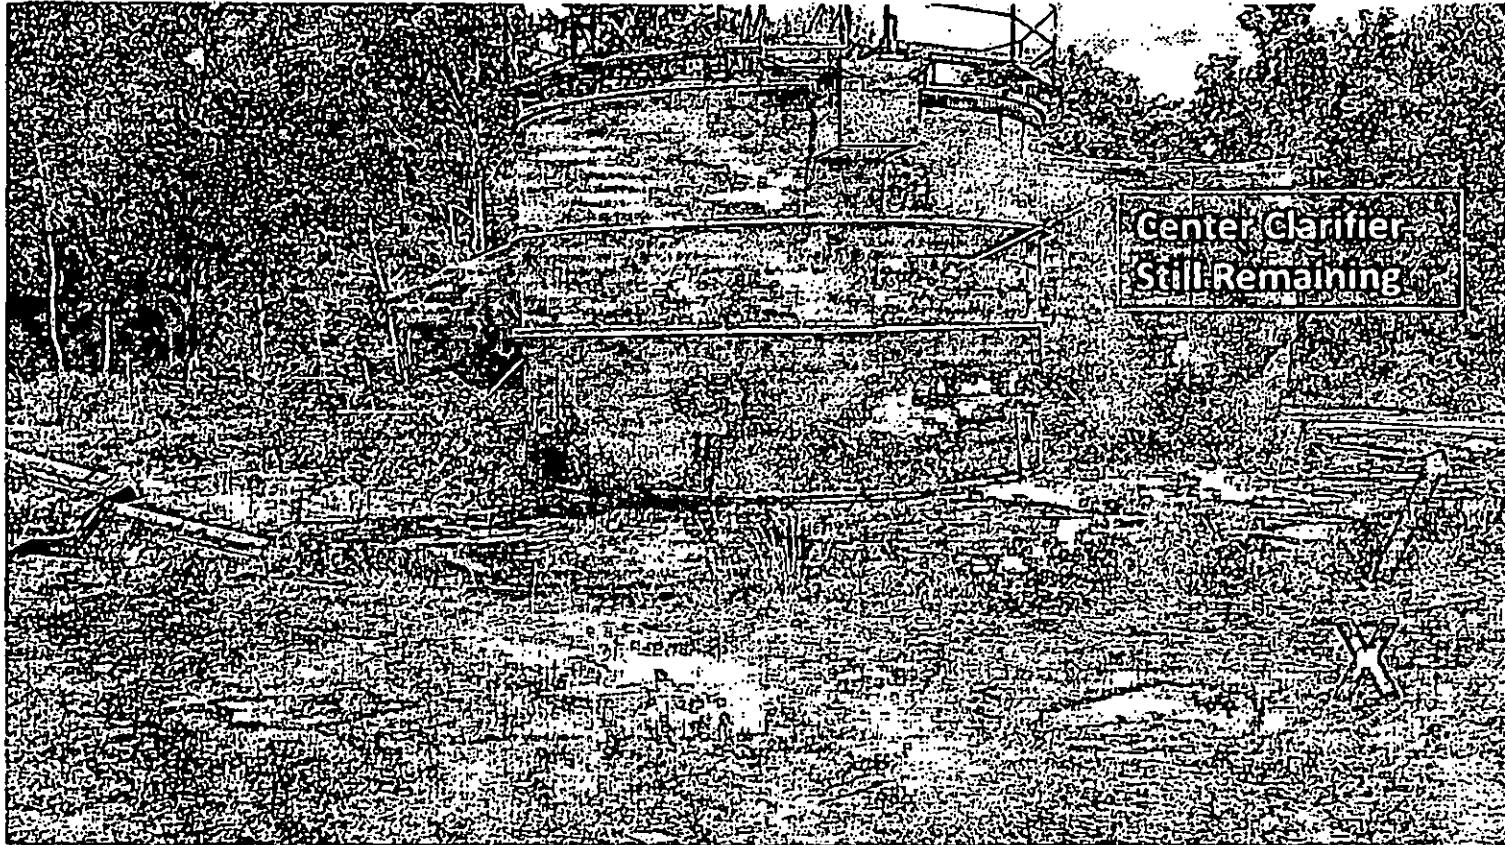
Exhibit "B" – Interior Concrete Slab
(looking East)

The field review noted that the "interior" concrete slab was actually in very good condition and did not show signs cracking or settlement (Exhibit "B"). A concrete scan was not performed, but the interior slab should have steel reinforcement that held the slab in place during the failure of the tank. While not all of the slab was visible due to some portions still remaining covered with sludge material and/or the remaining section of reinforced mixing tank/stairs and clarifier, Exhibit "C" shows the areas that were cleared and visible, mostly on the west side to the south and southeast (a majority of the slab that existed under the area of the aeration tank that failed).

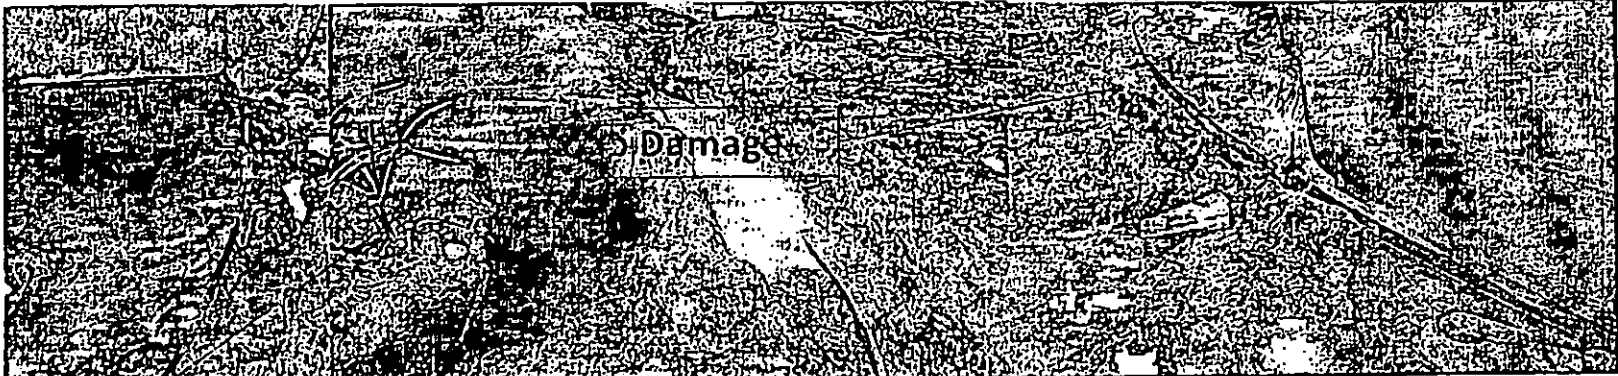
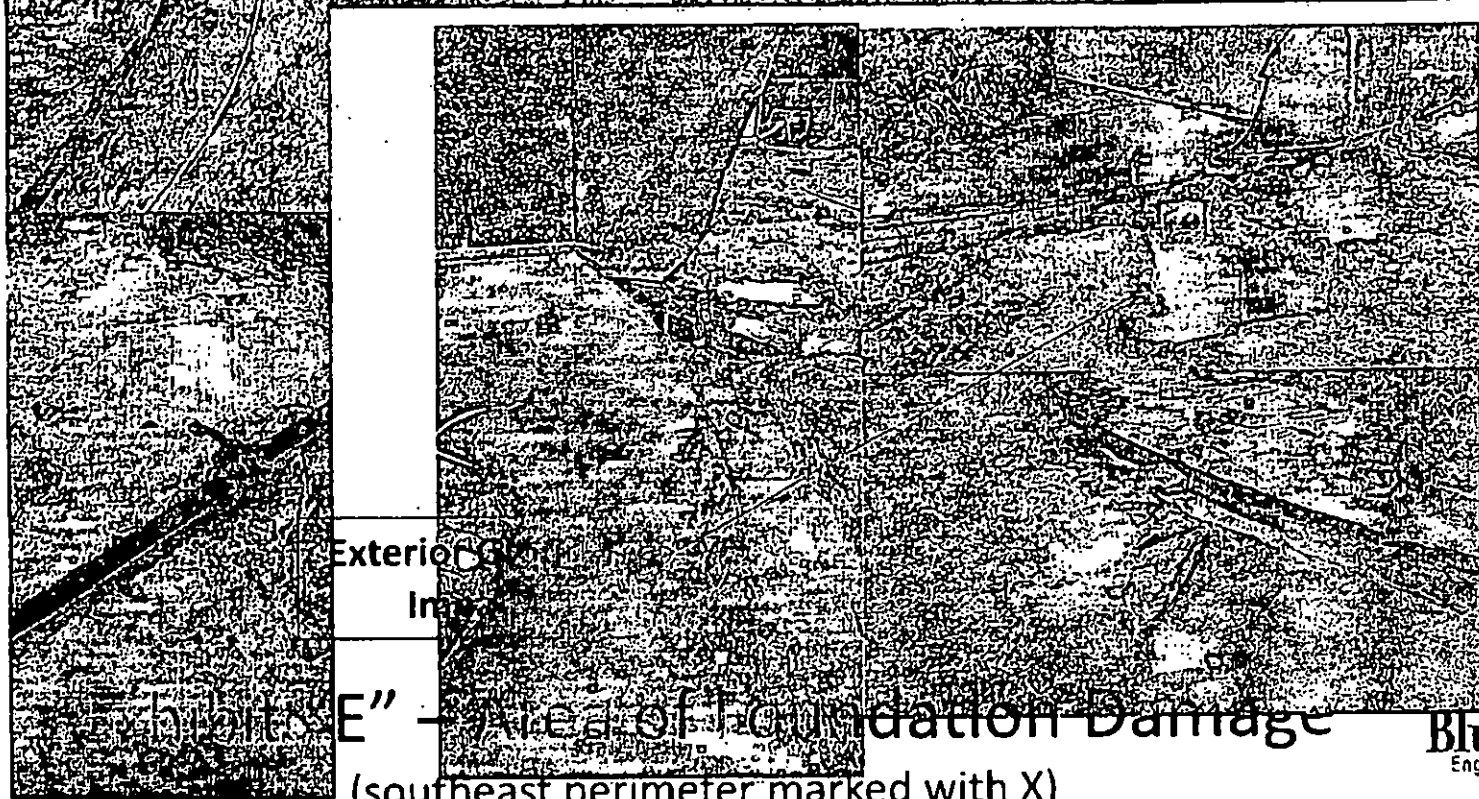
Exhibit "E" - Area of Foundation Damage
(southeast perimeter marked with X)

The most notable area of damage is shown in the southeast quadrant of the tankage – this area looks to have received the most damage along the exterior foundation as compared to rest of the perimeter foundation – this can be seen in Exhibit "E".

From inspection of the interior slab condition (very good), as well as inspection of the exterior of the foundation section (pieces that have broken off from the foundation and are scattered about the site) this is indicative of a shear failure of the concrete foundation between the interior and exterior sections of the foundation where the steel channel was installed, see Exhibit "G" for typical detail. Since the exterior portion of the concrete foundation did not include any additional steel reinforcement, the section of foundation from the steel channel outward separated along the shear plane and pulled free from the interior foundation and slab during the failure of the plant. Most likely this occurred at the exterior foundation's weakest point along the perimeter, which from the review of the perimeter damage seems to be at location "X" as seen in Exhibit "A" and "B", and as shown on Exhibit "E". Pictures of the exterior foundation pieces showing the shear plane are shown on Exhibit "F".

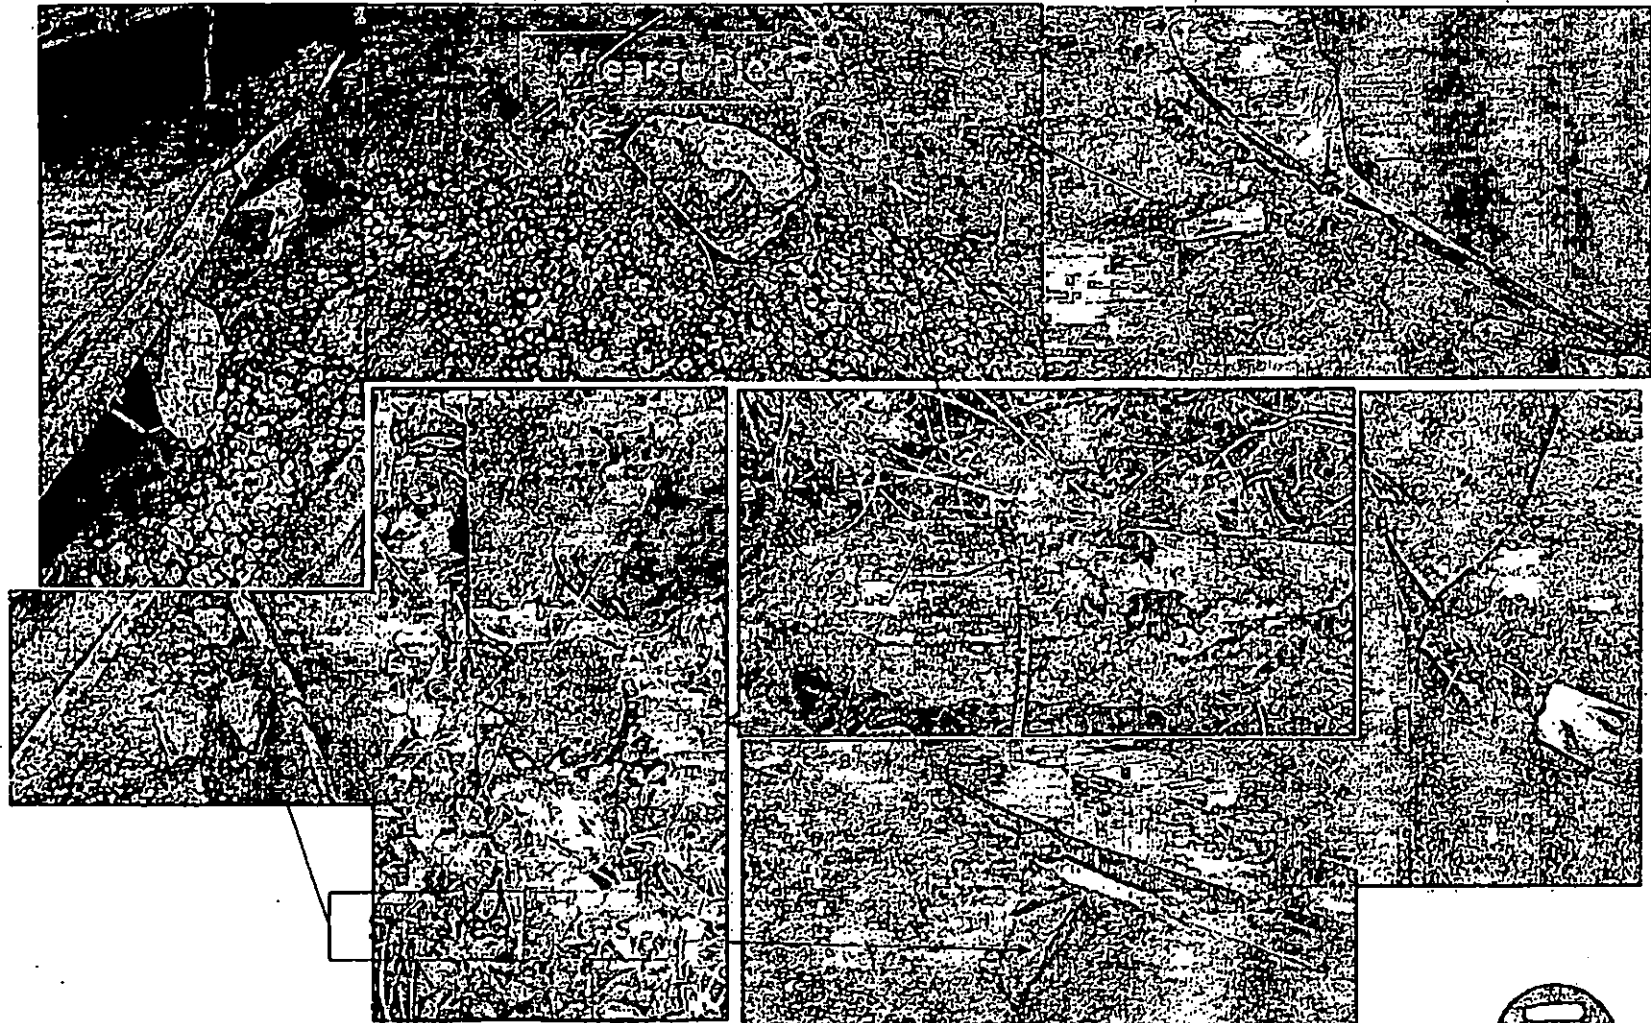
Exhibit "F" – Foundation Pieces Sheared off
(no steel reinforcement)

Most important to note is that none of the exterior portion of the concrete foundation that held the steel channel in place includes structural steel reinforcement. Upon failure of the tank and foundation, when the steel channel was pulled from the foundation, these exterior pieces of concrete slab separated into typical 3' and smaller sections that are scattered around the site. Examples of some of these exterior foundation slab pieces are shown in Exhibit "F". These exterior slab pieces were found as far as 100 feet away from the tank foundation site.

2. The exterior portion of the concrete foundation did not include steel reinforcement to account for "tension" force created by the channel pulling out of the foundation. Thus, the many pieces of concrete foundation that separated from the tank foundation demonstrate this smooth "shear plane" on their interior side.
3. The interior slab looks to be in excellent condition

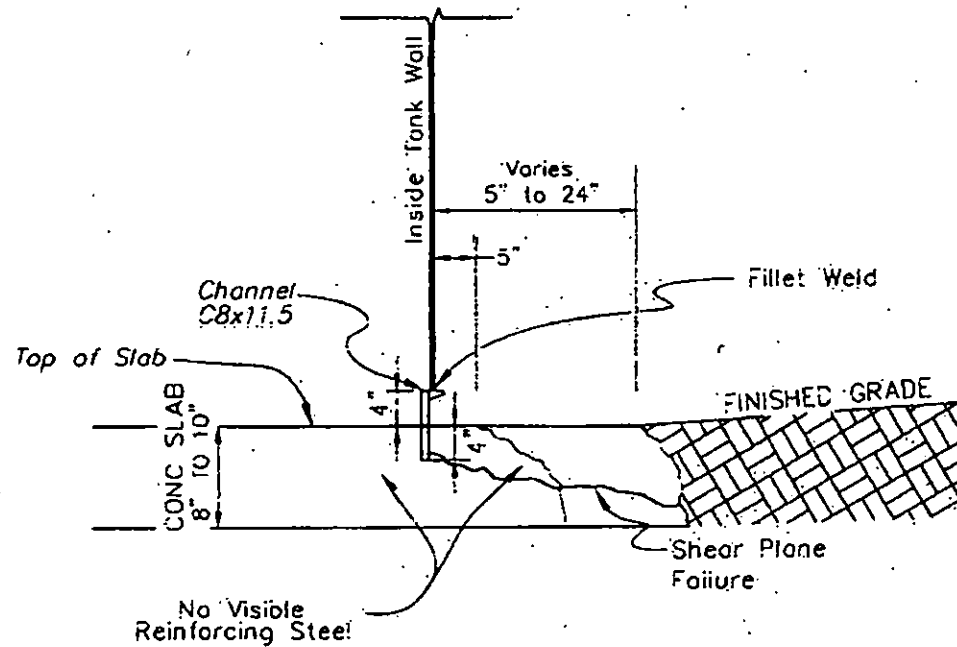
Exhibit "G" – Foundation Section

(shear plane failure)
