KENTUCKY POWER COMPANY RESPONSE TO
ATTORNEY GENERAL'S INITIAL SET OF DATA REQUESTS

Reference Application at page 1, paragraph 1, and at page 4, paragraphs 11-13, which Reference the sustained forced outage of the barge unloader at the Mitchell generating station, which “lasted approximately six weeks” and was the result of a broken head shaft. Please provide copies of the following:

Field Service Report Form
QSF FS 801

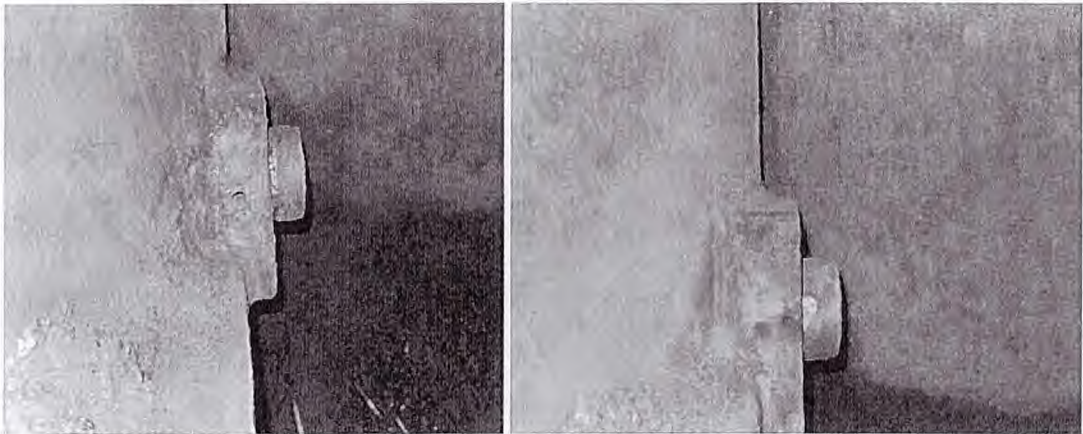
4. Reviewed the bucket pins which were originally installed on contract 6014 Drawing 6014-3-0202. The pin which is installed on the buckets is not the same. Asked Paul Deynman to review the contact and see when the pins were changed to the new style. Photo show the inside of the pin is smooth with set screw and keeper pin whereas drawing 0202 show the inside section of the pin is threaded.

BUCKET CONNECTION PIN PHOTO INSIDE THE BUCKET NOTE THE SET SCREW AND COTTER PIN.

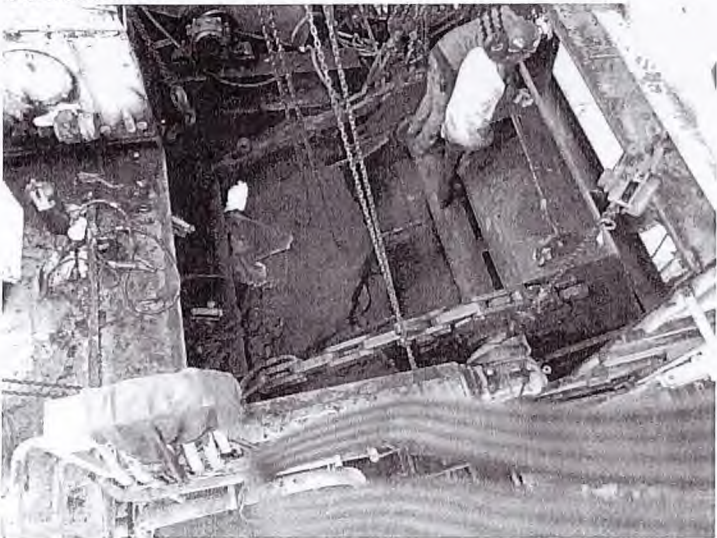
CREW REMOVING A BUCKET PLEASE NOTE THE DETERIORATED TOP PLATE.

7. I would highly recommend a complete new chain be purchased for the outage next year and the chain be replaced. Maintenance should ask for another 2 buckets, which would place 6 in stock. Each year replace 6 buckets and have the buckets repaired. The unloader has a total of 32 buckets.

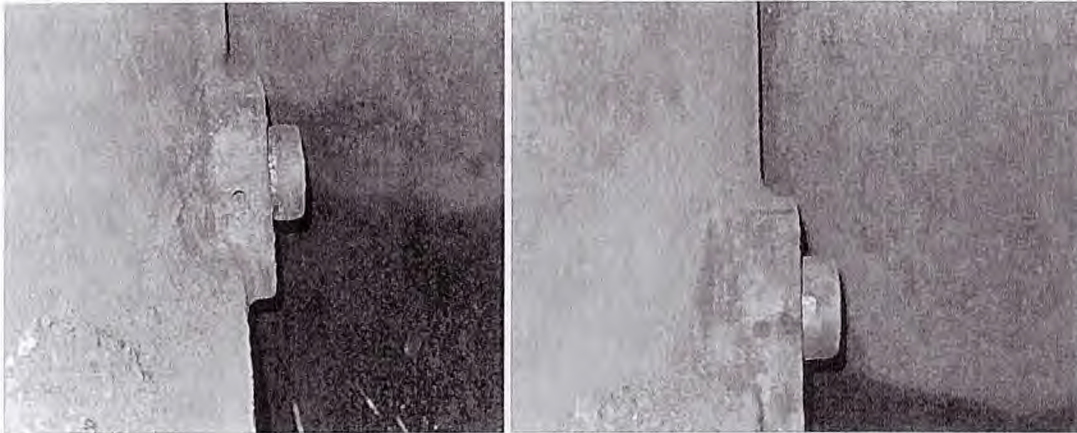
BUCKET CONNECTION PIN PHOTO INSIDE THE BUCKET NOTE THE SET SCREW AND COTTER PIN.

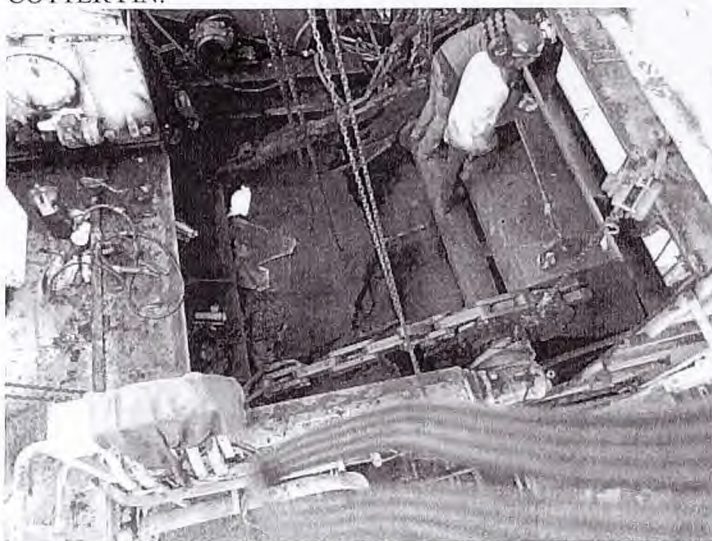
CREW REMOVING A BUCKET PLEASE NOTE THE DETERIORATED TOP PLATE.

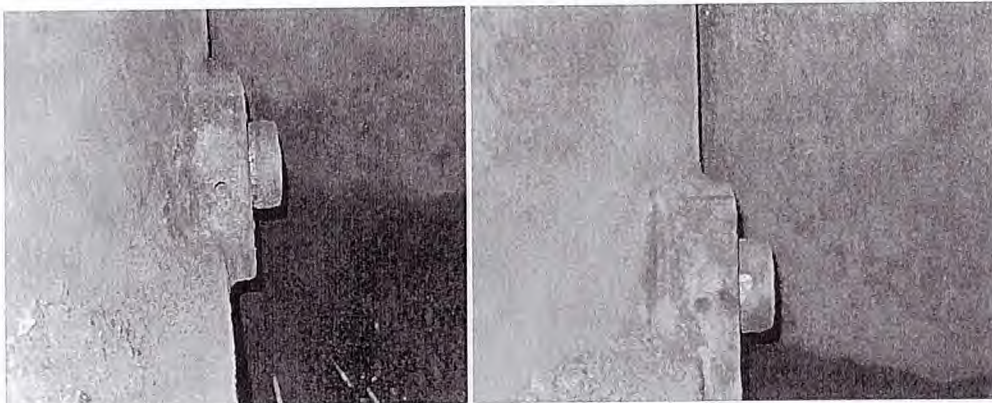
BUCKET CONNECTION PIN PHOTO INSIDE THE BUCKET NOTE THE SET SCREW AND COTTER PIN.

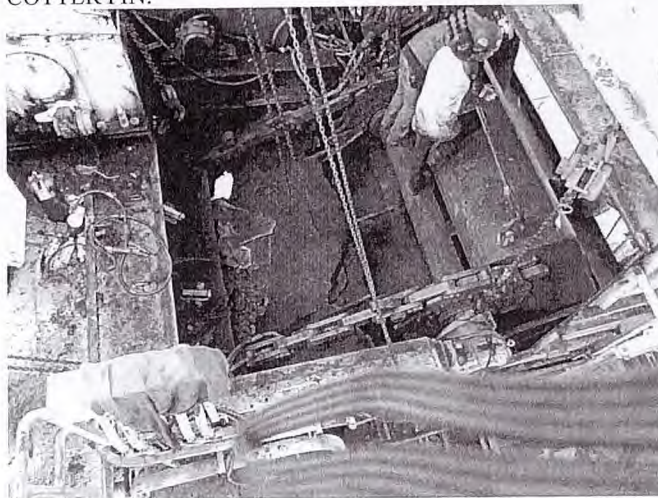
CREW REMOVING A BUCKET PLEASE NOTE THE DETERIORATED TOP PLATE.
