City of Liberty

Re: Case No. 2016-00391
Investigation into Compliance of City of Liberty Gas
Company with KRS 278.495 and 49 CFR Part 192

DISTRIBUTION PLANT INSPECTION AND LEAKAGE REPAIR

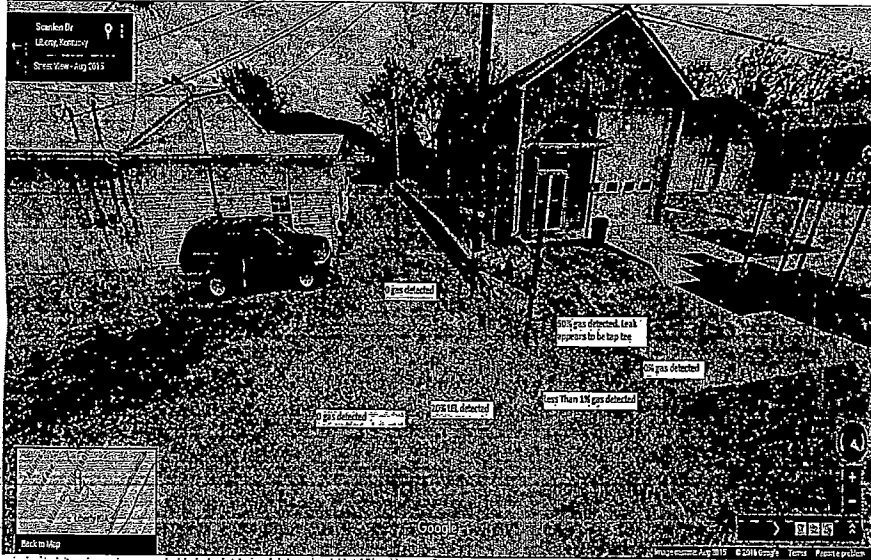
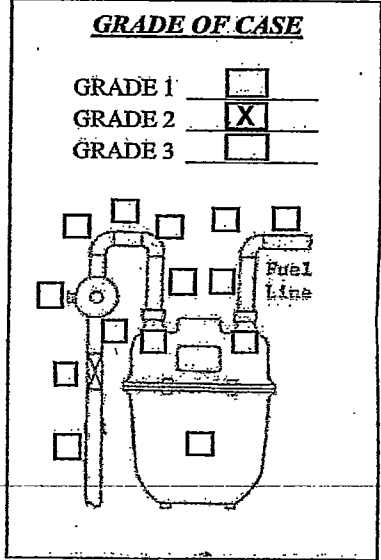
Page Number _____
 Field Case Number **2016-001**

Remarks: 50% gas detected in gravel lot 6 ft from EOP. Leak appears to be at tap tee.

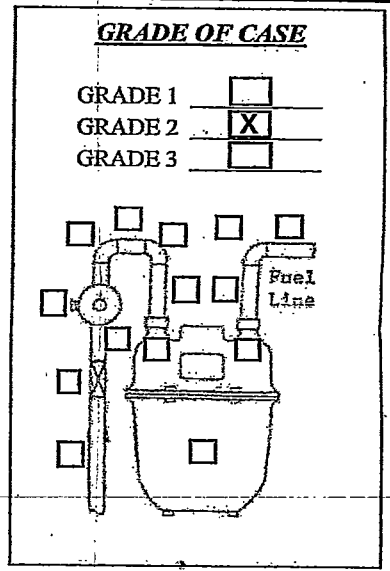
Page Number _____
 Field Case Number **2016-002**

Remarks: 20% gas detected in valve box
