City of Liberty

Re: Case No. 2017-00053

The leakage survey for the Liberty Gas System was completed by Heath Consultants in August 2017. During the survey, fourteen (14) grade 2 leaks were discovered in Liberty's gas system. Liberty Gas System has previously submitted a leakage repair report for one (1) leak found. Included in this letter, you will find five (5) more leakage repair reports from the Liberty Gas System as well as the Field Report from Heath Consultants.

**LEAKAGE CONTROL REPORT
FIELD SURVEY**

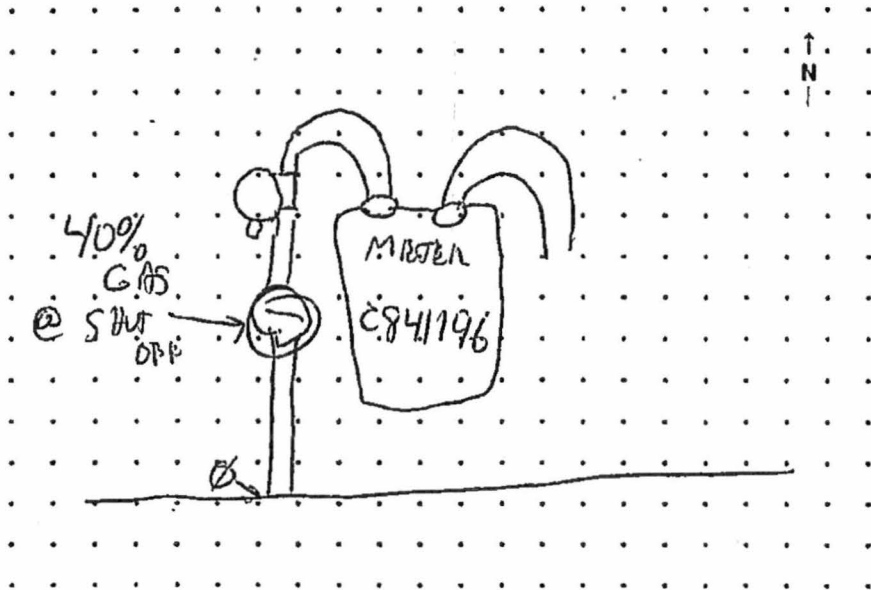
5917 KY 49

Remarks 40% GAS AT SHUT OFF VALVE ON ALBA.

Cause of Leak: **Corrosion** **Incorrect Operations** **Other Outside Force**

Date Repaired: 2-9-18 Repaired By: Darren Atwood

Repair Method: Replaced Leak Clamp Other - Explain: _____

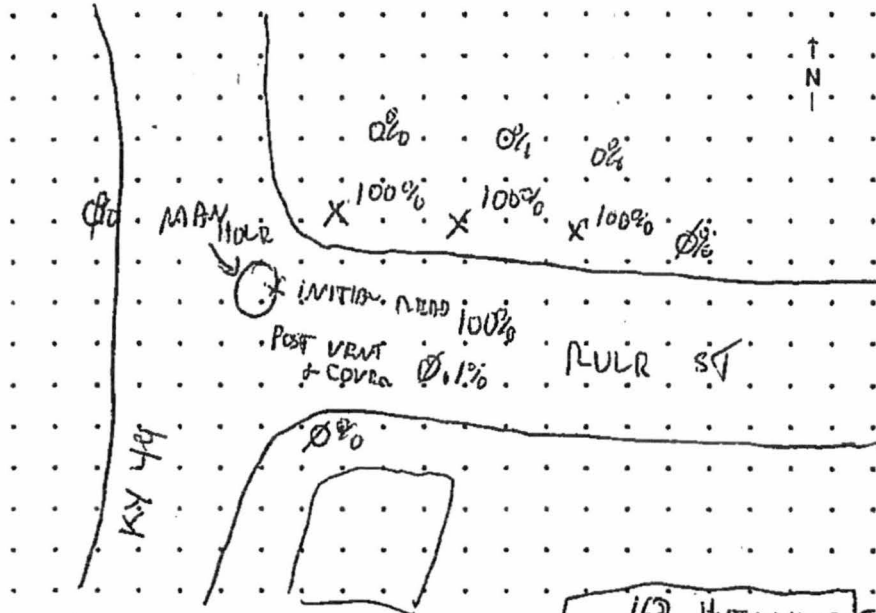
163 HUSTONVILLE ST

INITIALLY FOUND 100% GAS IN MANHOLE. AFTER LOCAL CROW VENTED MANHOLE AND DUE UP SOIL AT EDGE OF ROAD @ OTHER INDICATIONS, WAITED 20 MINUTES, THEN RECOVERED MANHOLE FOR 40 MINUTES, THEN TOOK SAMPLE READING SHOWING 0.1% GAS.

Cause of Leak: **Corrosion** Atmospheric
 External
 Internal
 (Send Pipe Sample to Director-Technical Services)

Date Repaired: 2-9-18 Repaired By: Darren Atwood Greg Rodgers

Repair Method: Replaced Leak Clamp Other - Explain: _____

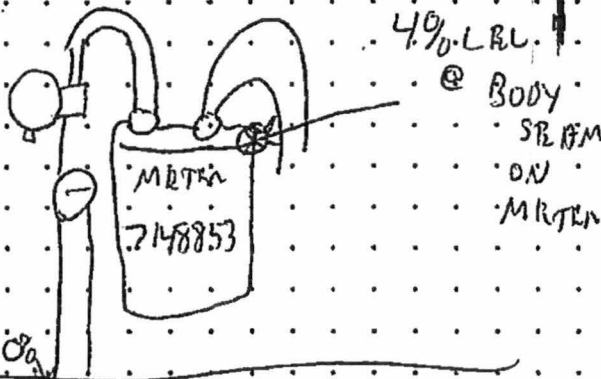
1.677 MAIL ST

Remarks 4% LRL ON BODY SEAM ON METER
(ON SIDE TOP EDGE, RIGHT SIDE)
NO OTHER INDICATION

Earthquake Excess Flow Valve Directional Fitting
 Earth/Rock Movement Filter Flange
 Flood Flow/Pressure Controller Mechanical Fitting
 Frost Heave Heater Pipe
 Landslide Meter Casing Plastic Fusion Coupling
 Lightning Odorizer Plastic to Plastic
 Subsidence Regulator/Relief Valve Compression Coupling
 Tornado Thread Plastic to Steel Transition
 Washout Valve Screw Fitting
 Other Other - Explain: Bad meter Tap-Tee
 Workmanship Defect
 Other - Explain: _____

Date Repaired: 2-9-18 Repaired By: Darren Atwood

Repair Method: Replaced Leak Clamp Other - Explain: _____

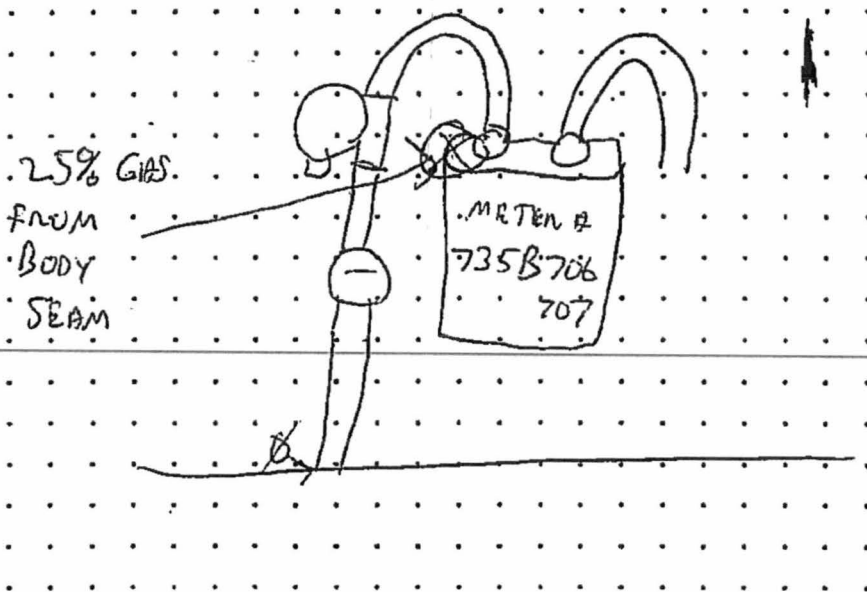
2277 ADAMS ST

Remarks 25% GAS FROM LEFT SIDE OF SEAM ON BODY OF METER

Earthquake Excess Flow Valve Directional Fitting
 Earth/Rock Movement Filter Flange
 Flood Flow/Pressure Controller Mechanical Fitting
 Frost Heave Heater Pipe
 Landslide Meter Casing Plastic Fusion Coupling
 Lightning Odorizer Plastic to Plastic
 Subsidence Regulator/Relief Valve Compression Coupling
 Tornado Thread Plastic to Steel Transition
 Washout Valve Screw Fitting
 Other Other - Explain: Bad meter Tap Tee
 Workmanship Defect
 Other - Explain: _____

Date Repaired: 2-9-18 Repaired By: Darren Ahwood

Repair Method: Replaced Leak Clamp Other - Explain: _____

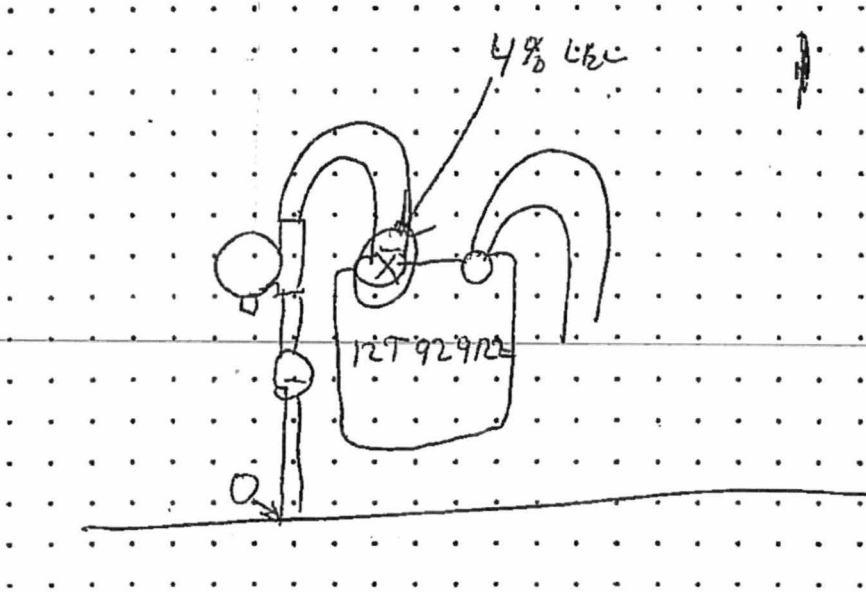
578 WHIPP AVE

Remarks 4% LEL @ INLET SWIRL ON METRA. NO OTHER INDICATION

Equipment Excess Flow Valve Filter Flow/Pressure Controller Heater Meter Casing Odorizer Regulator/Relief Valve Thread Valve Other - Explain: Meter nut

Date Repaired: 2-9-18 Repaired By: Darren Atwood

Repair Method: Replaced Leak Clamp Other - Explain: _____
