City of Liberty

Re: Case No. 2017-00053

LEAKAGE CONTROL REPORT
FIELD SURVEY

LEAK REPORT

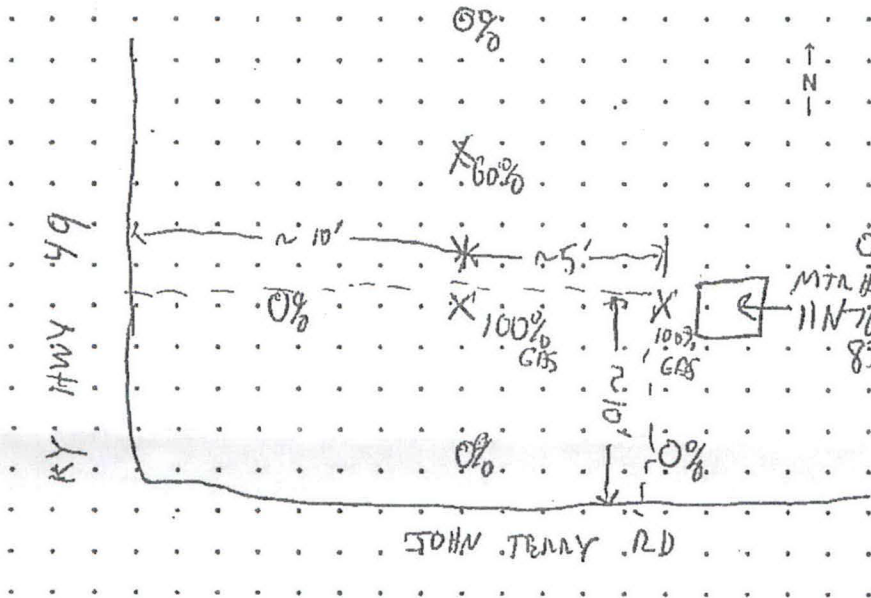
24111 KY 49

Remarks
100% GAS @ 2 BARHOLES, ONE ~ 10' FROM PAVEMENT EDGE OF KY 49, SECOND ~ 5' BEYOND @ RISEN, BOTH ~ 10' FROM EDGE OF JOHN TERRY RD. BARHOLES IN DIAGRAM ~ 5' APART.

Atmospheric Human Error External Loading
 External Ineffective Procedures Fire/Explosion
 Internal (Send Pipe Sample to Director-Technical Services) Vandalism
 Vehicle
 Other - Explain: no leak found CG meter

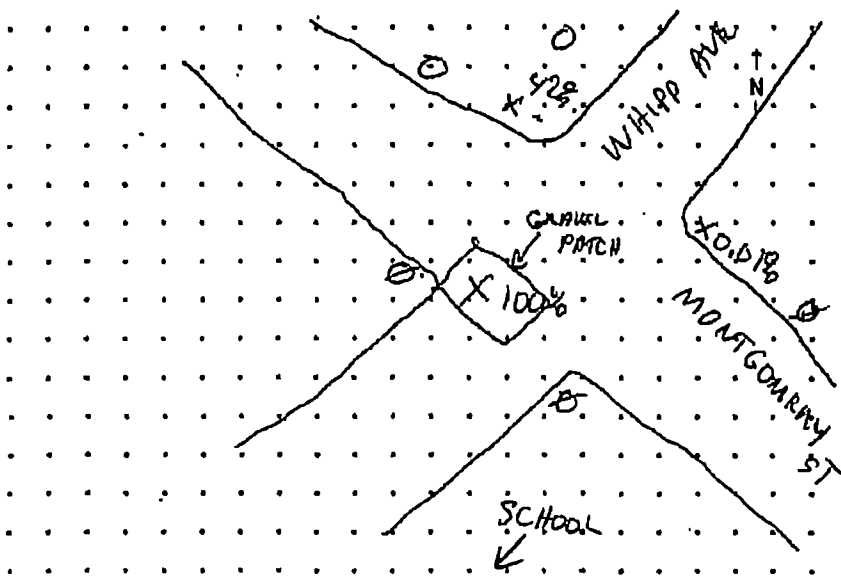
Leak Location: W. PP Montgomery

Remarks 100% GAS @ BANHOLE @ N NEAR MAIN
SPRINK ACROSS STREET TO 42% GAS @ BANHOLE
@ N CORNER OF INTERSECTION; AND
0.01% @ BANHOLE @ E CORNER OF INTERSECTION.
NO OTHER INDICATION.

Other Outside Force External Loading Fire/Explosion Vandalism Vehicle Other - Explain: Valve

Date Repaired: 2-20-18 Repaired By: JEFF Darren Berg
