# City of Liberty

Re: Case No. 2017-00053

The leakage survey for the Liberty Gas System was completed by Heath Consultants in August 2017. During the survey, fourteen (14) grade 2 leaks were discovered in Liberty's gas system. Liberty Gas System has previously submitted a leakage repair report for eight (8) leaks found. Included in this letter, you will find four (4) more leakage repair reports and two (2) that have been monitored and are scheduled for repair from the Liberty Gas System as well as the Field Report from Heath Consultants.

**LEAKAGE CONTROL REPORT  
FIELD SURVEY**

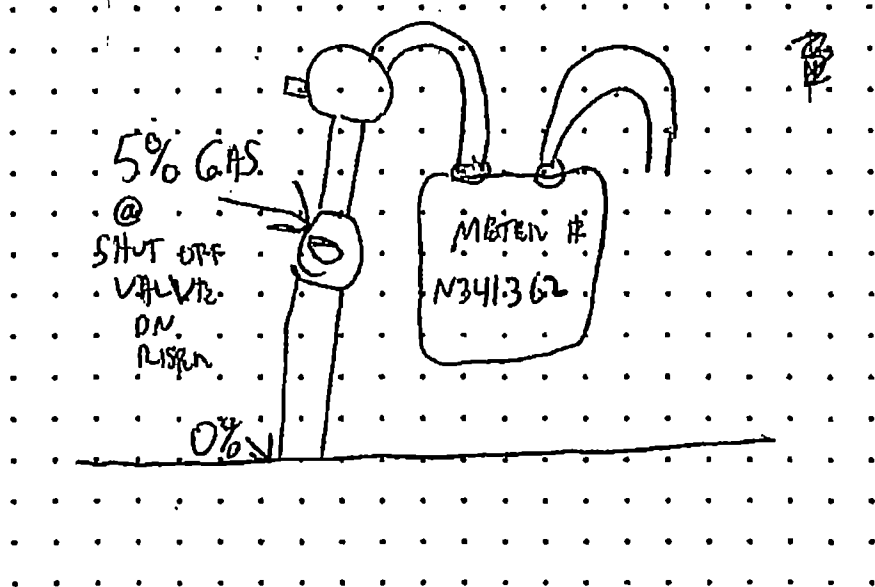
LIBERTY, AUTO. PARTS, ???, CAMPBELLSVILLE ST

Remarks 5% GAS @ SHUT OFF VALVE ON RISER,  
NO OTHER INDICATION.

Date Repaired: 3-6-18 Repaired By: Darren Jeff Chris Greg

Fixed removed meter

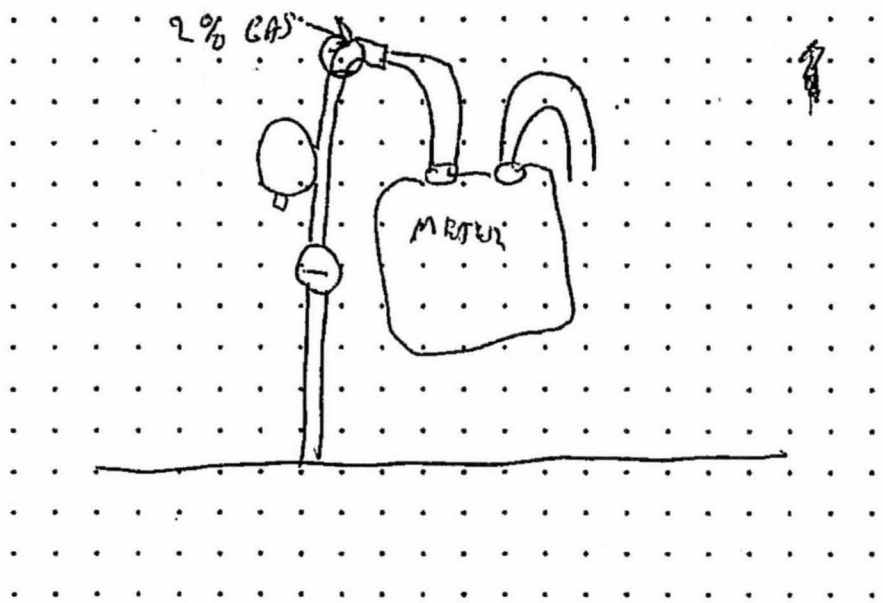
22 HUSKINVILLE LIBERTY

Remarks 2% GAS @ FIRST 90° ELBOW ON METER  
RMLB METER

Date Repaired: 3-6-18 Repaired By: Darren Greg

Atmospheric  Human Error  External Loading  
 External  Ineffective Procedures  Fire/Explosion  
 Internal  Vandalism  
 (Send Pipe Sample to Director-Technical Services)  Vehicle  
 Other - Explain: took out service

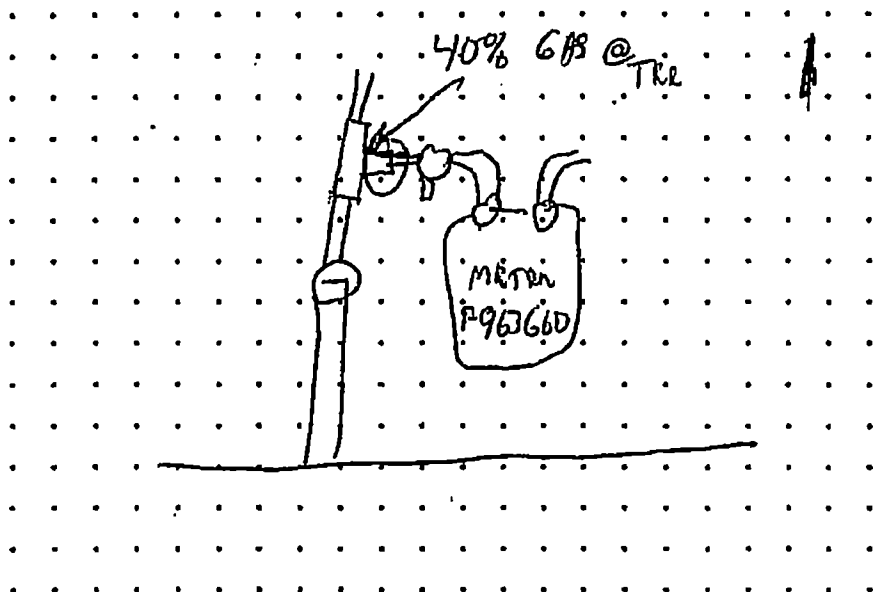
33 HUSTONVILLE LIBERTY

Remarks 40% GAS @ TER ON MAINLINE

How Discovered:  Leak Survey  Patrol  Other - Explain: going to fix in next 30 days

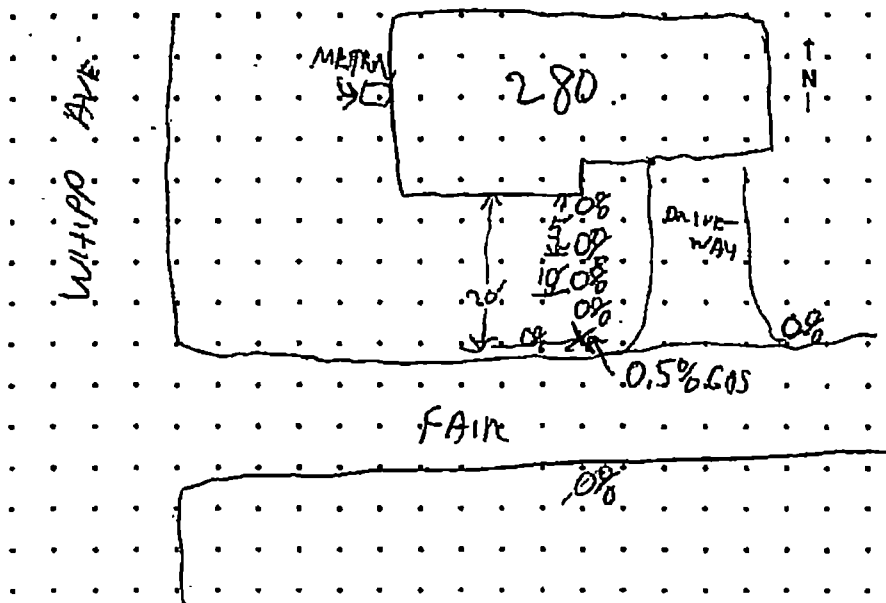
Leak Location: 280 Fair St

Remarks 0.5% GAS @ BATHOLE AT OR NEAR MAIN, N 20' FROM BLDG WALL. ZERO SPREAD @ LEFT EDGE OF DRIVEWAY

How Discovered:  Leak Survey  Patrol  Other - Explain: no leak found
