City of Liberty

Re: Case No. 2017-00053

Attached are the repair reports for the two remaining grade 2 leaks from the leakage survey for the Liberty Gas System, which was completed by Heath Consultants in August 2018.

LEAK REPORT

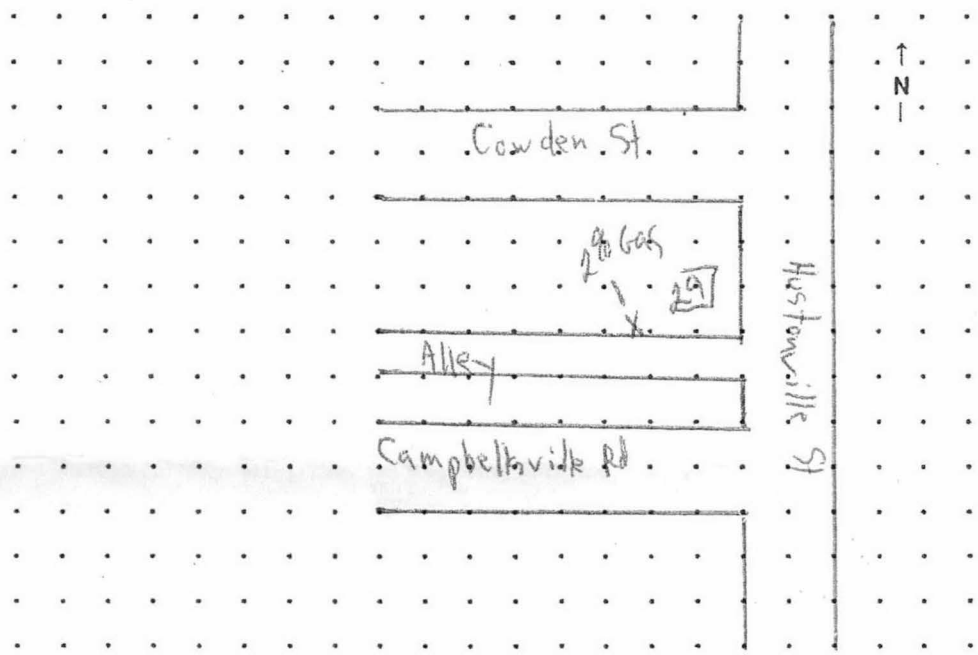
29, Hustonville St

LEAK INDICATION APPEARS TO BE AT:	
Main	<input type="checkbox"/>
Service	<input checked="" type="checkbox"/>
Service Tap	<input type="checkbox"/>
Main At Tie In	<input type="checkbox"/>
Drip	<input type="checkbox"/>
Meter	<input type="checkbox"/>
Curb Valve	<input type="checkbox"/>
Main Valve	<input type="checkbox"/>
Other	<input type="checkbox"/>

CGI TEST	
Positive <u>270</u>	<input checked="" type="checkbox"/>
Negative	<input type="checkbox"/>

Remarks Leak appears to be on service
