**Louisville Gas and Electric  
Company**  
State Regulation and Rates  
220 West Main Street  
PO Box 32010  
Louisville, Kentucky 40232  
www.lge-ku.com

**RE: *Louisville Gas and Electric Company Alleged Failure to Comply with  
KRS 278.495, 807 KAR 5:022, and 49 C.F.R. Part 192  
Case No. 2017-00119***

The following three couplings were removed from LG&E's transmission system:

## Bolt-Style Coupling (pressures > 3 psig)

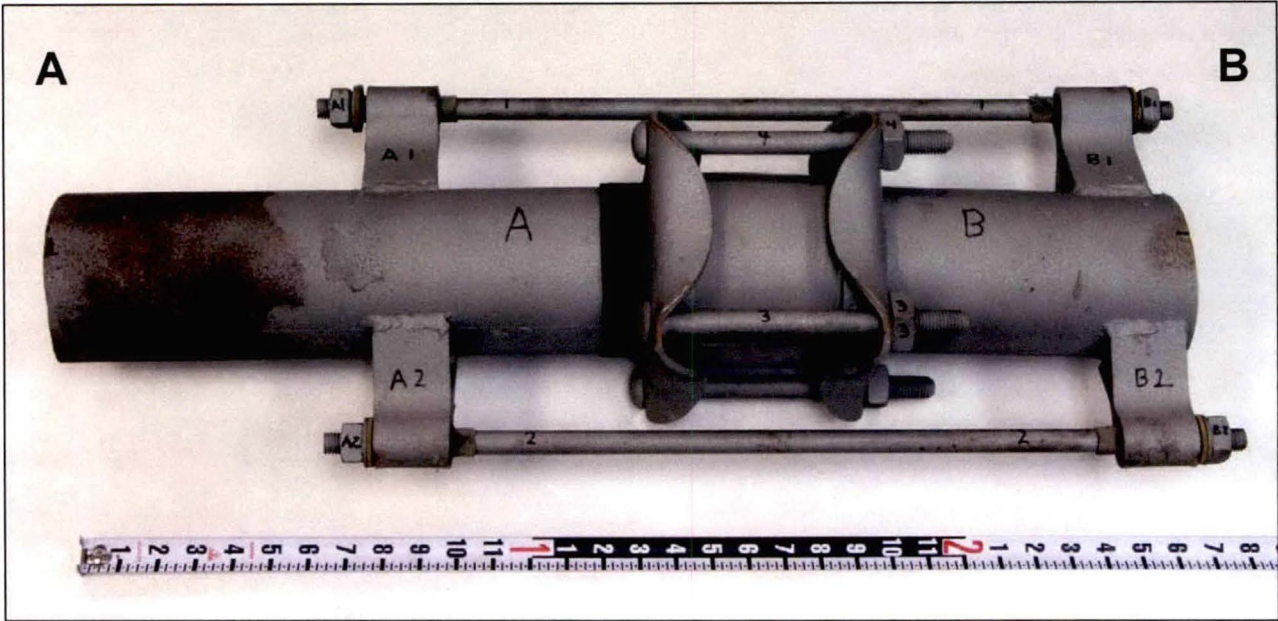
Figure 1. Photograph of the top of the submitted coupling sample. The bolt heads were all at End A, while the nuts were toward End B.

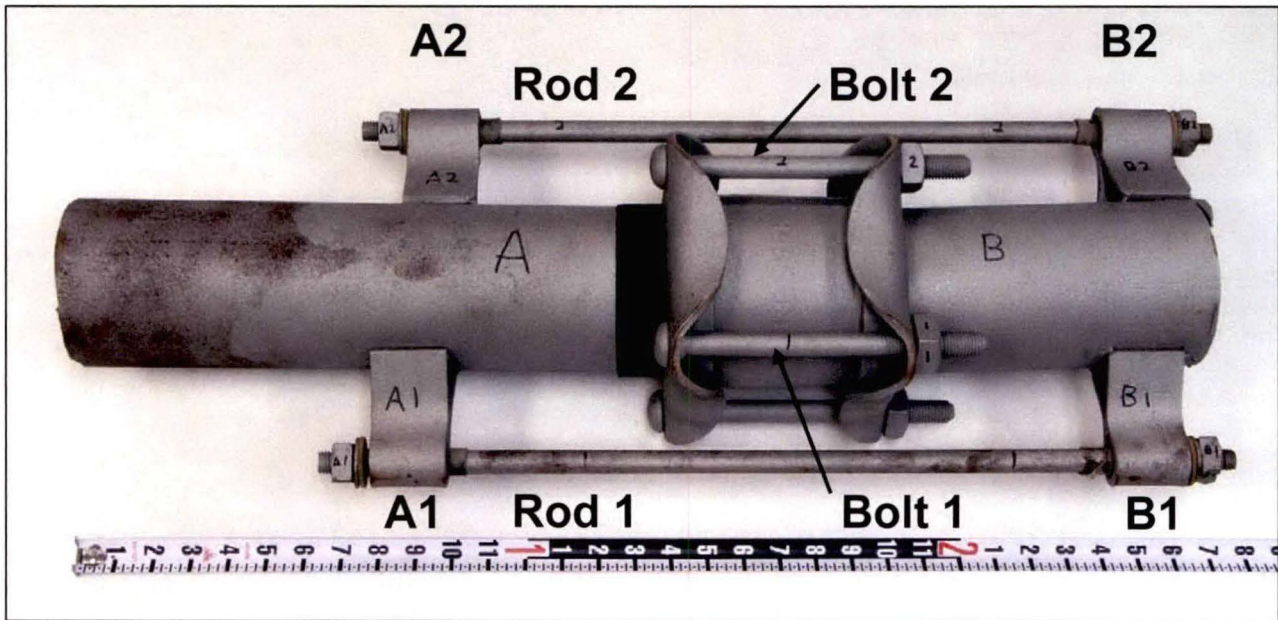
Figure 2. Photograph of the bottom of the submitted sample. Lug, rod and bolt identifications are shown.

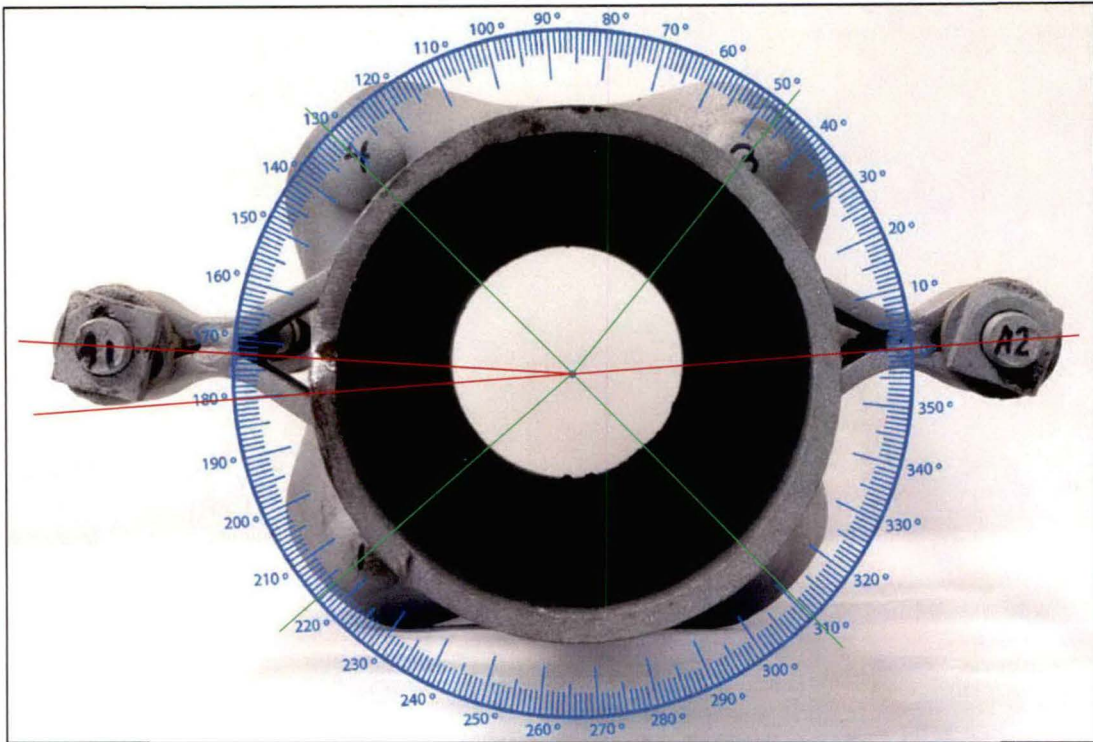
Figure 3. End facing image of the sample at End A. A superimposed protractor shows that the centers of Lugs A1 and A2 were approximately 8° from square.

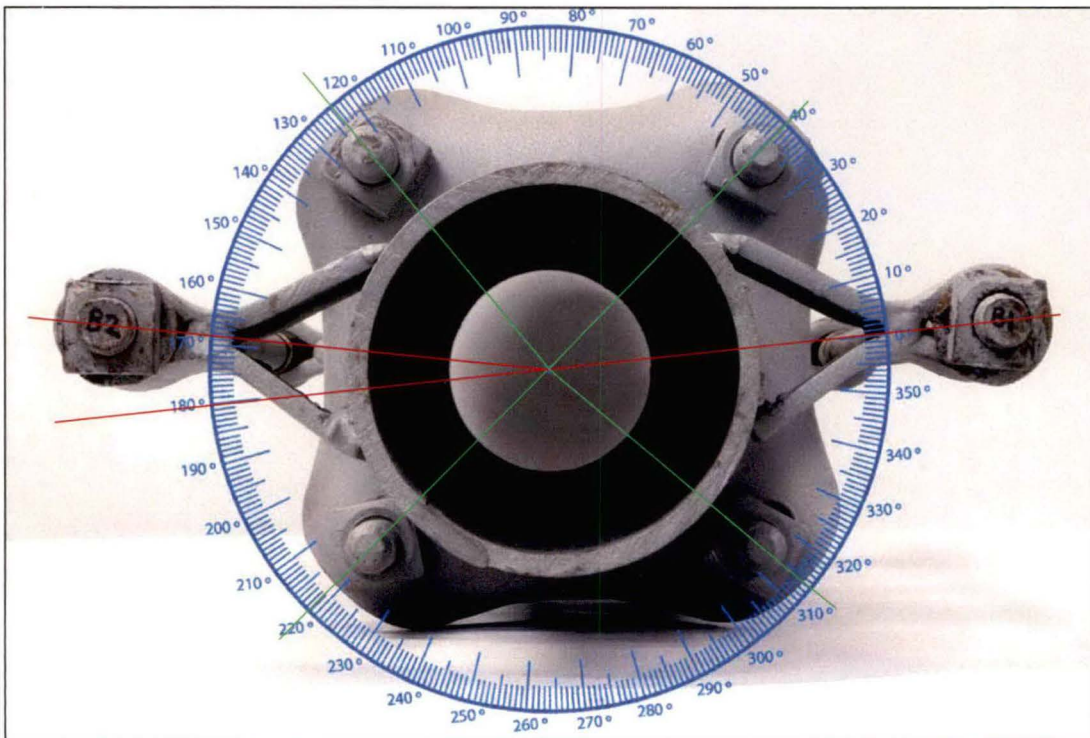
Figure 4. End facing image of the sample at End B. A superimposed protractor shows that the centers of Lugs B1 and B2 were approximately 11° from square.

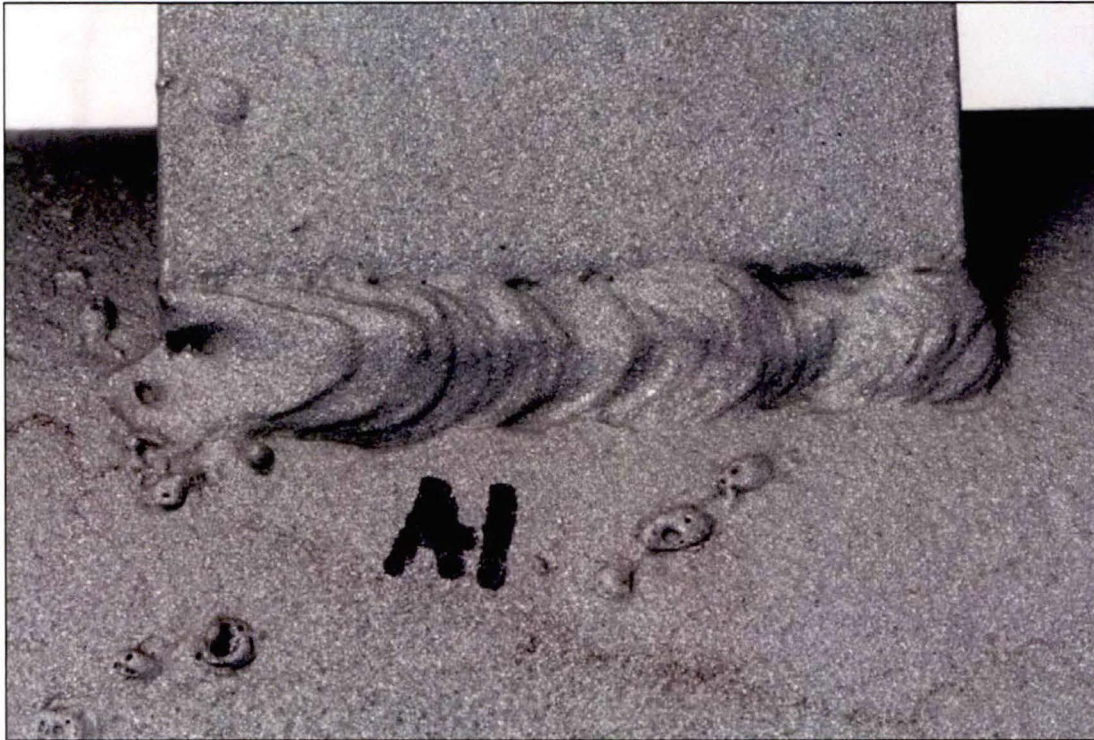
Figure 5. Image of the Lug A1 exterior top weld which exhibited substantial fusion except for some overlap, spatter and underfill.

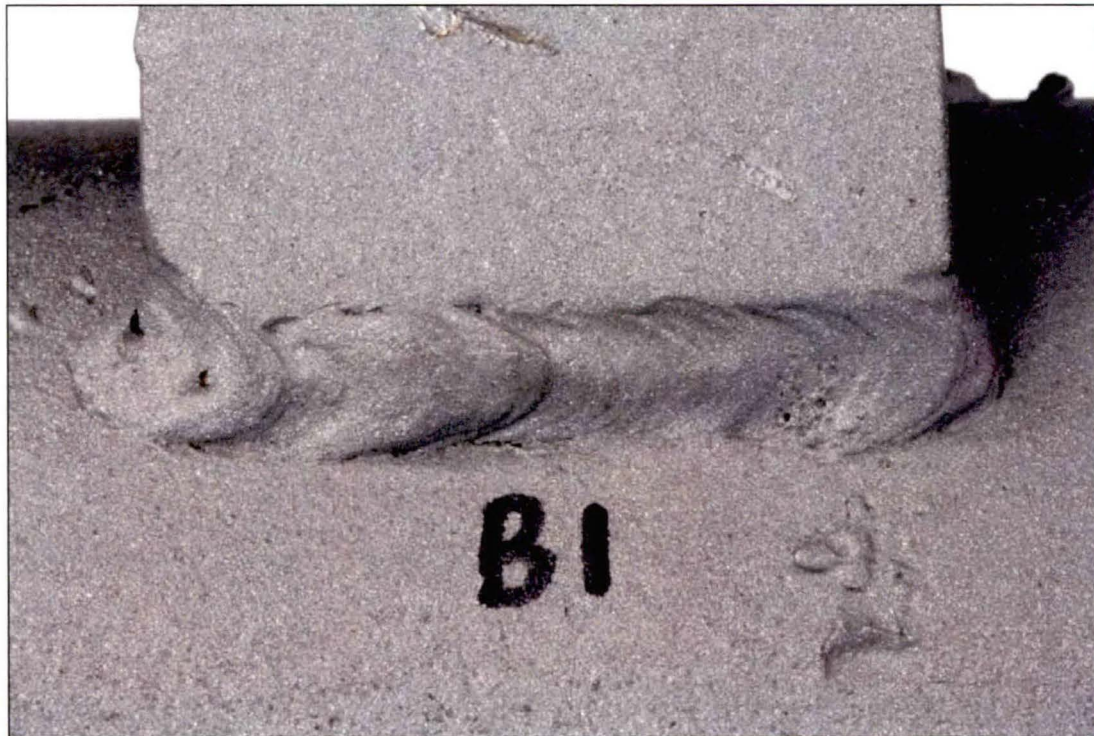
Figure 6. Image of the Lug B1 exterior top weld which exhibited minimal porosity.

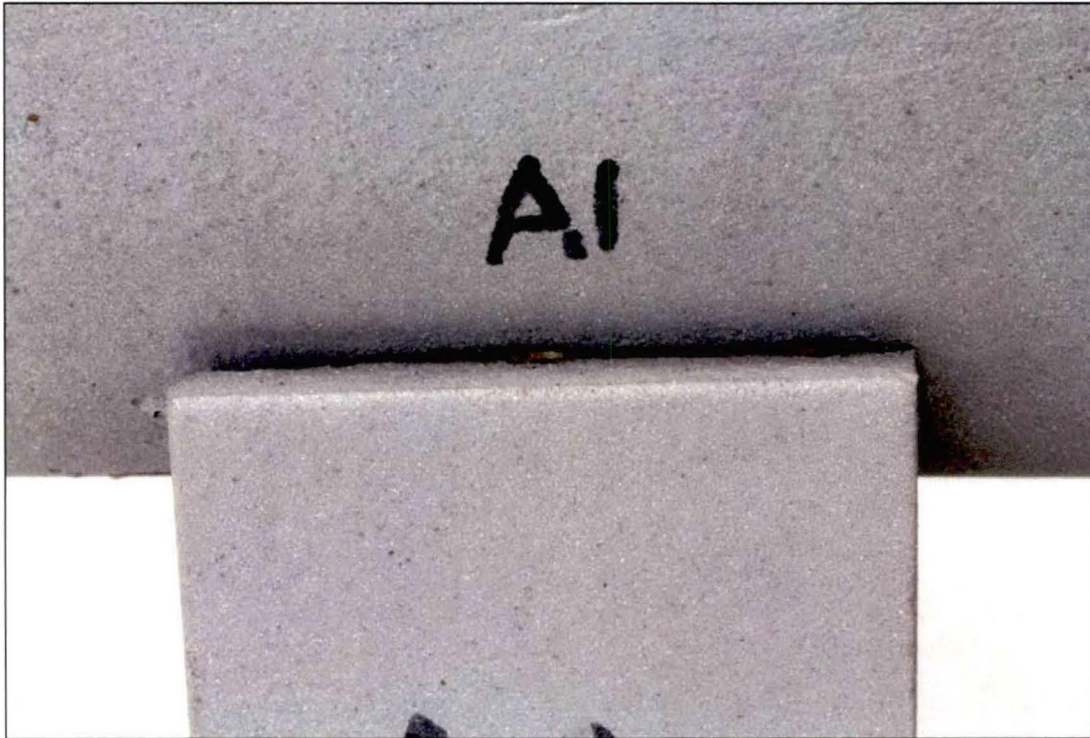
Figure 7. Image of the Lug A1 exterior bottom joint region which was not welded.

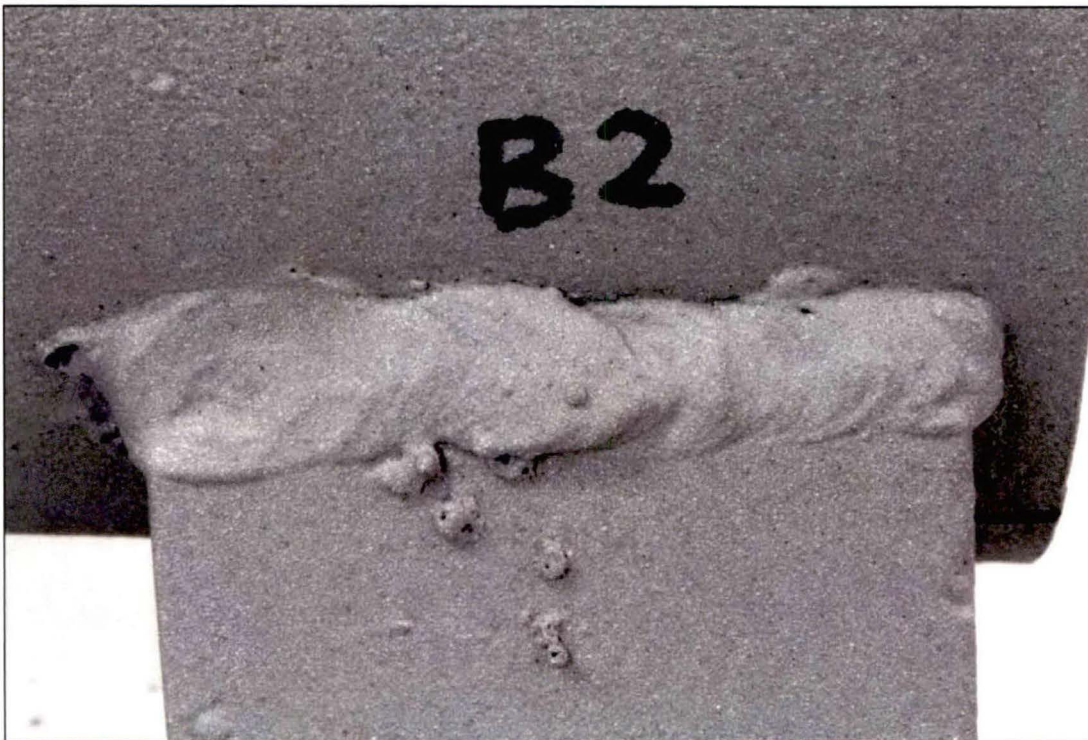
Figure 9. Image of the Lug B2 exterior top weld which exhibited substantial fusion except for some overlap and spatter.

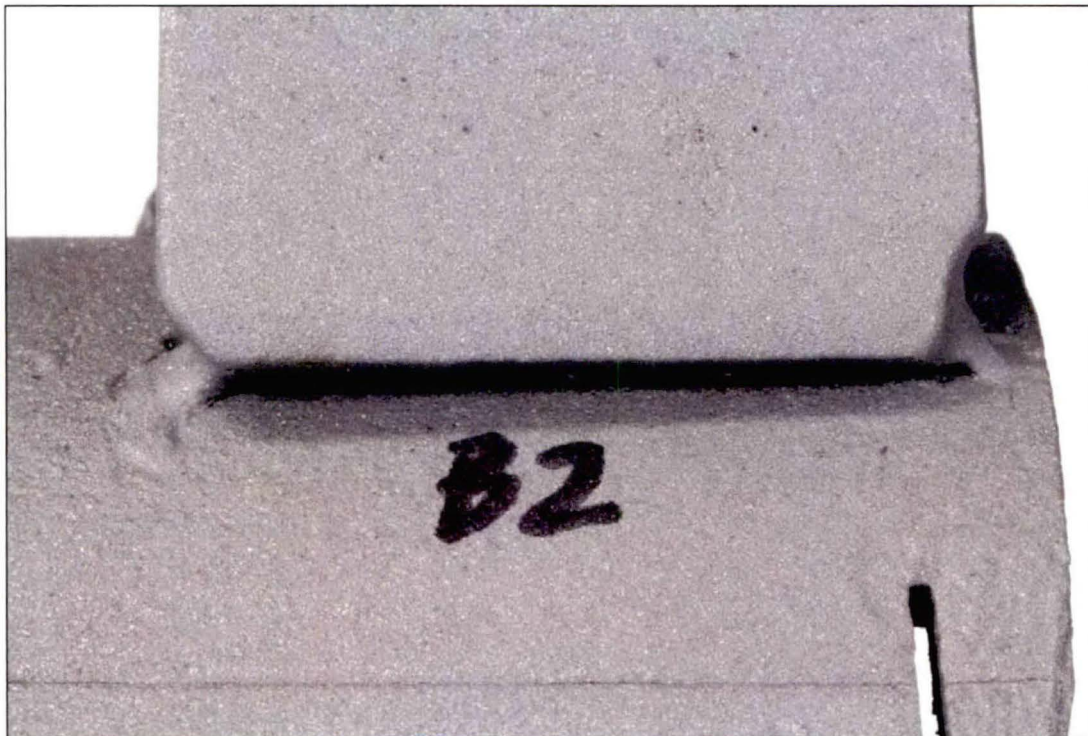
Figure 10. Image of the Lug B2 exterior bottom weld. Joining at the ends of the lug was from welding from the interior surface.

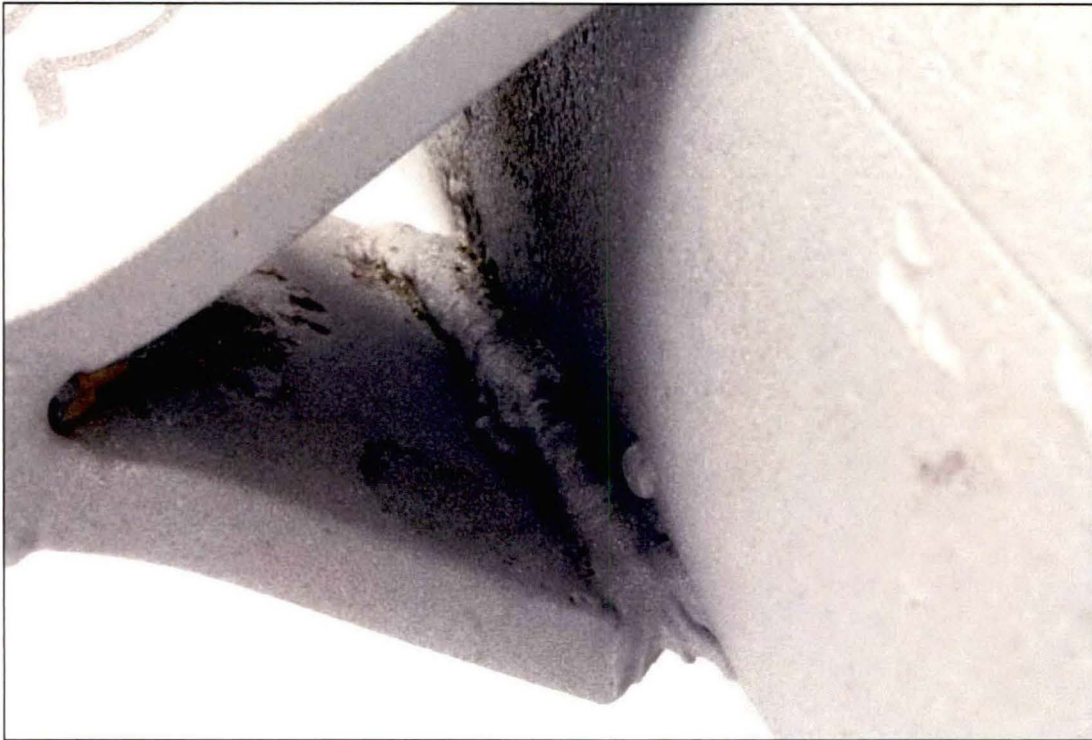
Figure 11. Image of the Lug A2 interior bottom weld which exhibited substantial fusion except for some overlap and spatter.

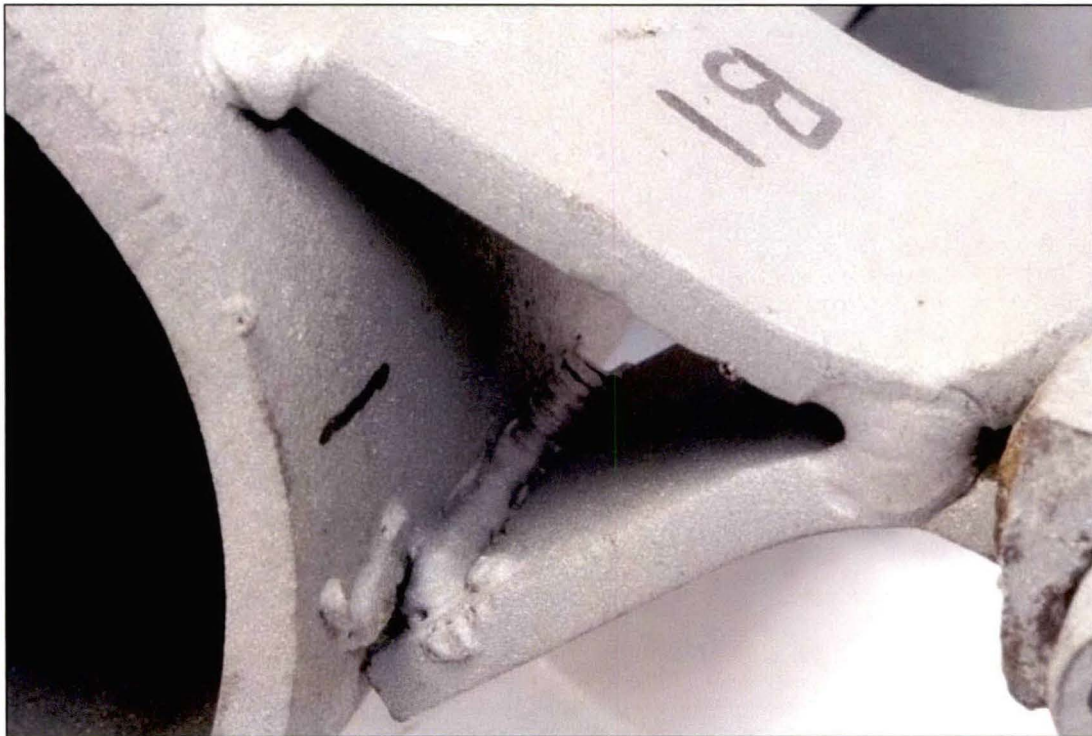
Figure 12. Image of the Lug B1 interior bottom weld which exhibited some fusion.

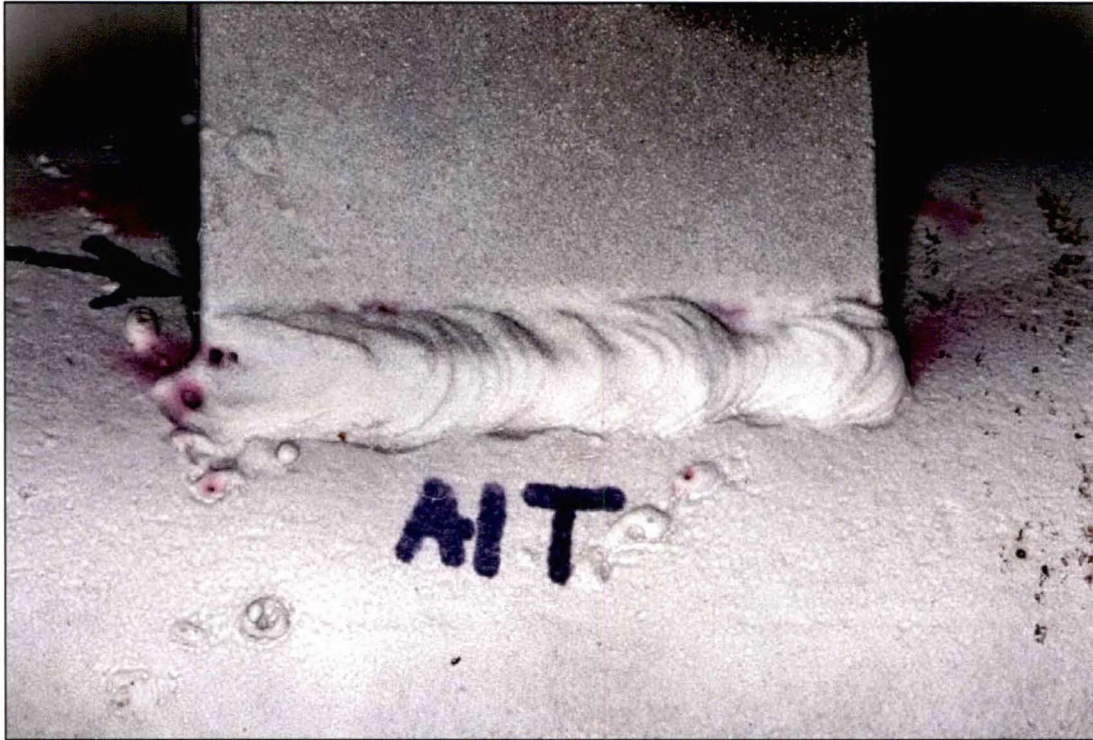
Figure 19. Image of the Lug A1 exterior top weld after dye penetrant media had been used during inspection.

OTHER INFORMATION:  
 A1B - No weld  
 A1B1 - Rejected porosity/crack  
 A1T - Accepted  
 A1T1 - Rejected  
 A2T - Accepted  
 A2T1 - No weld  
 A2B1 - Rejected  
 B1T - Accepted  
 B1T1 - Rejected CRACK  
 B1B1 - Rejected Lack of fusion  
 B1B - No weld  
 B2T - Accepted  
 B2T1 - No weld  
 B2B1 - Rejected Lack of fusion

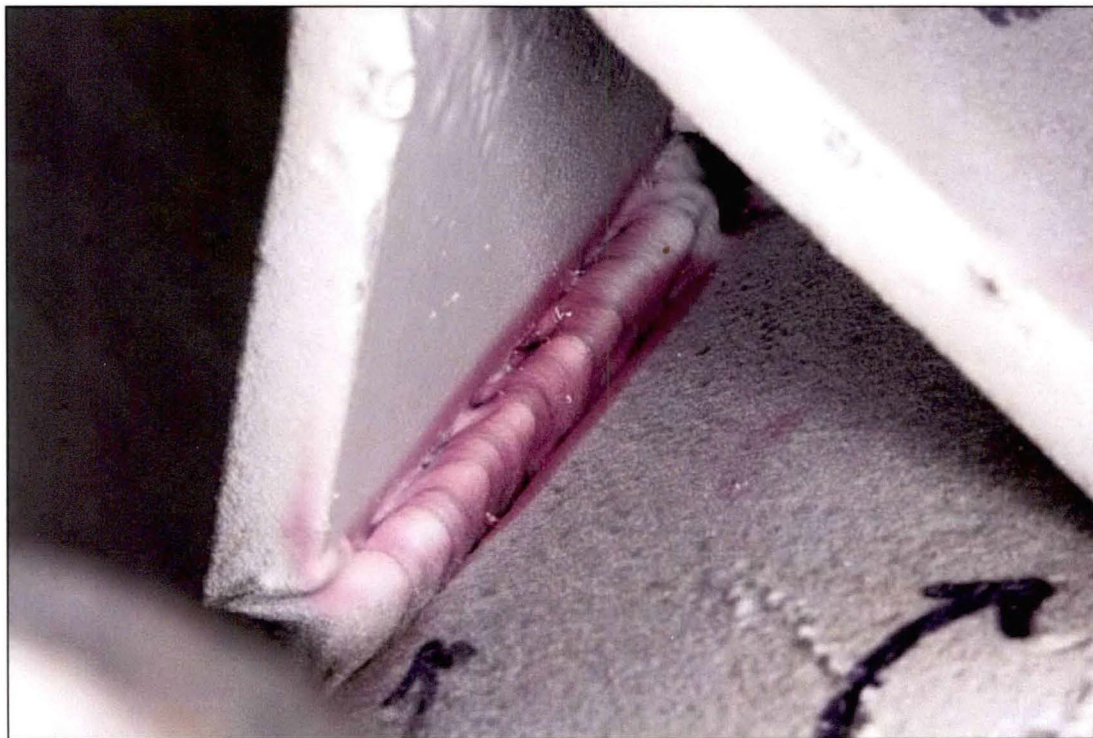
Figure 20. Image of the Lug B1 interior bottom weld after dye penetrant media had been used during inspection.

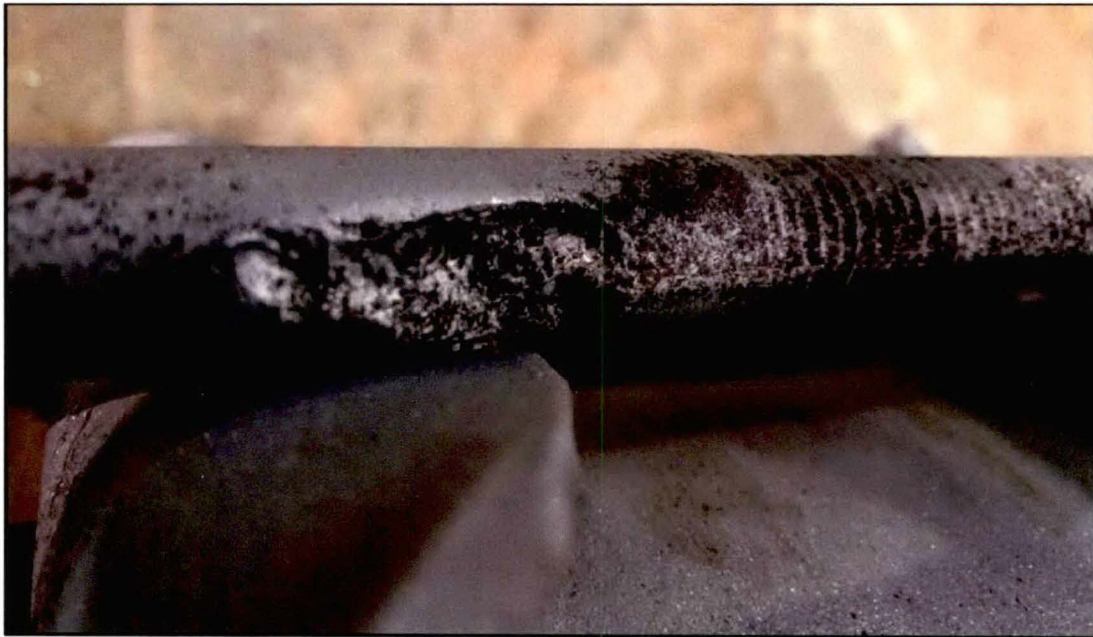
Figure 7- Rod 1 Metal Loss

- <sup>1</sup> Possible corrosion on rod 1. The rod is in contact with the coupler brackets. It is unknown if the indications on the rod and bracket are corrosion or metal loss due to rod and bracket rubbing against each other. See Figure 7.
- <sup>2</sup> Severe corrosion on nut A1. It is greater than .03. The pit gage would not lay flat against the nut in order to get an accurate measurement. See Figure 8.
- <sup>3</sup> Does not have an insulating washer.
- <sup>4</sup> The lugs do not conform to the curvature of the pipe and cannot make complete contact. See Figures 9 & 10.
- <sup>5</sup> The lugs are solid flat surfaces with no interior. See Figure 11.

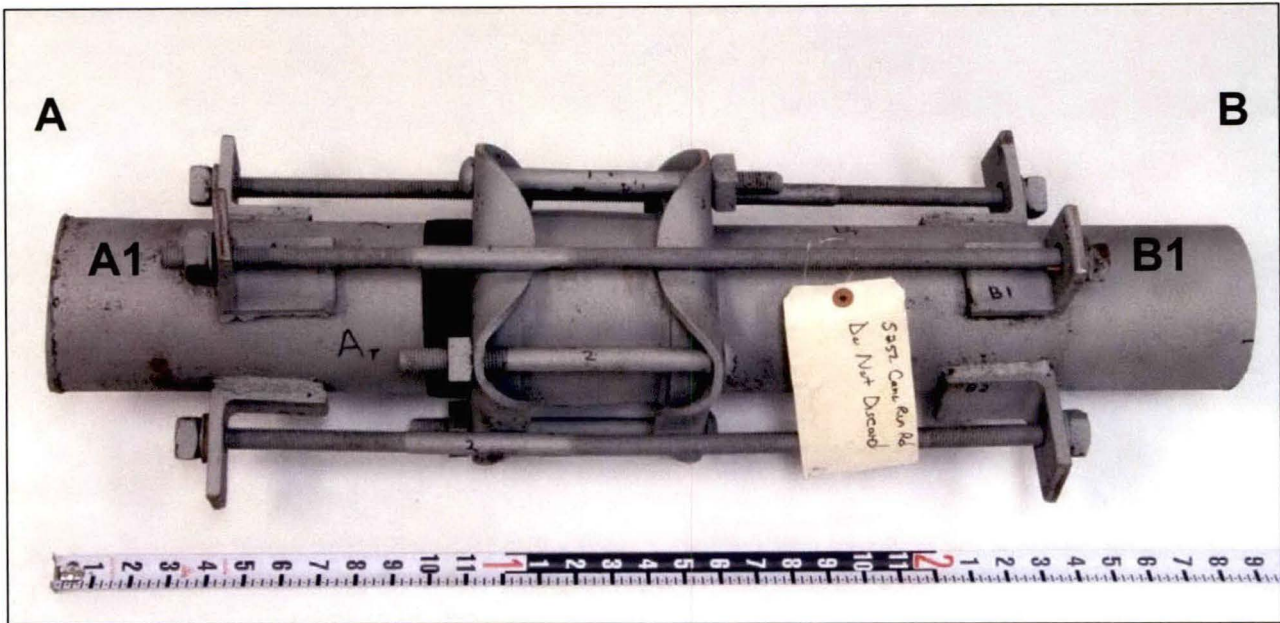
Figure 1. Photograph of the top of the submitted coupling sample. Three attachment rods were affixed with angle iron lugs. Lugs A1 and B1 are identified.

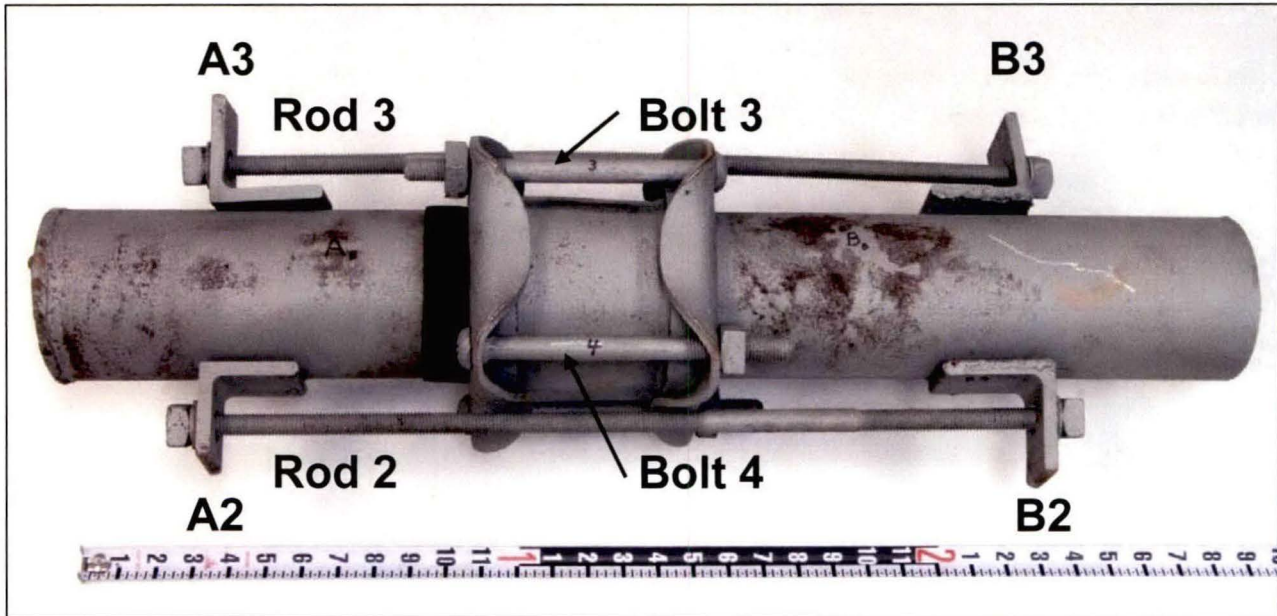
Figure 2. Photograph of the bottom of the submitted sample. Lug, rod and bolt identifications are shown.

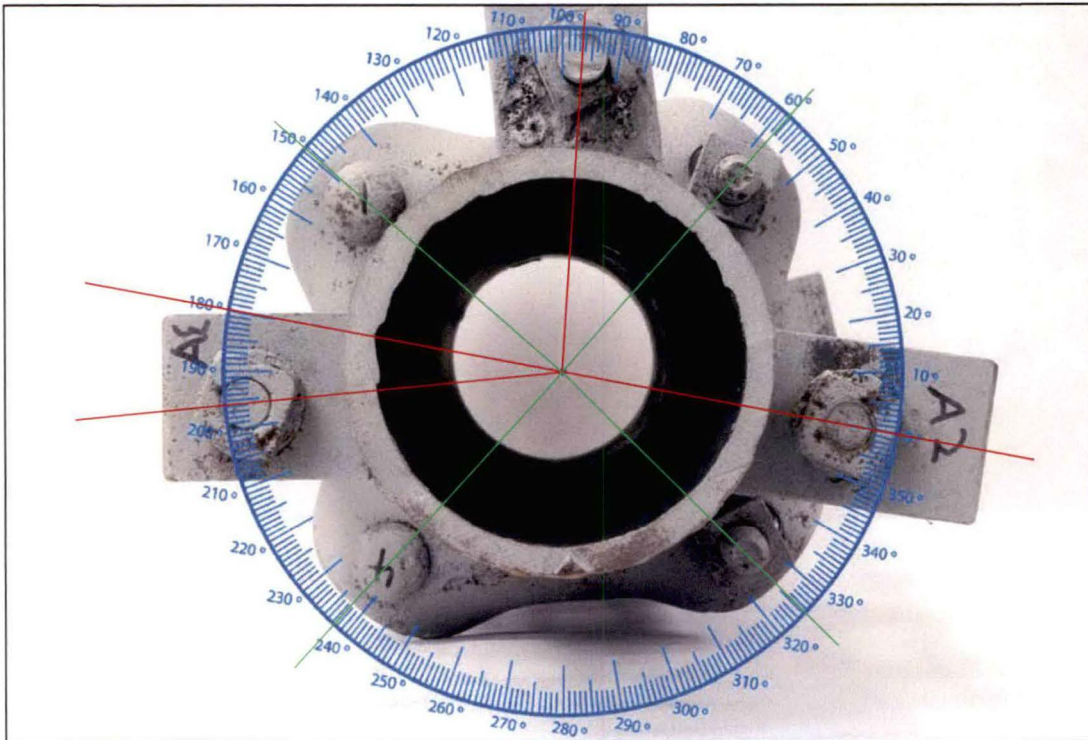
Figure 3. End facing image of the sample at End A. A superimposed protractor shows the angles between the centers of Lugs A1, A2 and A3.

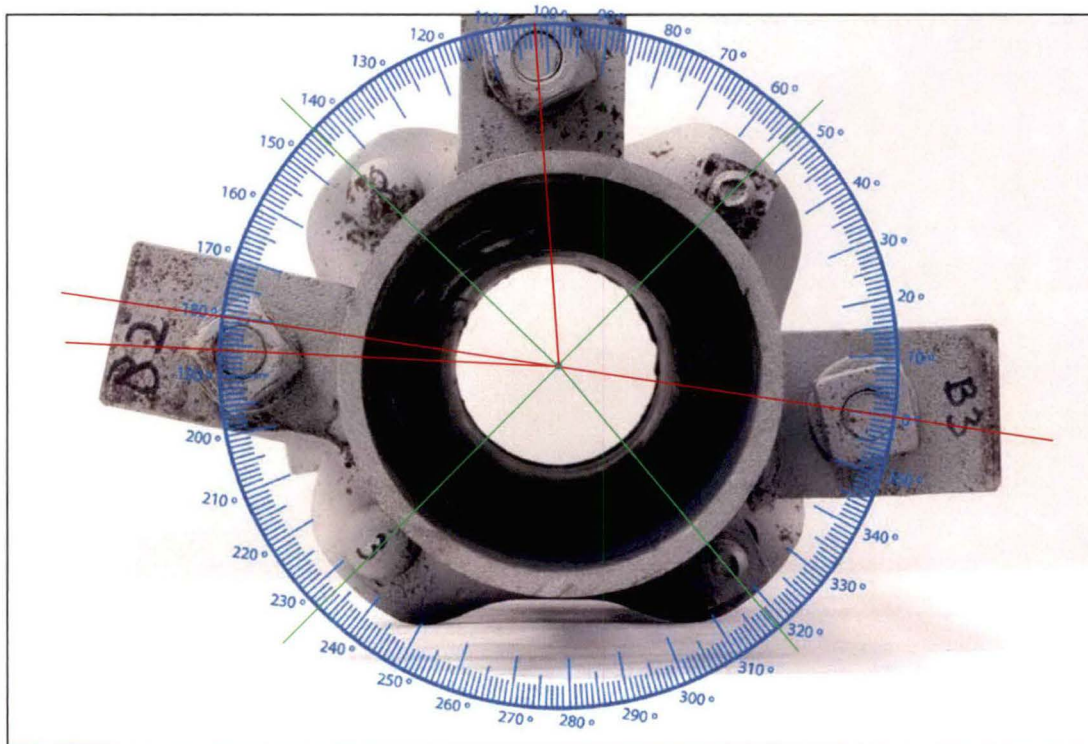
Figure 4. End facing image of the sample at End B. A superimposed protractor shows the angles between the centers of Lugs B1, B2 and B3.

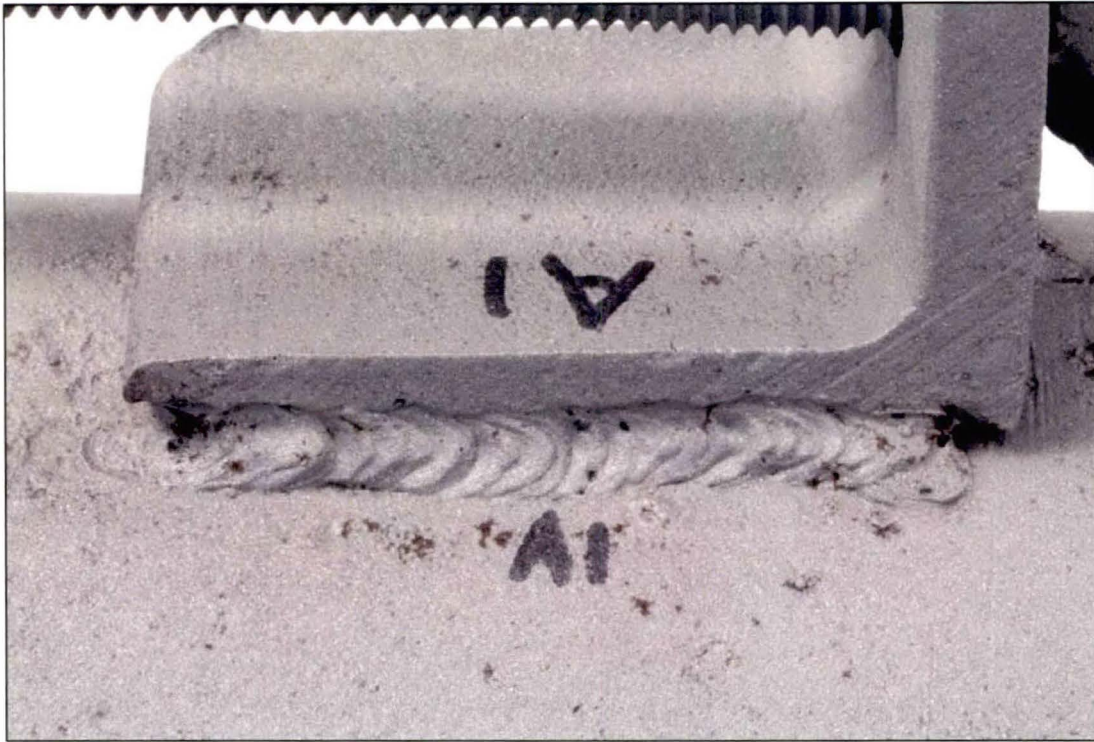
Figure 5. Image of the Lug A1 left weld which exhibited substantial fusion. Some porosity was apparent.

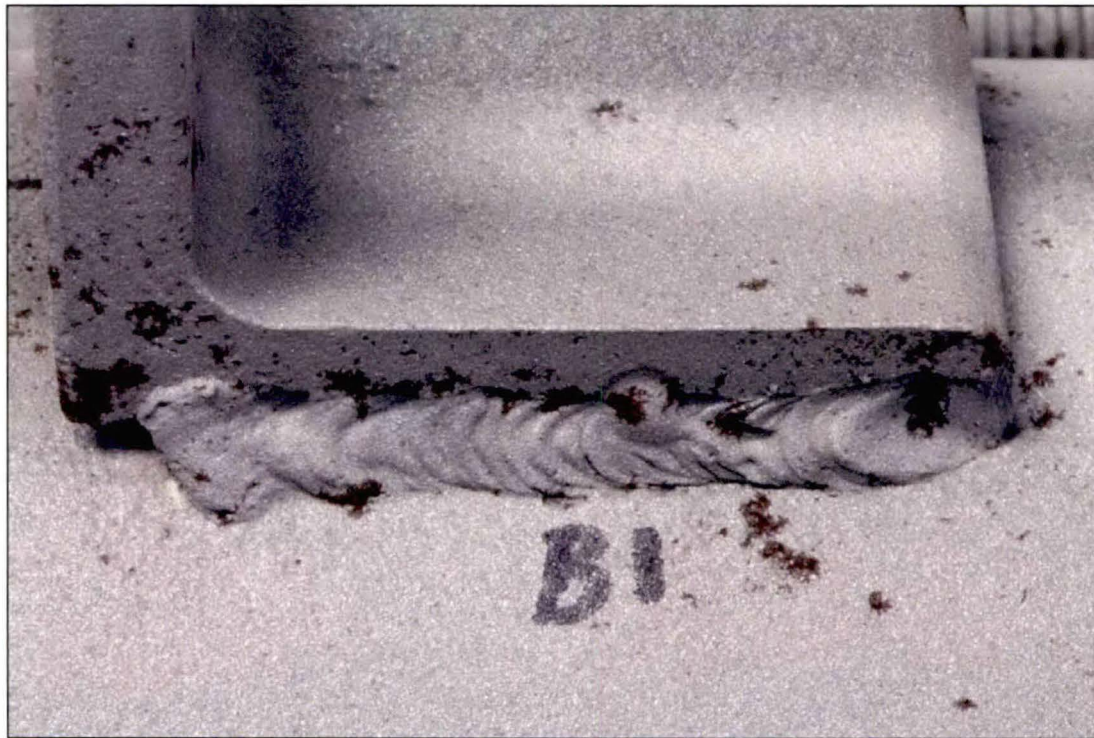
Figure 6. Image of the Lug B1 left weld which exhibited substantial fusion.

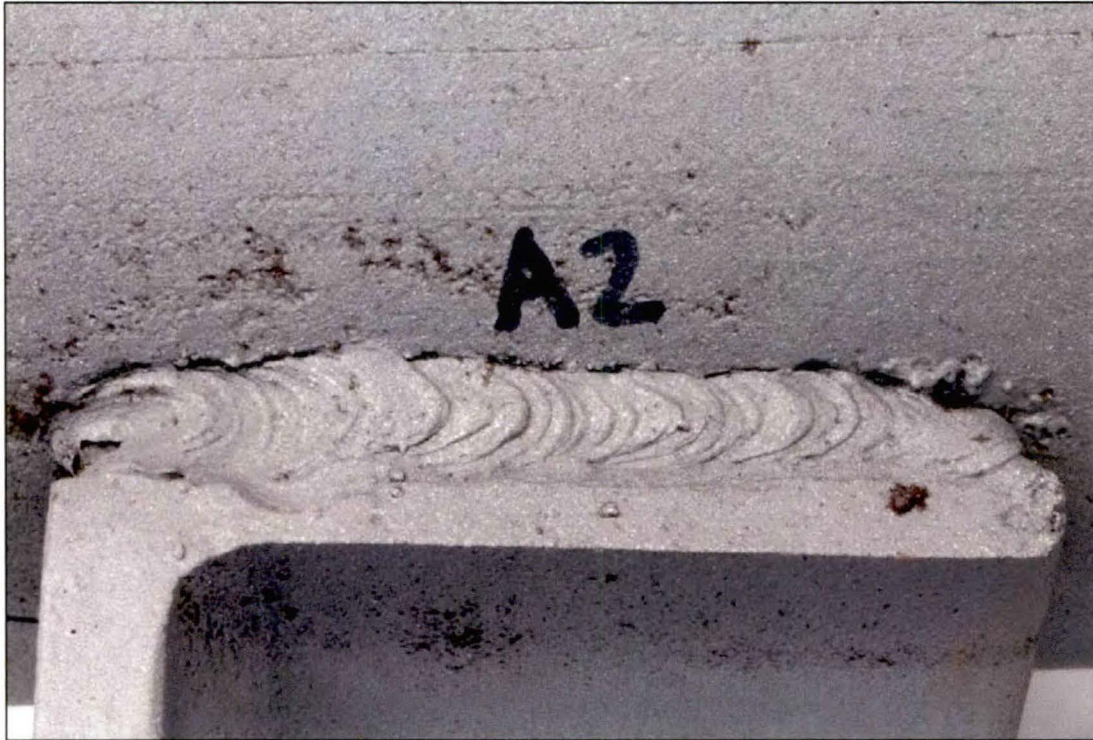
Figure 7. Image of the Lug A2 top weld. This weld exhibited some incomplete fusion.

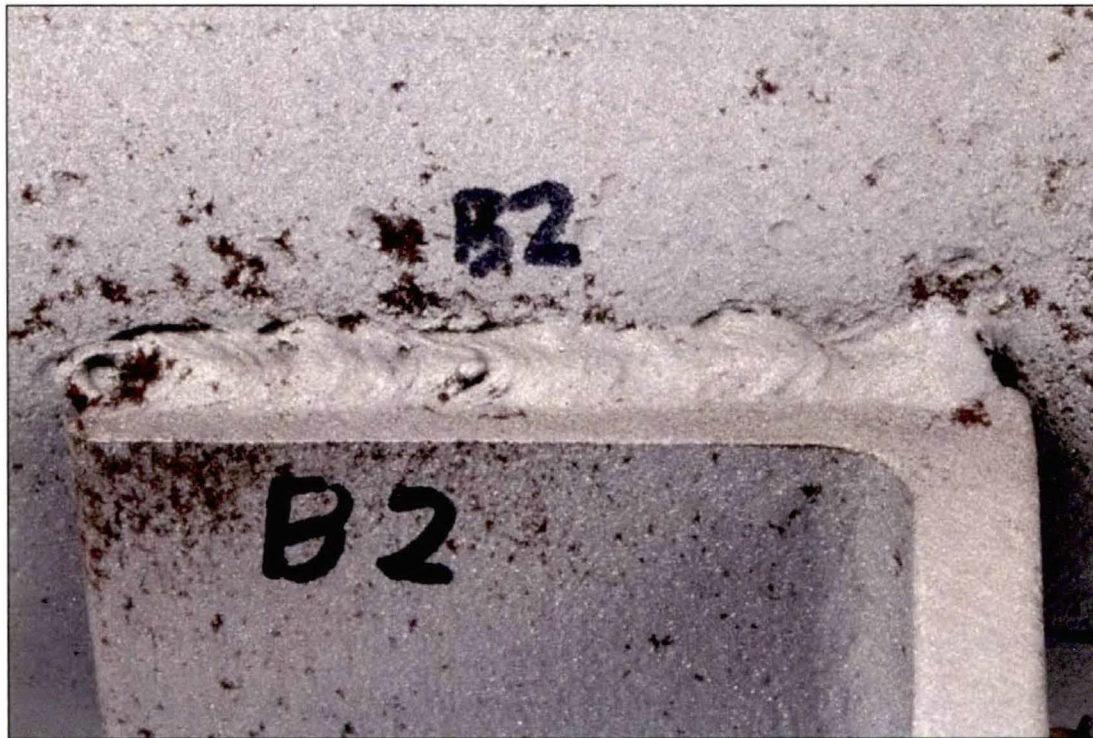
Figure 8. Image of the Lug B2 top weld region. This weld exhibited substantial fusion.

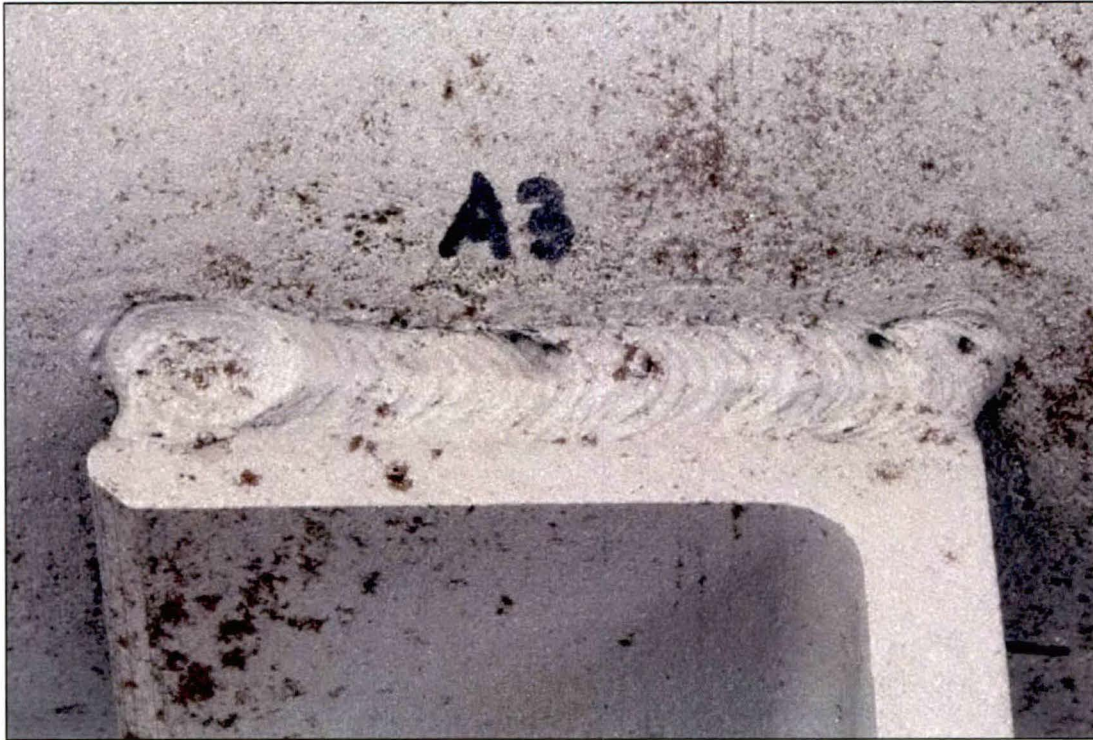
Figure 9. Image of the Lug A3 top weld with some porosity.

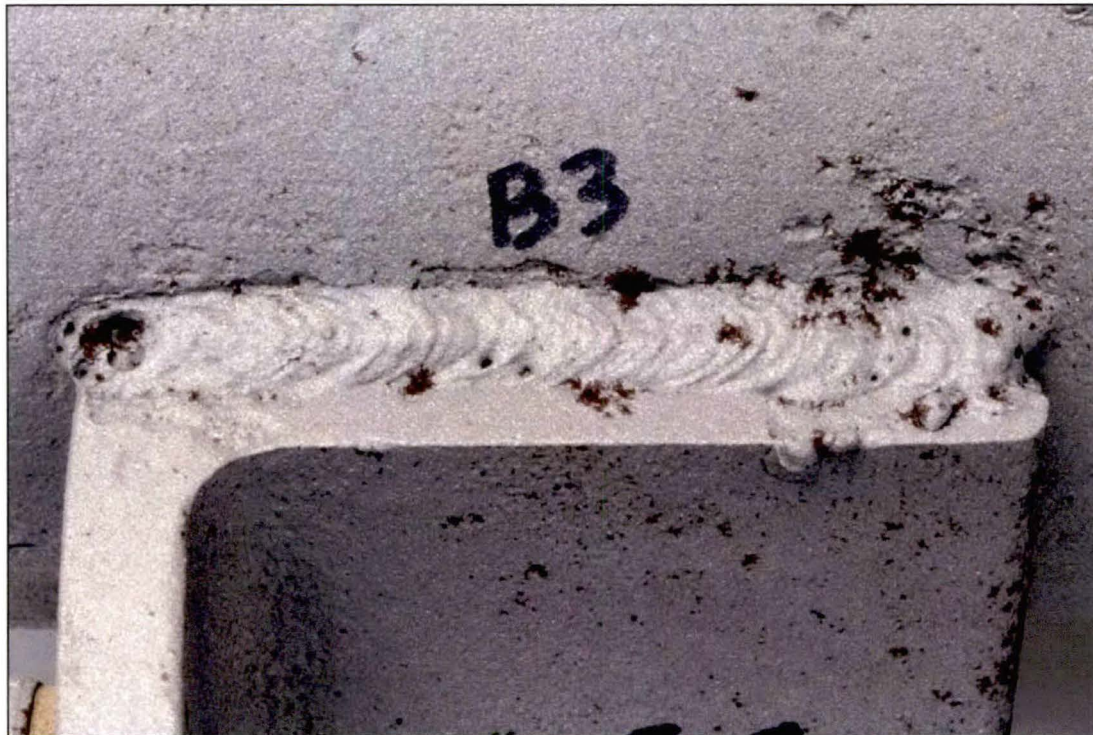
Figure 10. Image of the Lug B3 top weld showing spatter and porosity.

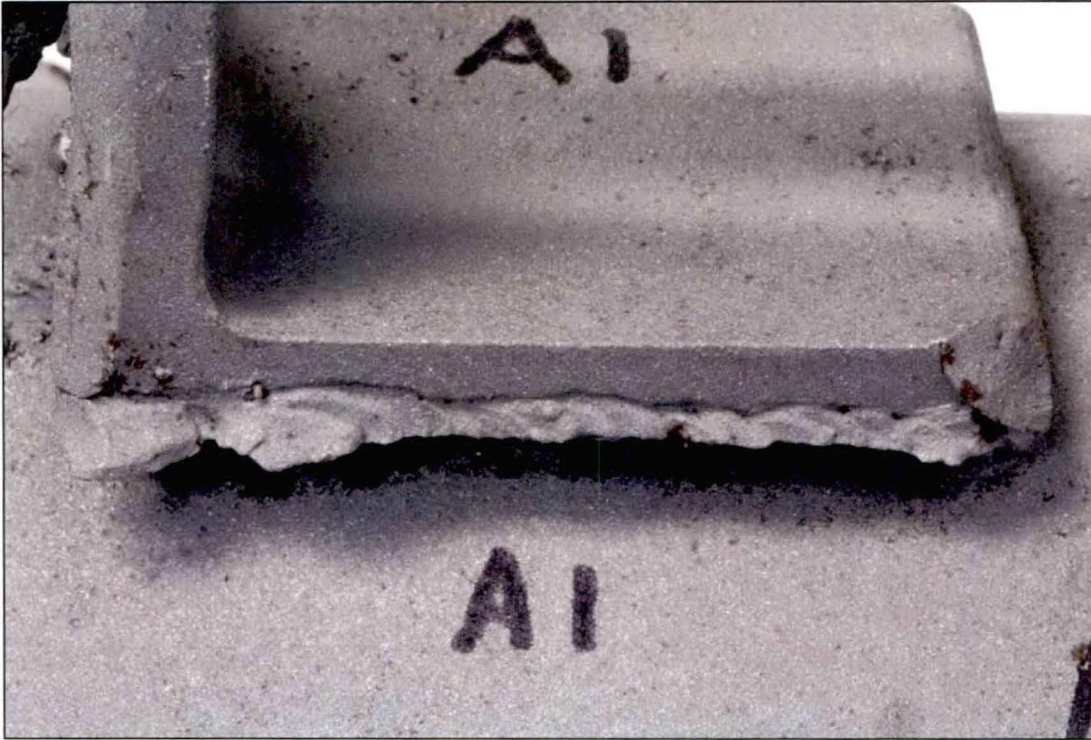
Figure 11. Image of the Lug A1 right side weld which was not fused. Due to the flat lug base configuration, one side of each lug was not properly welded.

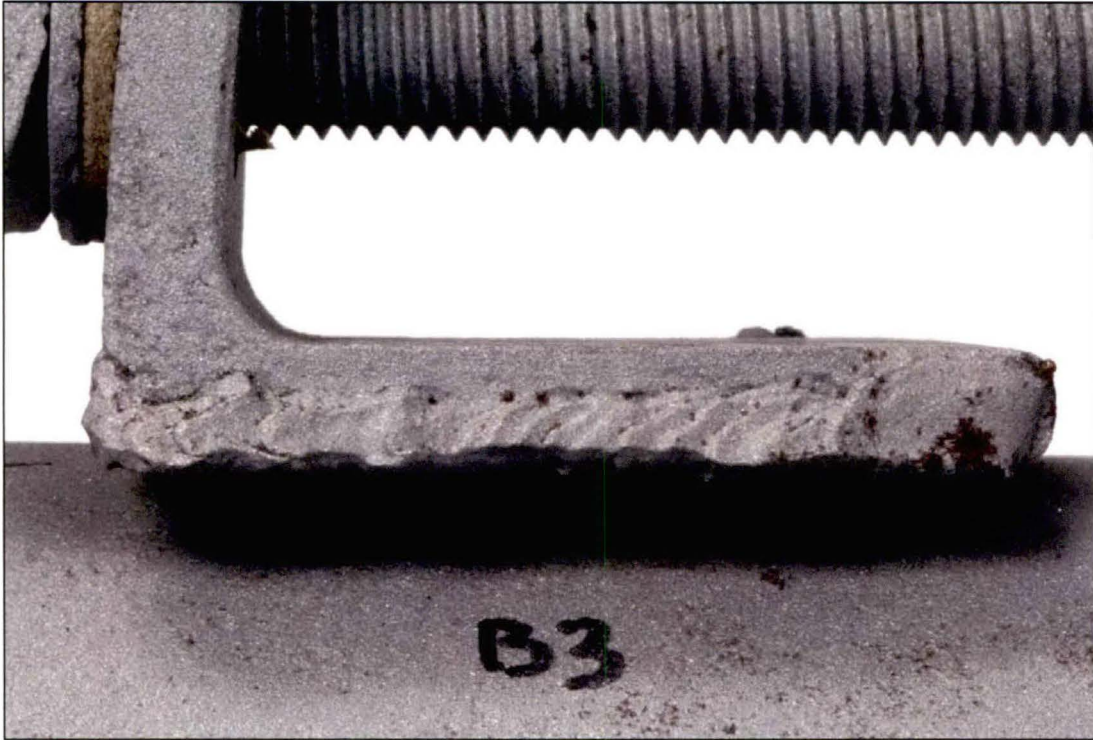
Figure 13. Image of the Lug B3 bottom weld with no fusion.

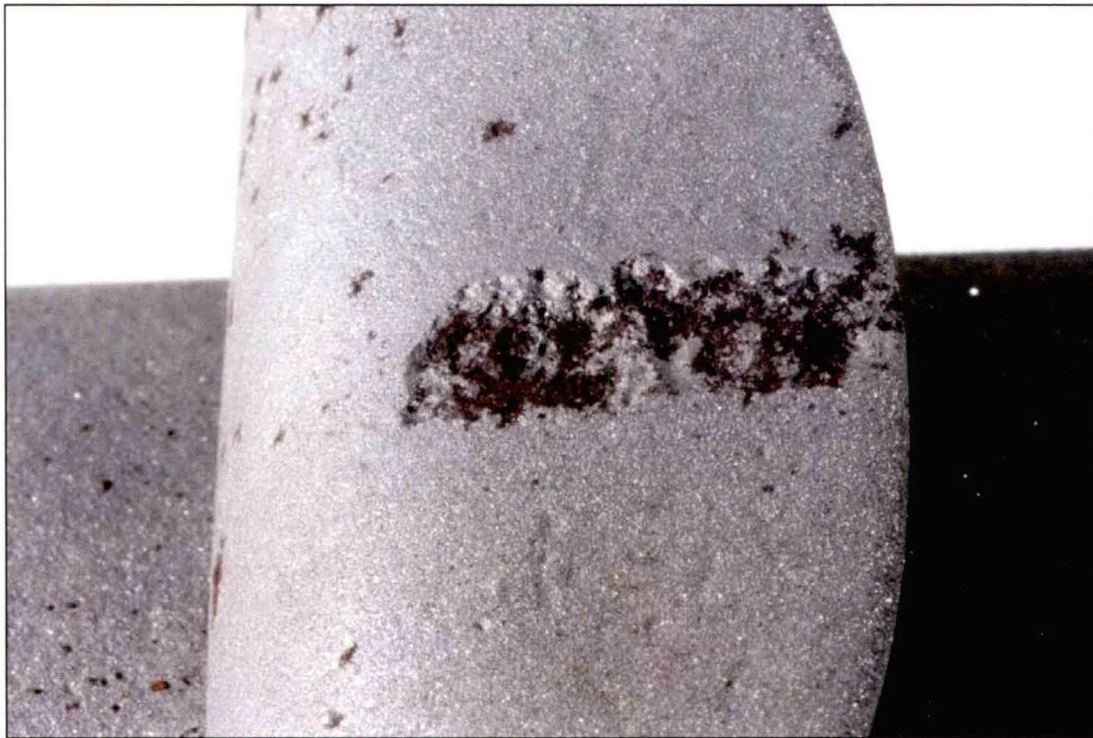
Figure 14. Photograph showing some superficial rust on the coupling surface where a rod had been in close proximity.
