**Louisville Gas and Electric  
Company**  
State Regulation and Rates  
220 West Main Street  
PO Box 32010  
Louisville, Kentucky 40232  
www.lge-ku.com

**RE: *Louisville Gas and Electric Company Alleged Failure to Comply with  
KRS 278.495, 807 KAR 5:022, and 49 C.F.R. Part 192  
Case No. 2017-00119***

The following three couplings were removed from LG&E's transmission system:

## Bolt-Style Coupling (pressures > 3 psig)

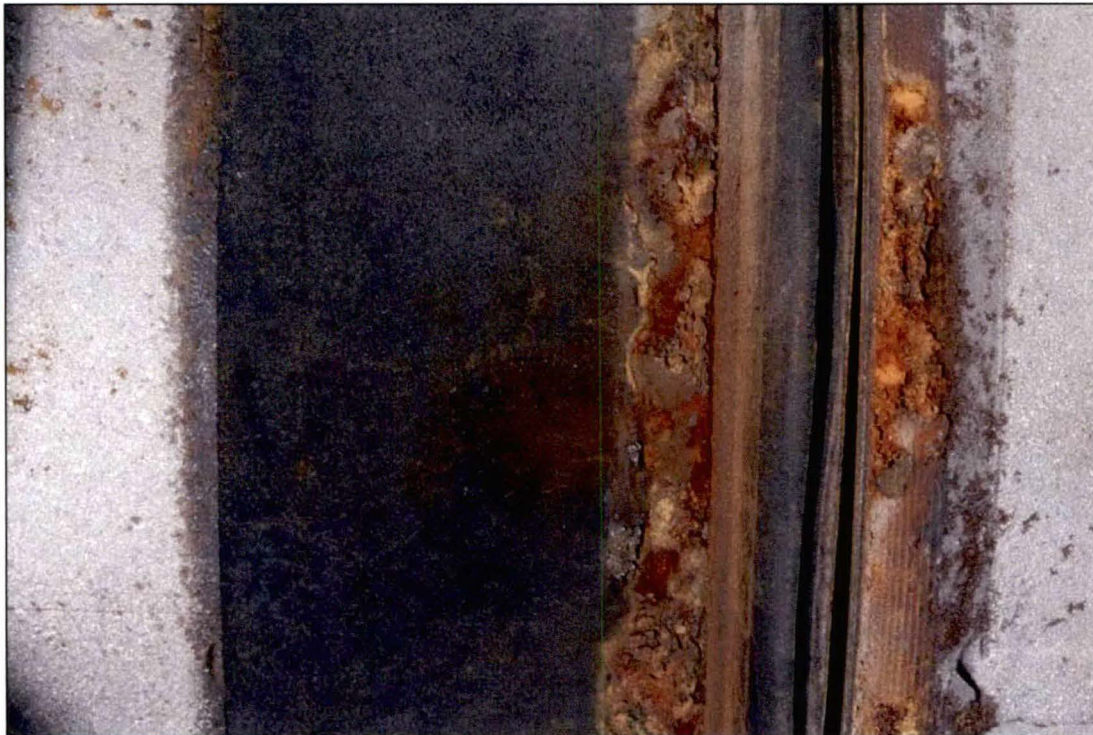
Figure 18. Image of the sleeve on the exterior of the pipe. Some debris was also present.

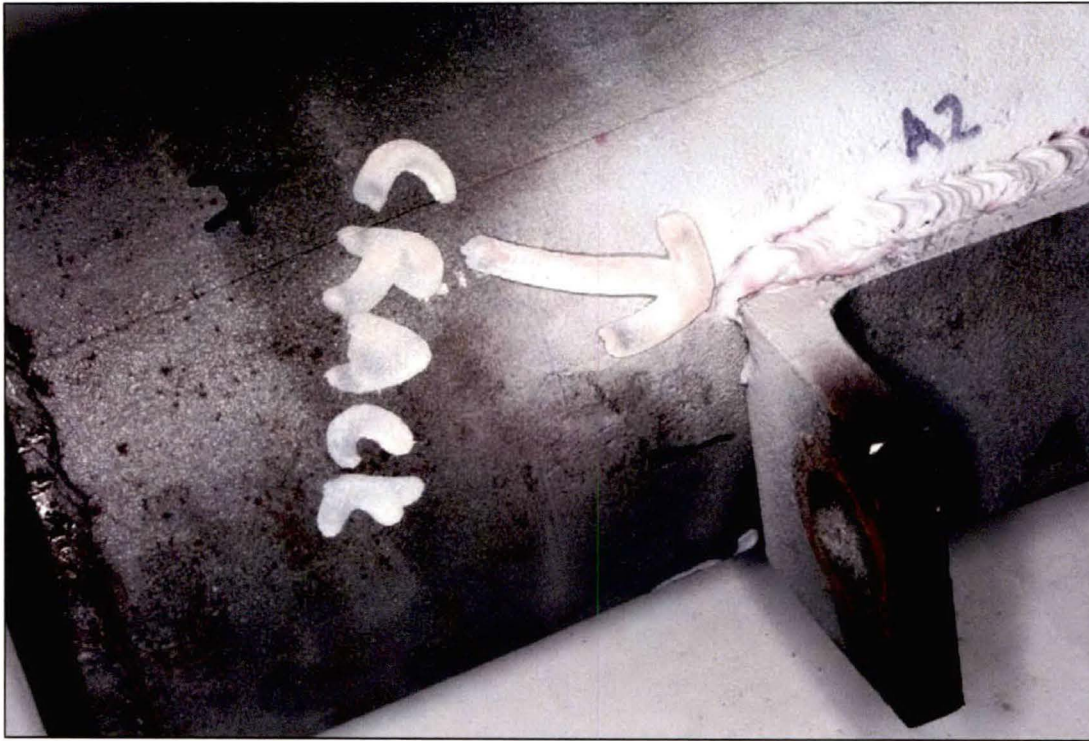
Figure 19. Image of the Lug A2 top weld which exhibited a crack that was detected during dye penetrant inspection.

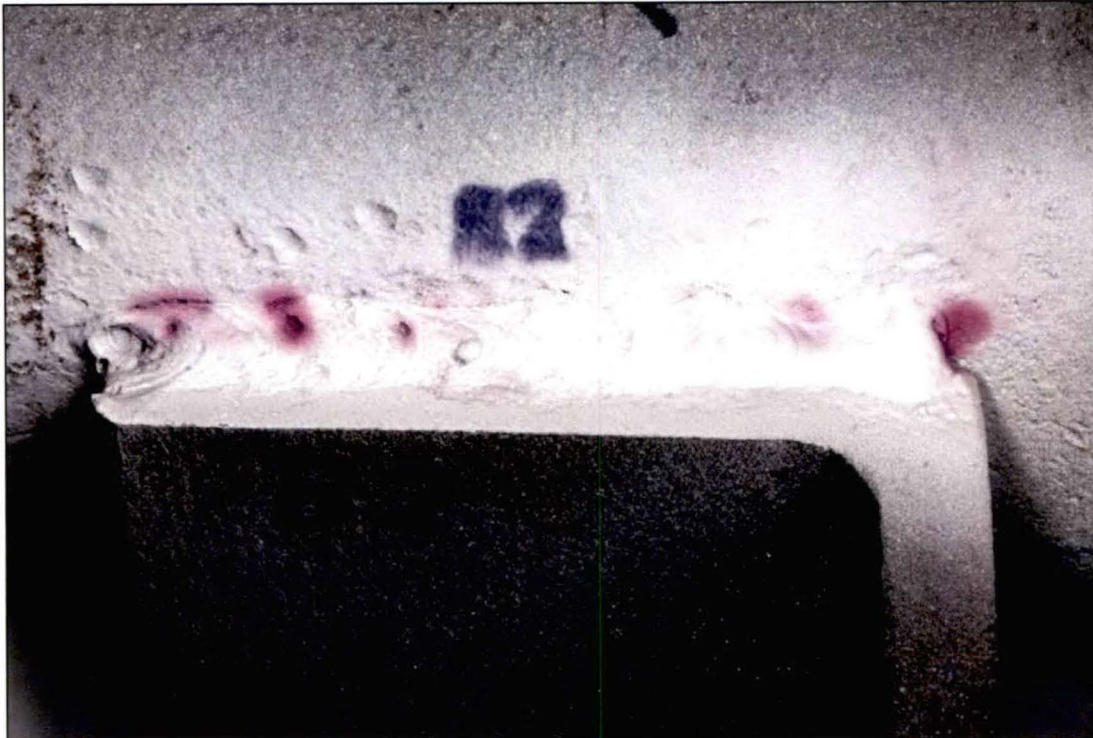
Figure 20. Image of the Lug B2 top weld which exhibited numerous pores.

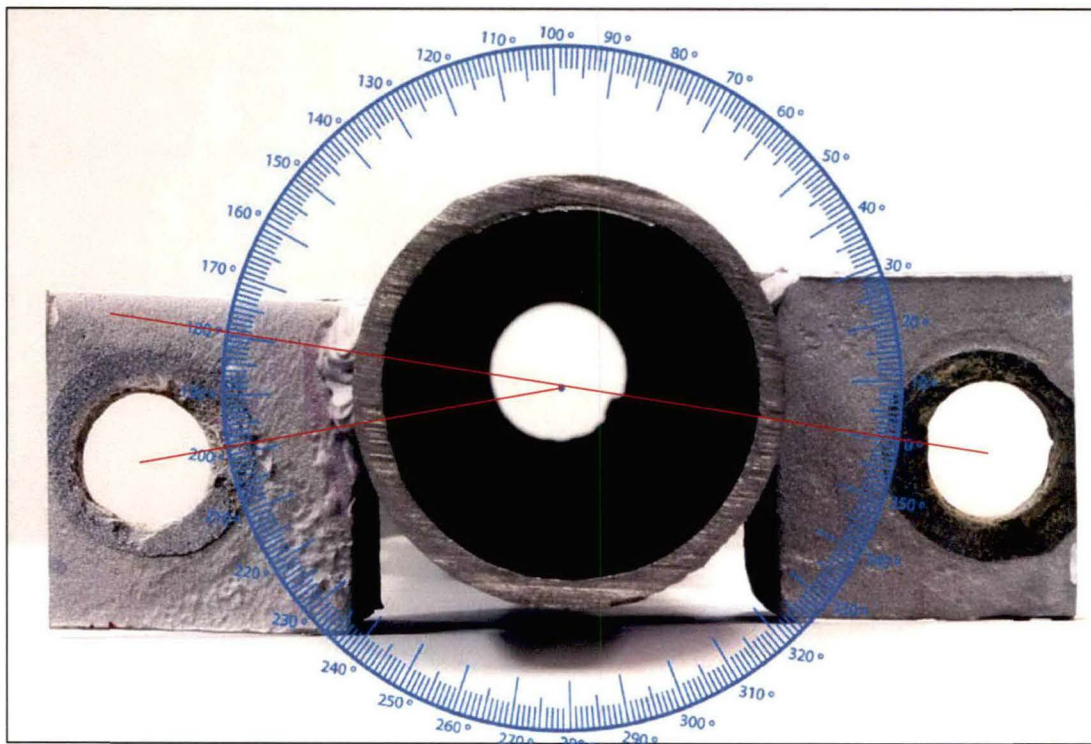
Figure 3. End facing image of the sample at End B. A superimposed protractor shows that the centers of Lugs A1 and A2 were approximately 19° from square.

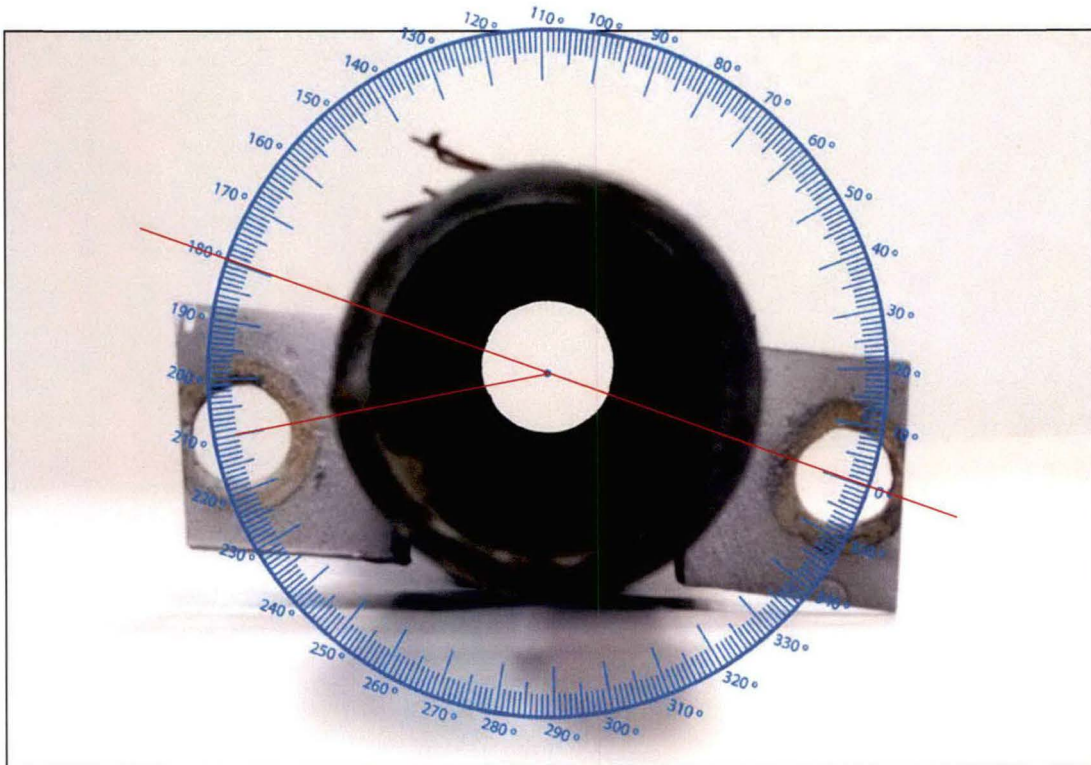
Figure 4. End facing image of the sample at End B. A superimposed protractor shows that the centers of Lugs B1 and B2 were approximately  $30^\circ$  from square.

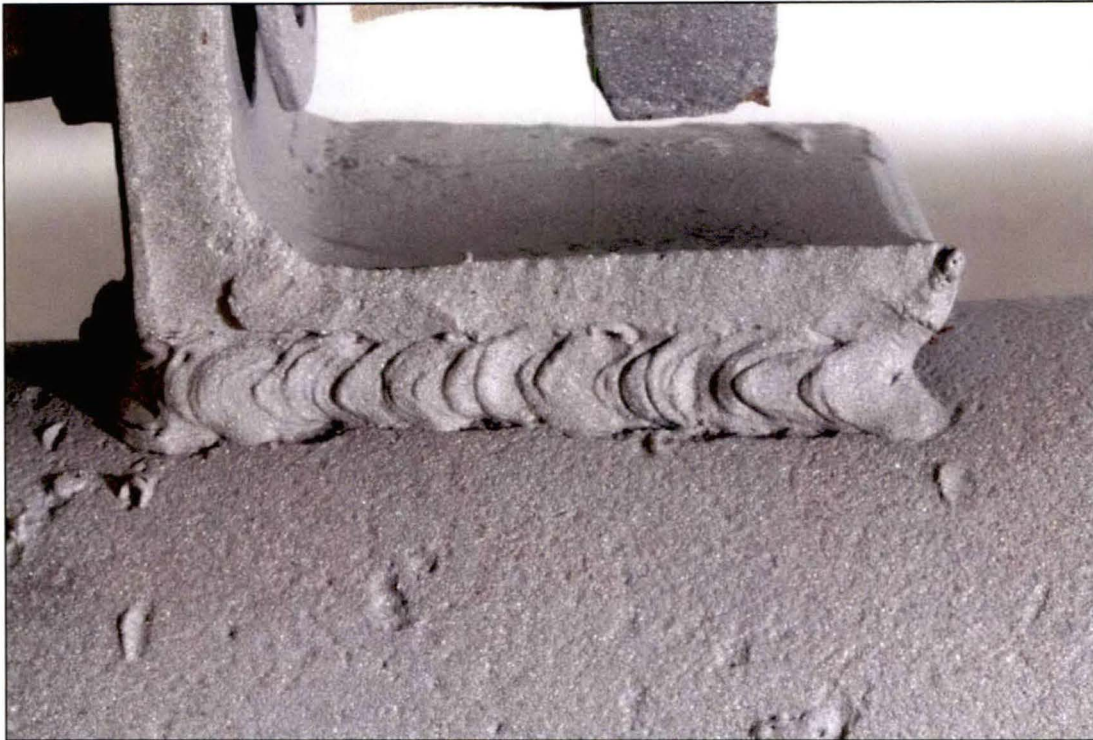
Figure 5. Image of the Lug A1 exterior top weld which exhibited substantial fusion except for some underfill, and undercut.

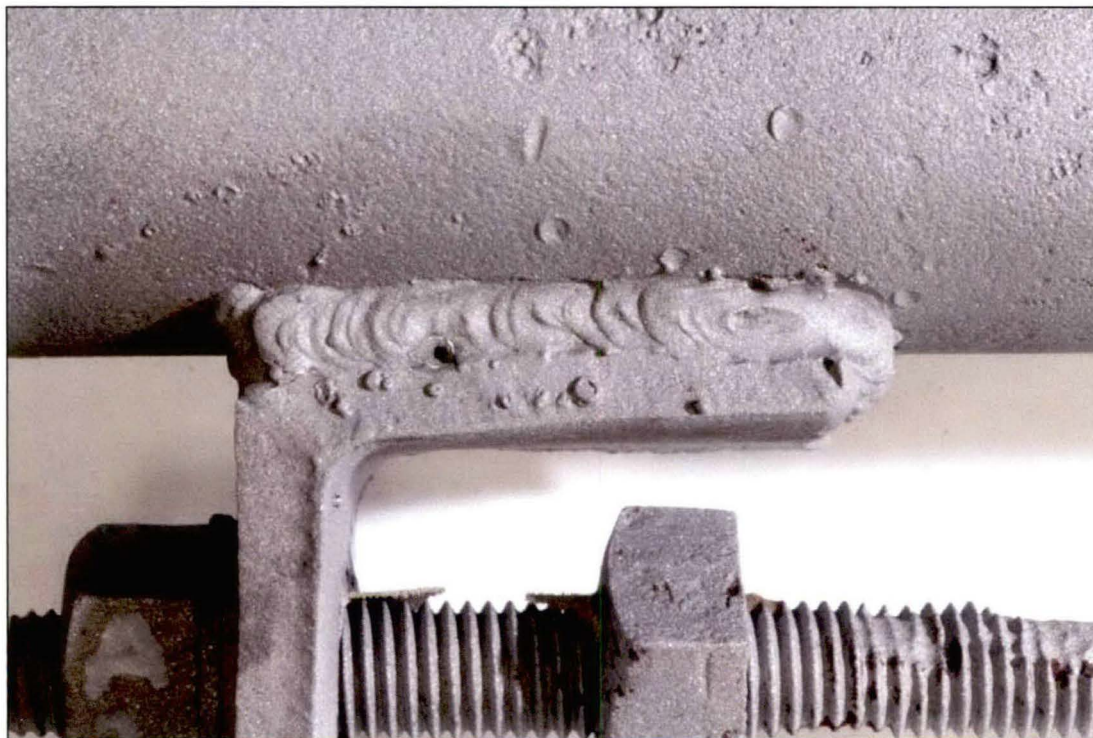
Figure 6. Image of the Lug A2 exterior top weld which exhibited substantial fusion except for some underfill, undercut and spatter.

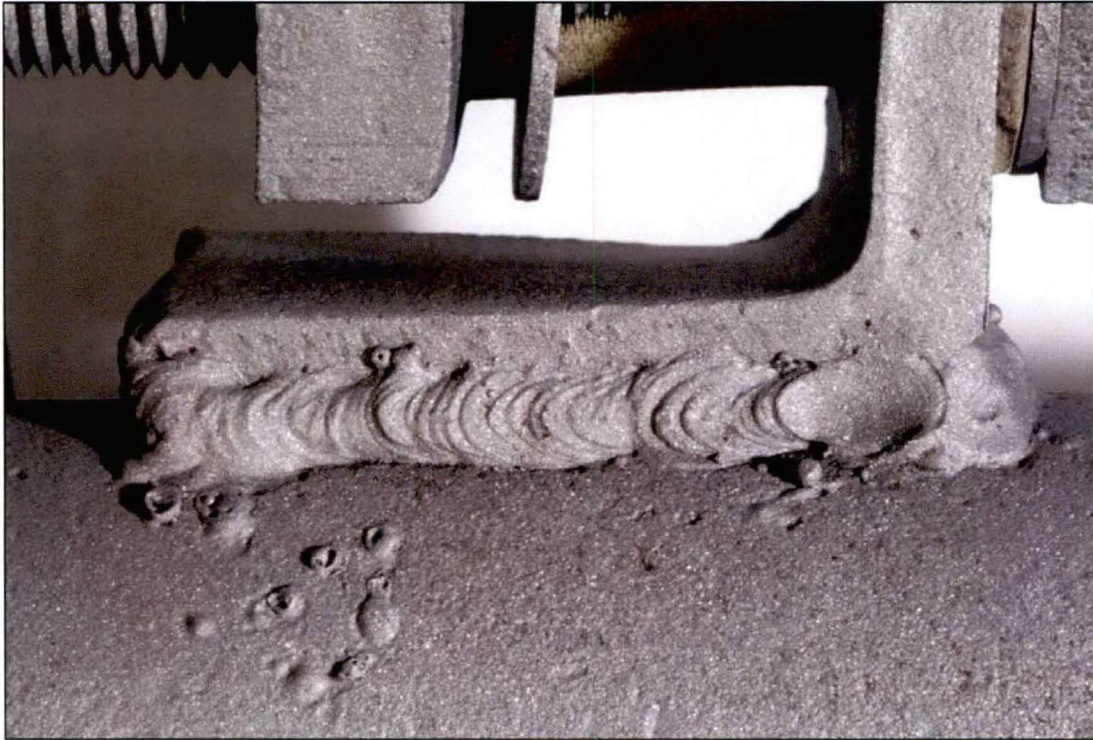
Figure 7. Image of the Lug B1 exterior top weld which exhibited substantial fusion except for some underfill, undercut and spatter.

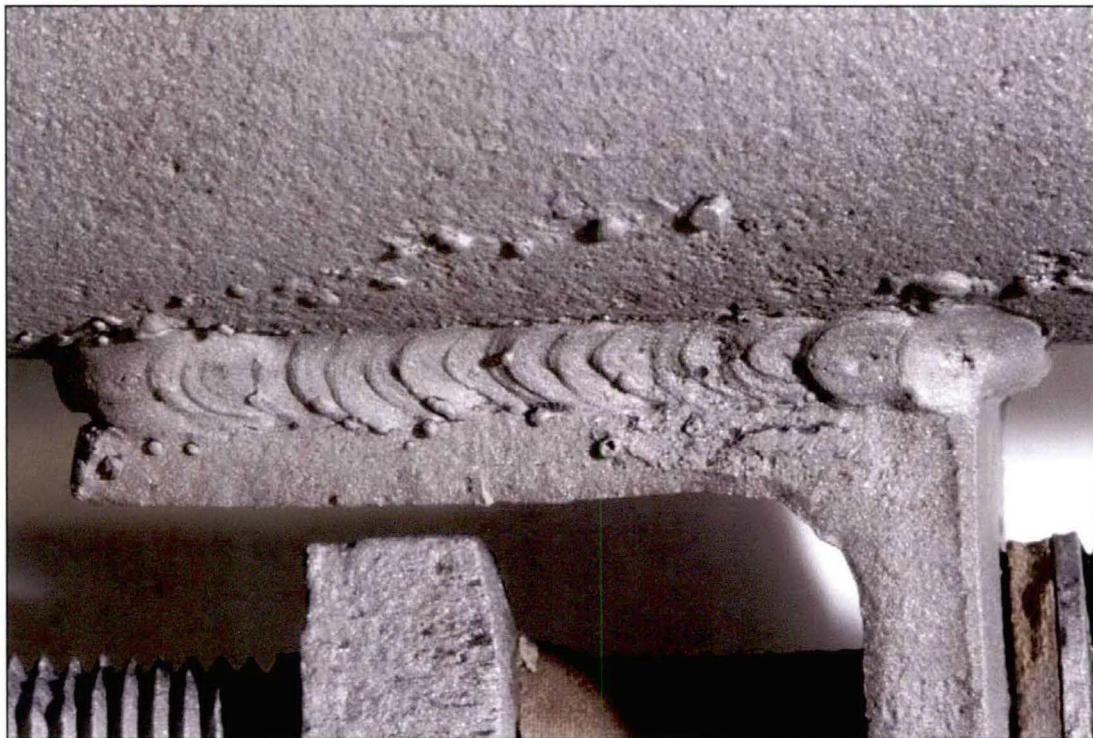
Figure 8. Image of the Lug B2 exterior top weld which exhibited substantial fusion except for some underfill, undercut and spatter.

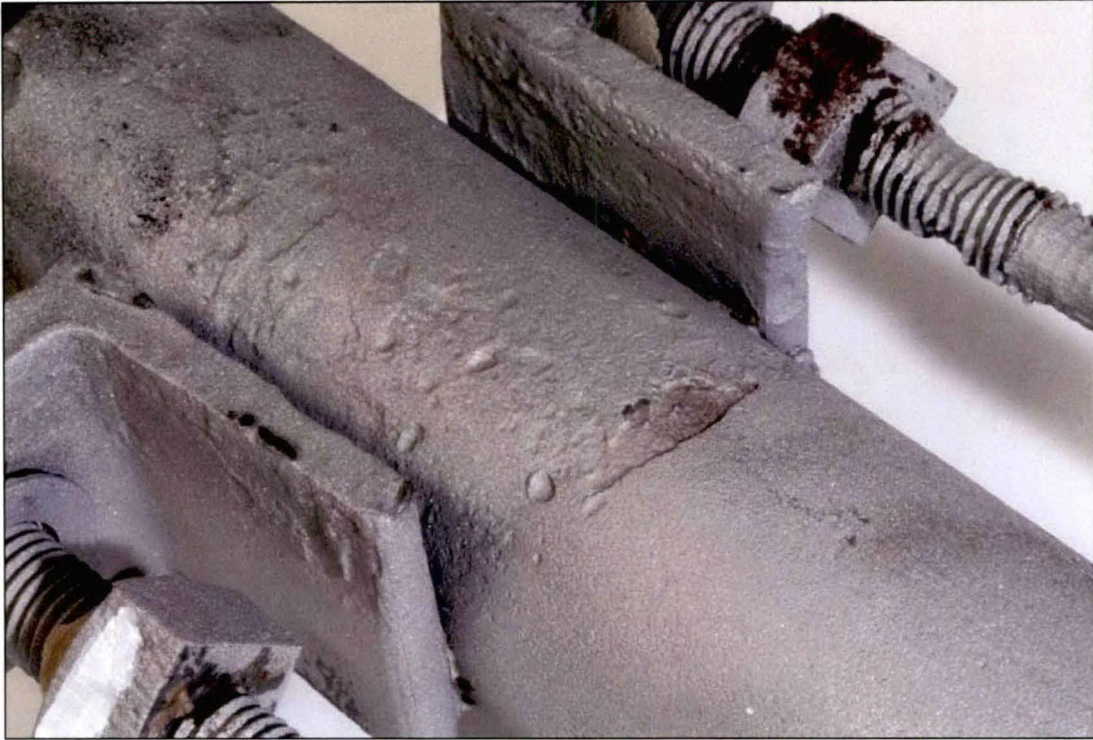
Figure 9. Image of the underside of Lugs A1 and A2 showing that no welding had been performed.

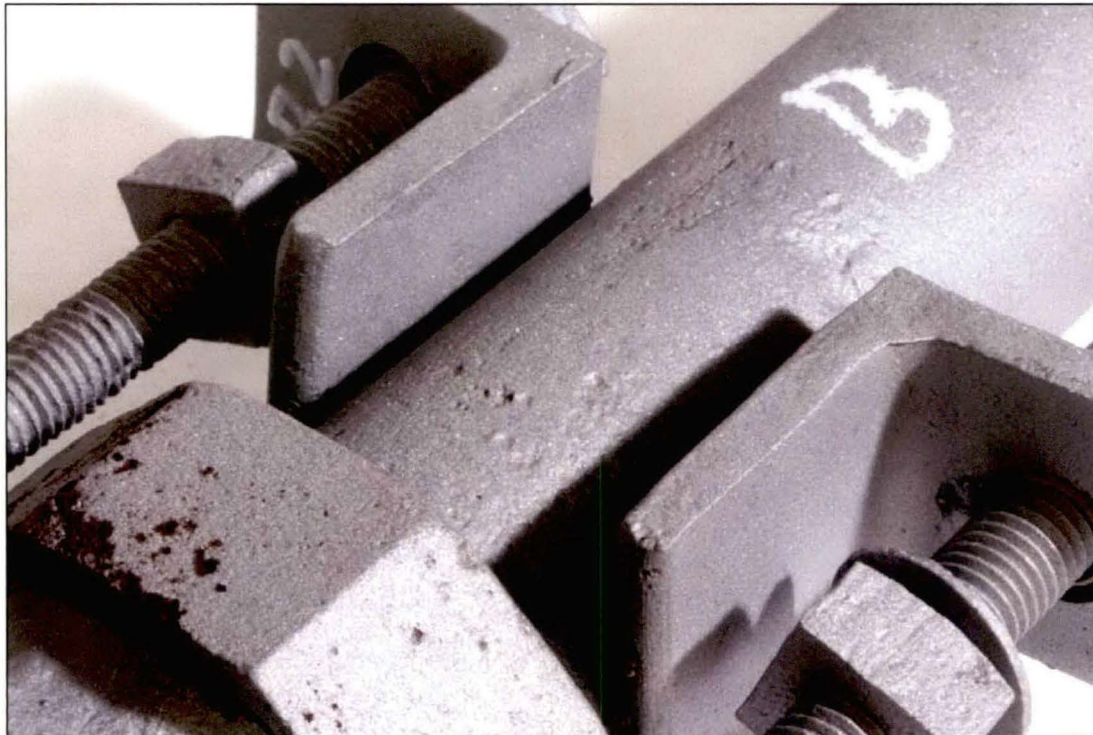
Figure 10. Image of the underside of Lugs B1 and B2 showing that no welding had been performed.

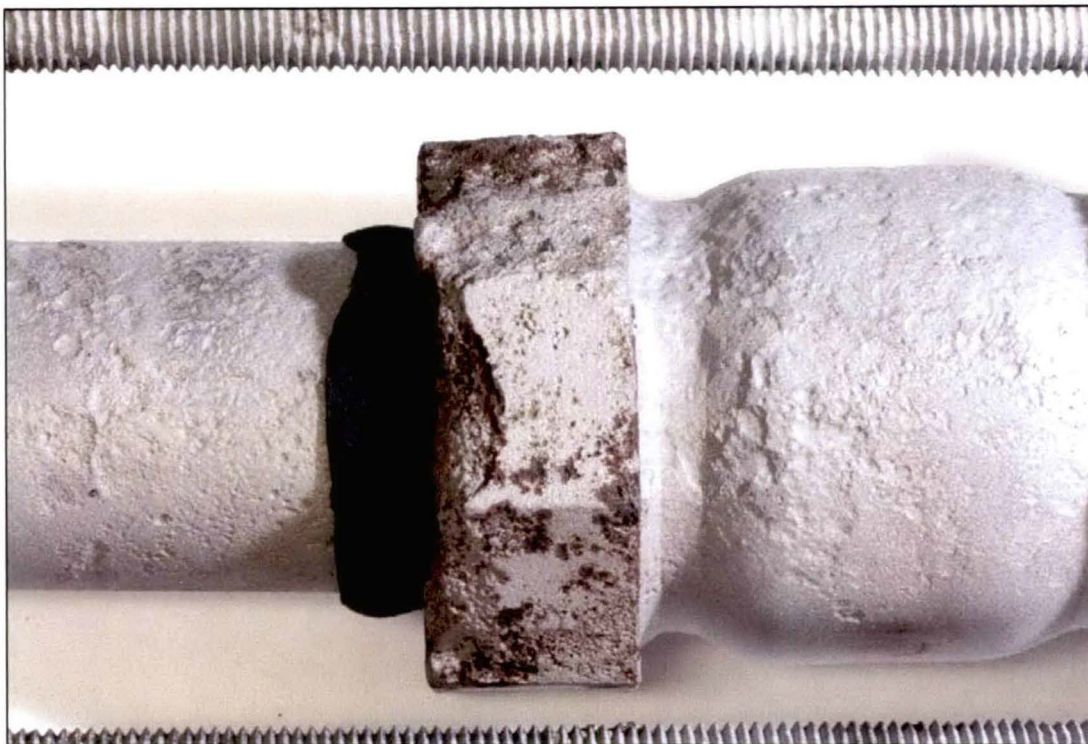
The coupling and harness rods were also inspected for corrosion alteration. Figure 11 shows the rusting damage to the coupling after the prior sandblasting. The observations for the rods are provided

Figure 11. Photograph of a corroded region on the bottom of the coupling.

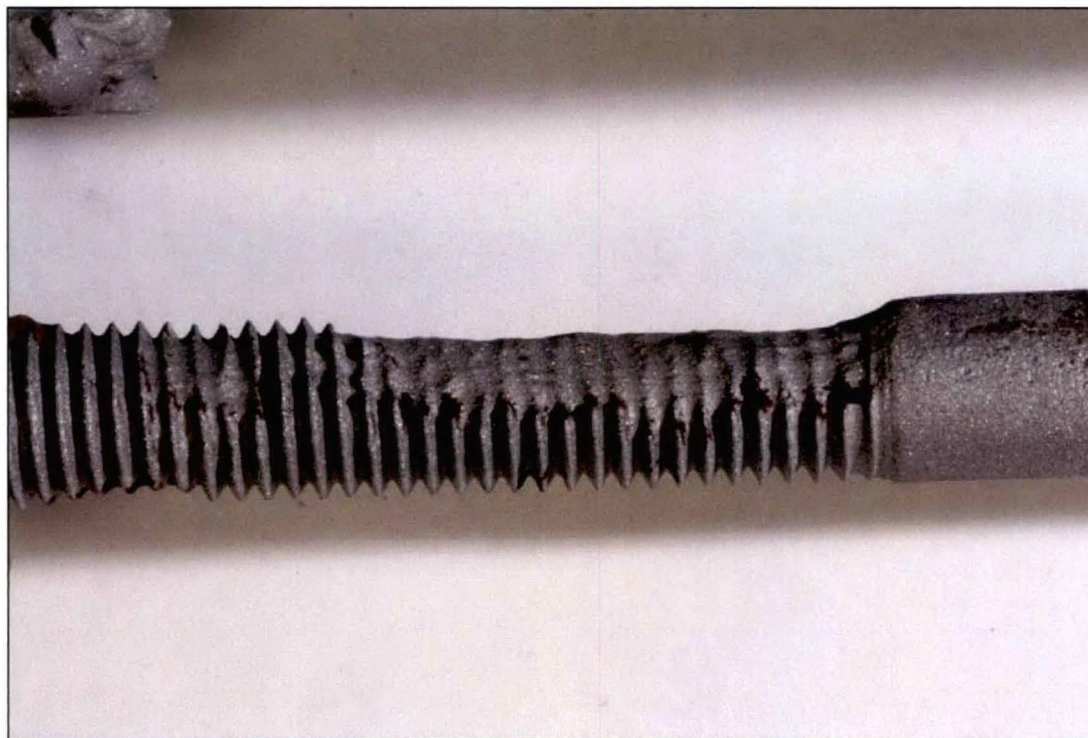
Figure 12. Photograph of the worst corrosion on one of the rods.
