**RE: Louisville Gas and Electric Company Alleged Failure to Comply with
KRS 278.495, 807 KAR 5:022, and 49 C.F.R. Part 192
Case No. 2017-00119**

Louisville Gas and Electric Company
2019 Annual Report
Case No. 2017-00119

In accordance with the Kentucky Public Service Commission's Order of March 16, 2018 in Case No. 2017-00119, Louisville Gas and Electric Company ("LG&E") submit the second annual report for the years 2018 – 2022. The annual report provides a status on the implementation of LG&E's Action Plan and the number of bolted-style coupling systems removed in 2019 from distribution lines having an operating pressure in excess of 60 psig along with observations of the removed couplings.

Distribution Couplings removed from the ground:

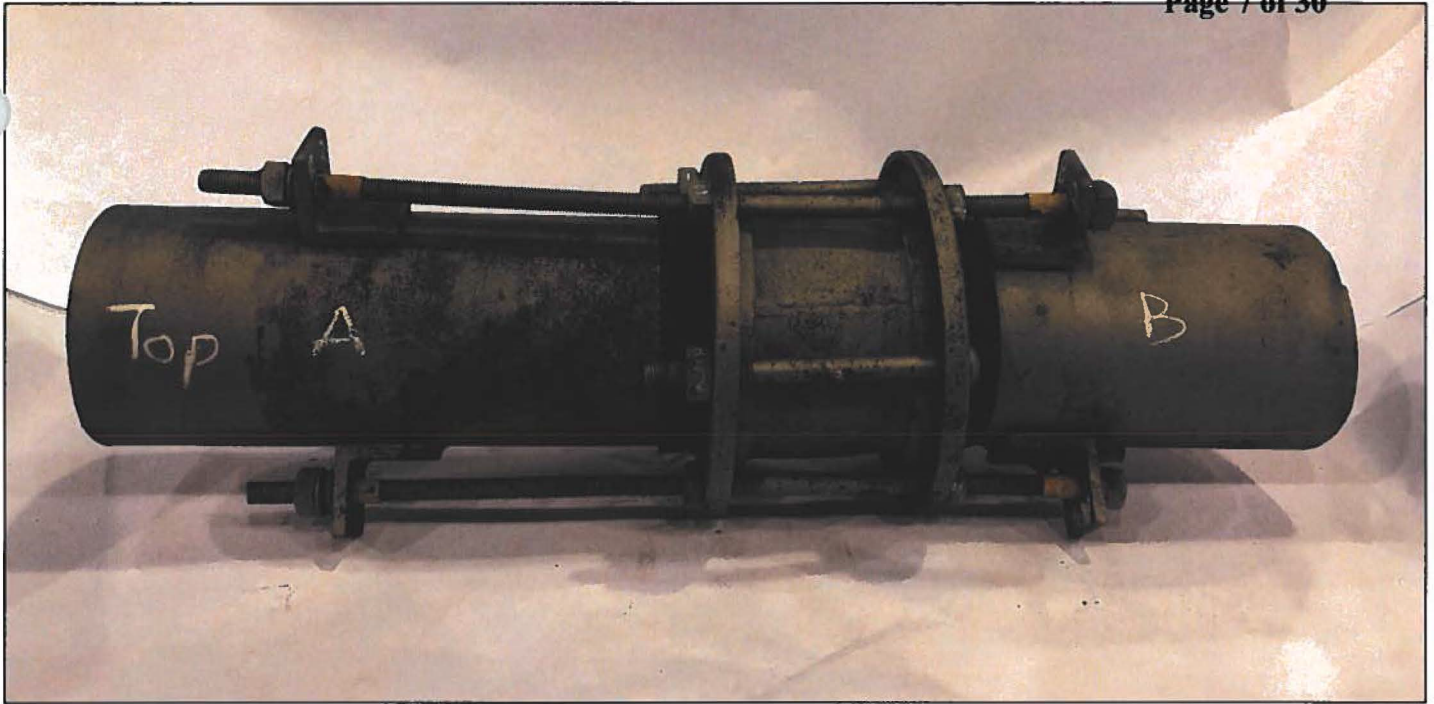
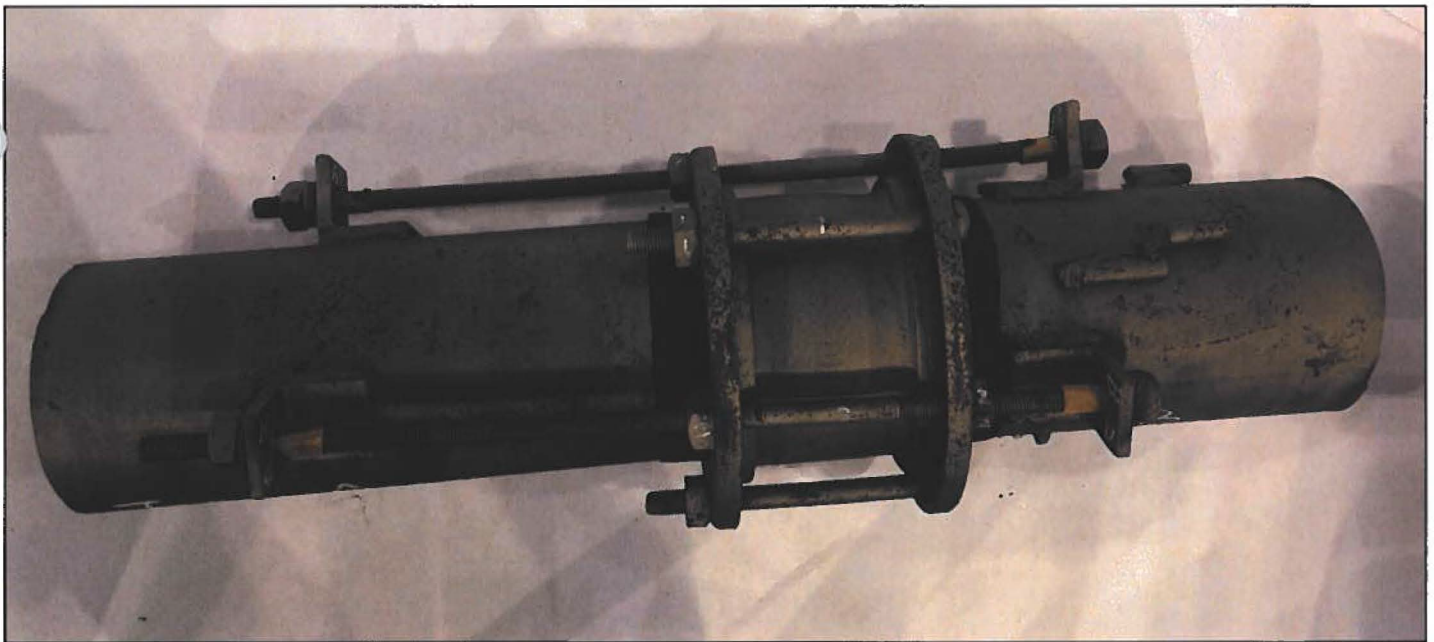
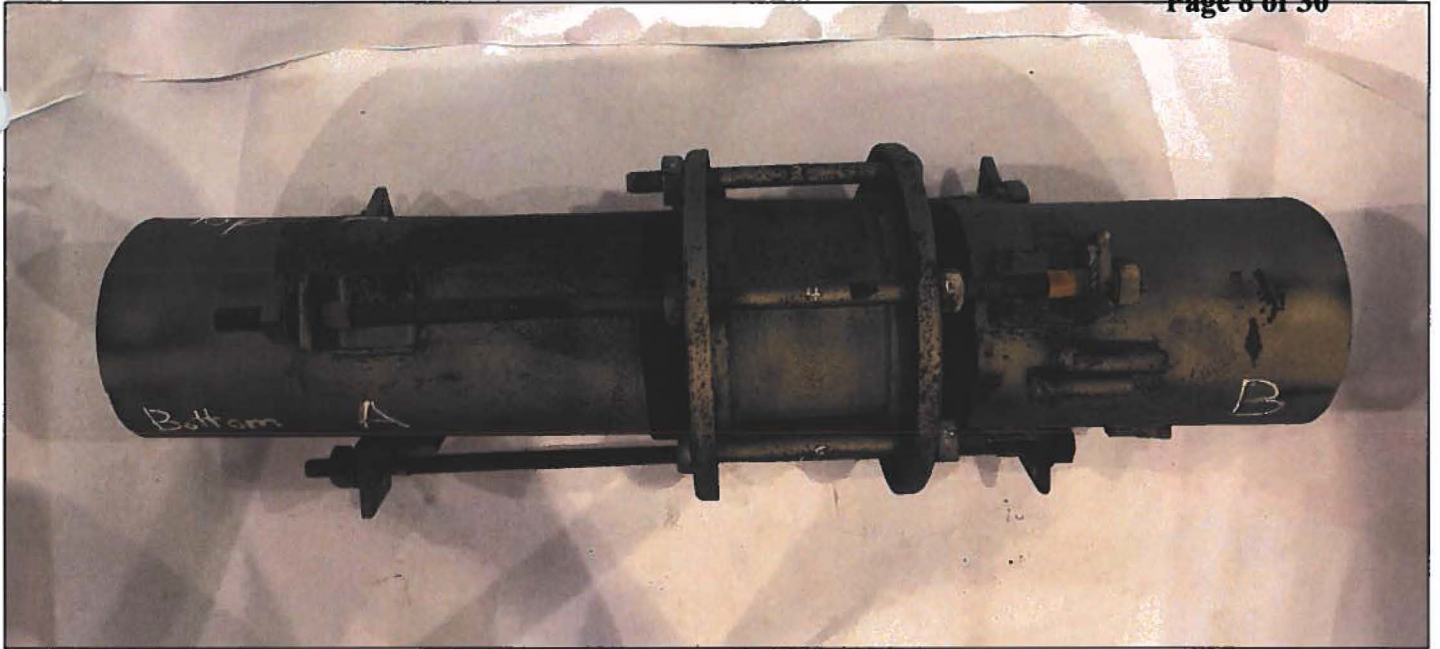
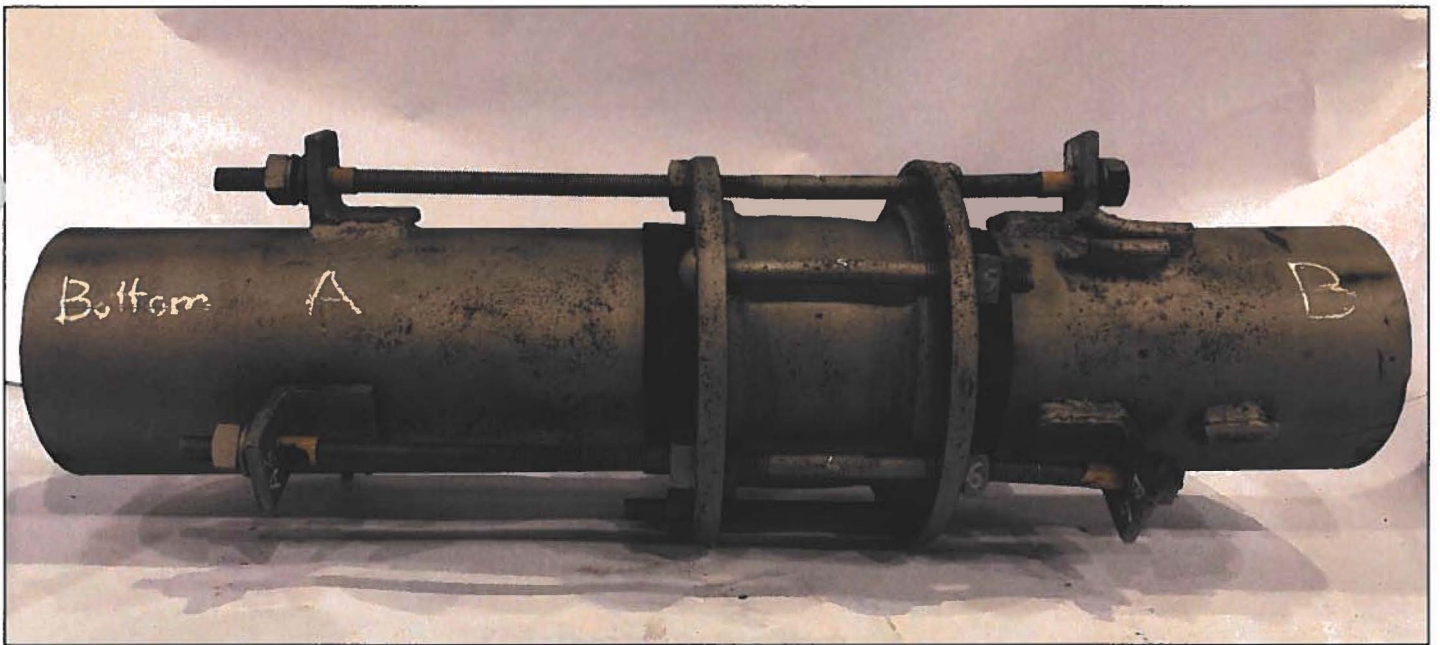
¹ The 3 reinforcement rods are threaded through the coupling body. They were used in place of 3 bolts. See Figures 1-4.**Table 2- Corrosion**

- Rubber Seals are intact
- The reinforcement rods are threaded through the body of the coupling instead of using provided bolts
- Some of the nuts on the rods are not fully threaded. In the worst case, the rod is not threaded half way into the nut. In figure 7, the pen is inserted more than 3/8 inch into the hole. The nut is almost 5/8 inch thick.

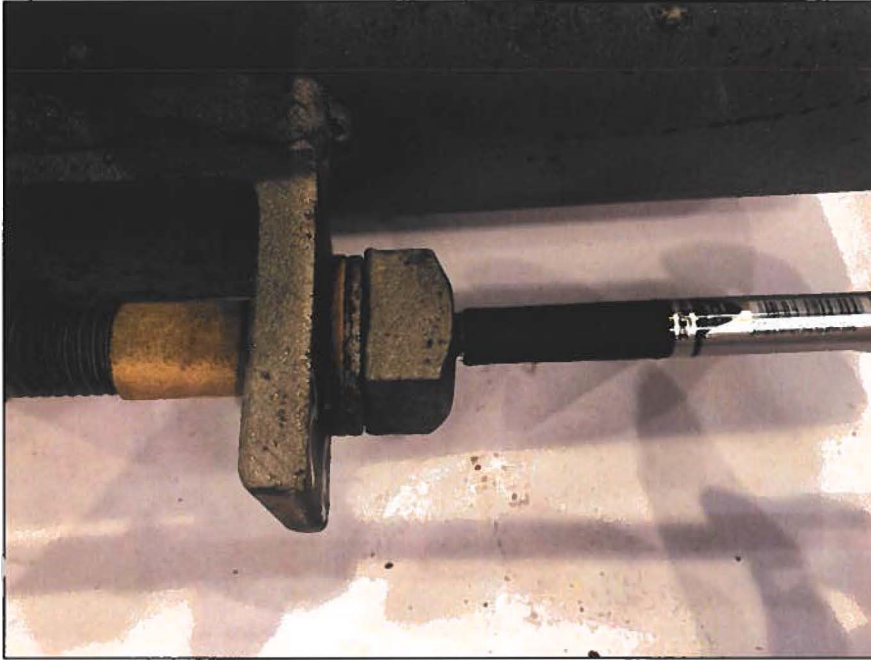
Figure 7- Depth of pen in nut

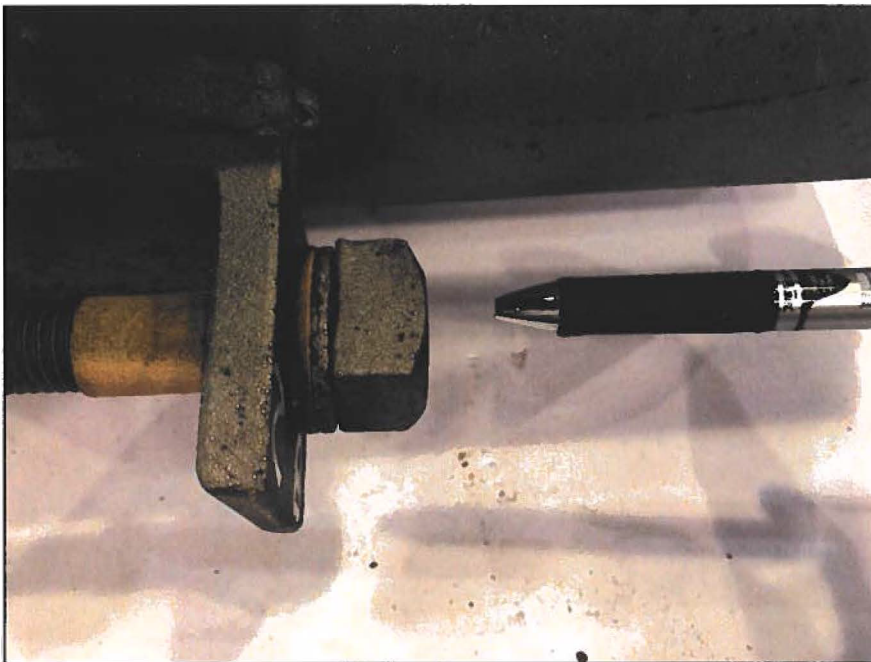
Figure 8- View of pen outside of nut

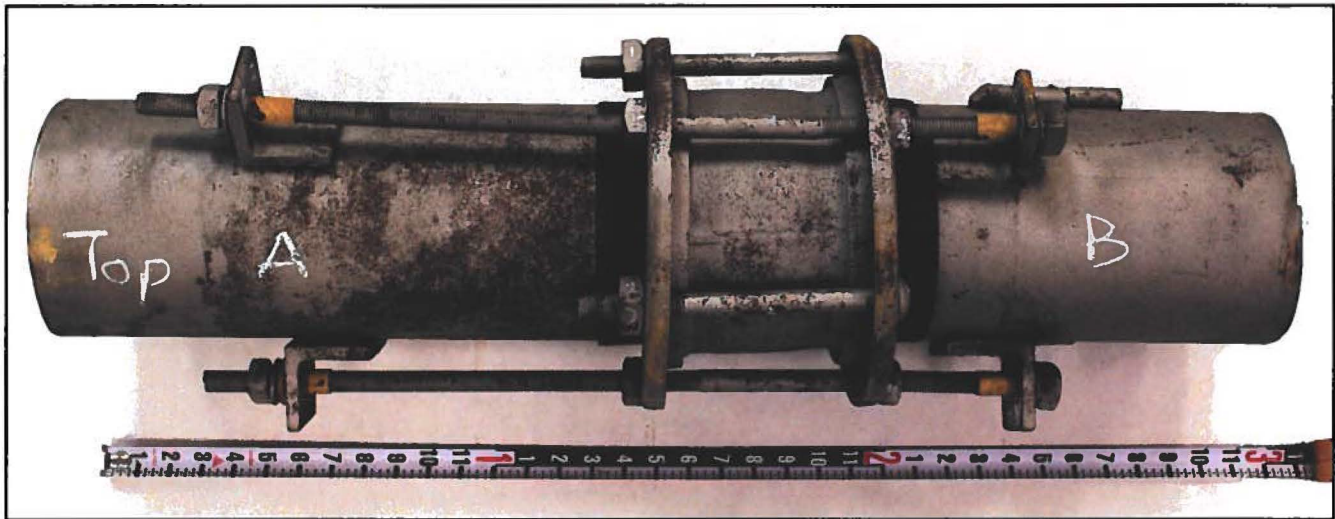
The submitted pipe section with the coupling is shown in Figures 1 through 4. Three lugs of the joint harnesses had been fillet welded to both pipe segments. Three rods and associated nuts had been affixed through the welded lugs to apply compression to the coupled joint. The coupling consisted of a steel coupling with an interior nonmetallic gasket / sleeve. Prior to receipt, the ends of the pipe segment were labelled as Ends A and B, as shown in Figures 1 through 4. The top and bottom of the coupling section were also marked. Lugs A2, A4 and A6 were welded to Pipe A, and Lugs B2, B4 and B6 were welded to Pipe B. The rod between Lugs A2 and B2 was identified as Rod 2. The remaining lugs were identified in a corresponding fashion.

Atypical for the couplings, three of the coupling holes accommodated the rods with standard bolts through the remaining three coupling holes. Many secondary welds without lugs were evident.

Figure 1. Photograph of the top of the submitted coupling sample.

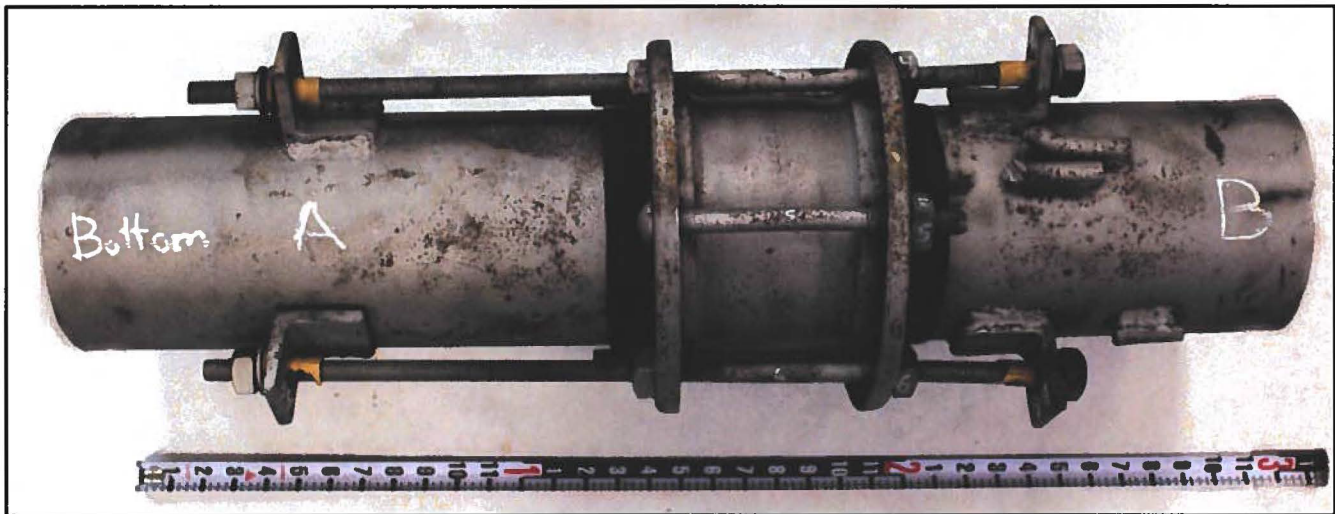
Figure 2. Photograph of the bottom of the submitted sample.

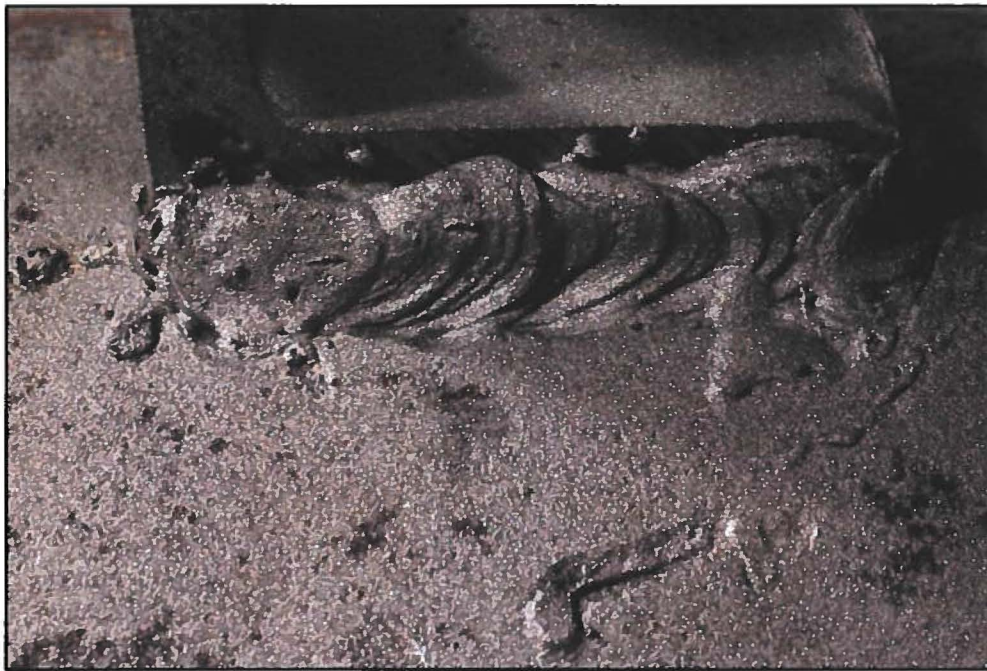
Figure 5. Image of the Lug A4 exterior bottom weld which exhibited substantial fusion except for some arc burn, porosity and spatter.

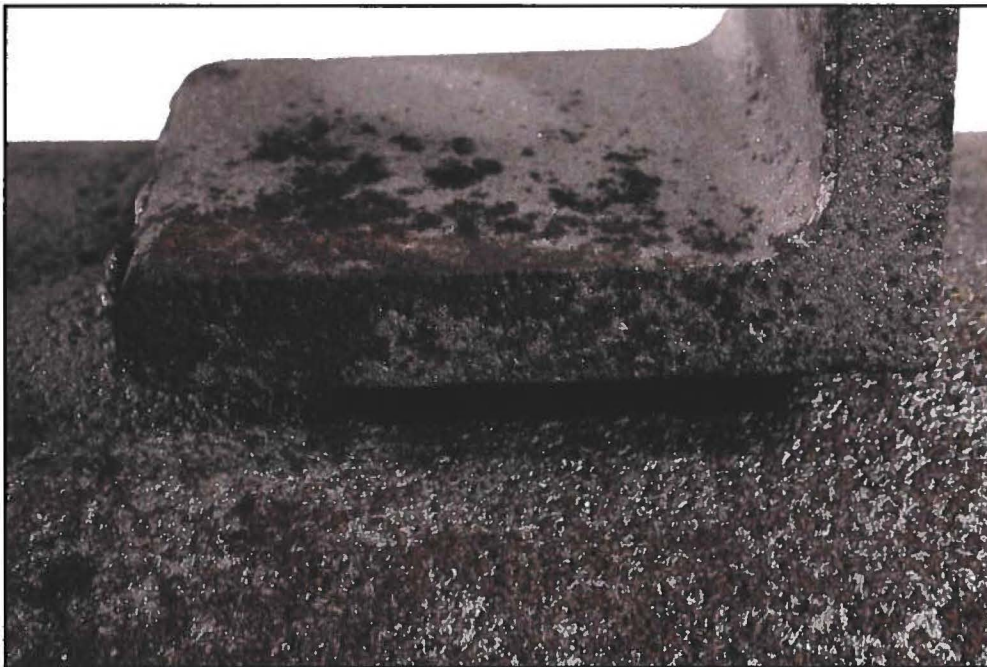
Figure 6. Image of the Lug A4 exterior top weld which exhibited no fusion.

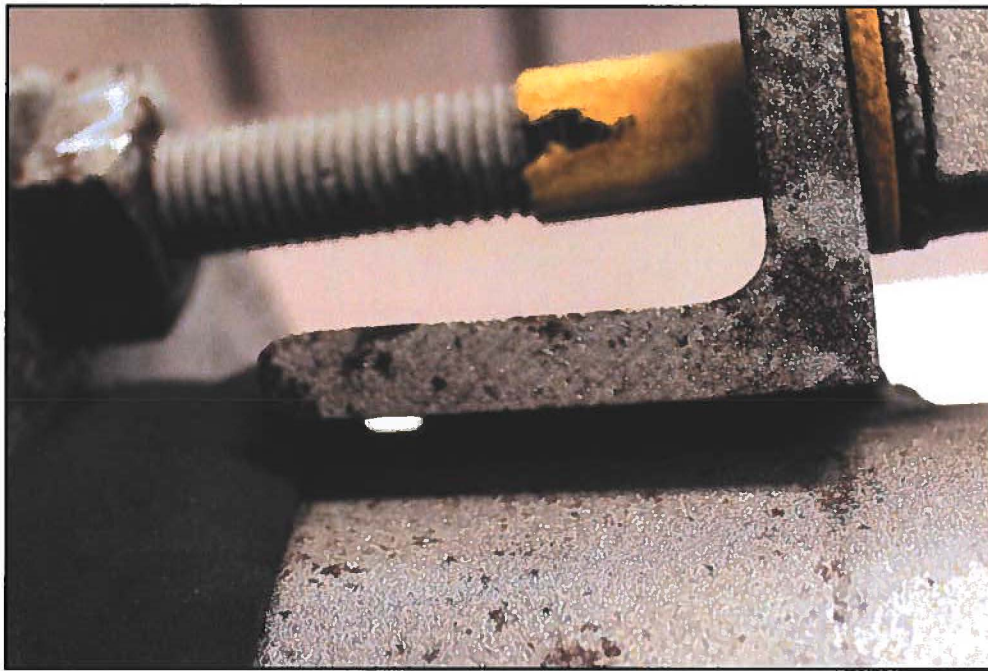
Figure 7. Image of the Lug B2 exterior top weld which exhibited no fusion.

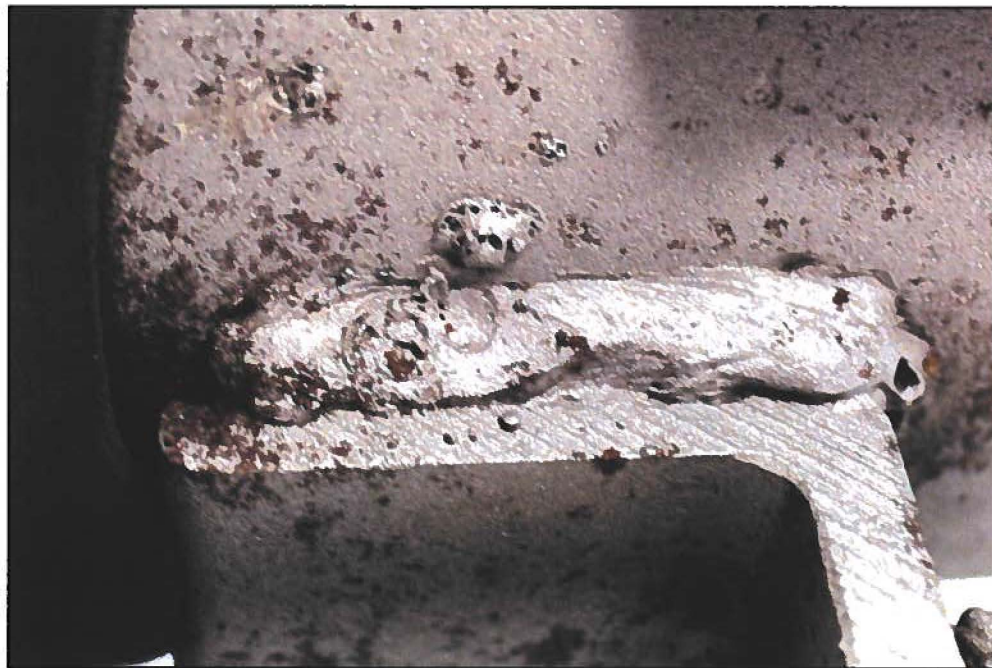
Figure 8. Image of the Lug B2 exterior bottom weld which exhibited substantial fusion except for some arc burn, spatter, porosity and undercut.

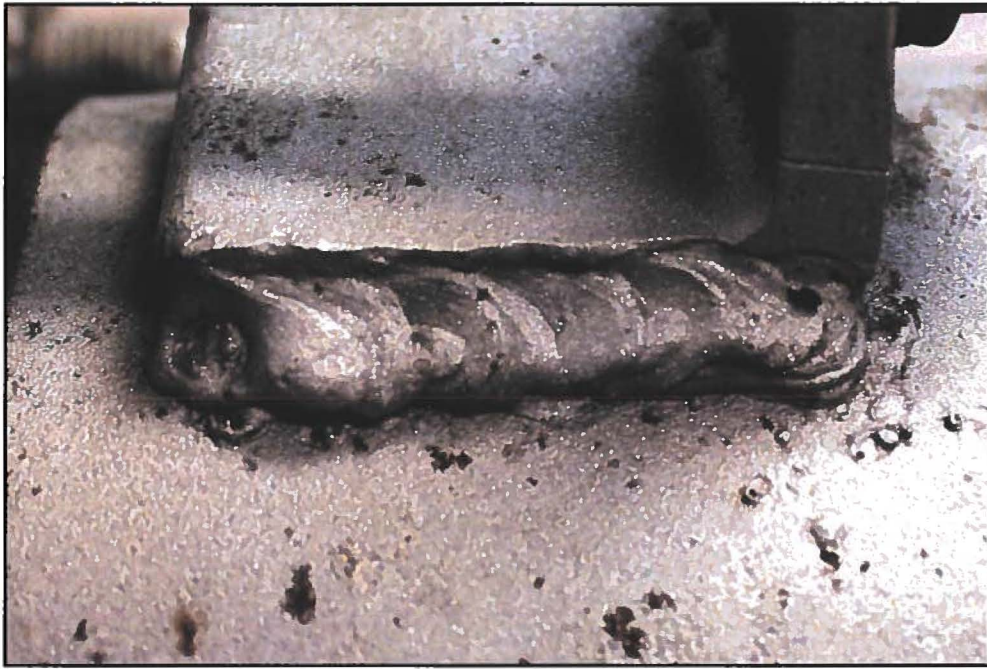
Figure 9. Image of the Lug B6 exterior top weld which exhibited substantial fusion except for some arc burn, porosity, spatter and undercut.

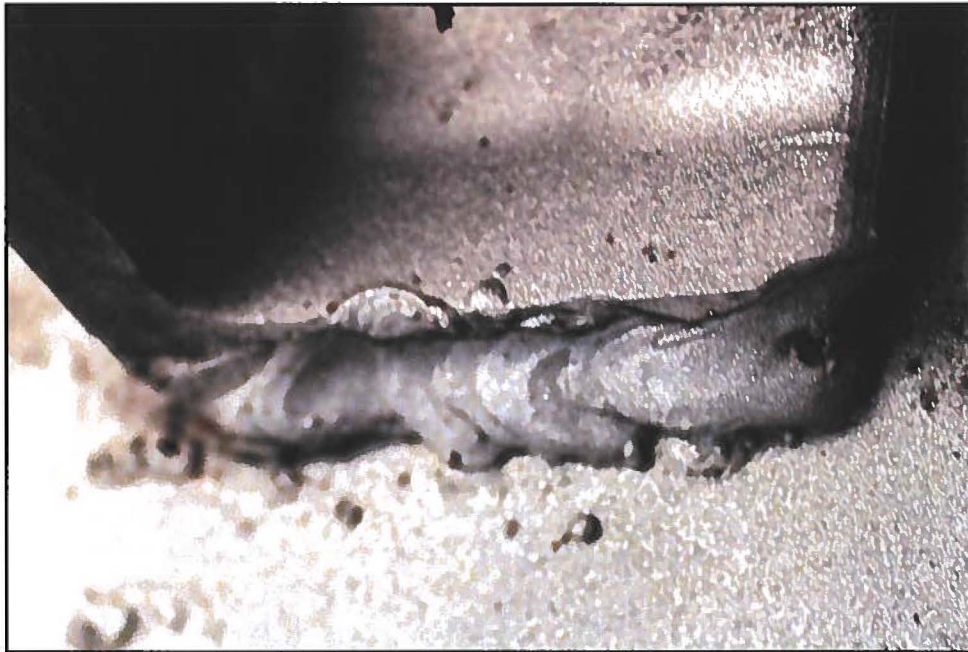
Figure 10. Image of the Lug B6 exterior bottom weld which exhibited substantial fusion except for some arc burn, porosity, spatter and undercut.

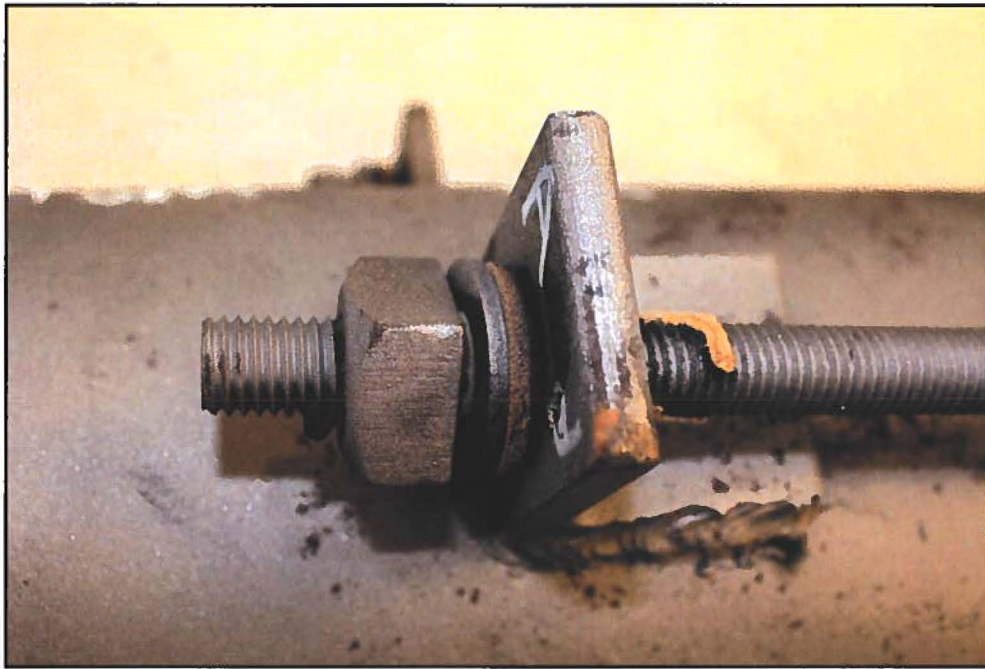
Figure 11. Image of the Lug A6 fastener assembly which was loose.

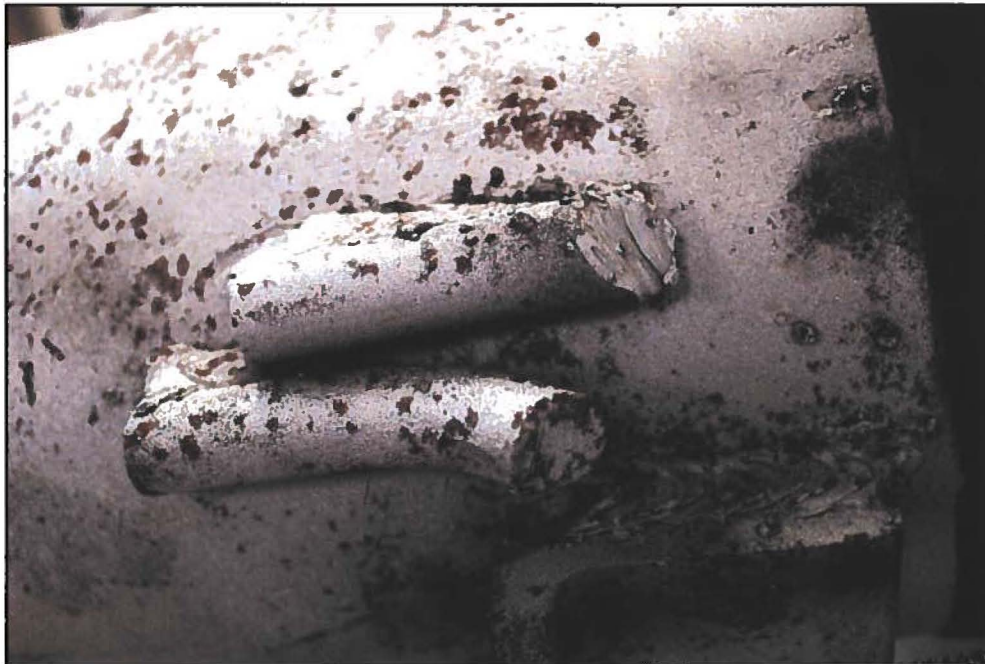
Figure 12. Image of the remainders of additional rods, which had been welded then cut off, present on Side B of the assembly.

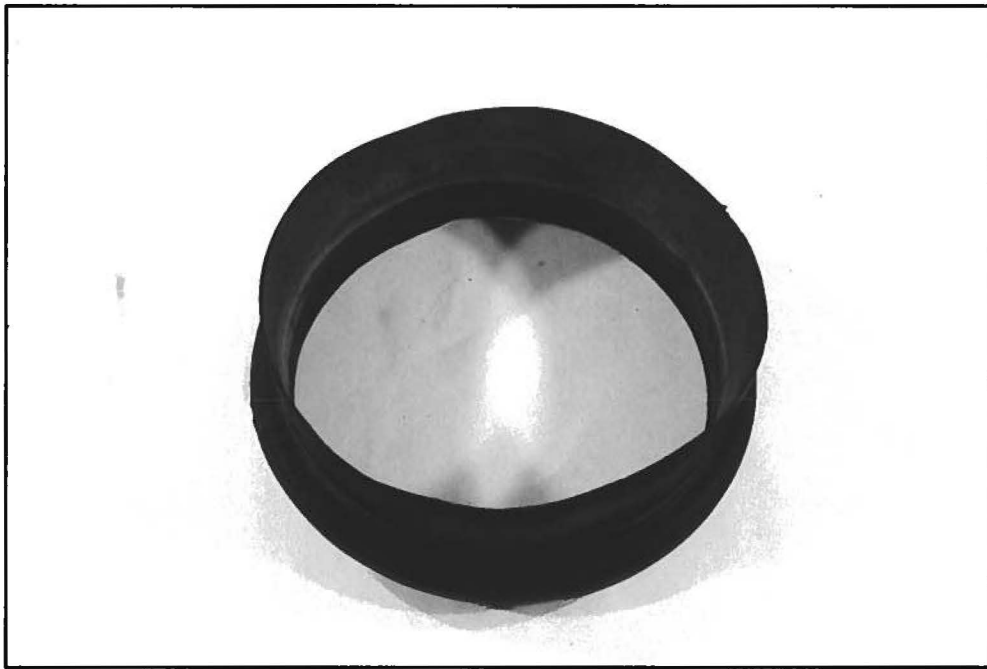
Figure 13. Image of the Side A gasket which was mostly intact and separated entirely from its housing upon disassembly of the coupling.

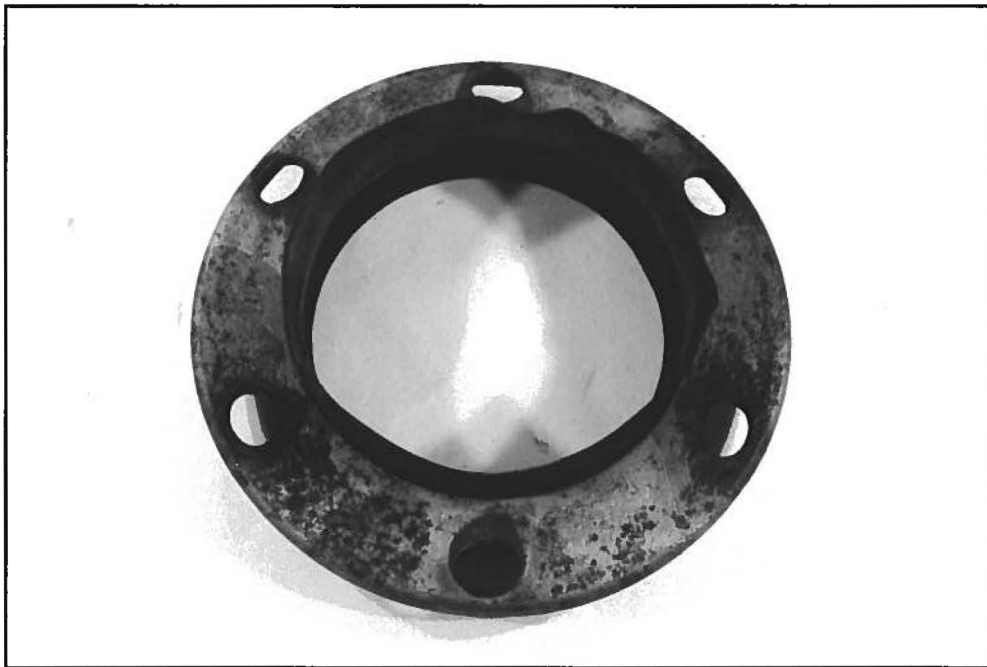
Figure 14. Image of Side B gasket which was mostly intact but remained attached to its housing.

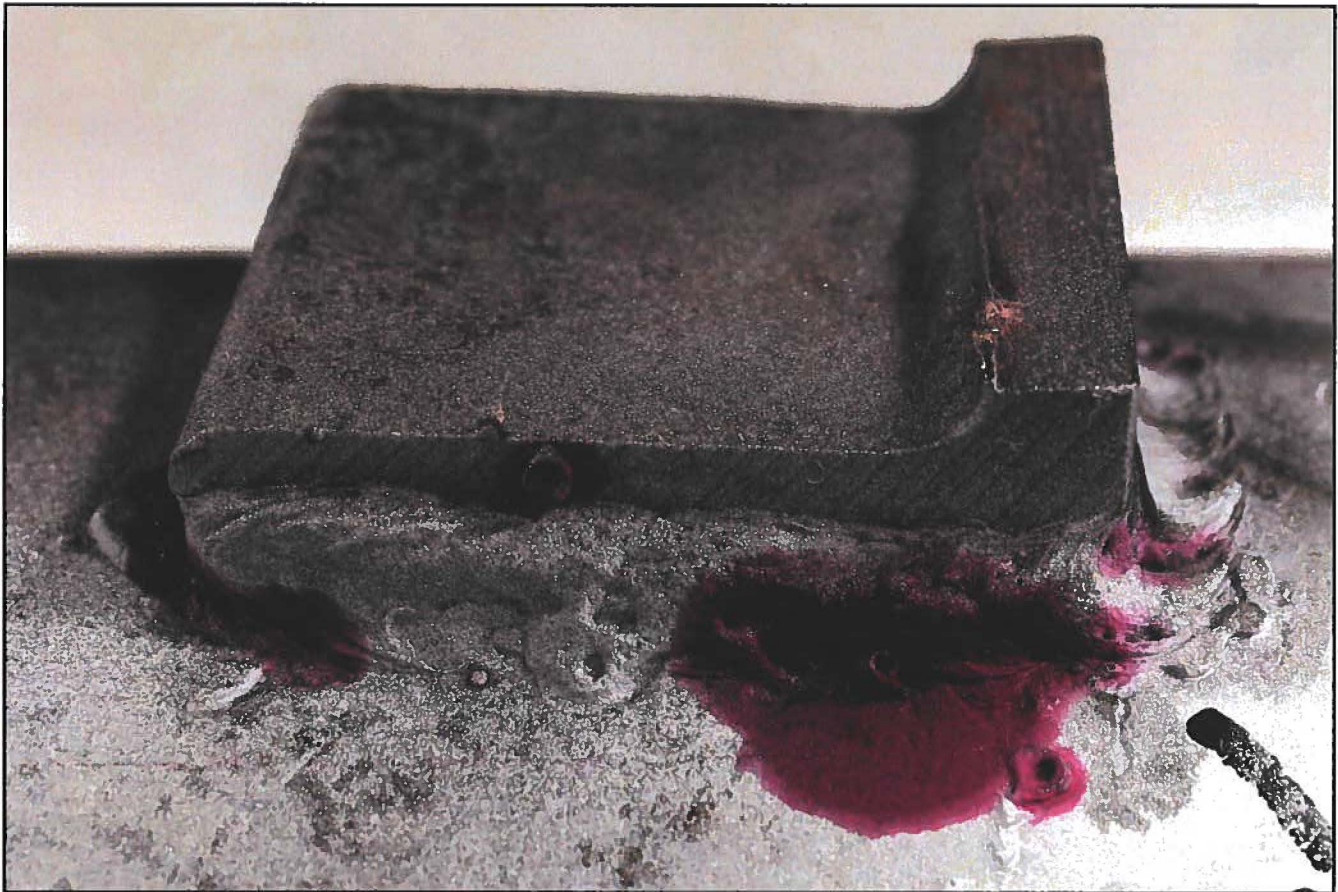
Figure 15. Image of the Lug A2 exterior top welds after dye penetrant media had been used during inspection.

9. Sketch/Description
A1 - CRACK, LOF, Porosity
A2 - CRACK, LOF
A3 - LOF, Porosity
B1 - LOF
B2 - OK
B3 - LOF
B4 - LOF, Porosity
B5 - LOF
B6 - LOF, Porosity
B7 - LOF, Cluster, Porosity
B8 - LOF, Porosity

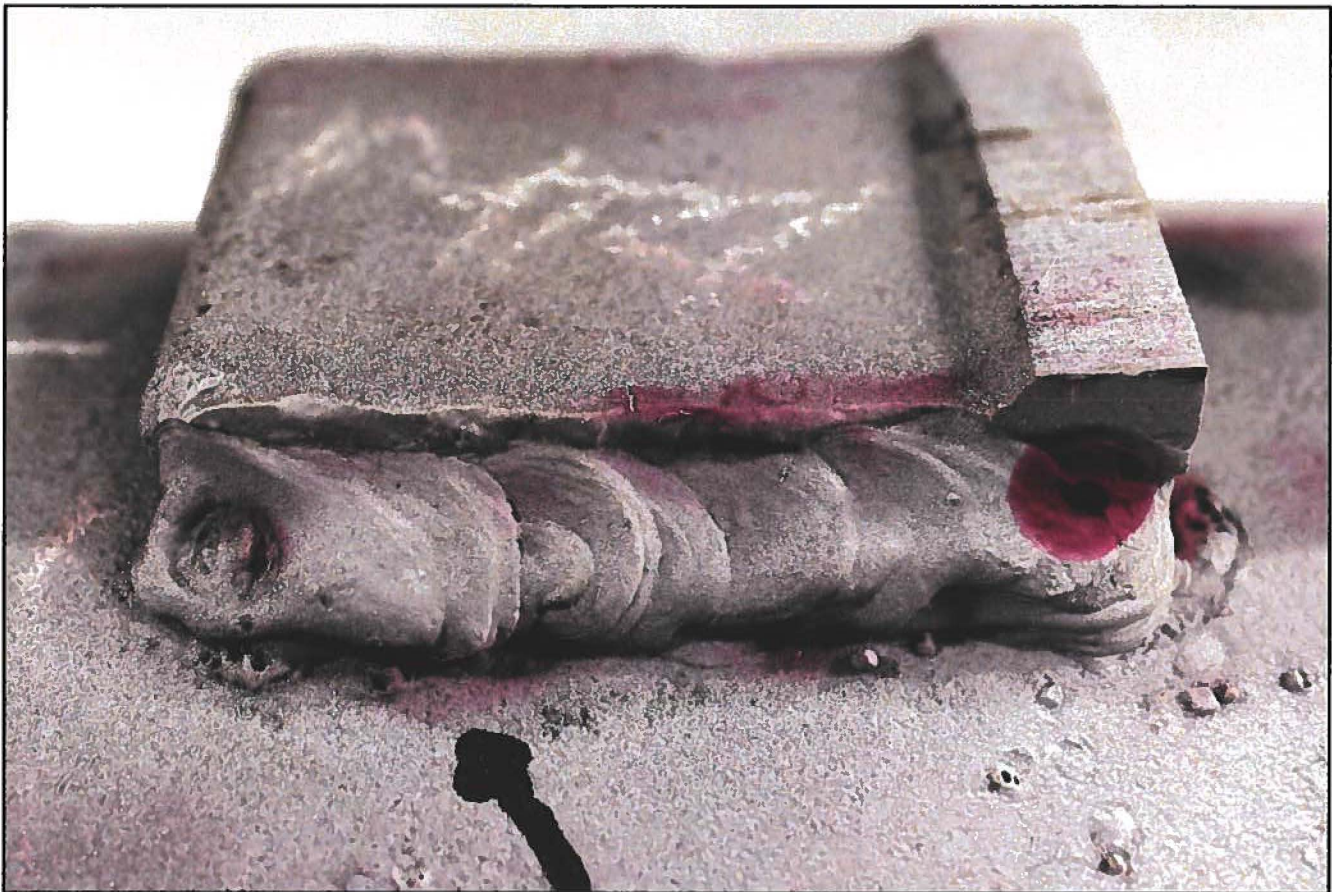
Figure 16. Image of the Lug B2 exterior top welds after dye penetrant media had been used during inspection.

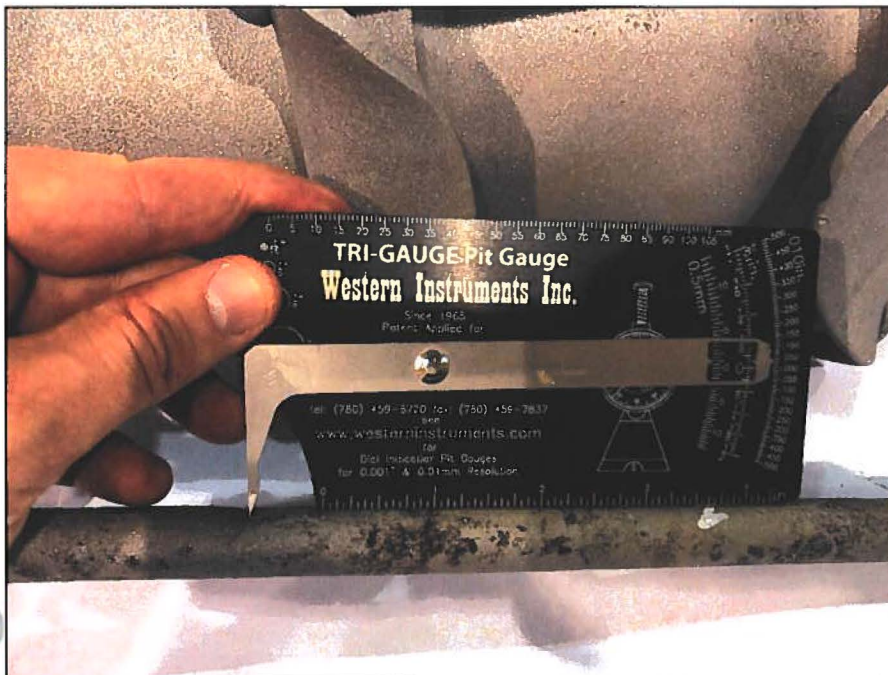
Pipe A	Pipe B	Coupler Body	Bolts	Rods	Lugs	Nuts
General External Corrosion Present?	No	No	No	Yes, bolt 3. Slight Corrosion	Yes, rod 2. Moderate Corrosion	Lug B2. Moderate Corrosion ³	But B2. Moderate Corrosion
Localized Corrosion Present?	No	No	No	No	No	No	No
Pit Depths	Not Applicable	Not Applicable	Not Applicable	Pits too small for measurement	0.03"	Not able to measure with a handheld pit gage.	Not able to measure with a handheld pit gage.
Internal Corrosion?	No	No

Figure 7- Corrosion, Rod 2
version 6.0 (4/24/2019)

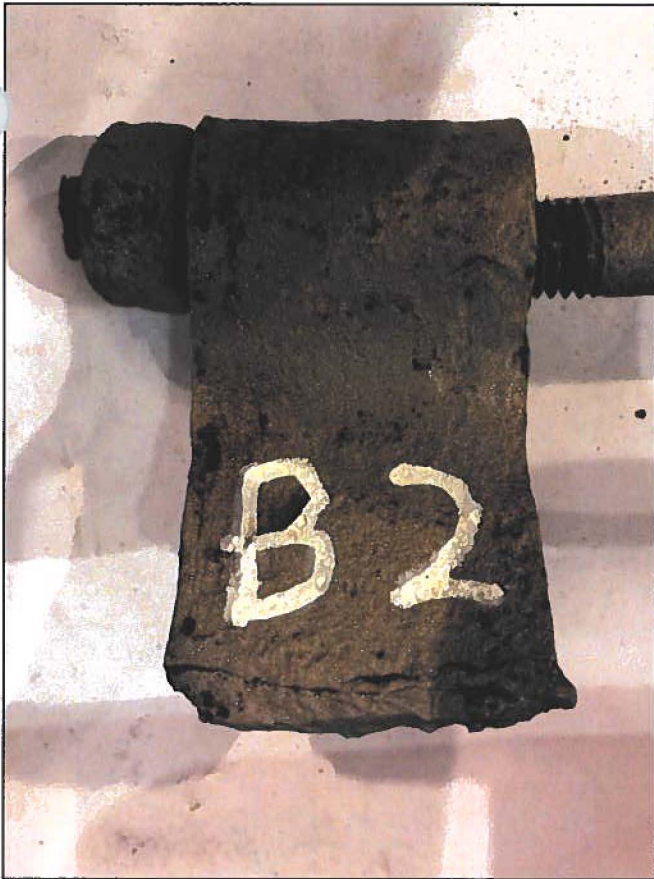
Figure 8- Corrosion, Lug B2

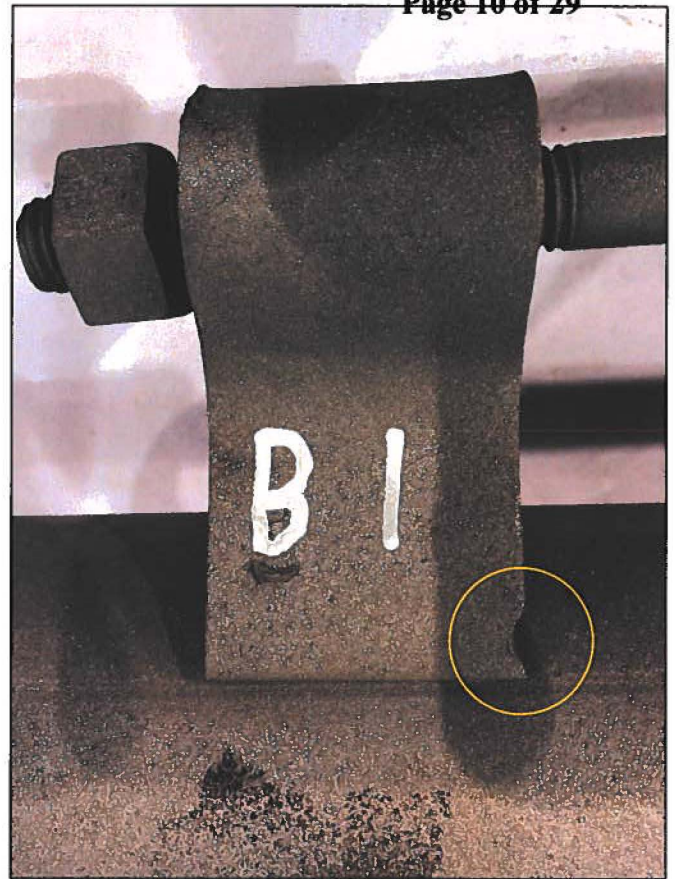
³ Lug B1 has a wall loss but appears to be a damage rather than corrosion.

Figure 9- Damage, Lug B1

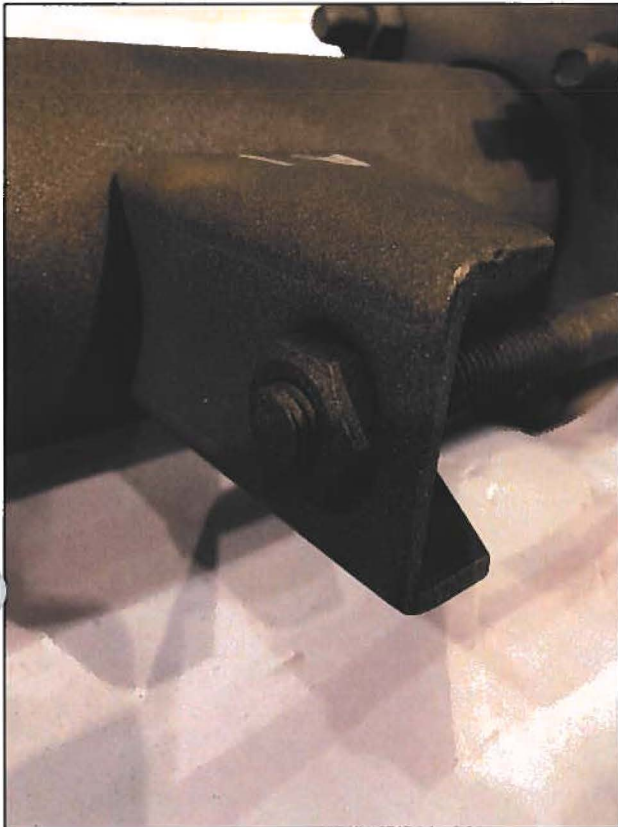
⁴The nut is jammed into the hole of the lug. See Additional Comments Section.

Figure 10- Jammed nut, exterior view

It was observed that the nut on reinforcement rod 1 was jammed into the hole of lug A1. An attempt was made during the inspection to remove the nut from the hole but it could not be removed with a moderate human push. It could most likely be removed from the hole with a strong human push or with the assistance of hand tools. The purpose of the observation is to show that without a washer, the nut could go through the hole. The jammed nut in lug 1 could have easily become dislodged by gas pressure. Since a lug on rod 2 had already become detached from the pipe, neither rod was serving as proper reinforcement for the coupling.

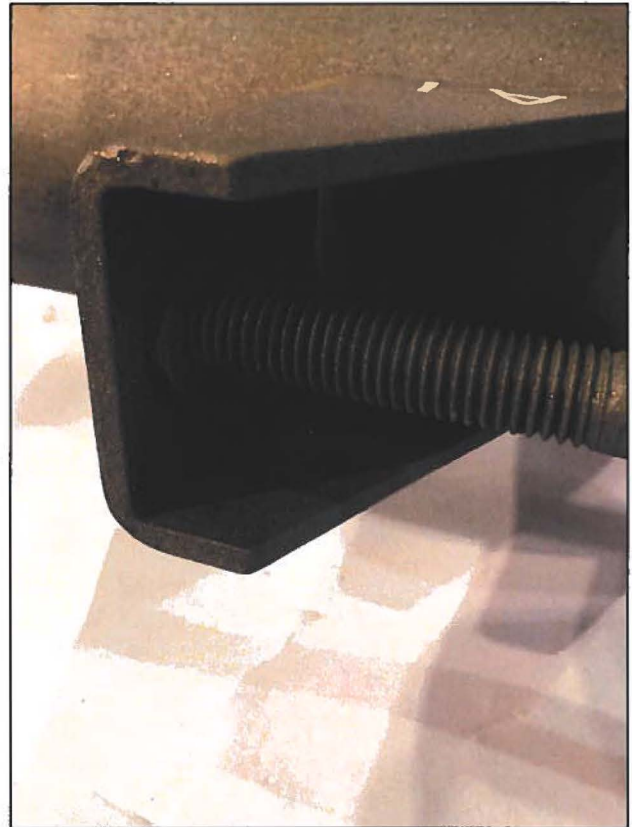
Figure 11- Jammed Nut, interior view

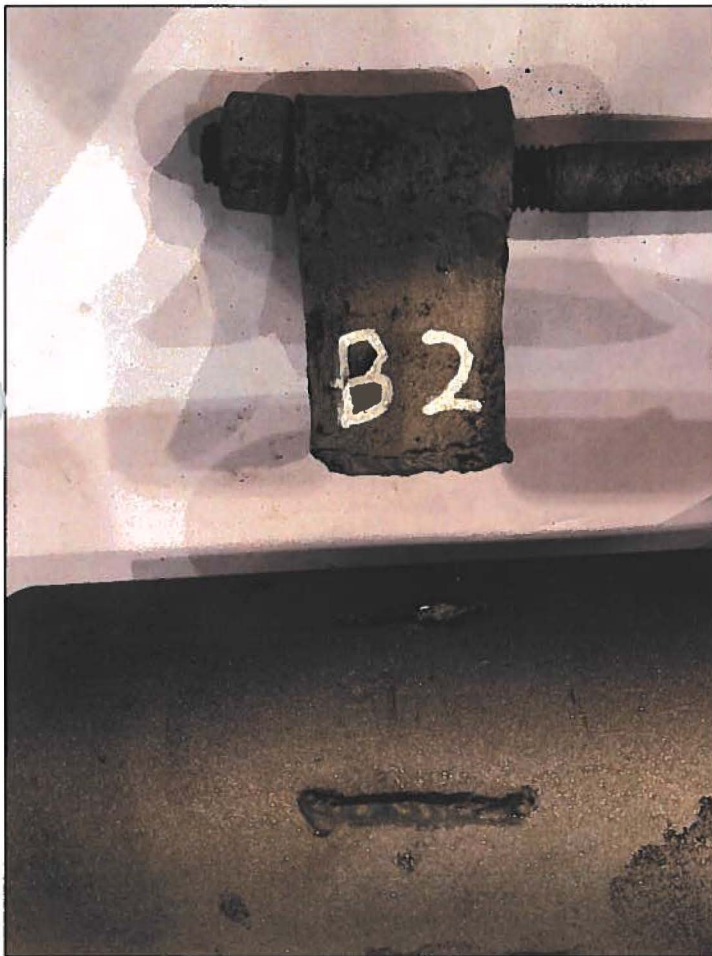
⁵ Lug B2 is broken off the pipe. Measurements cannot be taken.

Figure 12- Detached lug, B2

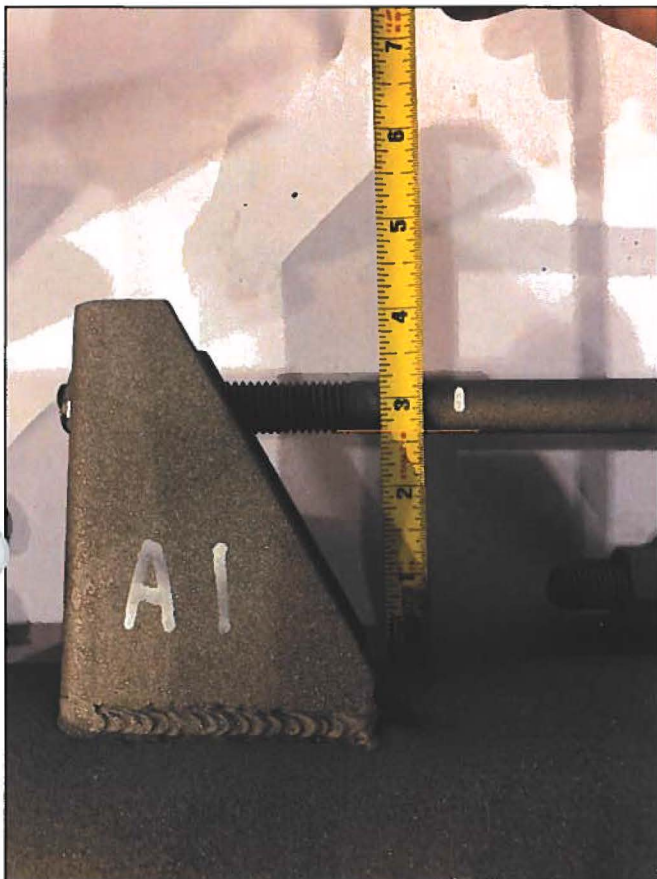
Figure 13- Lug A1, 2-5/8 inches from pipe

Different lug styles were used on a shared reinforcement rod. The lugs cause the reinforcement rod to have different distances from the pipe.

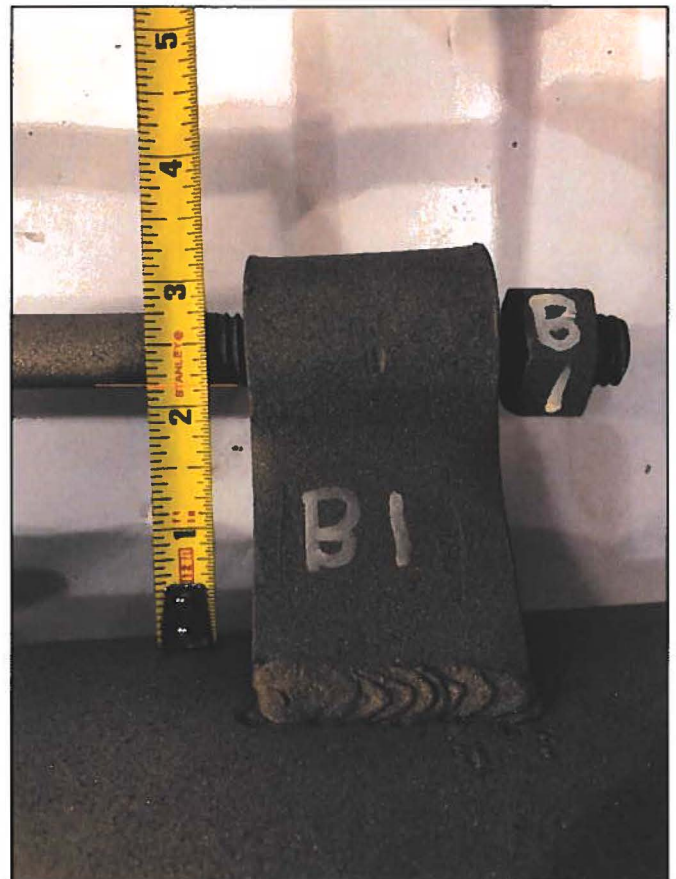
Figure 14- Lug B1, 2-3/16 inches from pipe

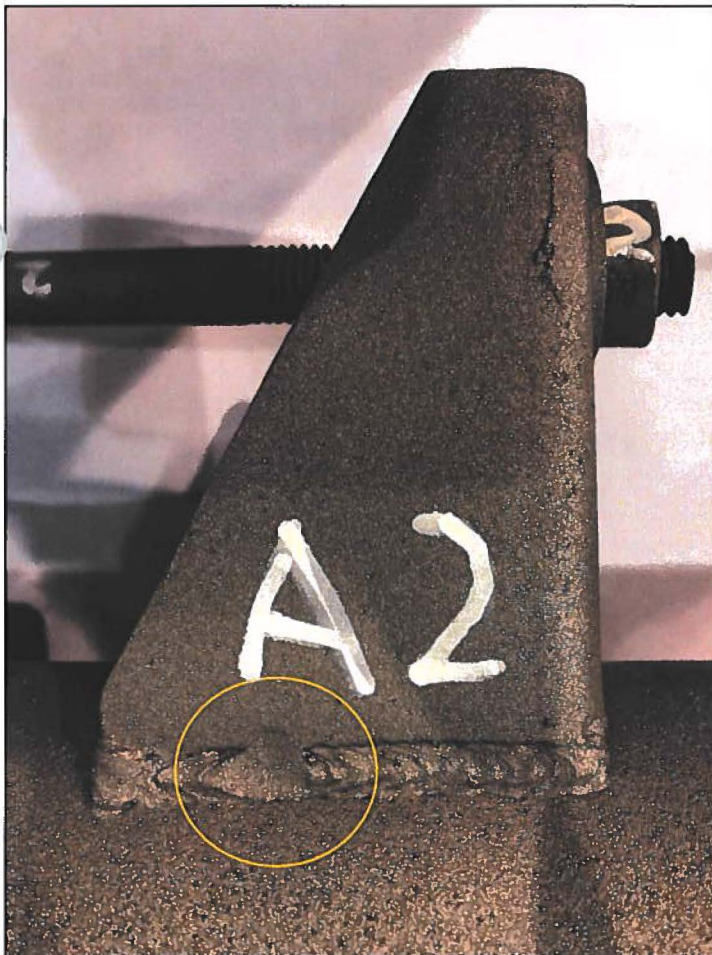
Figure 15- Lug A2, Slight weld imperfection

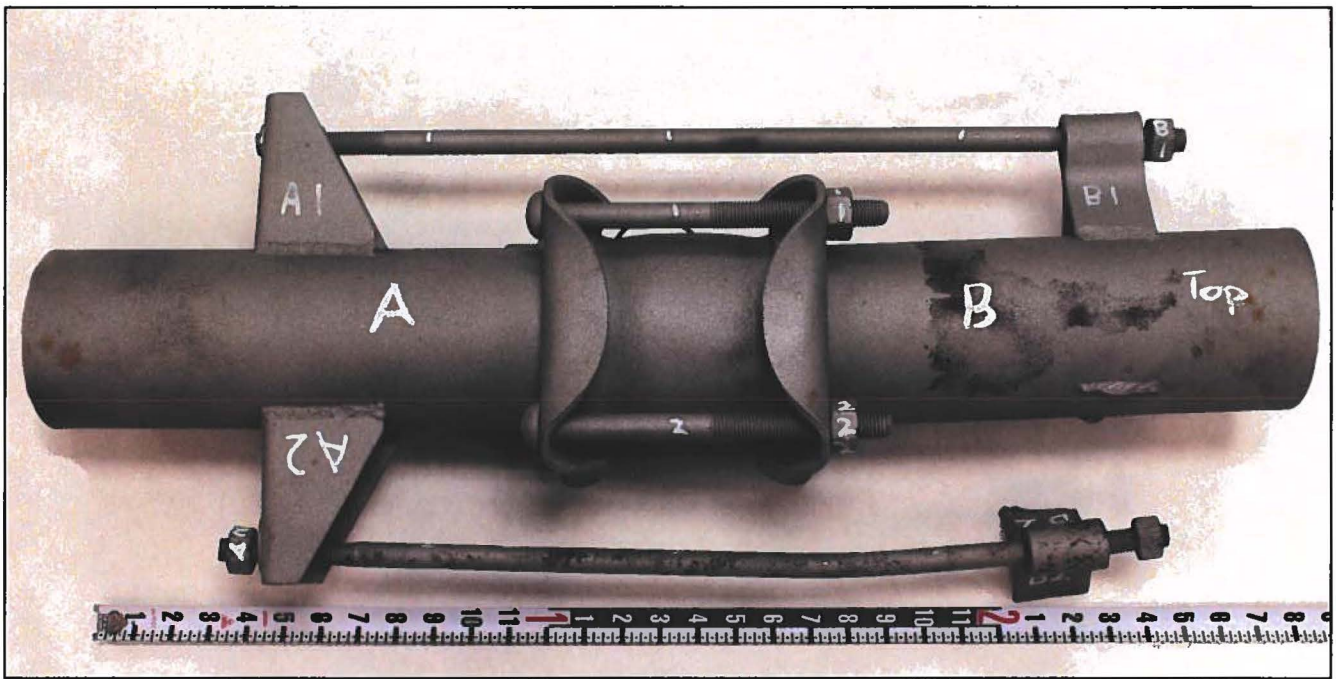
Lug B2 was not attached to pipe section B at the time of receipt. It appeared that both attachment welds were present but had fractured. Additionally, a washer was missing on Lug A1 causing the nut of Rod 1 to be pulled partially through the opening in the lug during installation.

Figure 1. Photograph of the top of the submitted coupling. Lug and rod identifications are shown.
