**RE: Louisville Gas and Electric Company Alleged Failure to Comply with
KRS 278.495, 807 KAR 5:022, and 49 C.F.R. Part 192
Case No. 2017-00119**

Louisville Gas and Electric Company
2019 Annual Report
Case No. 2017-00119

In accordance with the Kentucky Public Service Commission's Order of March 16, 2018 in Case No. 2017-00119, Louisville Gas and Electric Company ("LG&E") submit the second annual report for the years 2018 – 2022. The annual report provides a status on the implementation of LG&E's Action Plan and the number of bolted-style coupling systems removed in 2019 from distribution lines having an operating pressure in excess of 60 psig along with observations of the removed couplings.

Distribution Couplings removed from the ground:

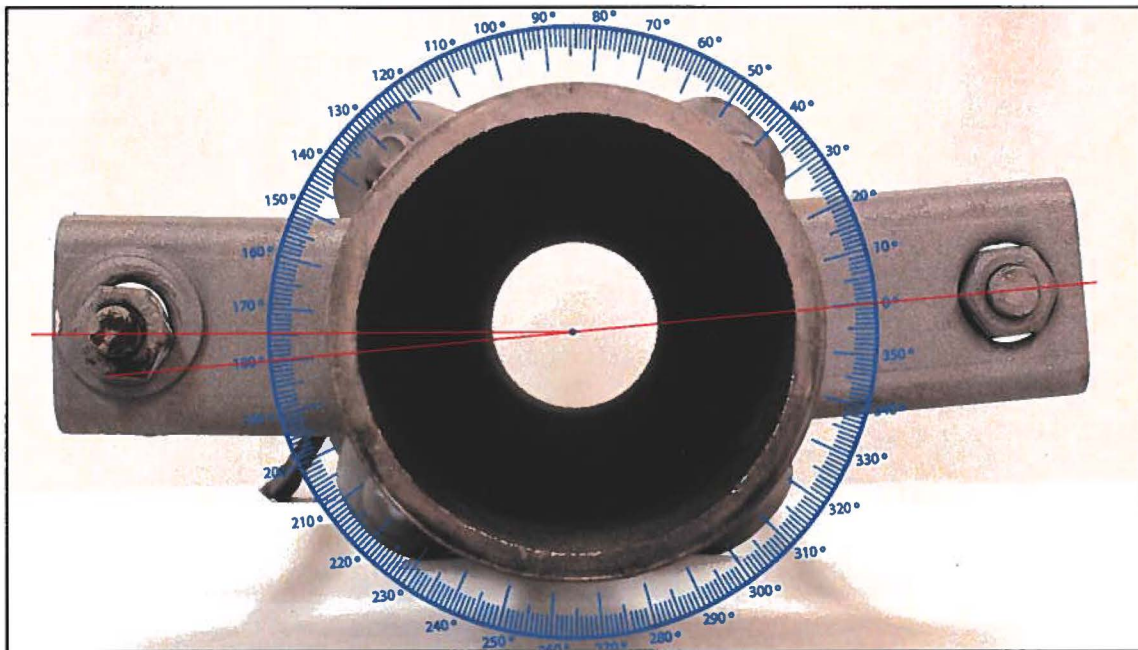
Figure 3. End facing image of the sample at End A. A superimposed protractor shows that the centers of Lugs A1 and A2 were approximately 5° from square.

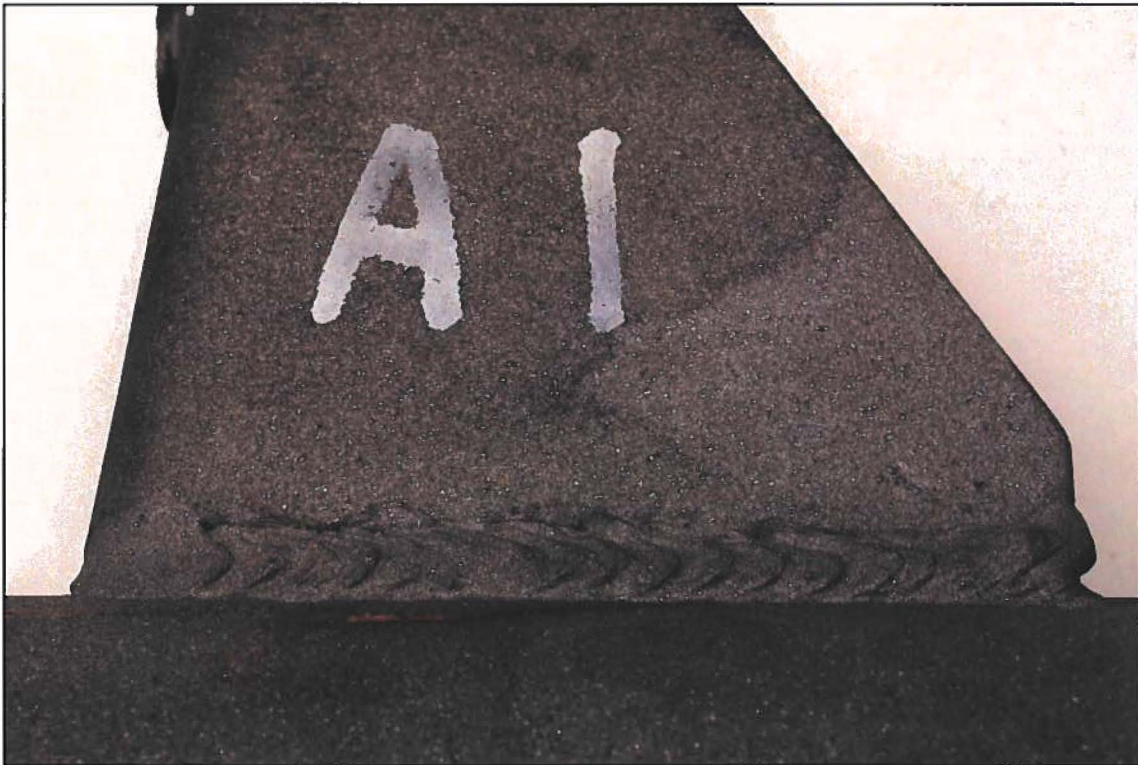
Figure 4. Image of the Lug A1 exterior top weld which exhibited substantial fusion except for some overlap, spatter and porosity.

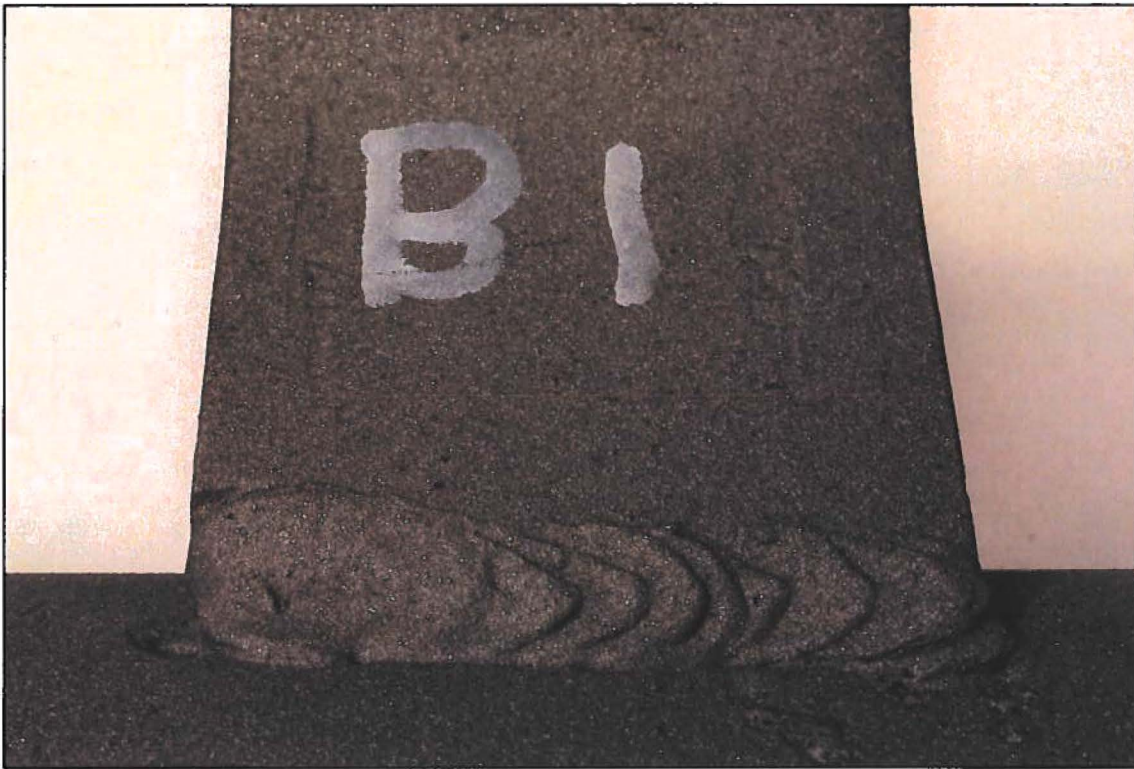
Figure 5. Image of the Lug B1 exterior top weld which exhibited substantial fusion except for some overlap, spatter, arc strike and porosity.

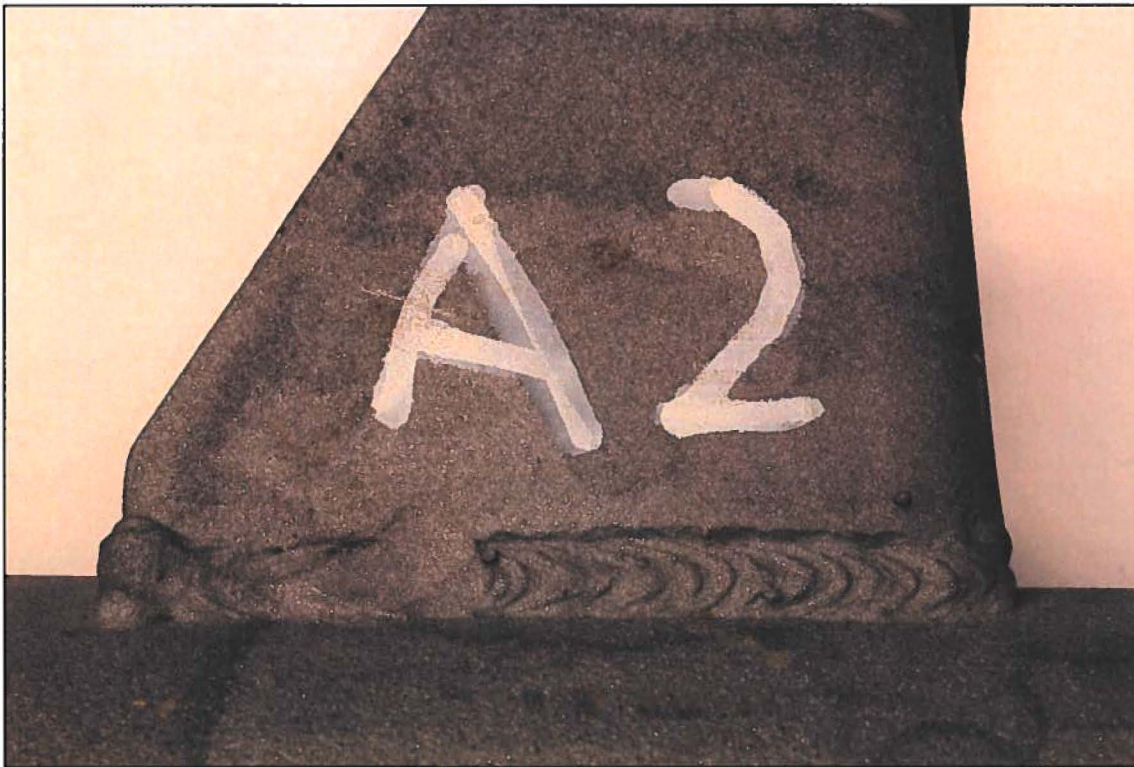
Figure 6. Image of the Lug A2 exterior top weld which exhibited substantial fusion except for some undercut, porosity and spatter.

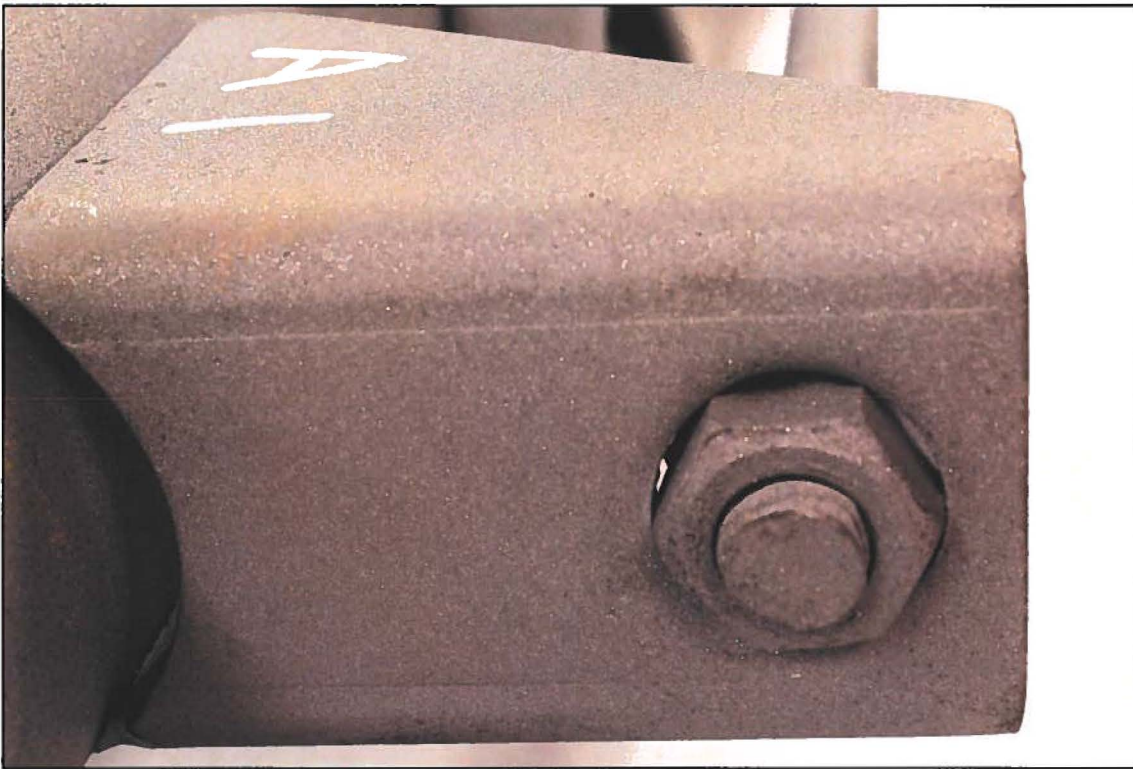
Figure 7. Photograph showing the nut of Rod 1 embedded into the opening of Lug A1.

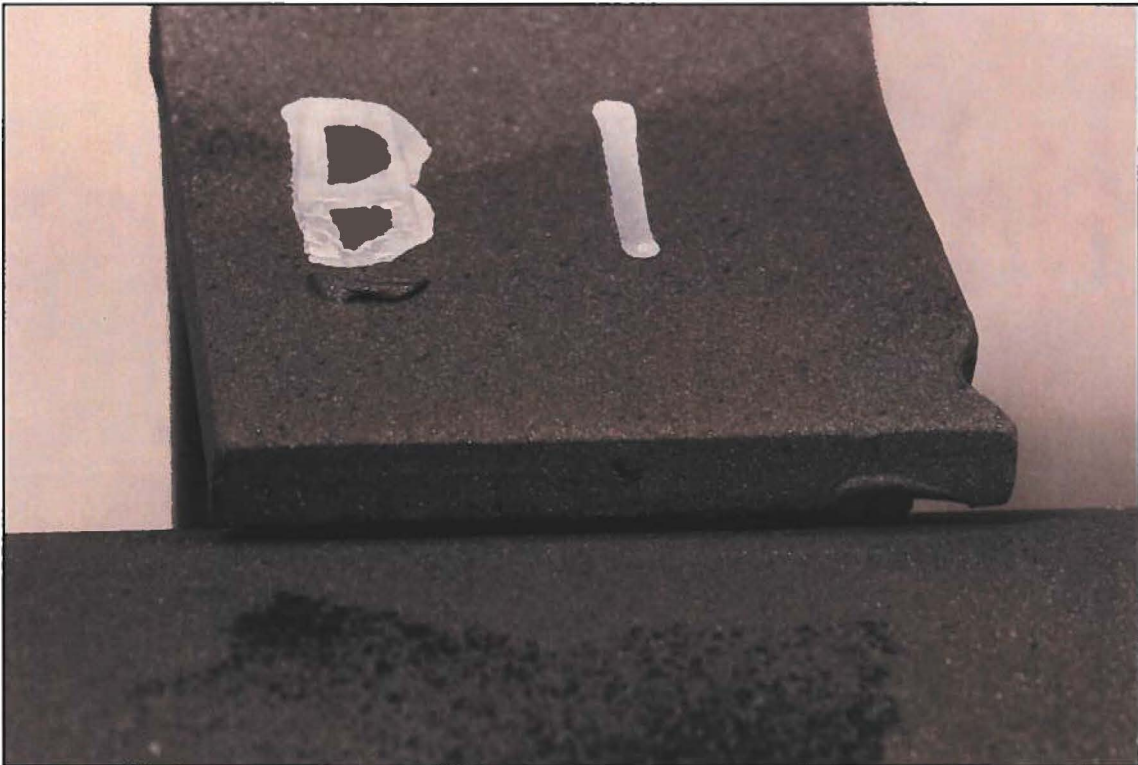
Figure 10. The exterior bottom location of Lug B1 was not welded.

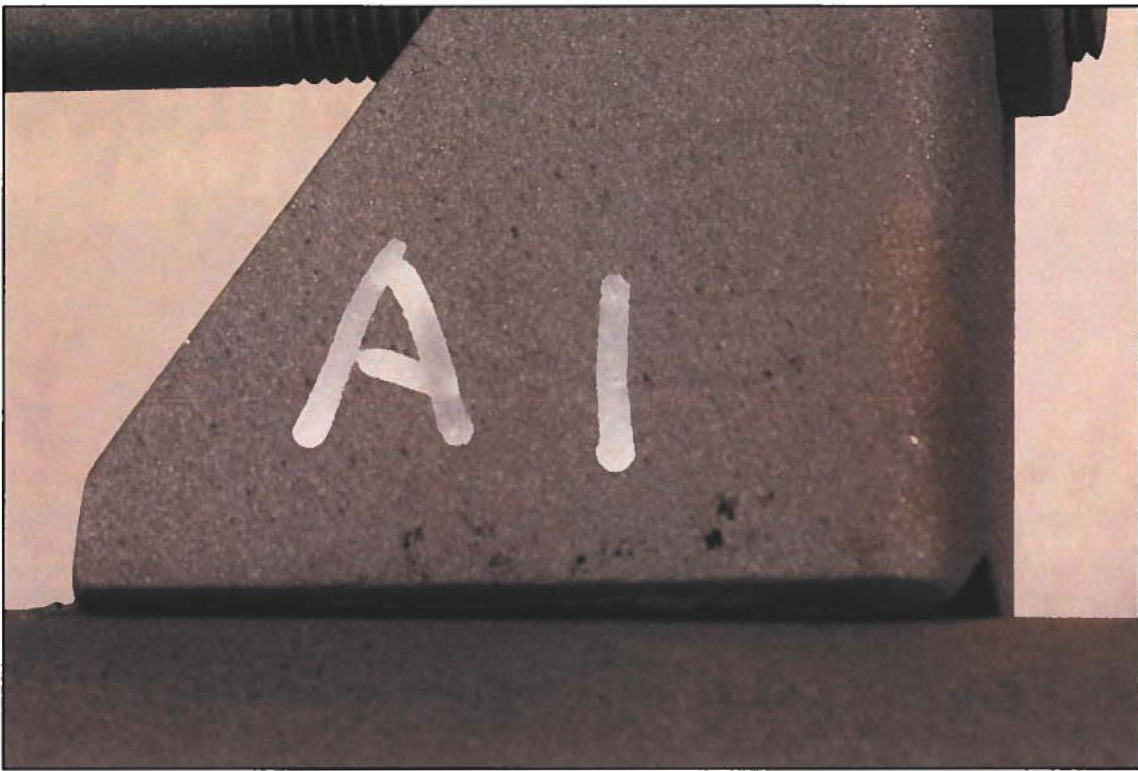
Figure 11. The exterior bottom location of Lug A1 was not welded.
