**RE: Louisville Gas and Electric Company Alleged Failure to Comply with
KRS 278.495, 807 KAR 5:022, and 49 C.F.R. Part 192
Case No. 2017-00119**

Louisville Gas and Electric Company
2020 Annual Report
Case No. 2017-00119

GTI Report Section 3, Part F: Continuous Process Improvement and Leading Indicators

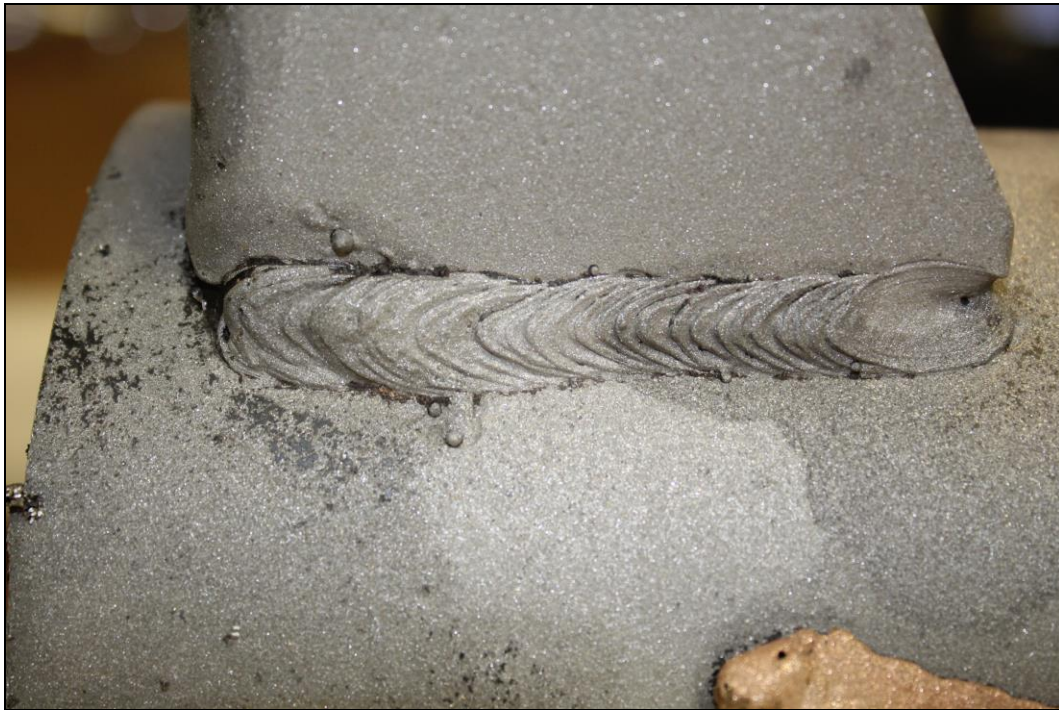
Figure 5. Image of the Lug A2 exterior top weld which exhibited substantial fusion except for some arc burn, porosity, undercut, and spatter.

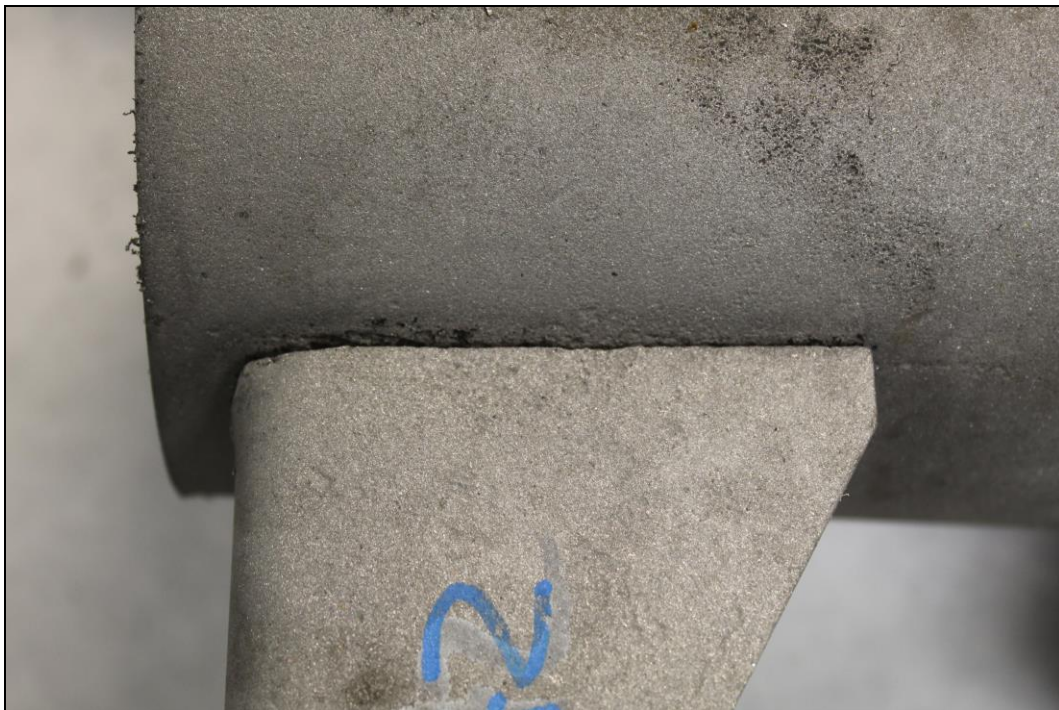
Figure 6. Image of the Lug A2 exterior bottom weld which exhibited no fusion.

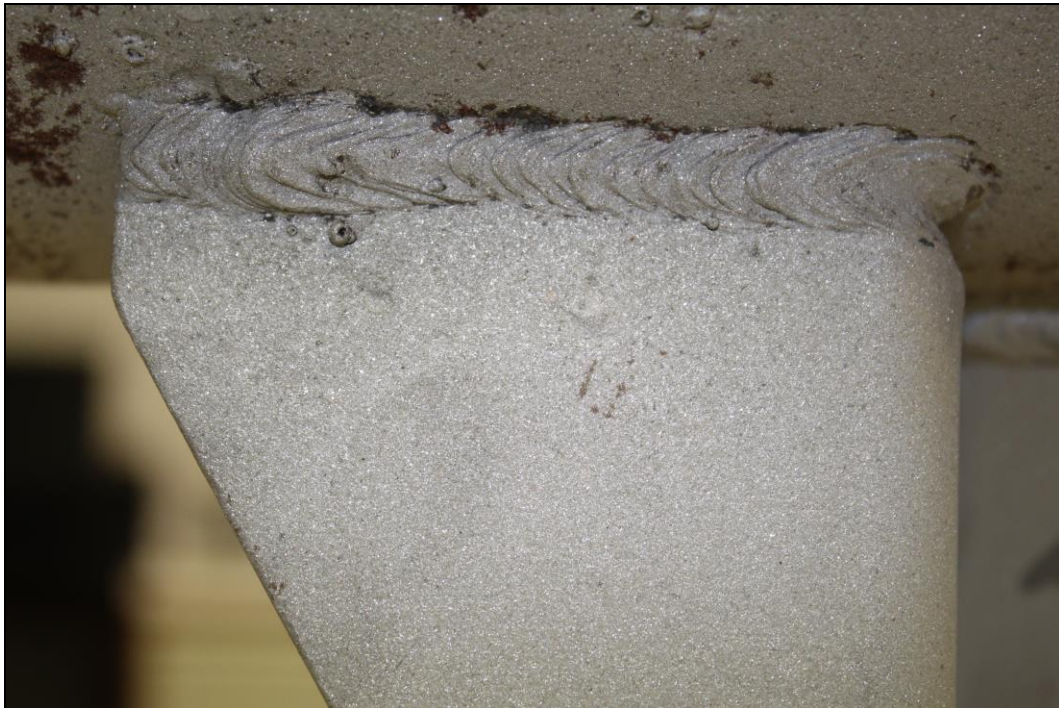
Figure 7. Image of the Lug B2 exterior top weld which exhibited substantial fusion except for some arc burn, spatter, porosity and undercut.

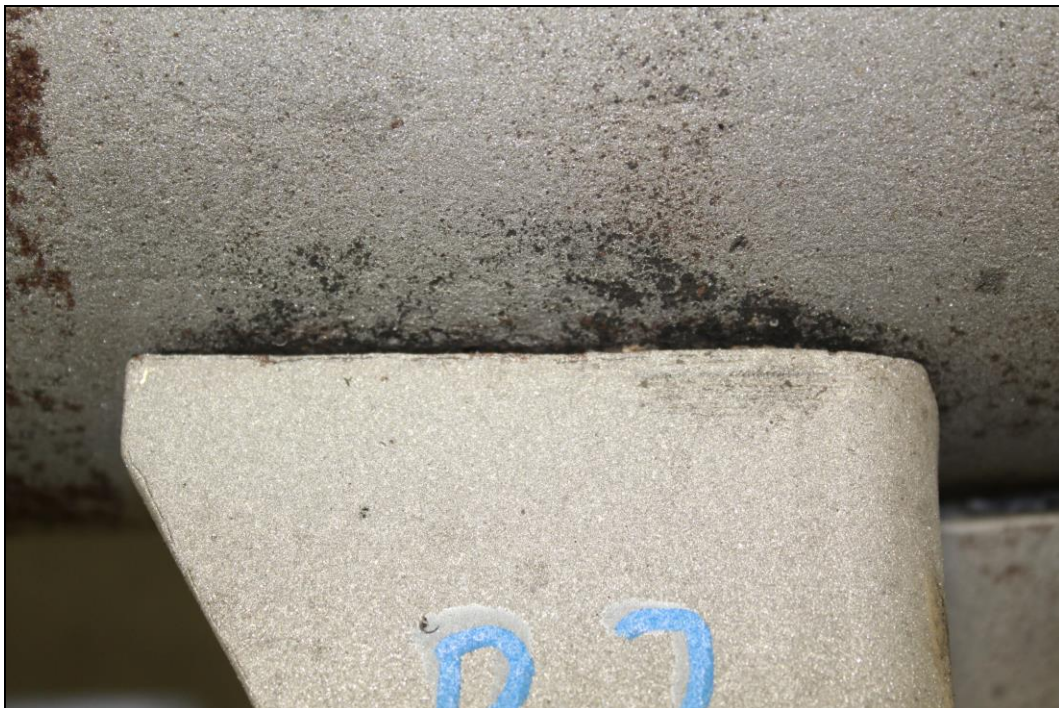
Figure 8. Image of the Lug B2 exterior top weld which exhibited no fusion.

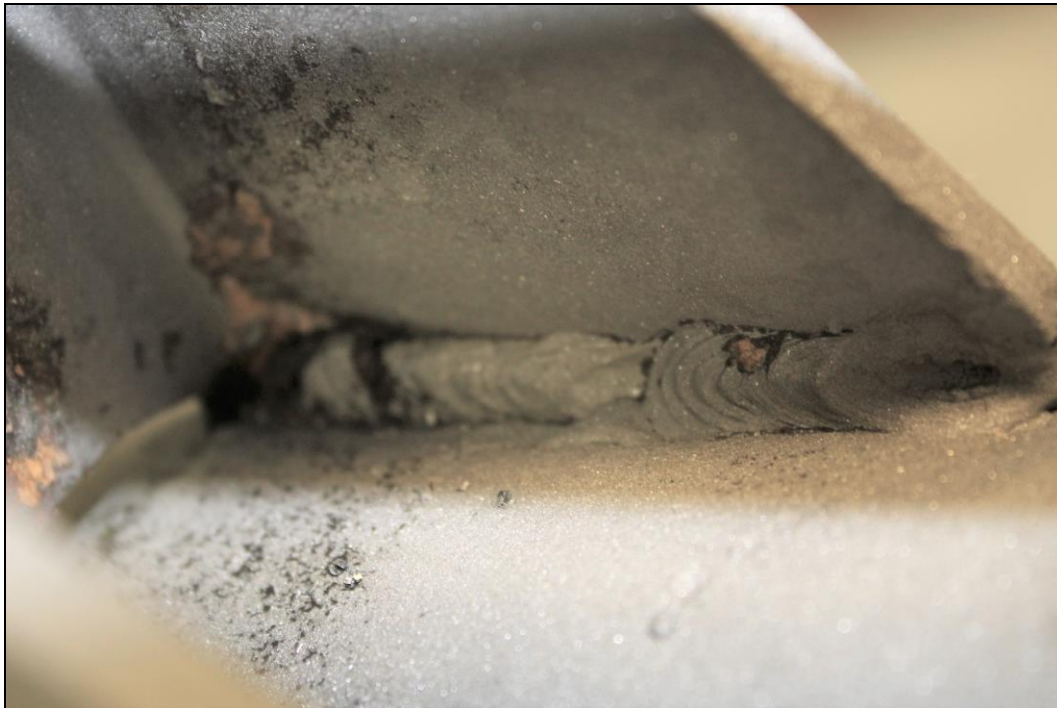
Figure 9. Image of the Lug B1 interior bottom weld which exhibited substantial fusion except for some porosity and spatter.

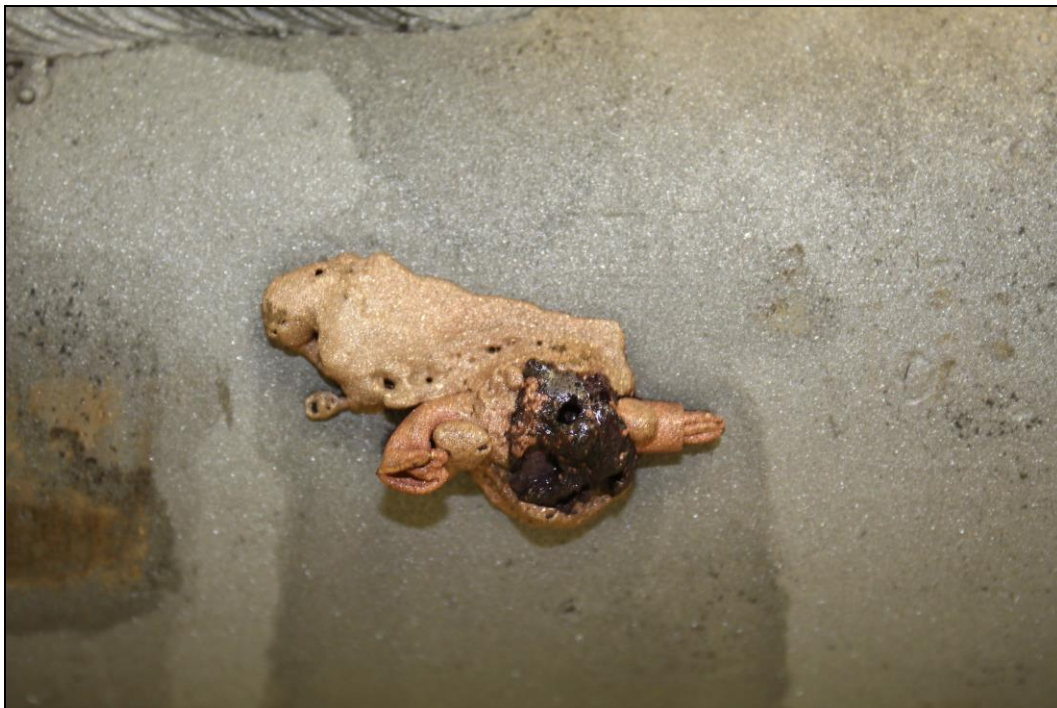
Figure 10. Image of the remainders of an additional piece, which had been welded then cut off, present on Side A of the assembly.

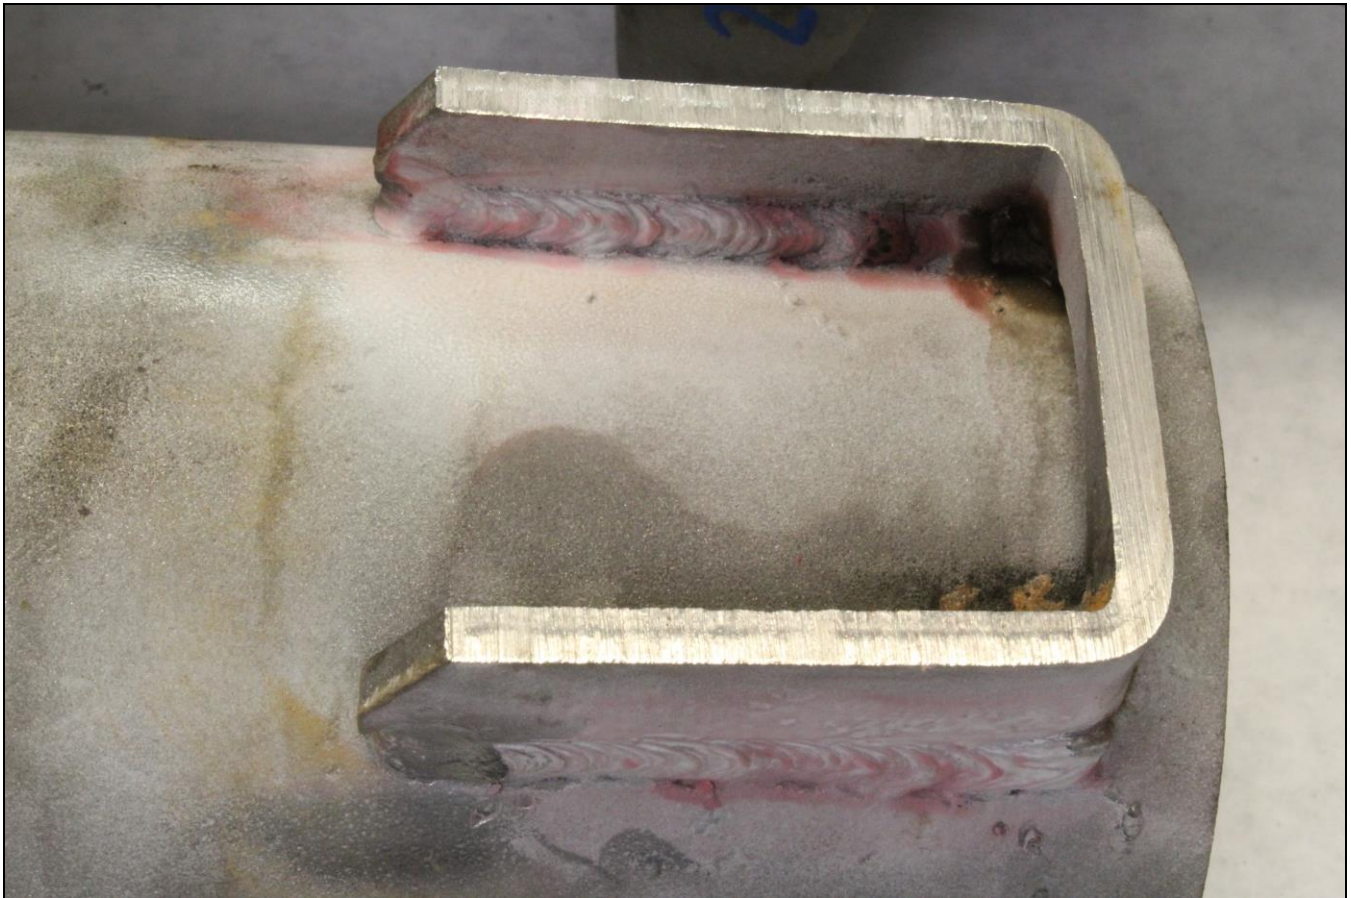
Figure 11. Image of the Lug A1 exterior top welds after dye penetrant media had been used during inspection.

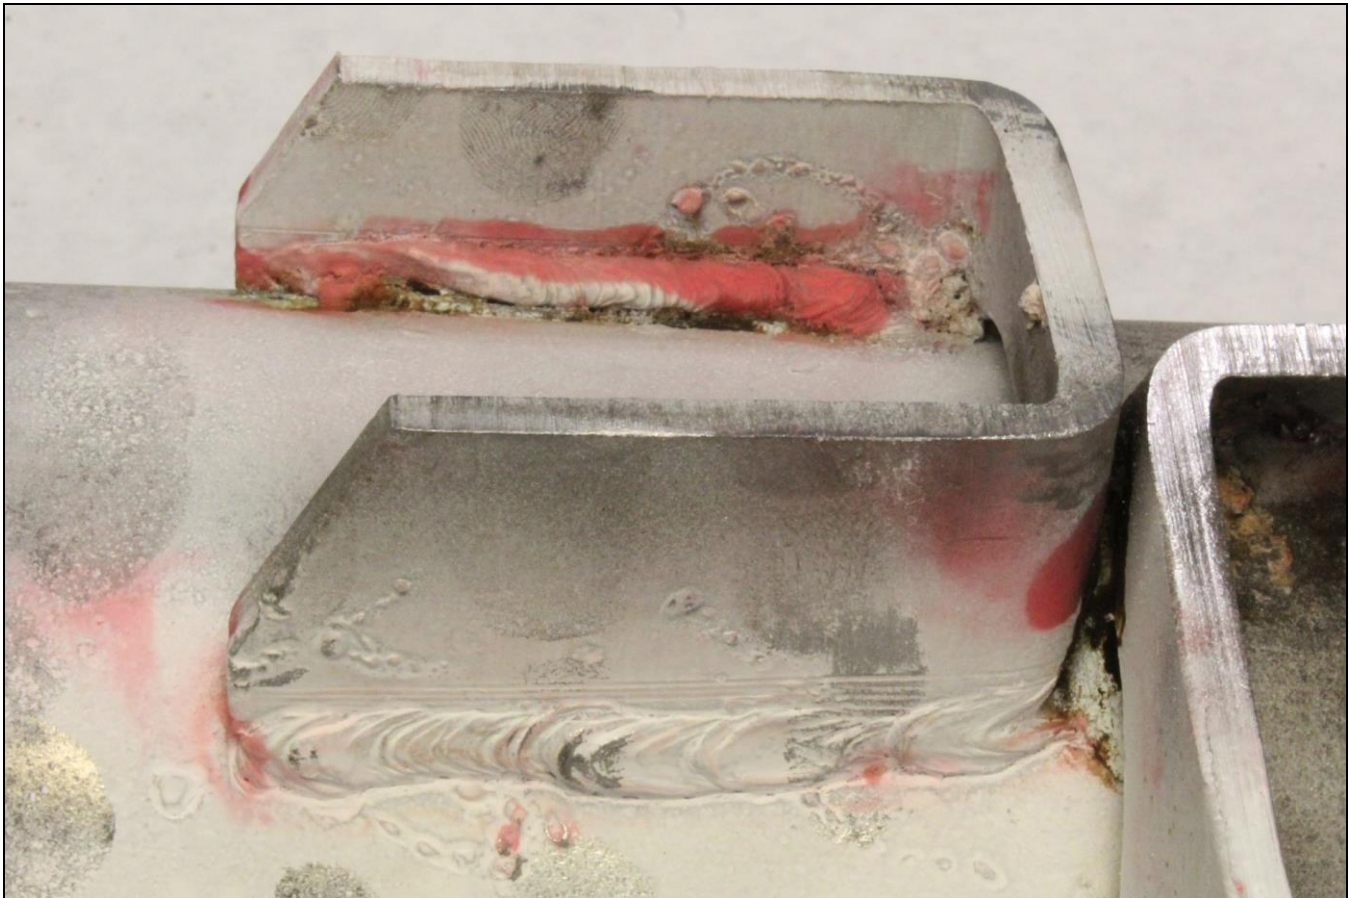
Figure 12. Image of the Lug B1 exterior top welds after dye penetrant media had been used during inspection.

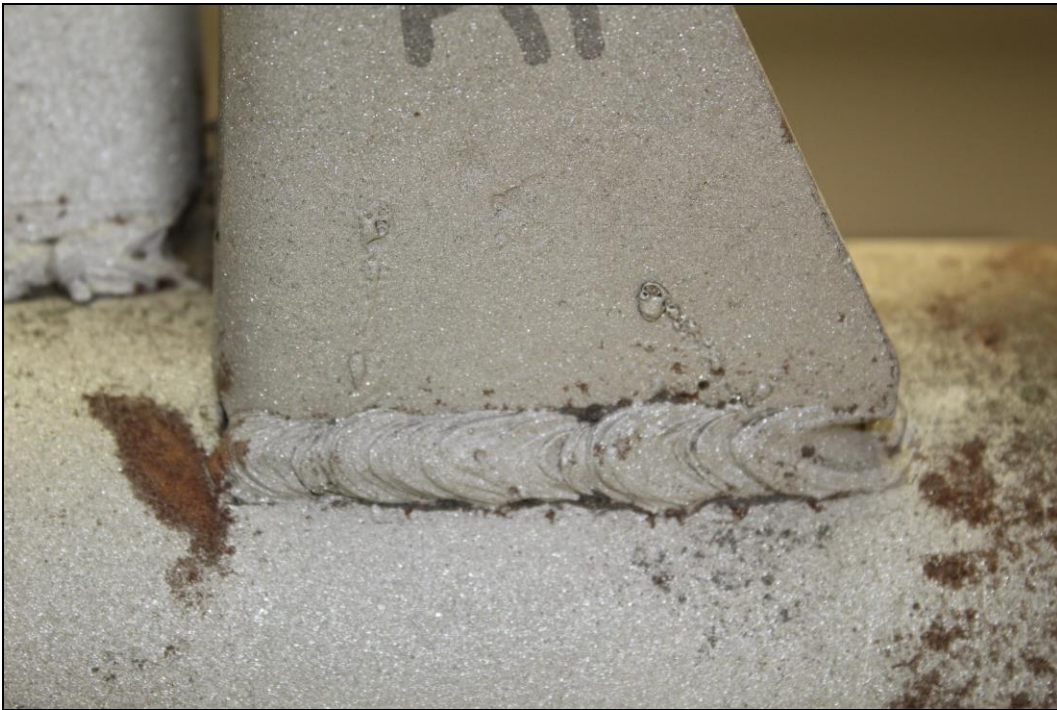
Figure 4. Image of the Lug A1 exterior top weld which exhibited substantial fusion except for some arc burn, porosity, undercut, and spatter.

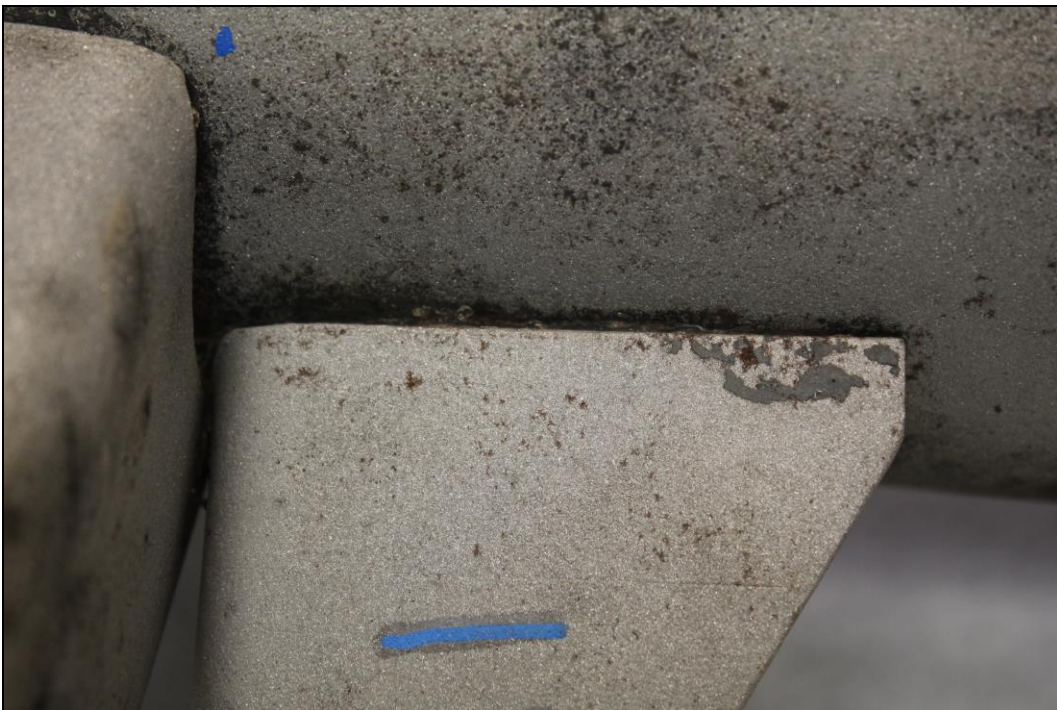
Figure 5. Image of the Lug A1 exterior bottom weld which exhibited no fusion.

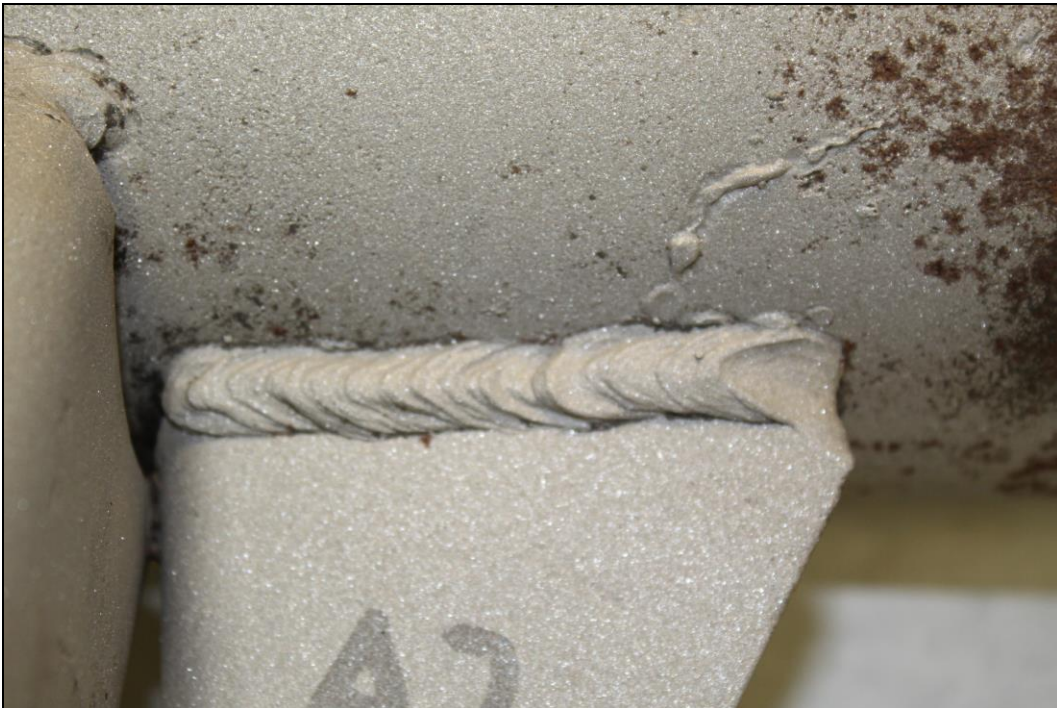
Figure 6. Image of the Lug A2 exterior top weld which exhibited substantial fusion except for some arc burn, and undercut.

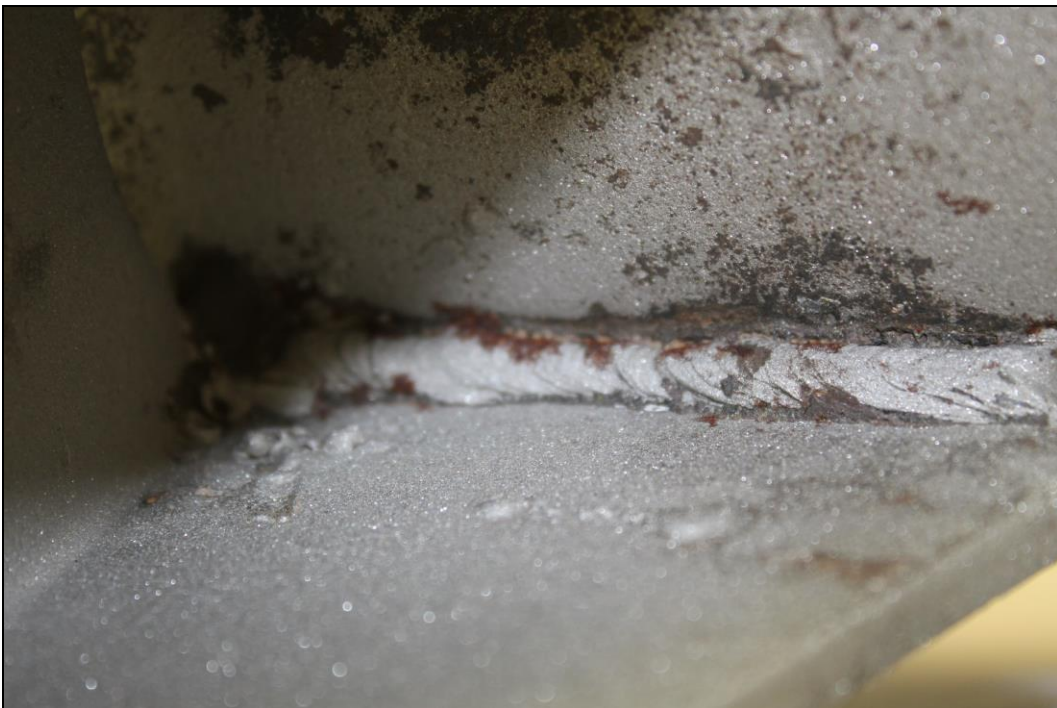
Figure 7. Image of the Lug A2 interior bottom weld which exhibited substantial fusion except for some arc burn and spatter.

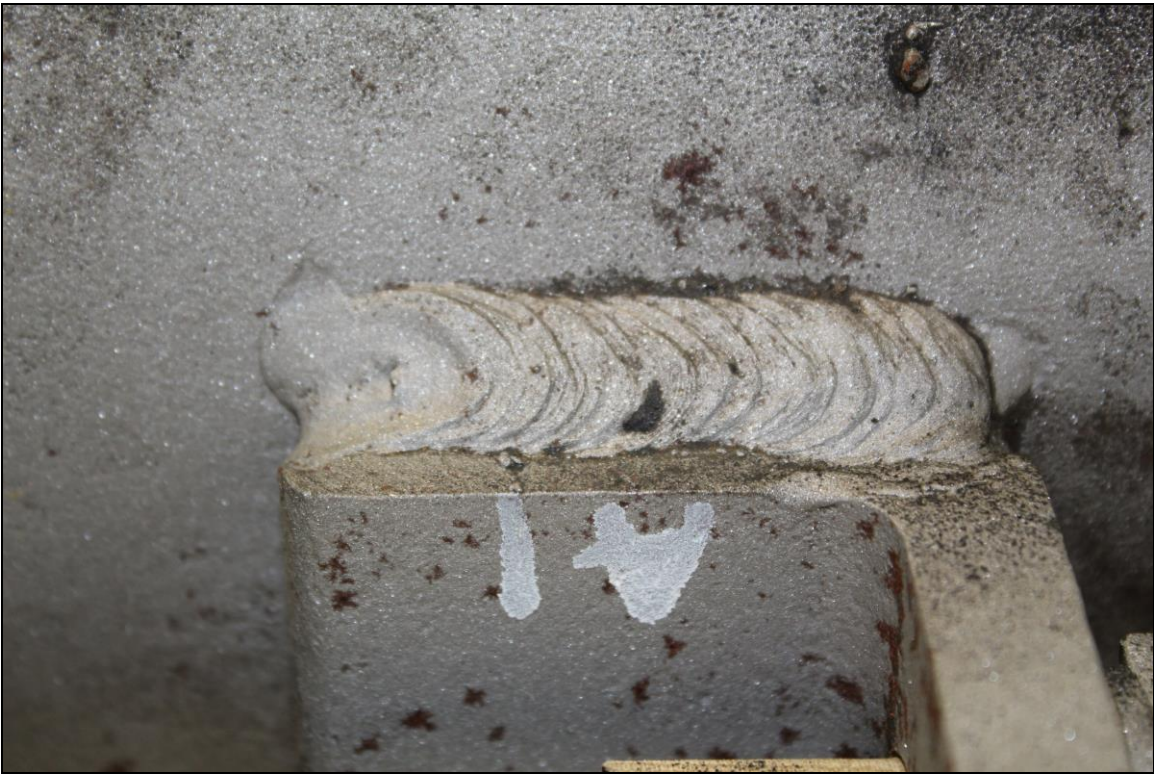
Figure 5. Image of the Lug A1 exterior top weld which exhibited substantial fusion except for some arc burn and undercut.

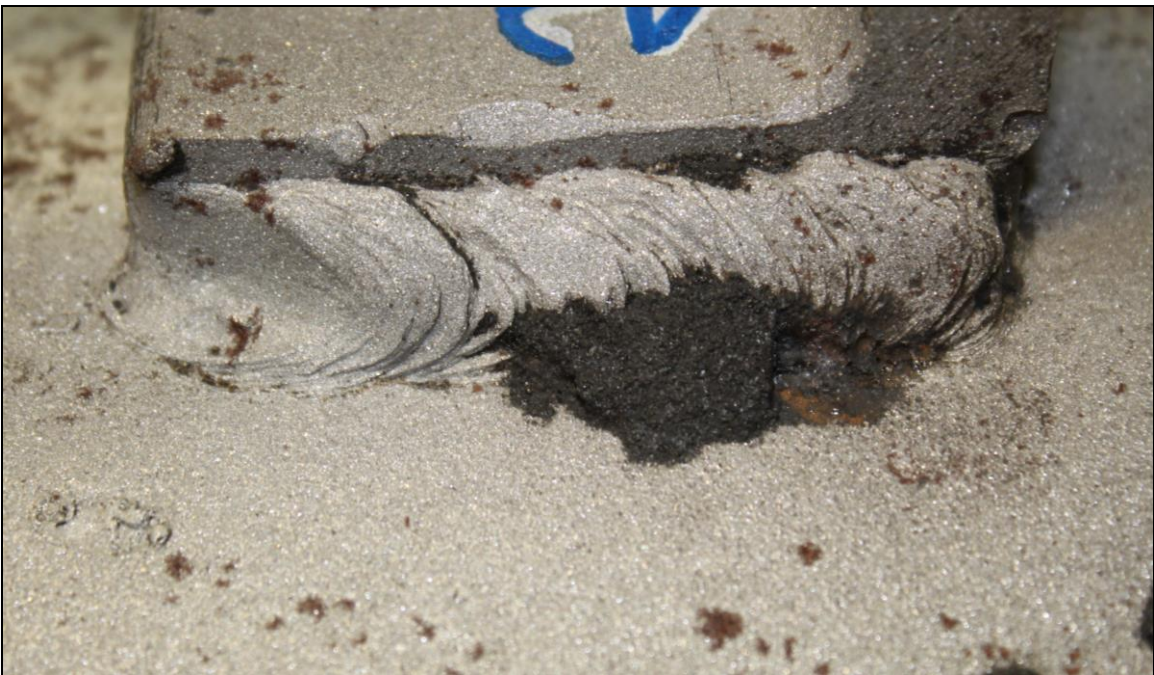
Figure 6. Image of the Lug A3 exterior top weld which exhibited substantial fusion except for some spatter and undercut.

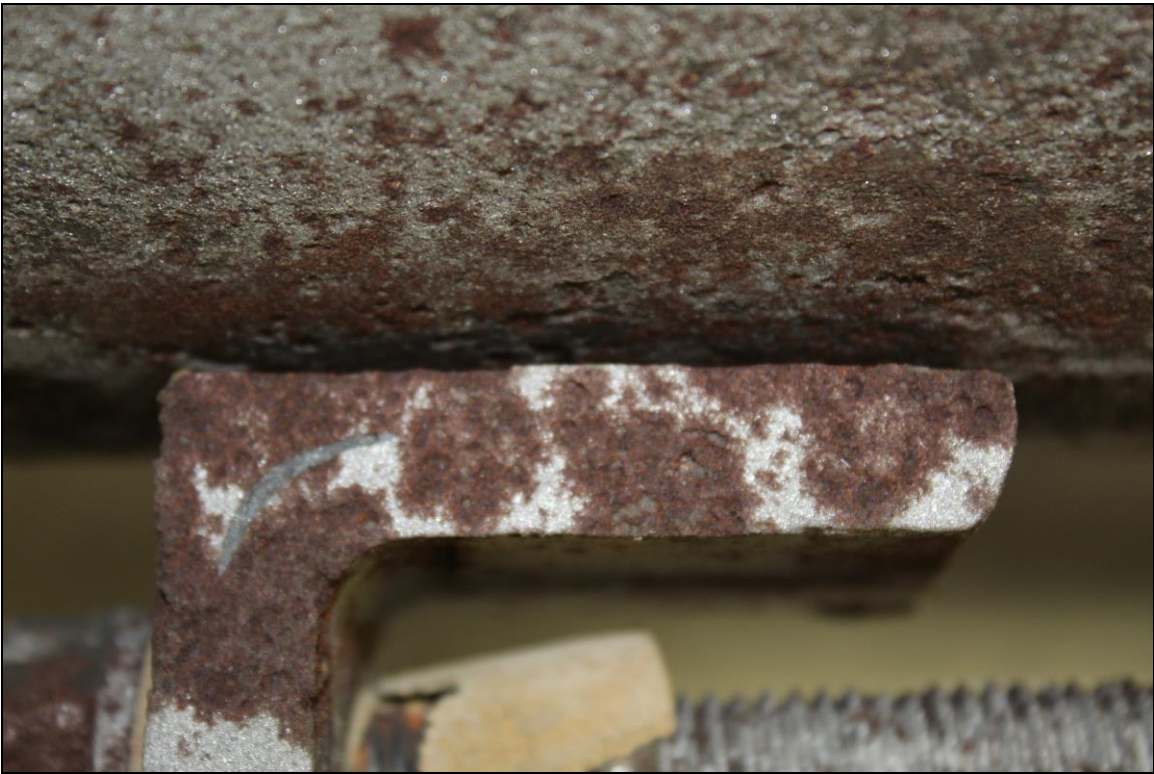
Figure 7. Image of the Lug A5 exterior bottom weld which exhibited no fusion.

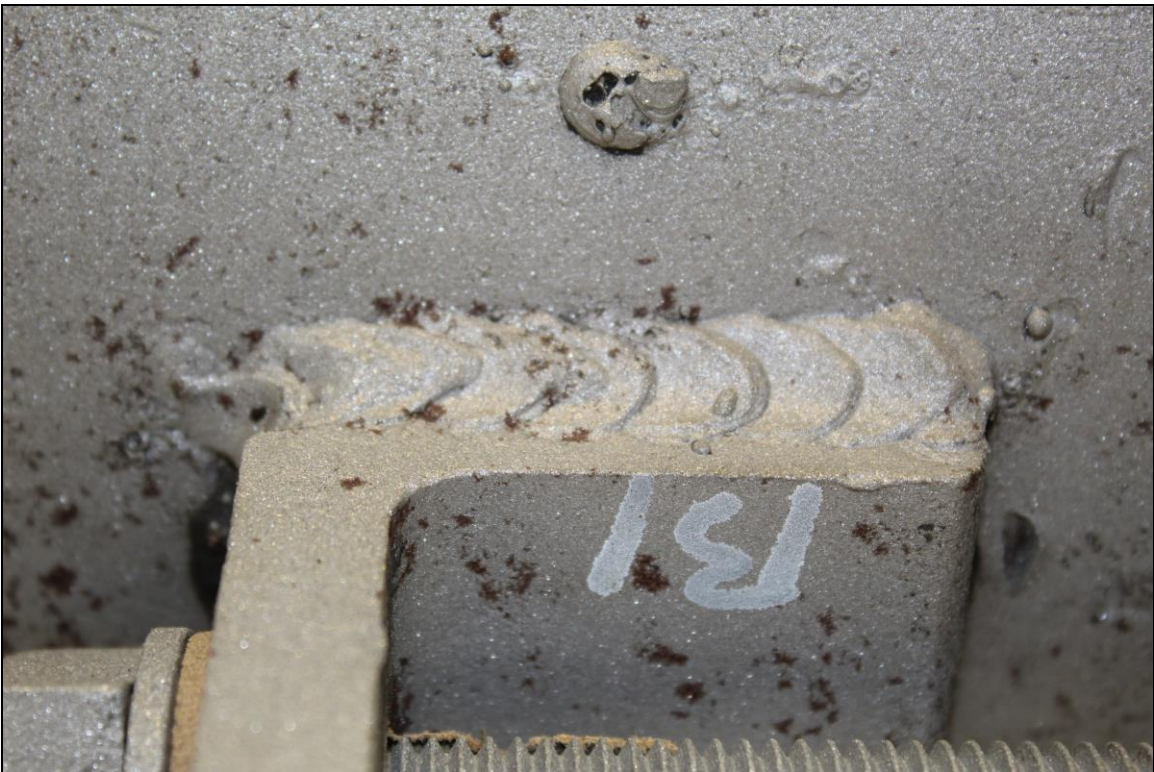
Figure 8. Image of the Lug B1 exterior top weld which exhibited substantial fusion except for some arc burn, spatter, porosity and undercut.

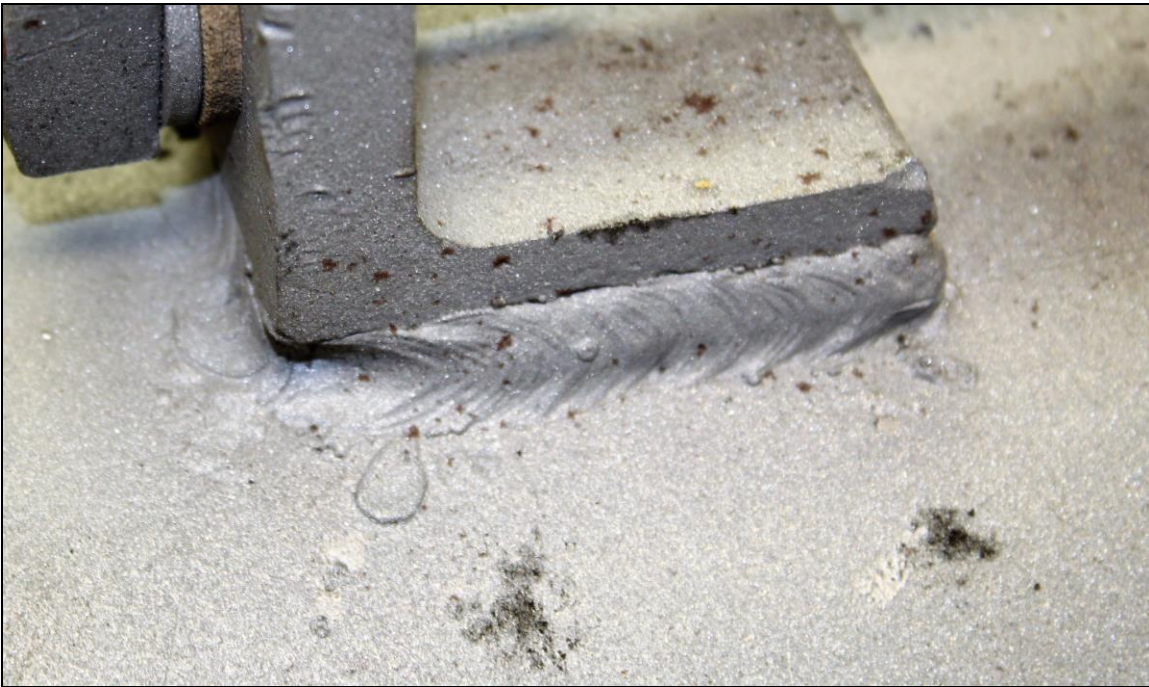
Figure 9. Image of the Lug B3 exterior top weld which exhibited substantial fusion except for some arc burn, porosity, spatter and undercut.

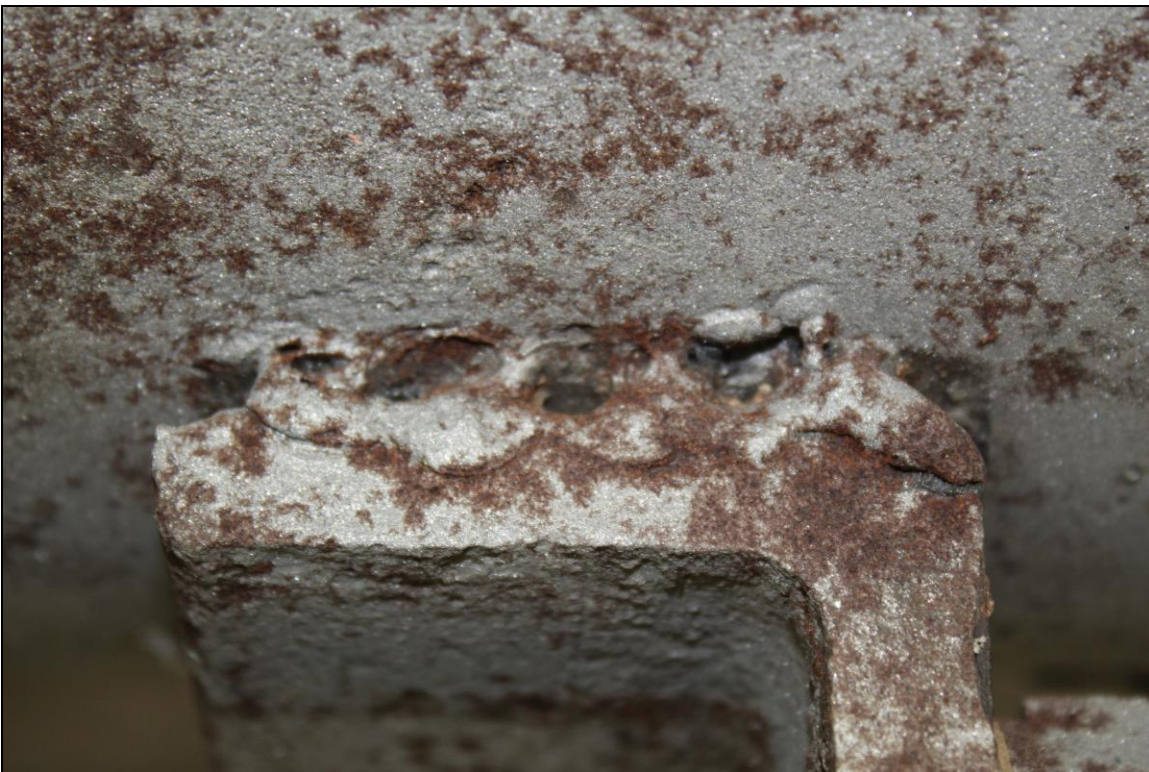
Figure 10. Image of the Lug B5 exterior bottom weld which exhibited minimal fusion.

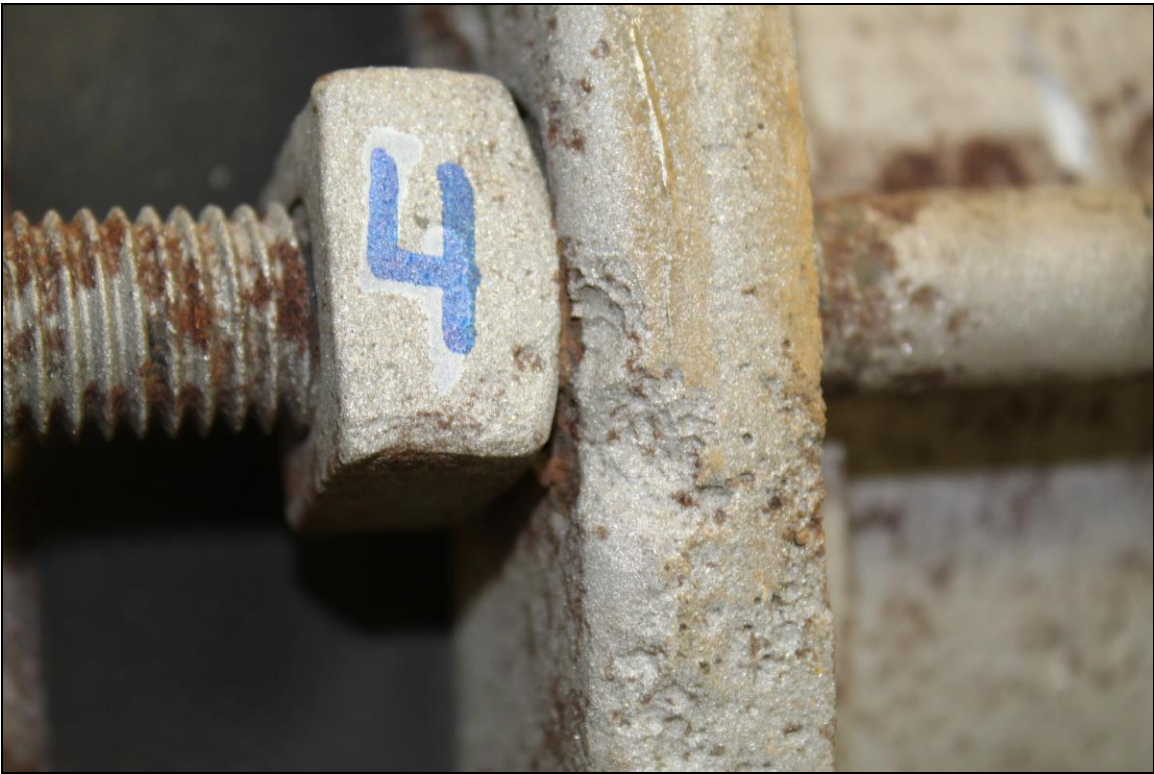
Figure 11. Image of the Bolt A4 fastener assembly which exhibited corrosion and pitting.

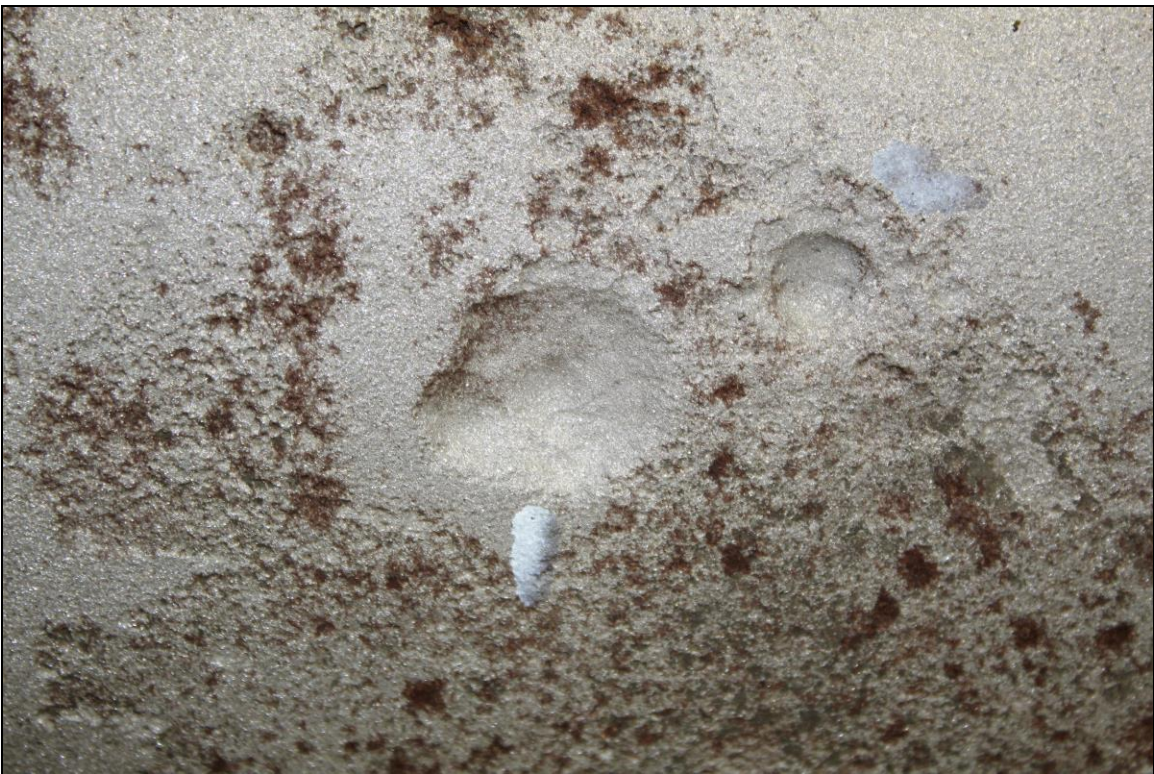
Figure 12. Image of the pipe exterior wall surface which exhibited substantial pitting damage.

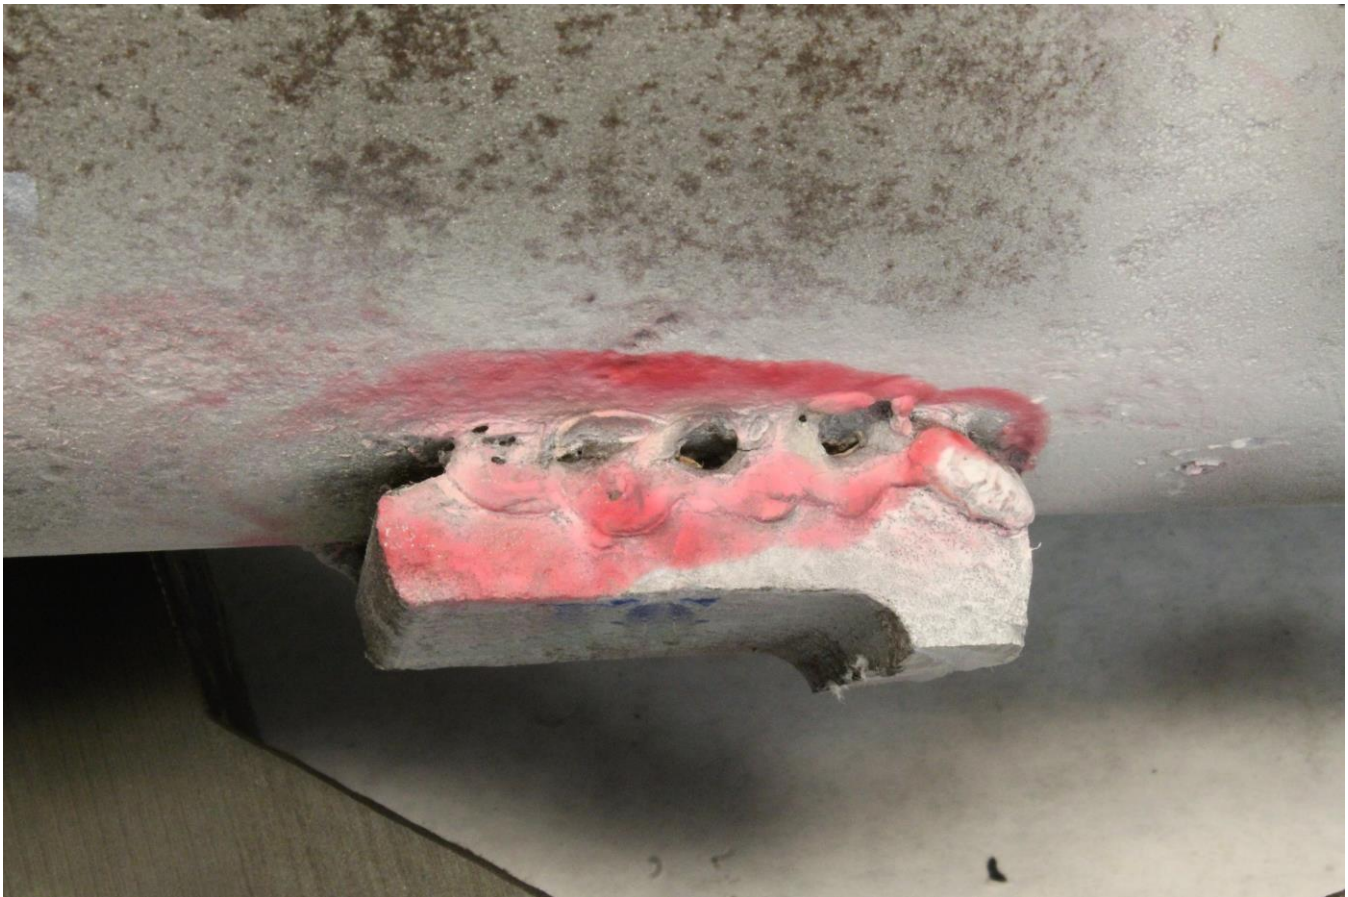
Figure 13. Image of the Lug B5 exterior bottom welds after dye penetrant media had been used during inspection.

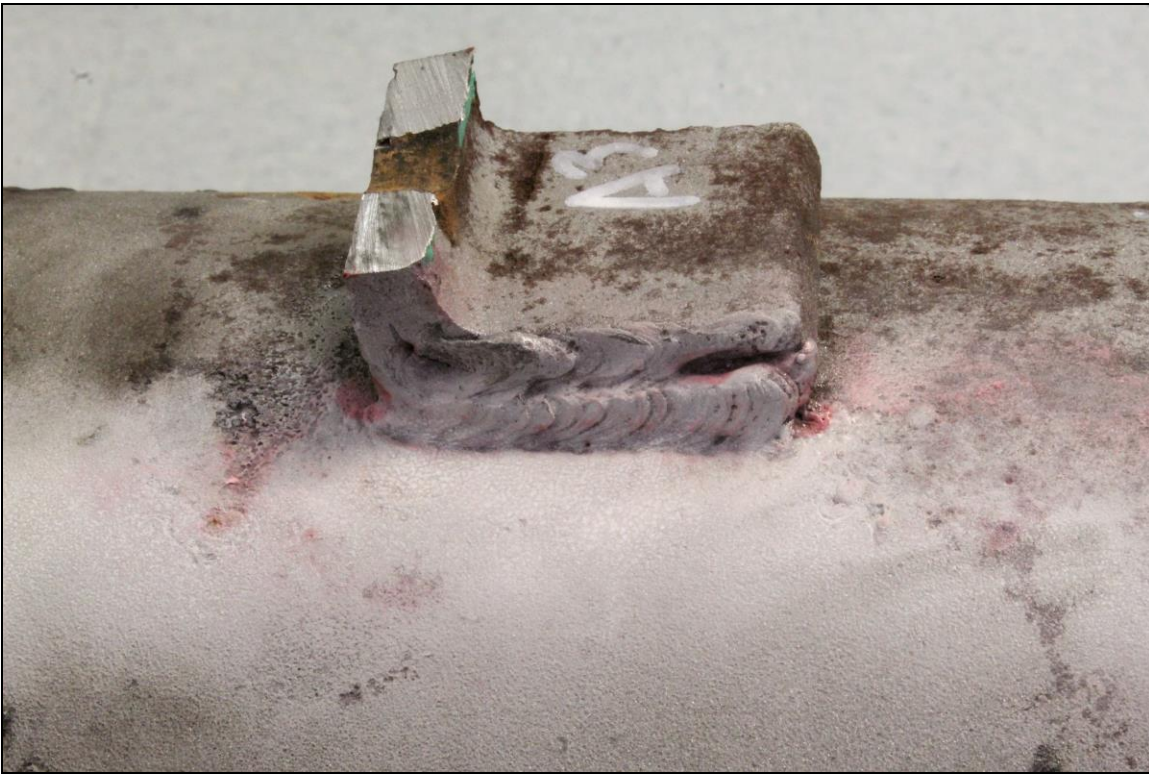
Figure 14. Image of the Lug A3 exterior top welds after dye penetrant media had been used during inspection.

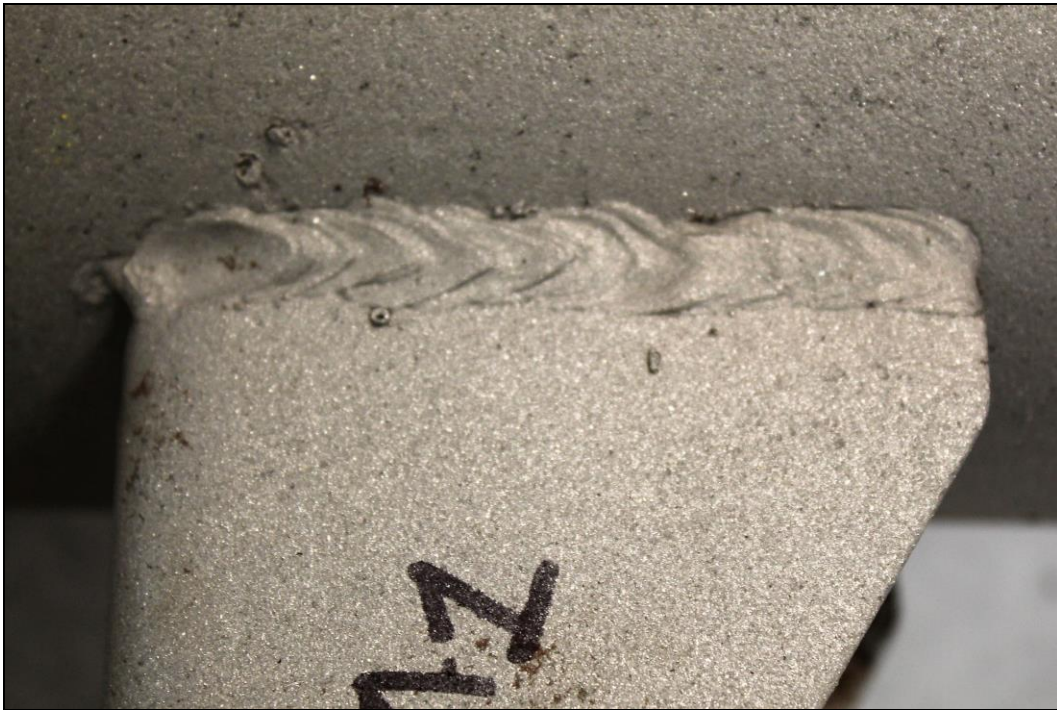
Figure 5. Image of the Lug A1 exterior top weld which exhibited substantial fusion except for some porosity and spatter.

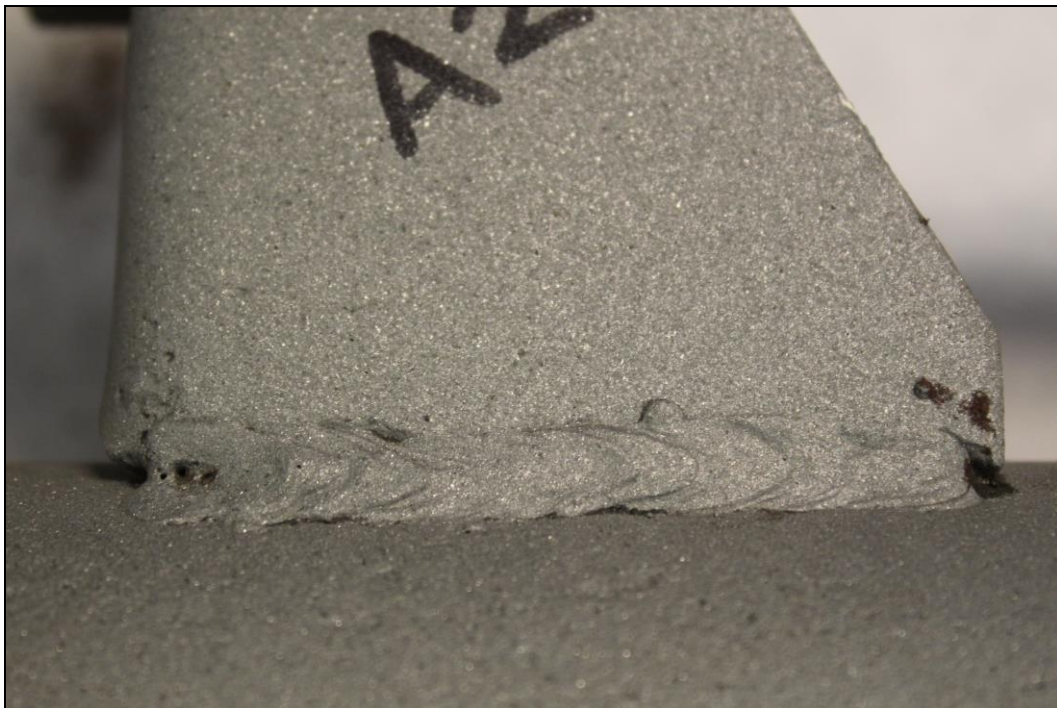
Figure 6. Image of the Lug A2 exterior top weld which exhibited substantial fusion except for some porosity.

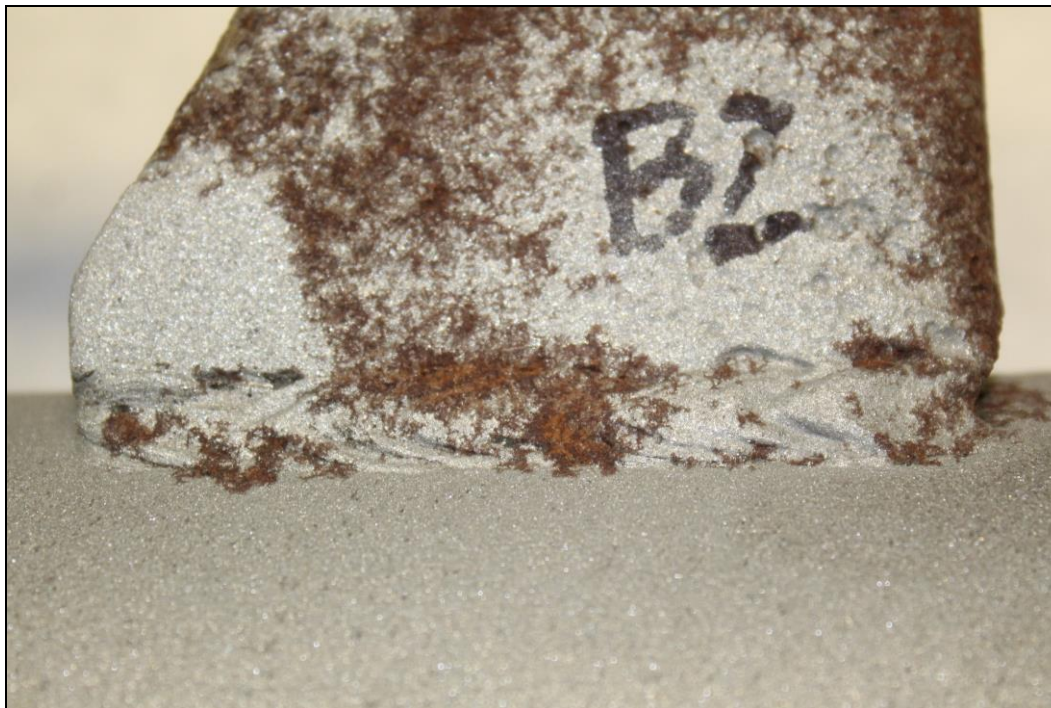
Figure 7. Image of the Lug B2 exterior top weld which exhibited substantial fusion except for some undercut, and porosity. Pitting corrosion damage was observed.

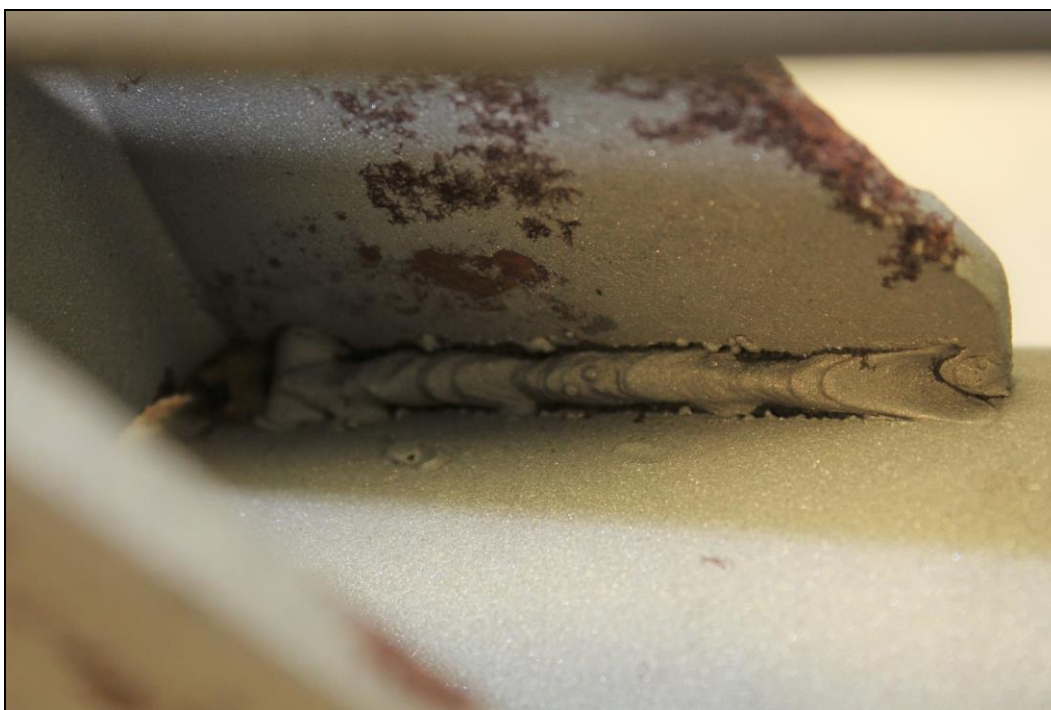
Figure 8. Image of the Lug B2 interior bottom weld which exhibited substantial fusion except for some arc burn, spatter, porosity and undercut.
