**RE: Louisville Gas and Electric Company Alleged Failure to Comply with
KRS 278.495, 807 KAR 5:022, and 49 C.F.R. Part 192
Case No. 2017-00119**

Louisville Gas and Electric Company
2020 Annual Report
Case No. 2017-00119

GTI Report Section 3, Part F: Continuous Process Improvement and Leading Indicators

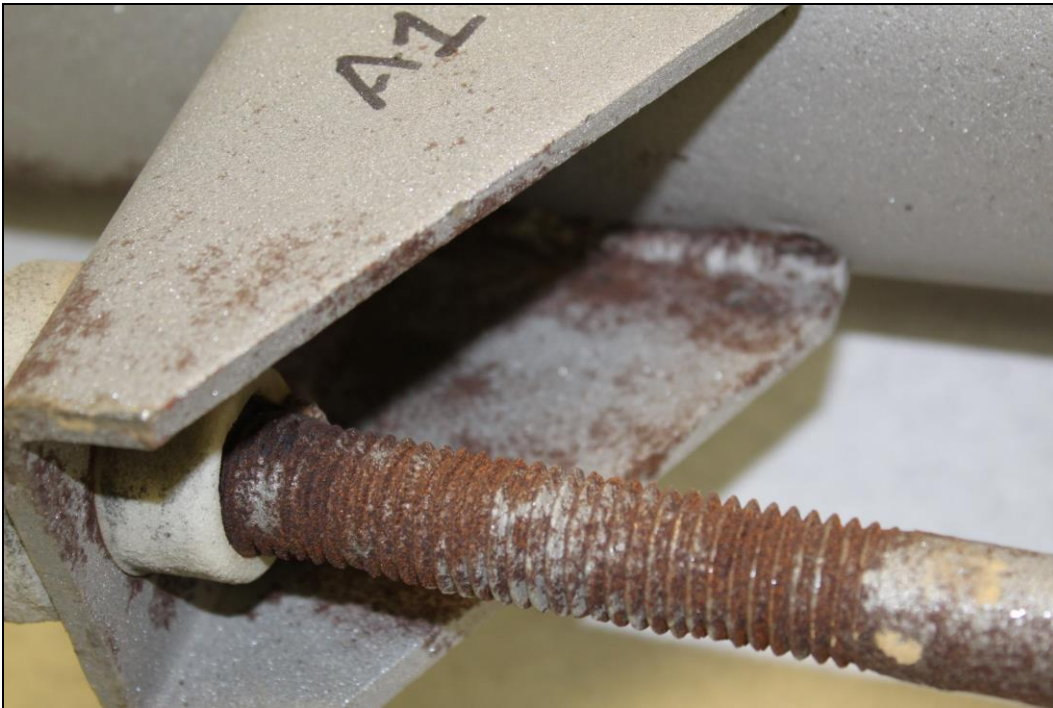
Figure 9. Image of the Lug A1 fastener assembly which exhibited substantial corrosion.

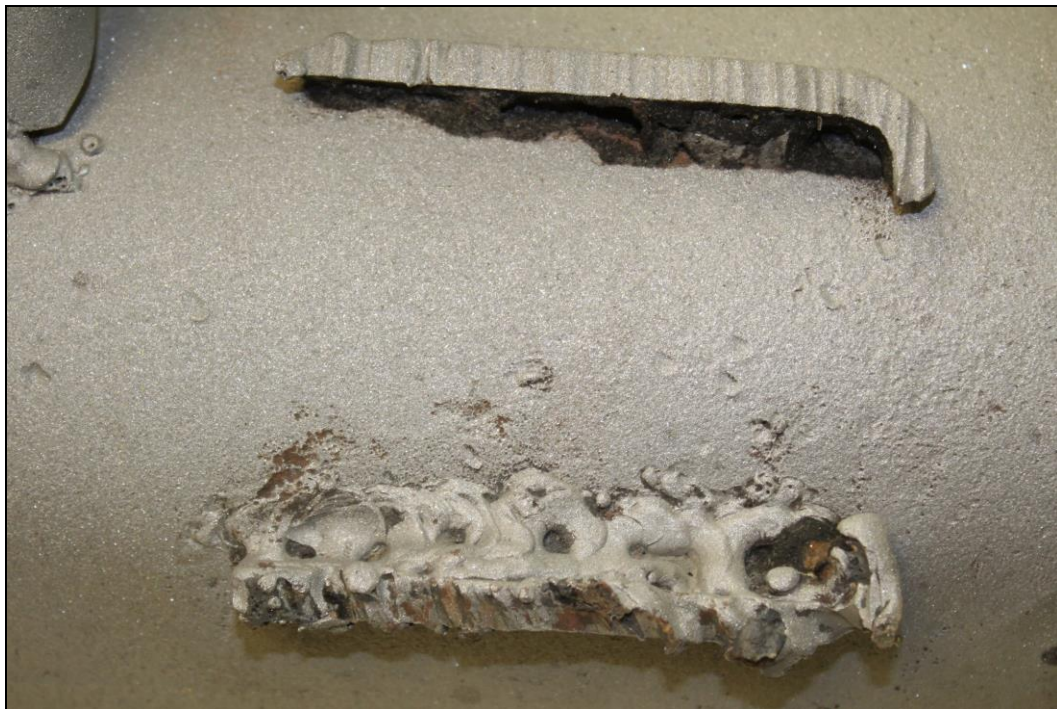
Figure 10. Image of the remainders of additional lugs, which had been welded then cut off, present on Side A of the assembly.
