Re: U.S. 60 Water District
Alleged Failure to Comply with 807 KAR 5:006, Sections 26 and 27, and
807 KAR 5:066, Section 7
Case No. 2015-00037

NOTICE OF FILING OF TANK INSPECTION REPORTS

Ground Storage Inspection Report

Elevated Water Tank Inspection Report

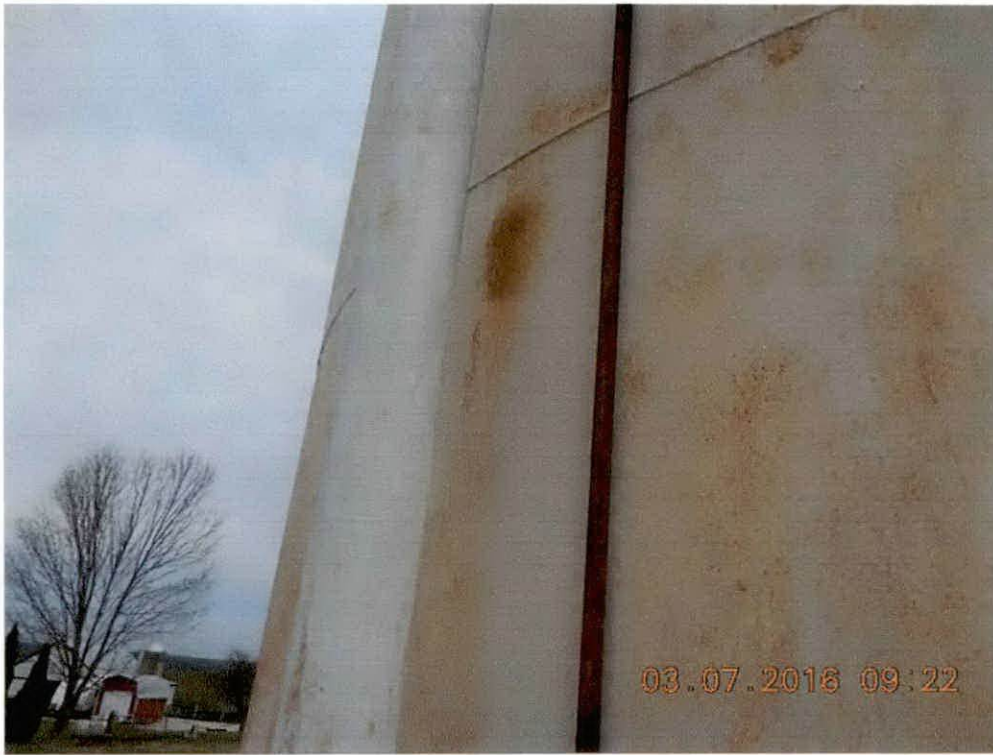
Failed coating tank exterior

It is time to repaint the tank, the current coating we feel are lead containing, and recommend an overcoat of the exterior to avoid having to deal with the lead issues and everything that comes along with them as well as the expense. There are very specific products on the market for this purpose, Some of which offer a 10 year warranty.

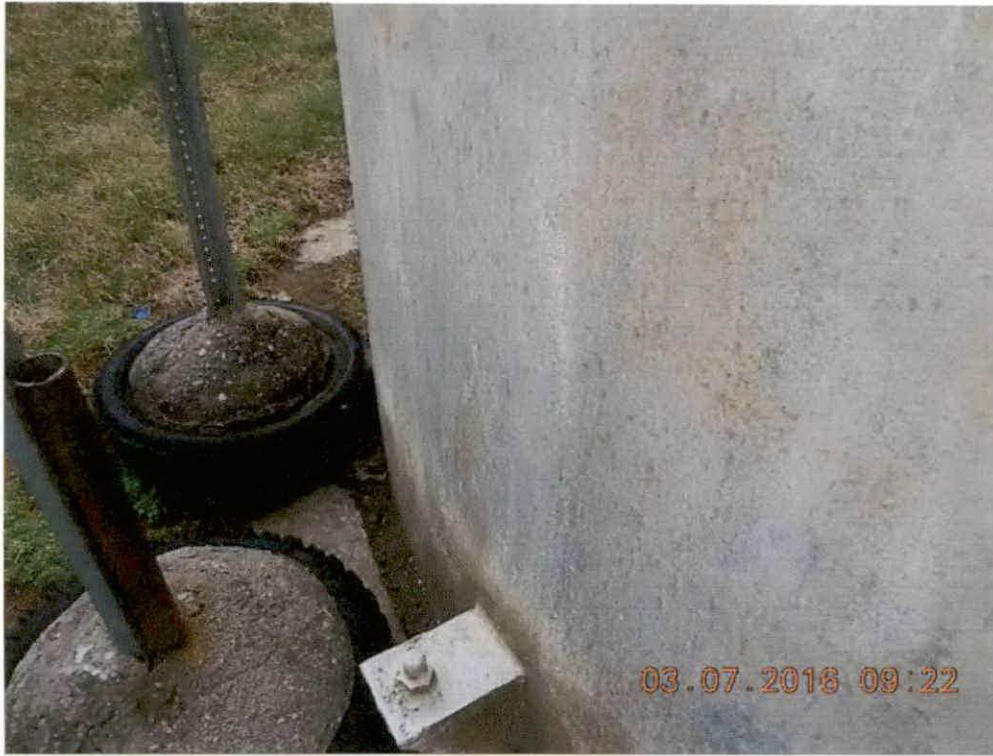
Tank sidewall to foundation

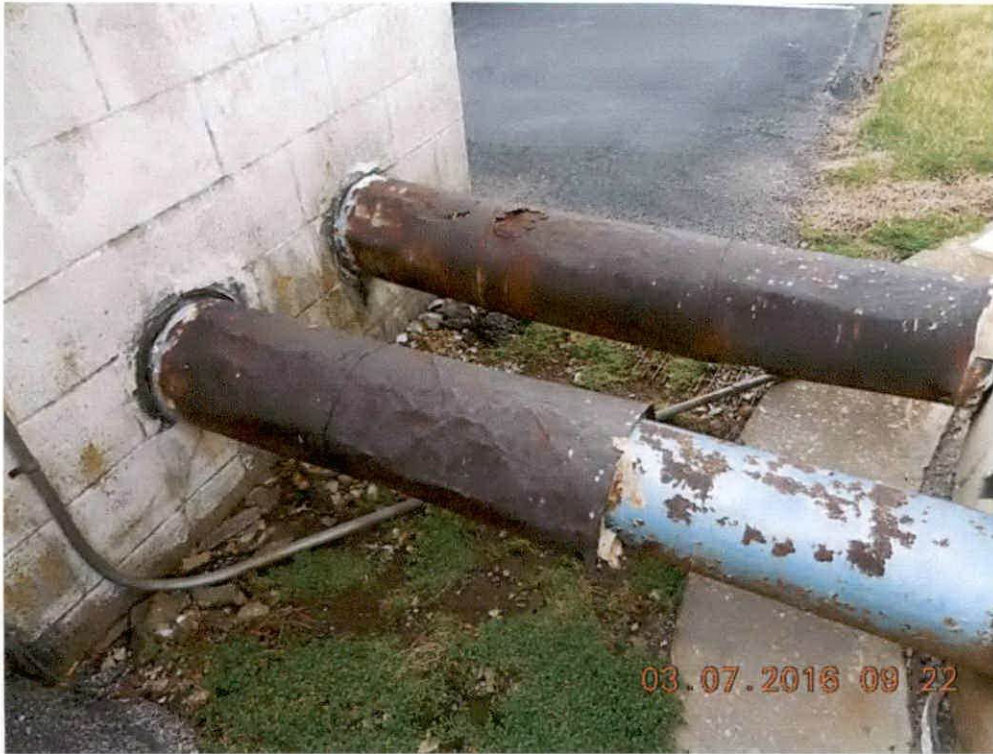
Are they in good condition and well supported? **No**

Describe: **Need replacing**

Inlet /outlet piping to valve house, most insulation damaged or missing

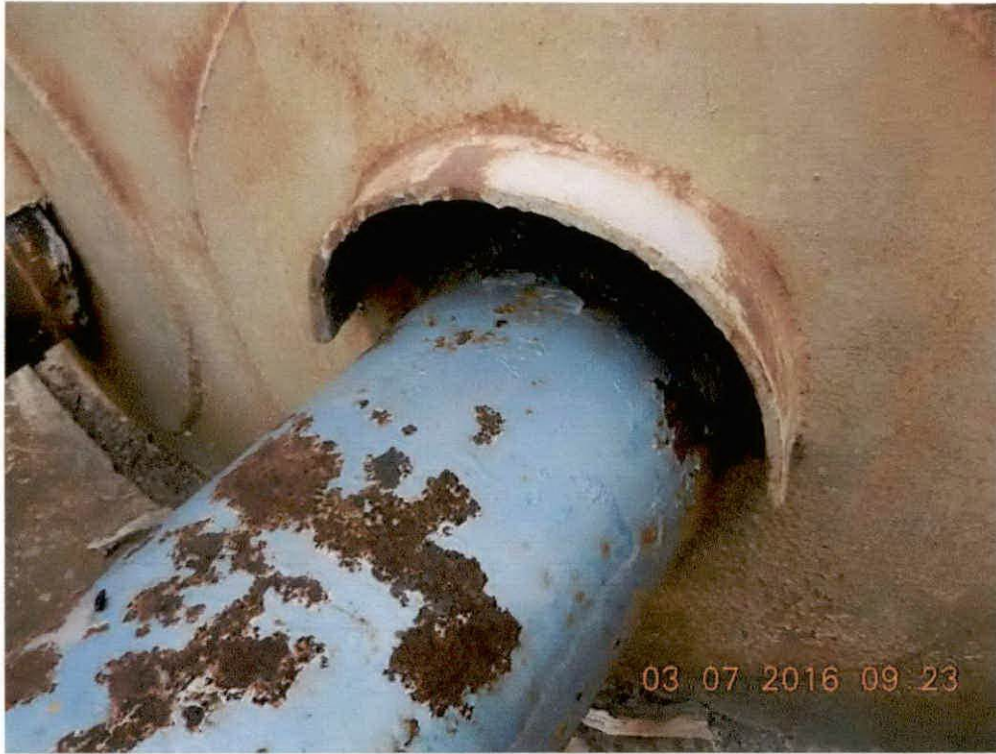
Inlet pipe no insulation

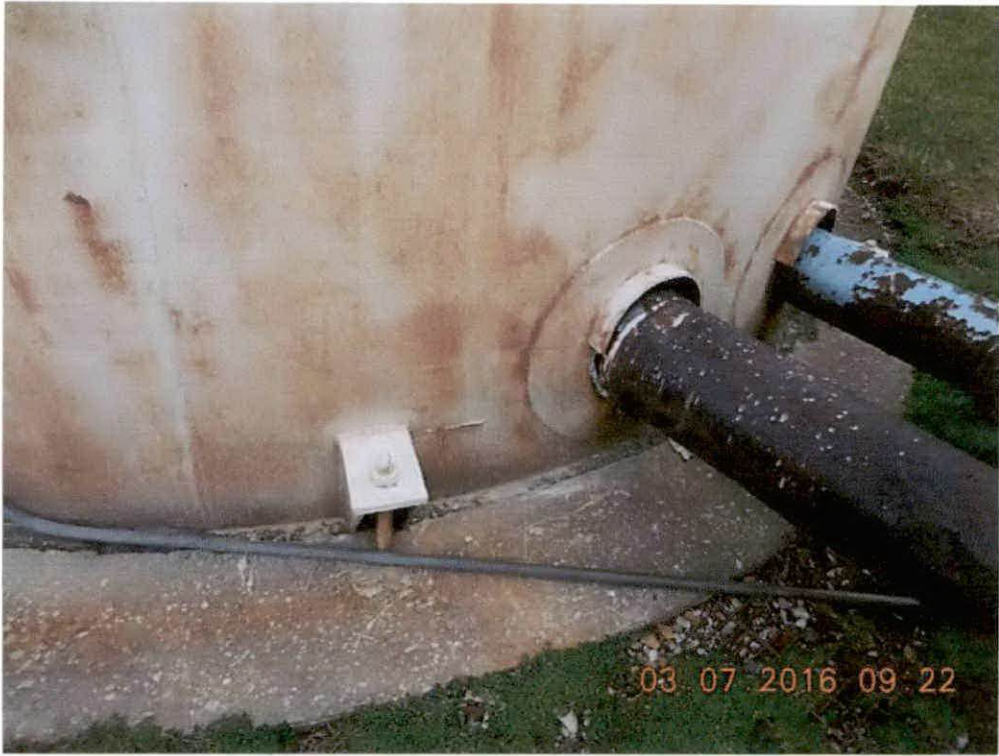
Foundation and piping

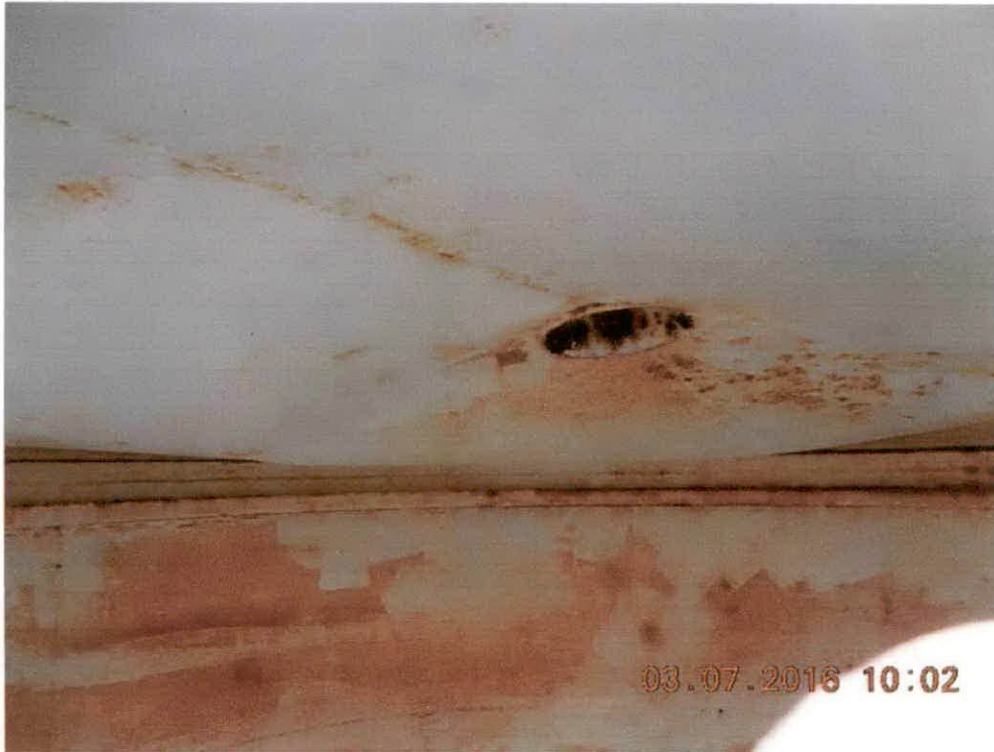
The most outstanding issue is the imploded roof(most likely the result of a frosted vent screen). During a cold winter. This creates a number of problems.

- **Structural integrity of the tank is now in question.**
- **The roof no longer sheds water as intended. Thus causing ponding of water on the roof, this ponding adds a tremendous amount of weight to the roof. Which also adds stress to the sidewalls of the tank. The tank was not designed for standing water (this has to be addressed asap). Furthermore this can and will over time lead to a very serious structural issue with the tank, that could lead to a catastrophic conclusion.**

**Interior roof and vent failed coatings, compression ring rusted heavily.
Note that roof has a bow inward. This is from the imploded roof(see
comments in report, about roof)**

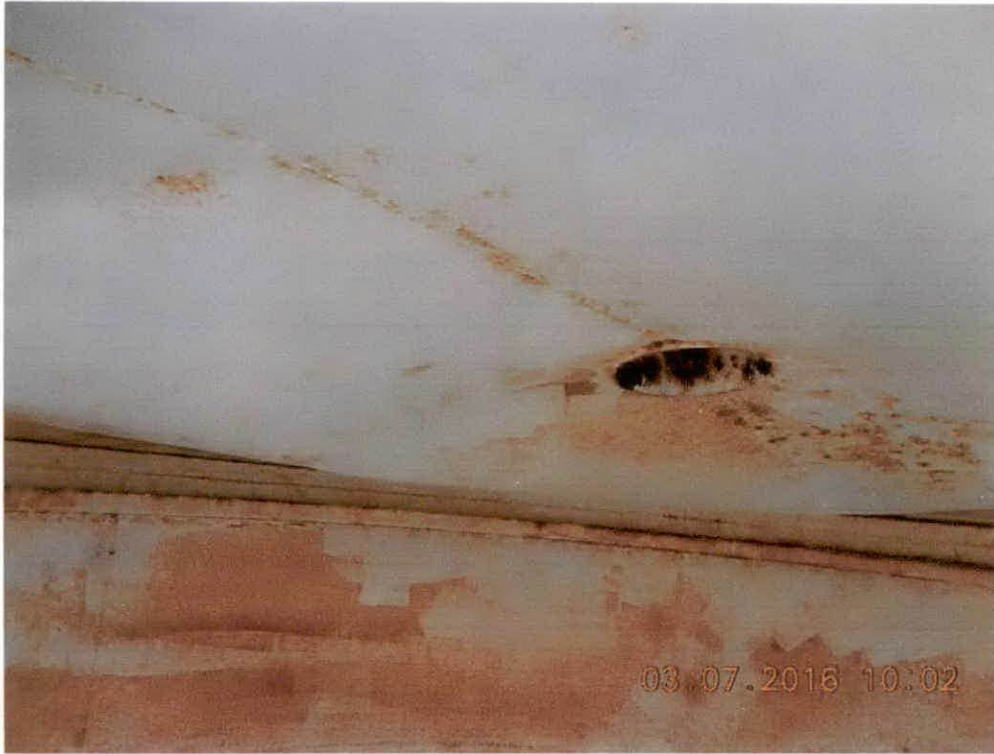
Roof vent interior heavily rusted

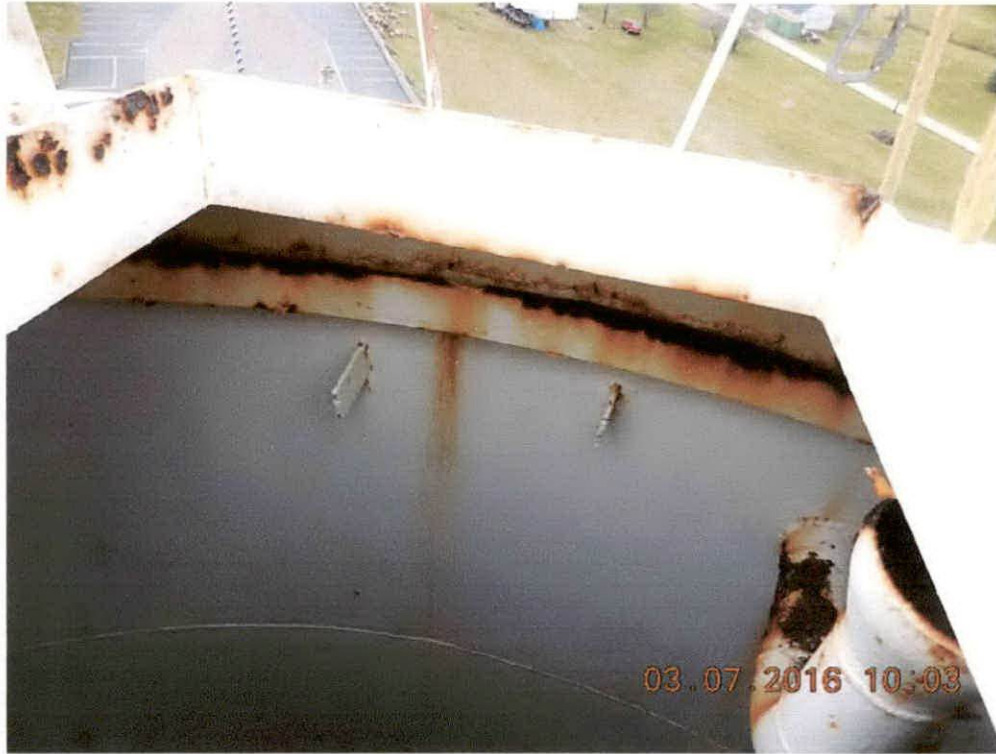
Describe: **Rusted and comprised**

Roof manway, compression ring heavily rusted. Old ladder supports not removed, when ladder was removed. Overflow piping heavily rusted

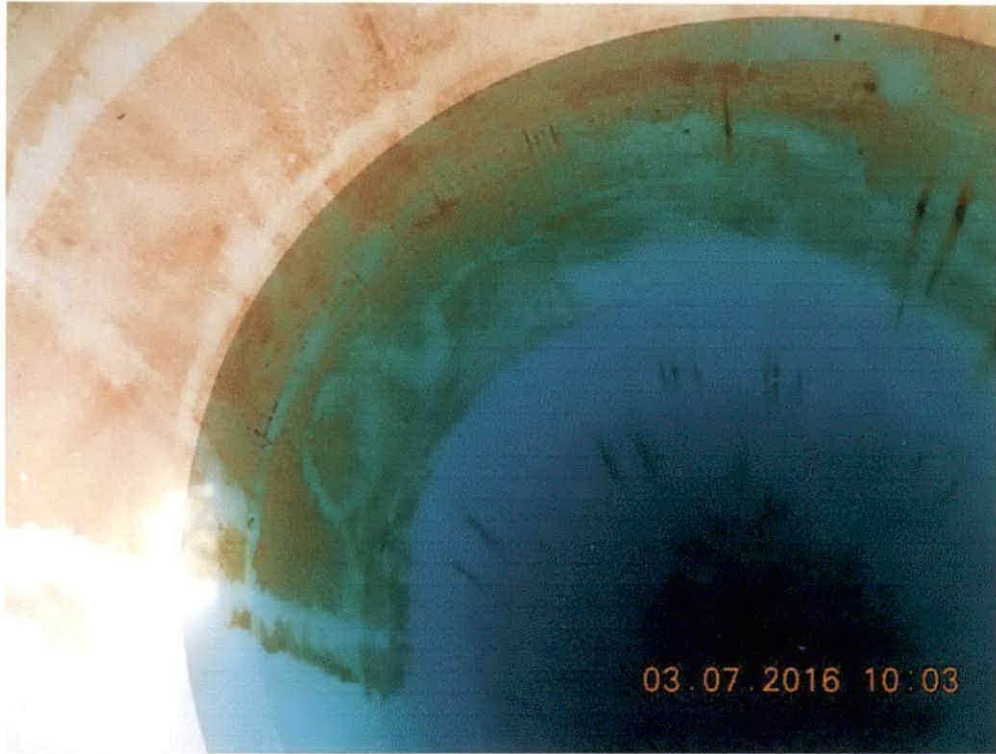
Looking into tank, failed coating upper 3 courses, as well as numerous failed areas in sidewall of tank

Needs attention this year, the protective coating is providing little if any protection of the steel, (see video). The interior needs to be completely removed and replaced with a high performance coating product

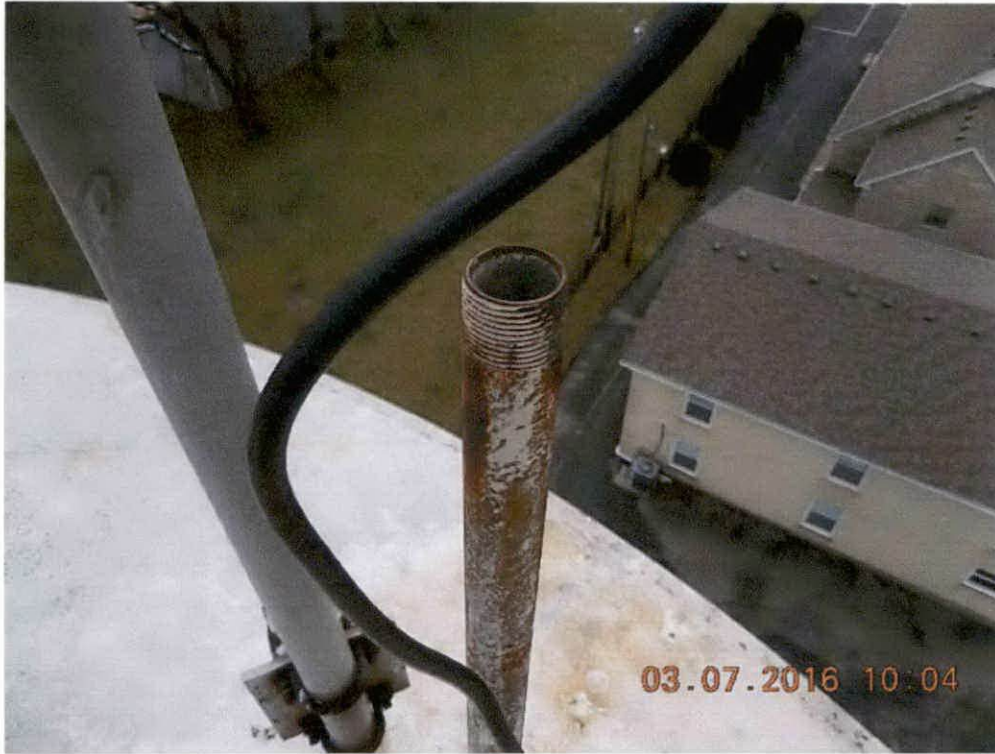
Comm antenna mast and wire not secured

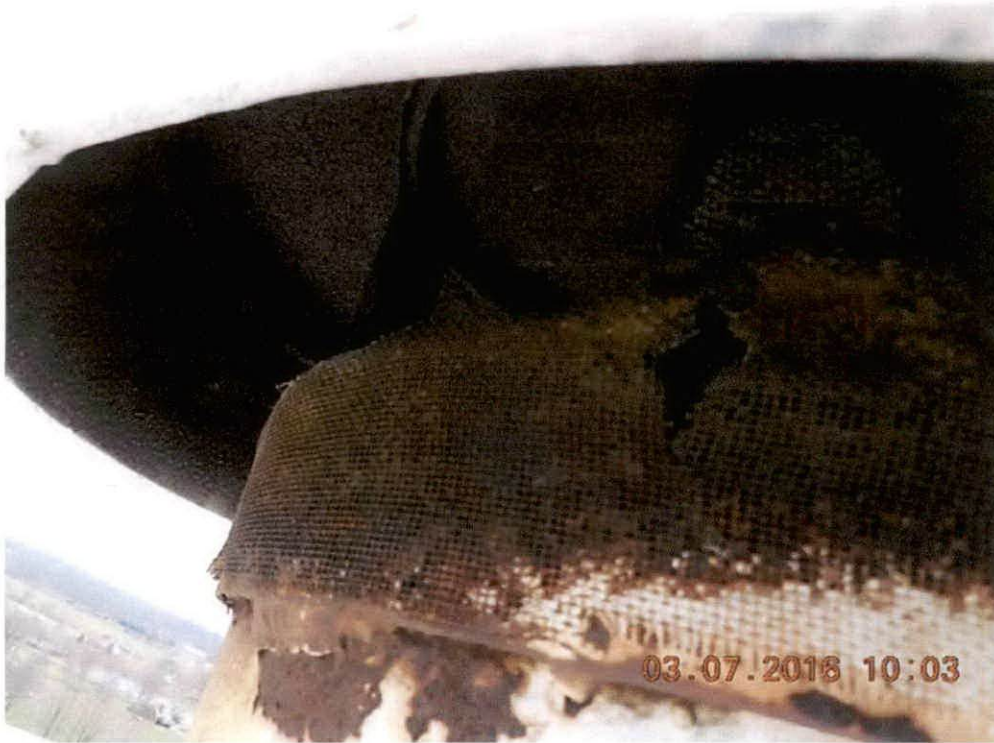
Roof vent with fine mesh screen. This screen is most likely the cause of the roof collapse/implosion. Most likely the screen frosted over during a cold period.

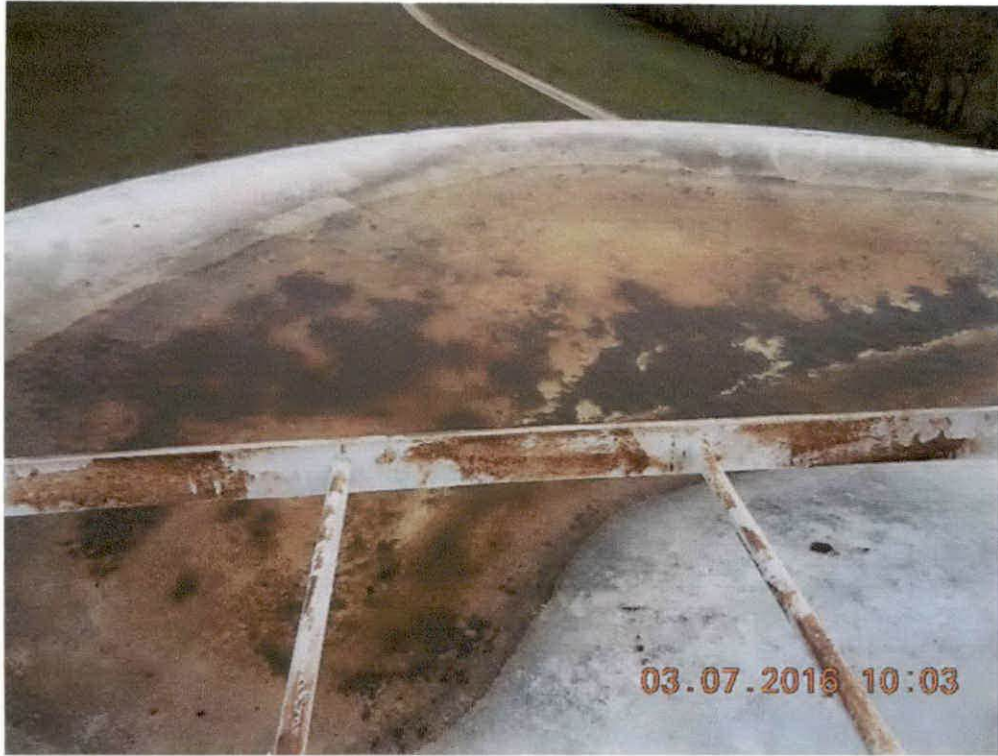
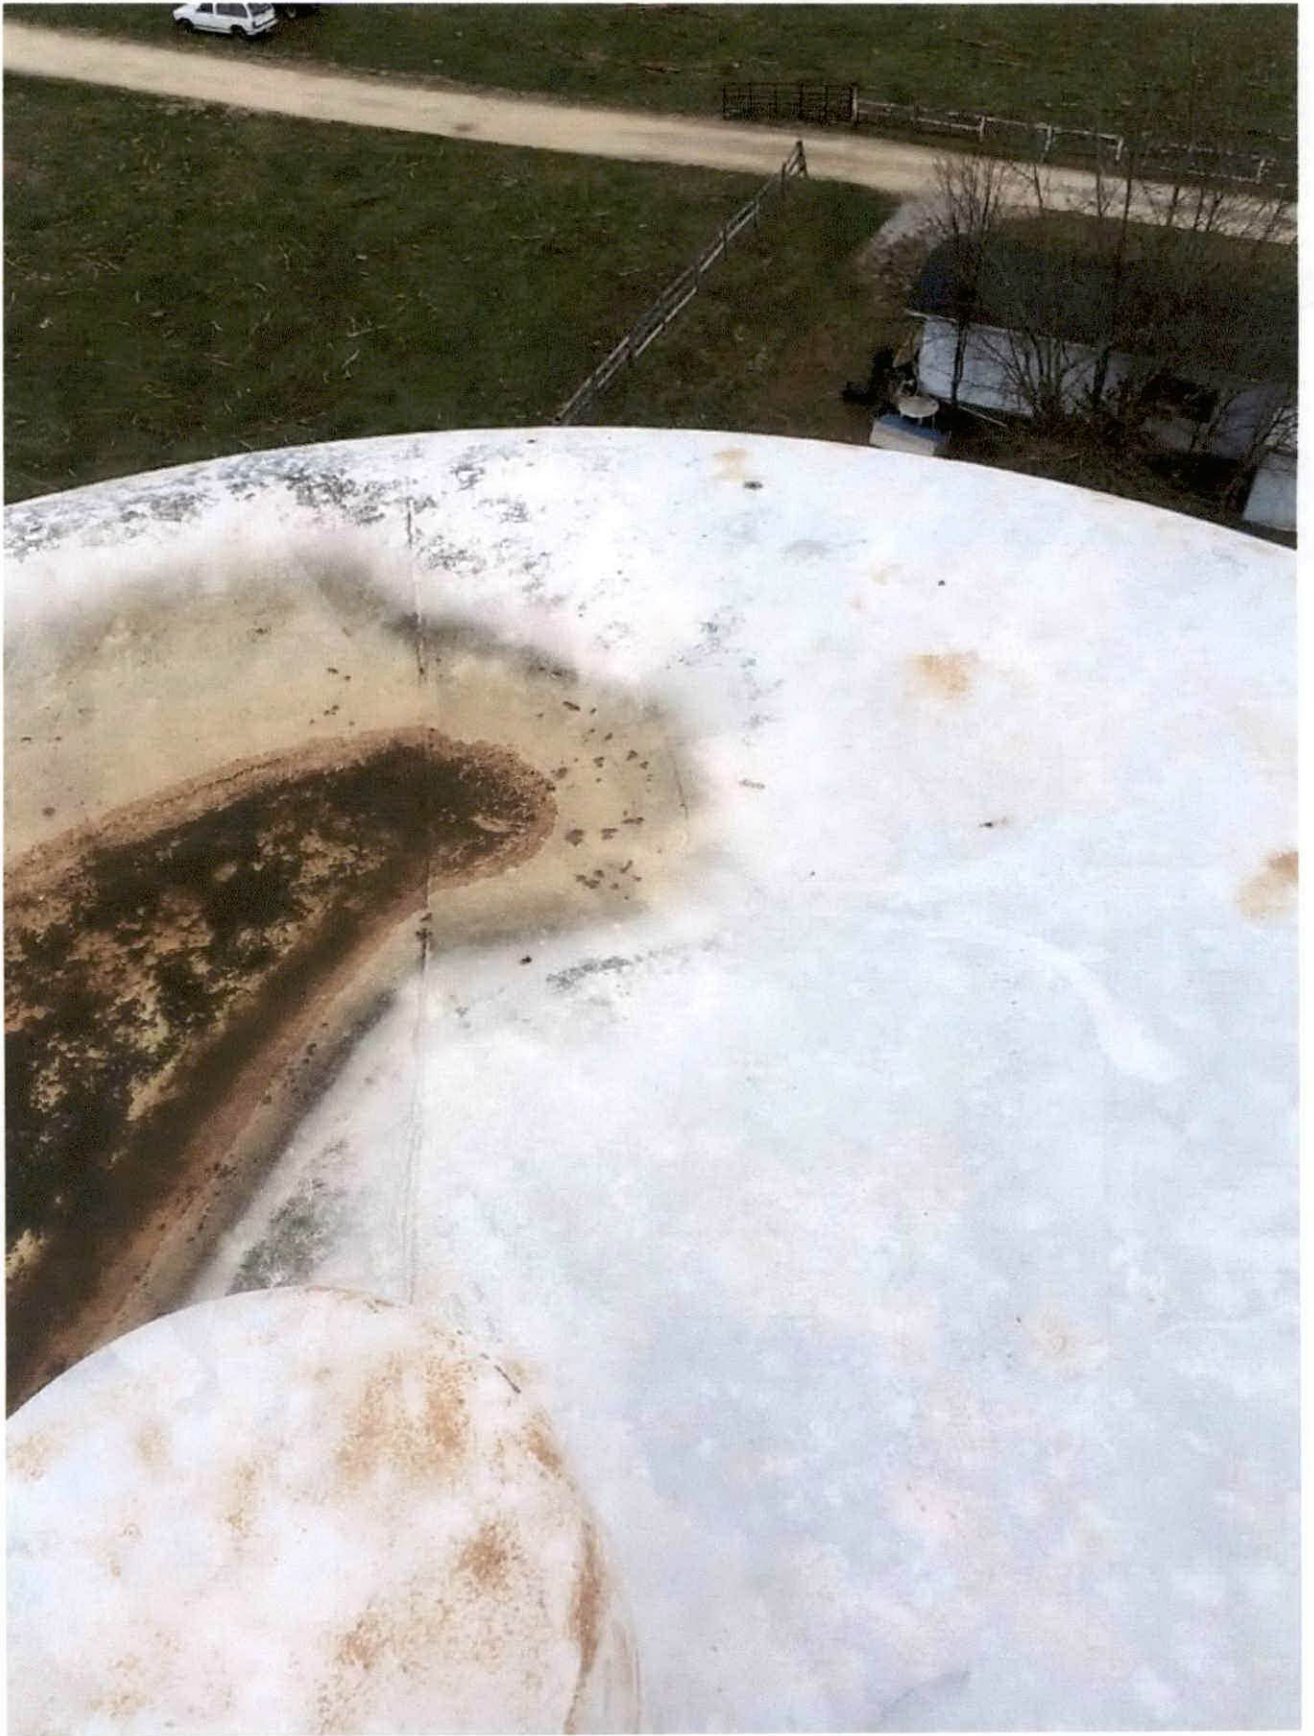
Imploded roof

1. Repairs made by inspector: **Temporary vent screen**
2. Recommended Repairs: *Wet or Dry has a KY registered P.E. structural engineer that can fully evaluate the roof system of the tank, and make a full recommendation to the District if so desired.*

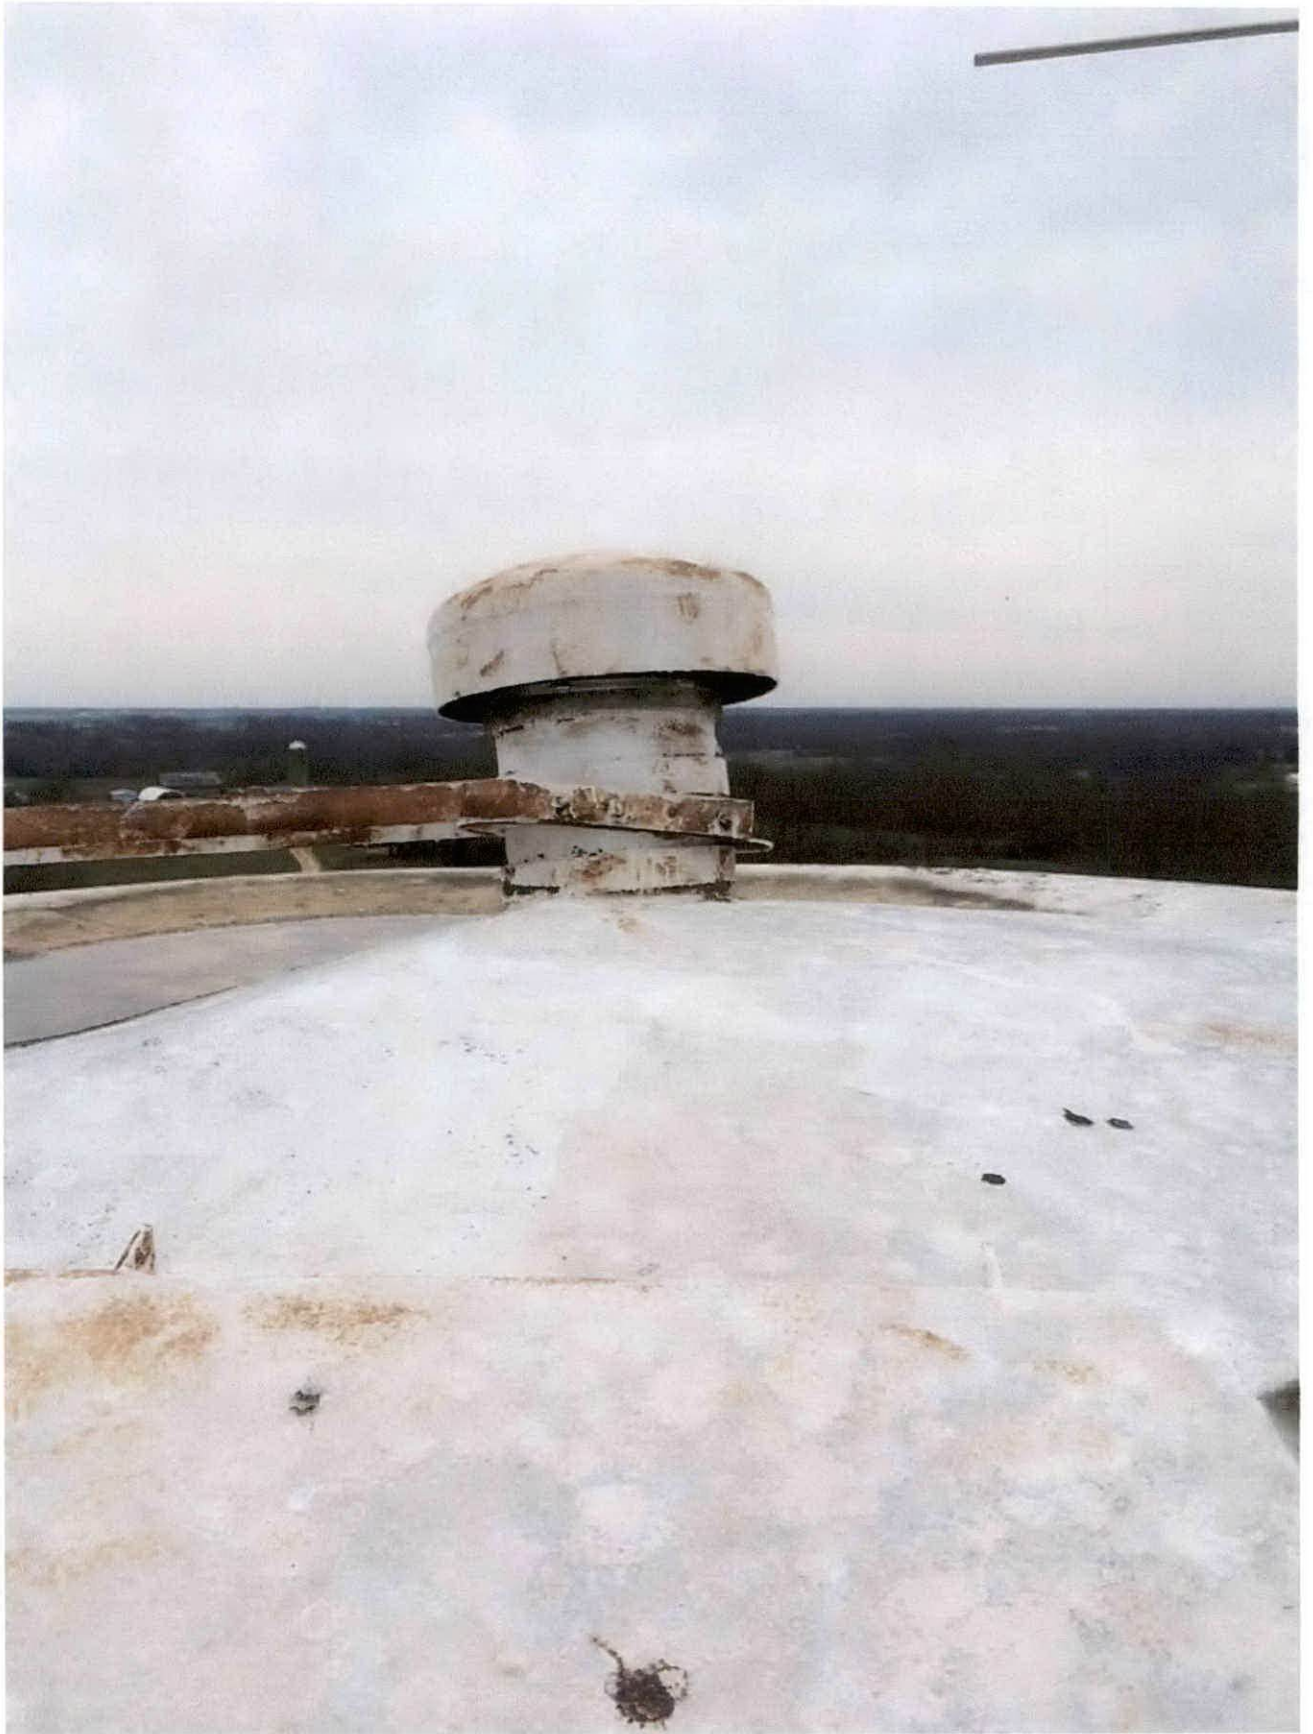
Roof vent and imploded roof. Note vent is no longer straight

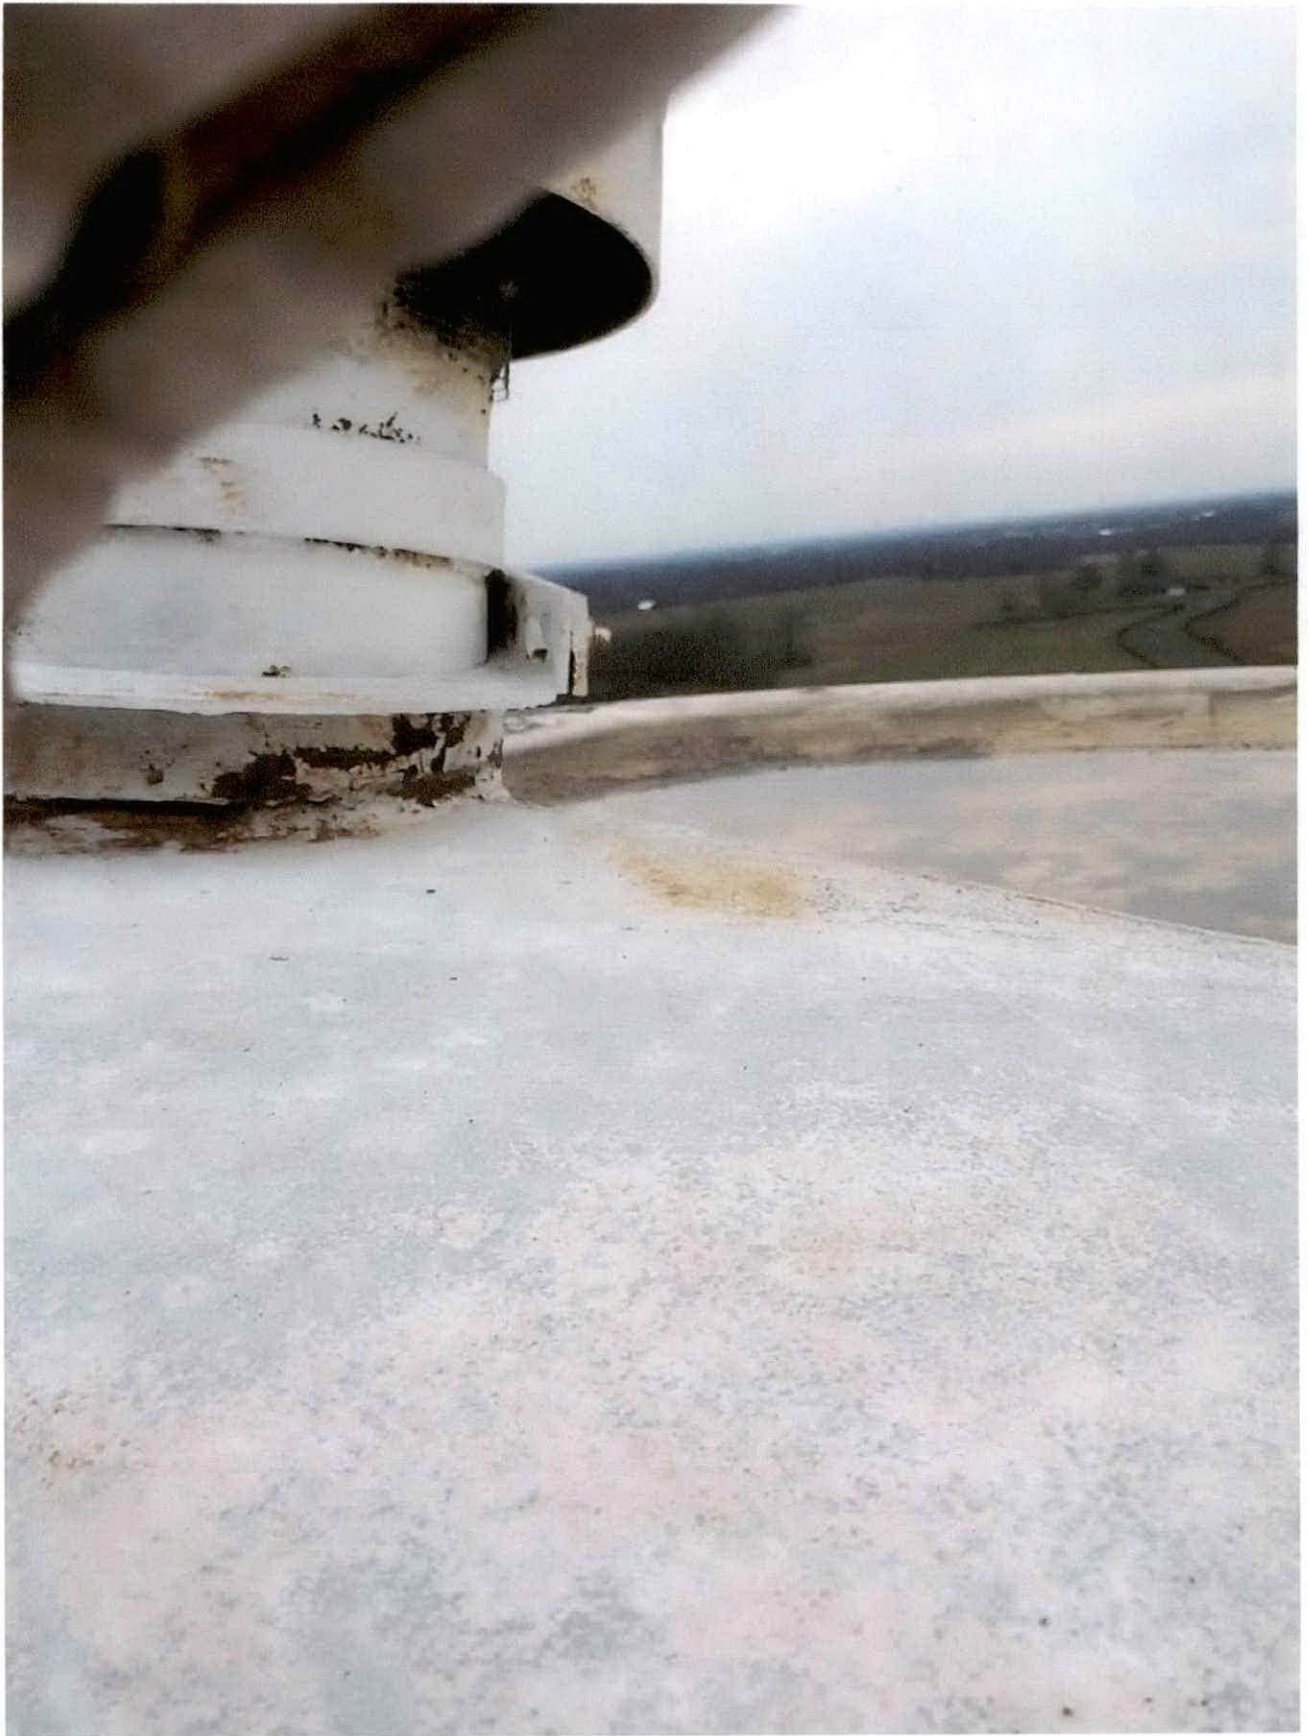
Another view of vent and roof with ponding water

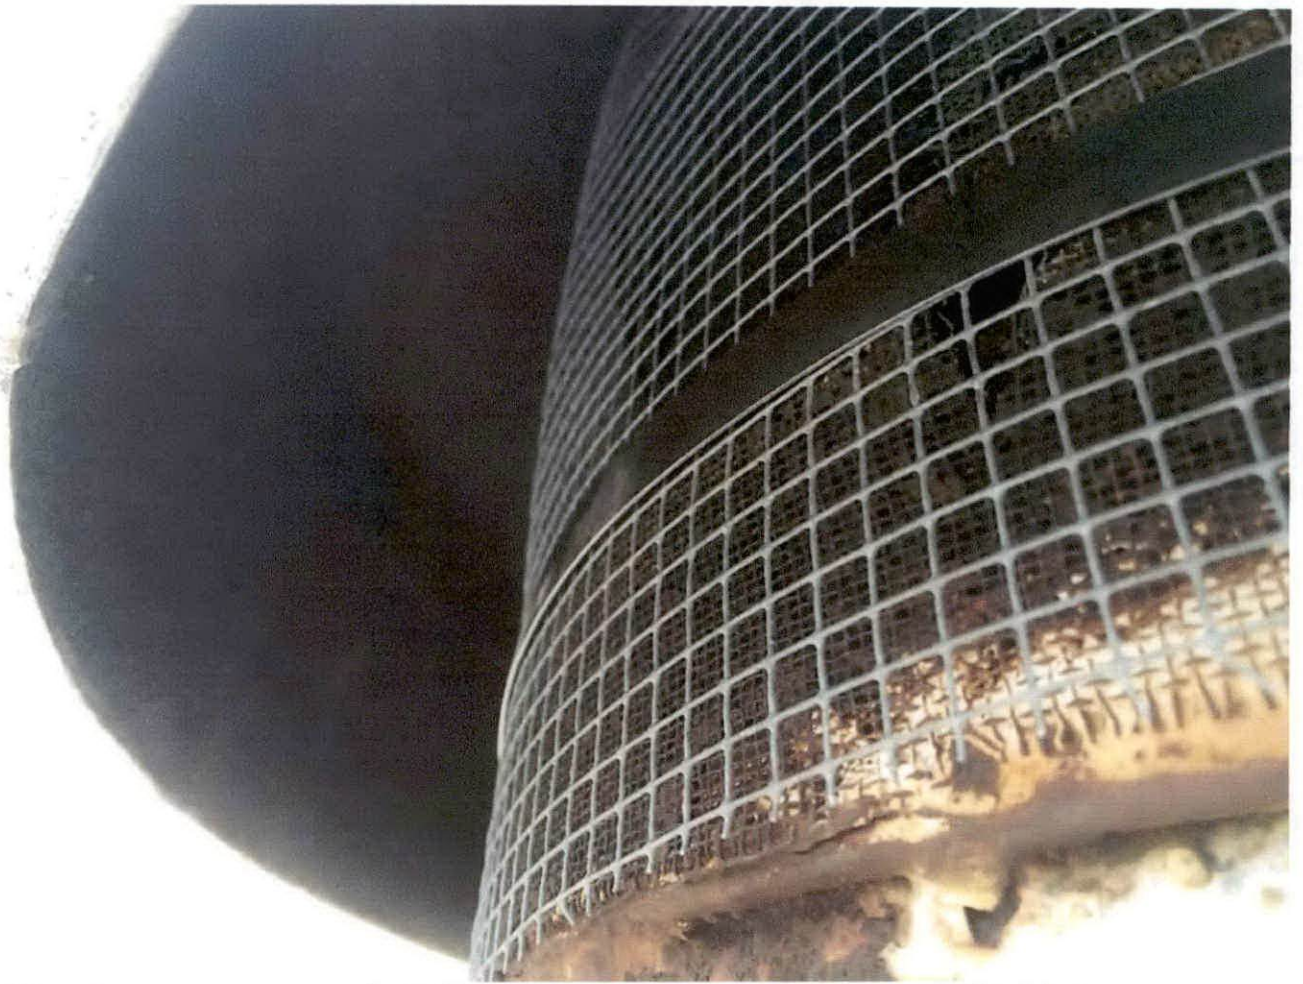
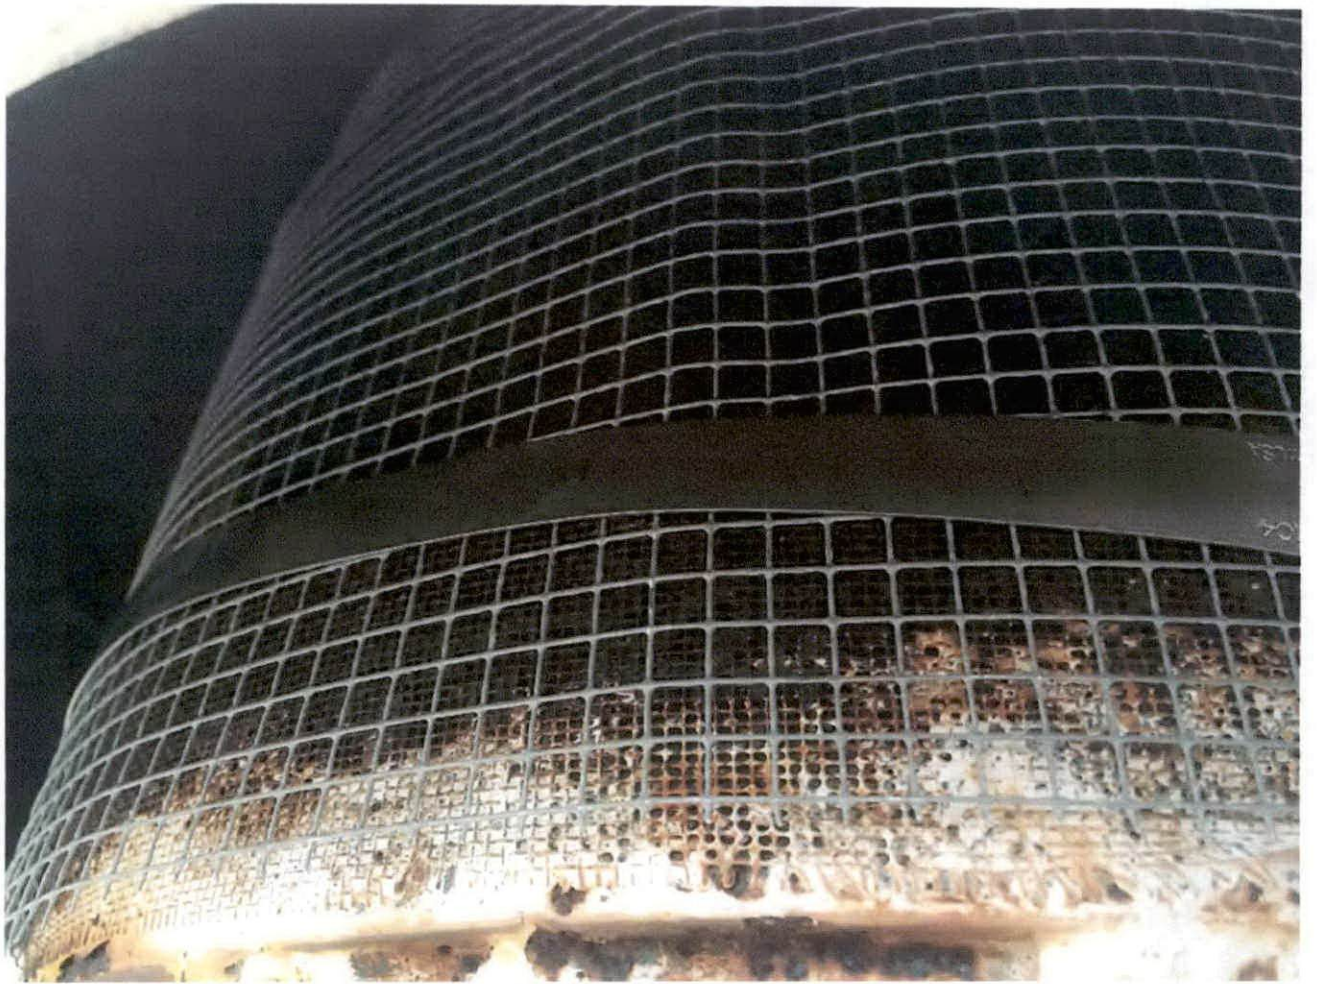
**New temporary screen installed by Wet or Dry, to keep un-desirables,
access to tank interior**

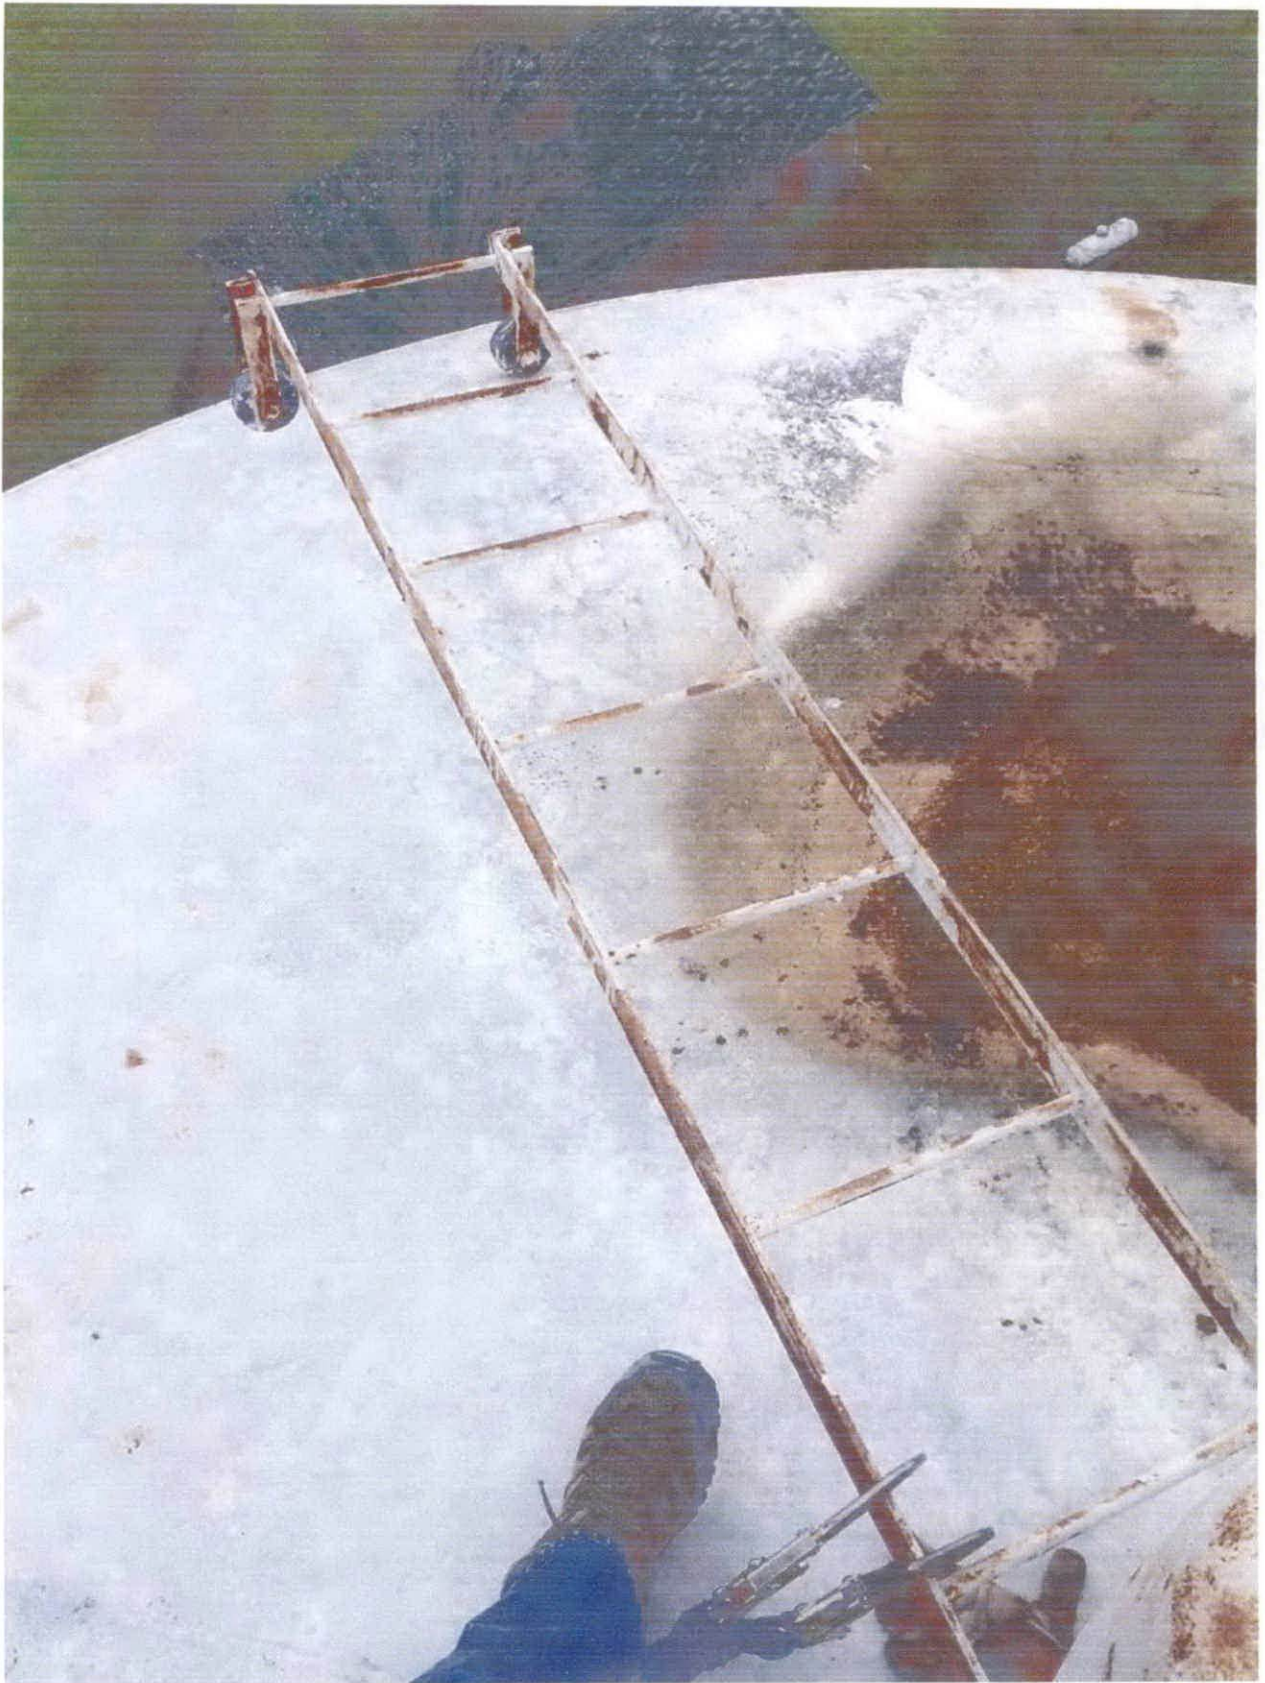
Ponding water on roof(where imploded), roof ladder(not secured, no

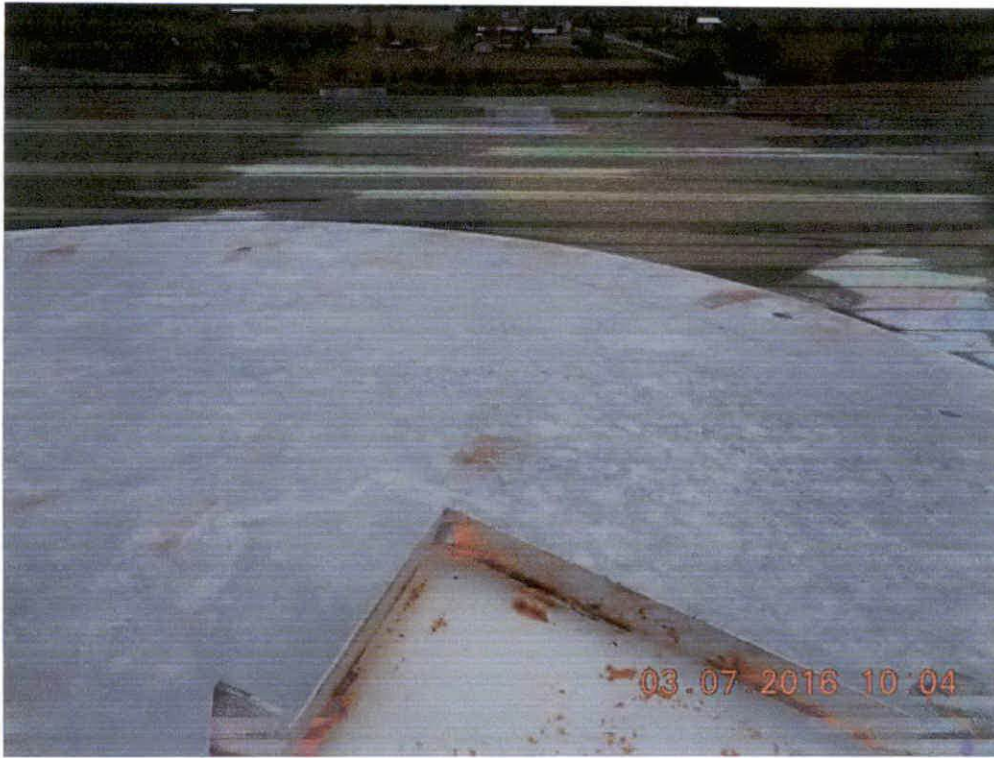
Failed coatings roof

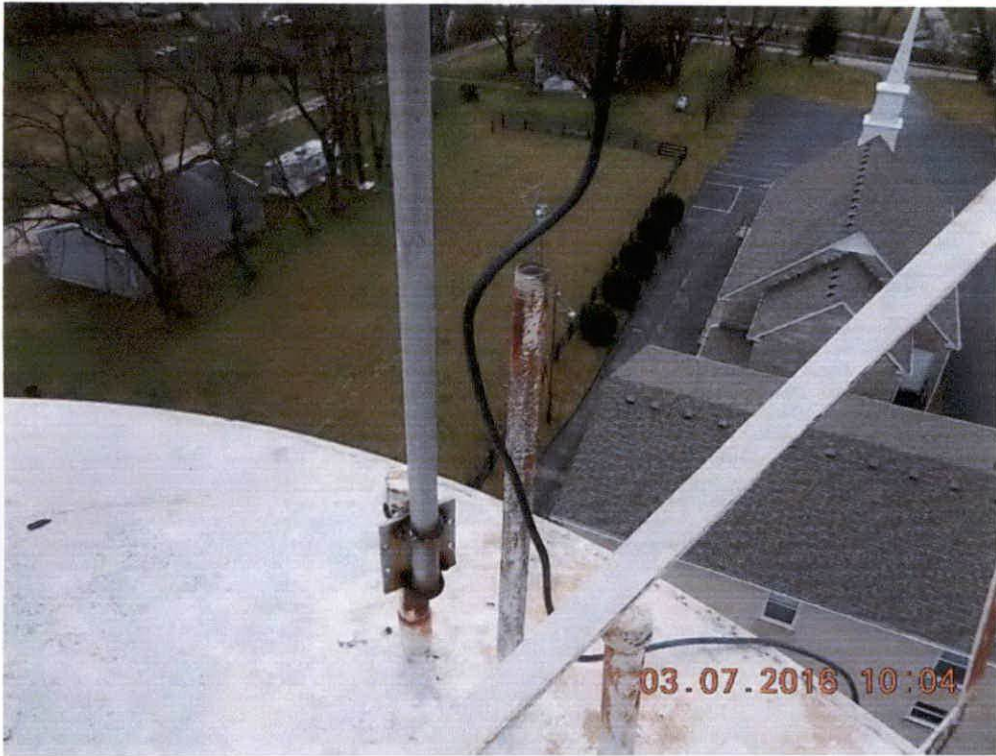
Unsecured comm cable
