Re: U.S. 60 Water District
Alleged Failure to Comply with 807 KAR 5:006, Sections 26 and 27, and
807 KAR 5:066, Section 7
Case No. 2015-00037

NOTICE OF FILING OF TANK INSPECTION REPORTS

Ground Storage Inspection Report

Elevated Water Tank Inspection Report

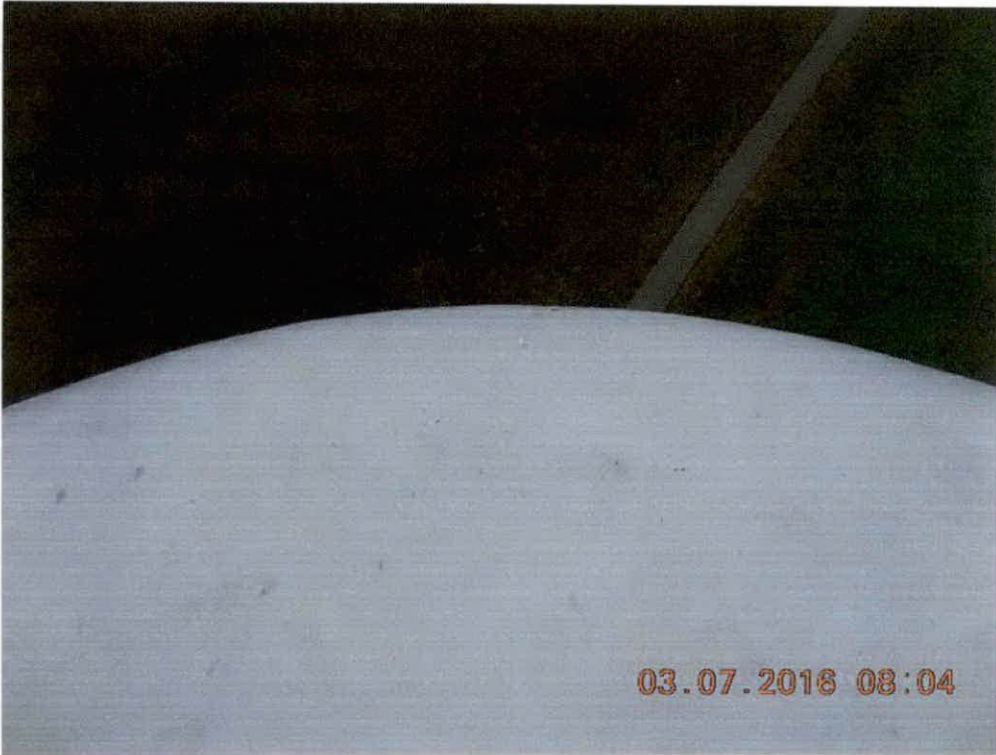
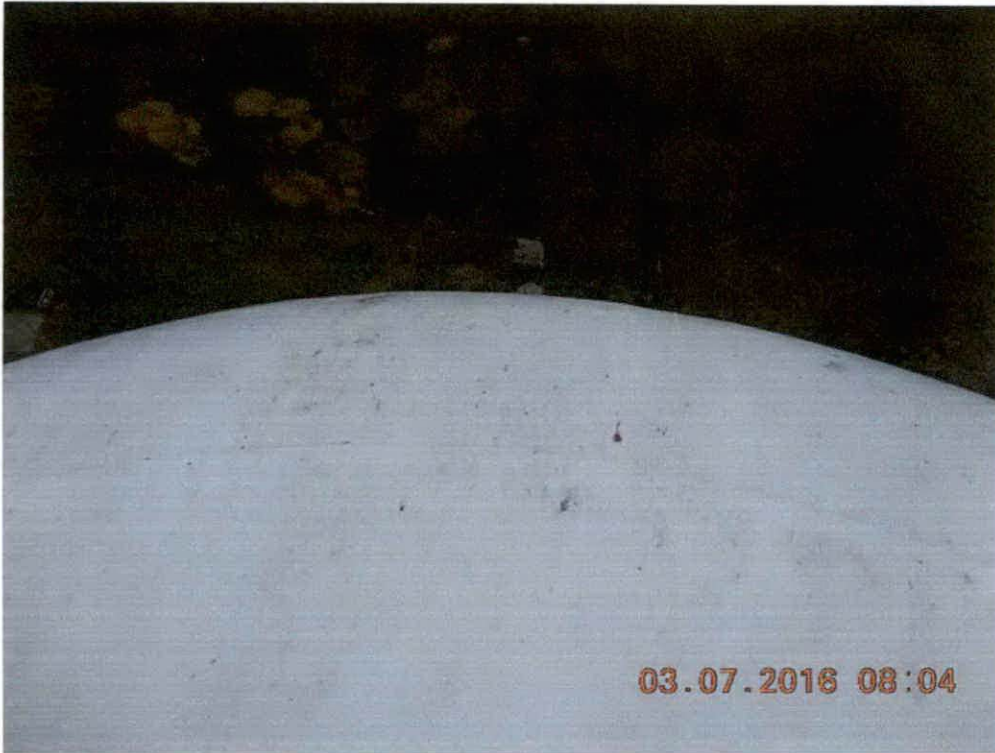
Roof coating thinning

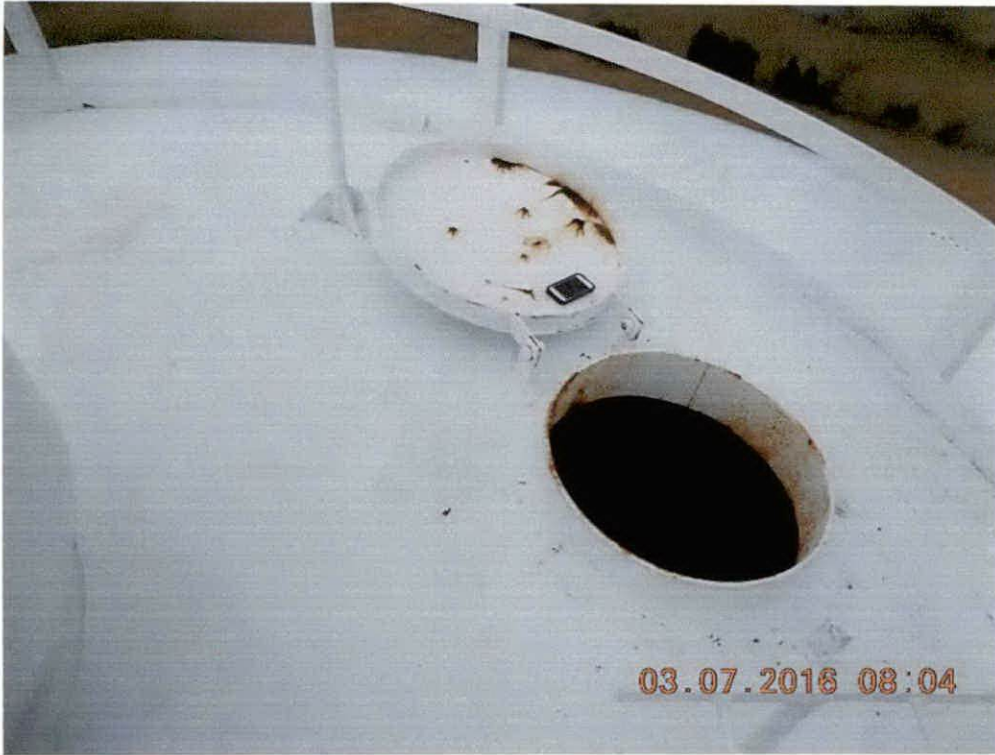
Roof manway failed coating

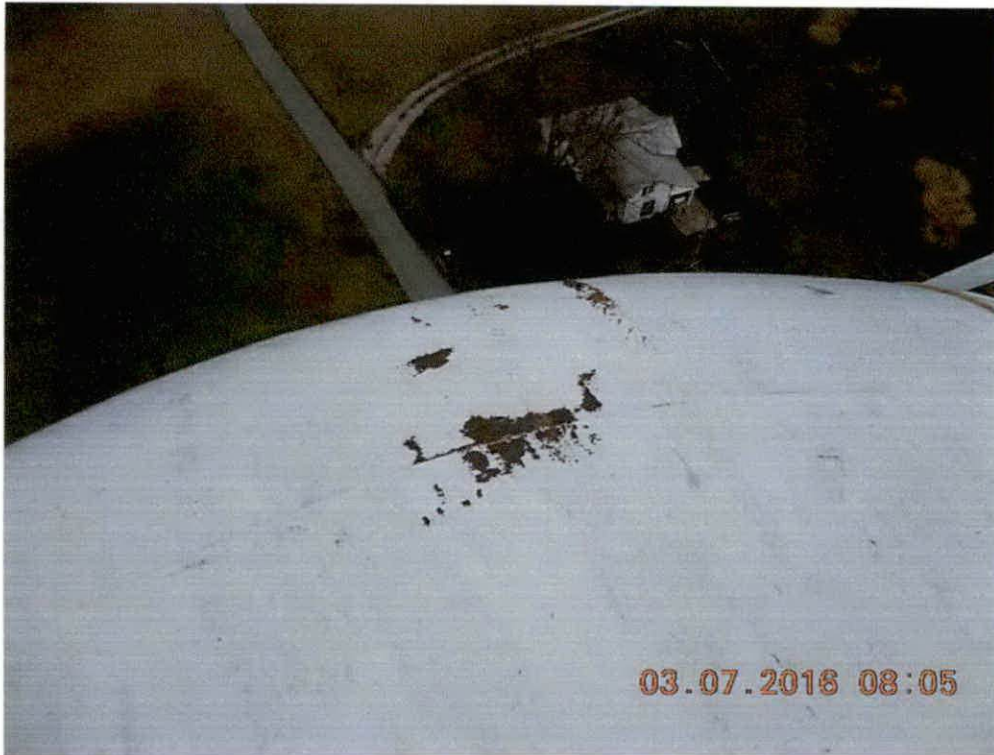
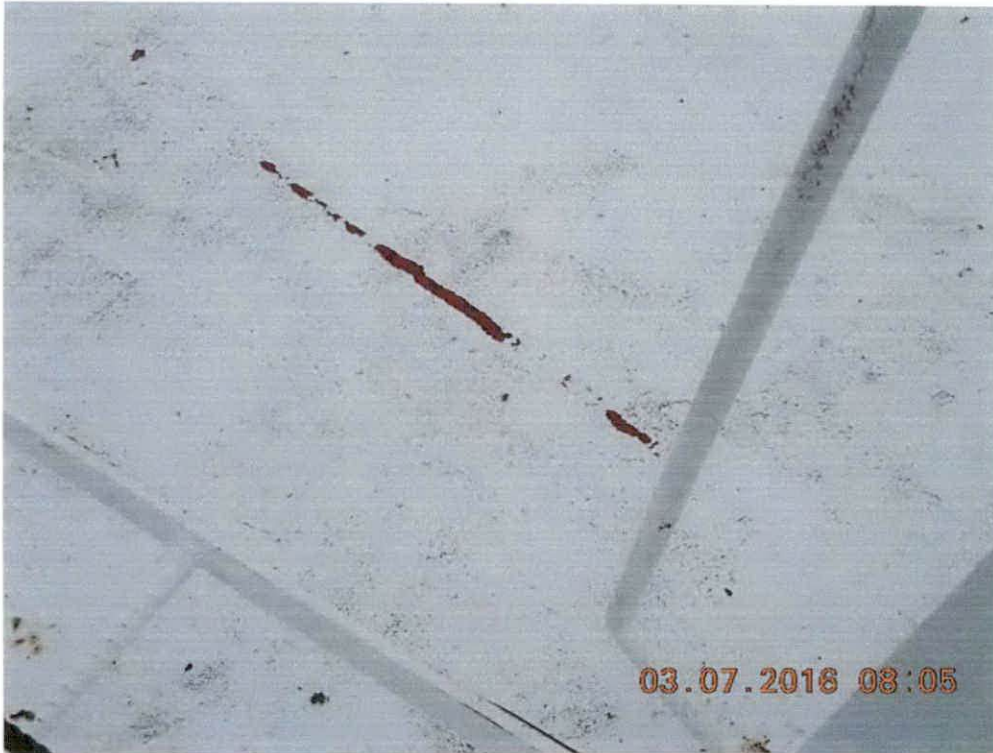
Failed coating roof

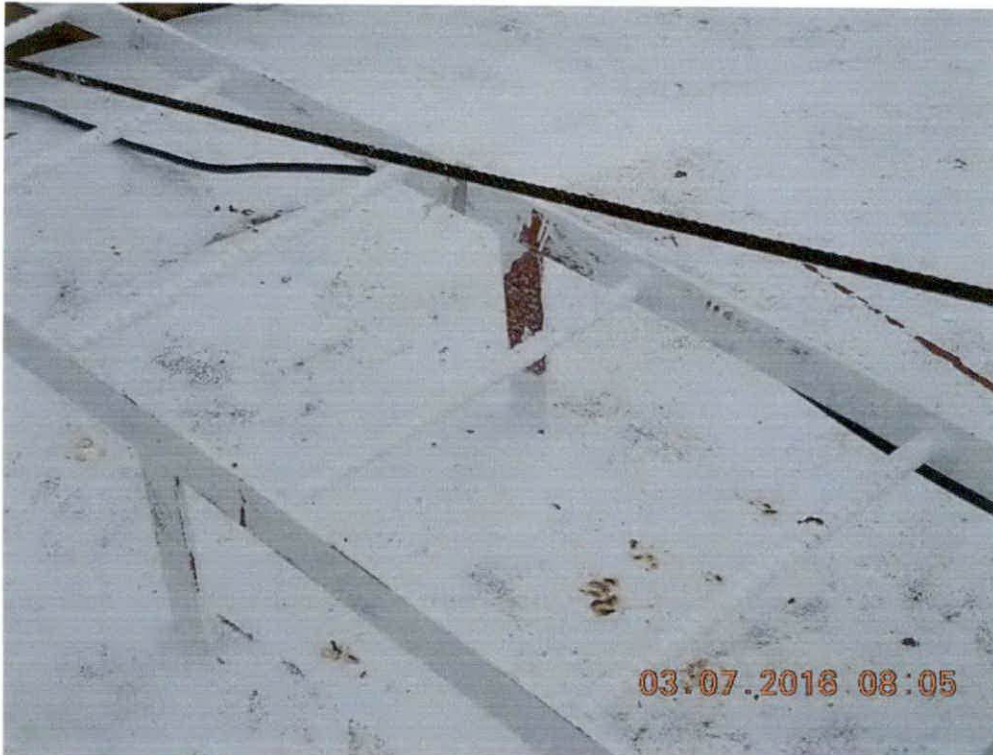
Failed coating roof and ladder

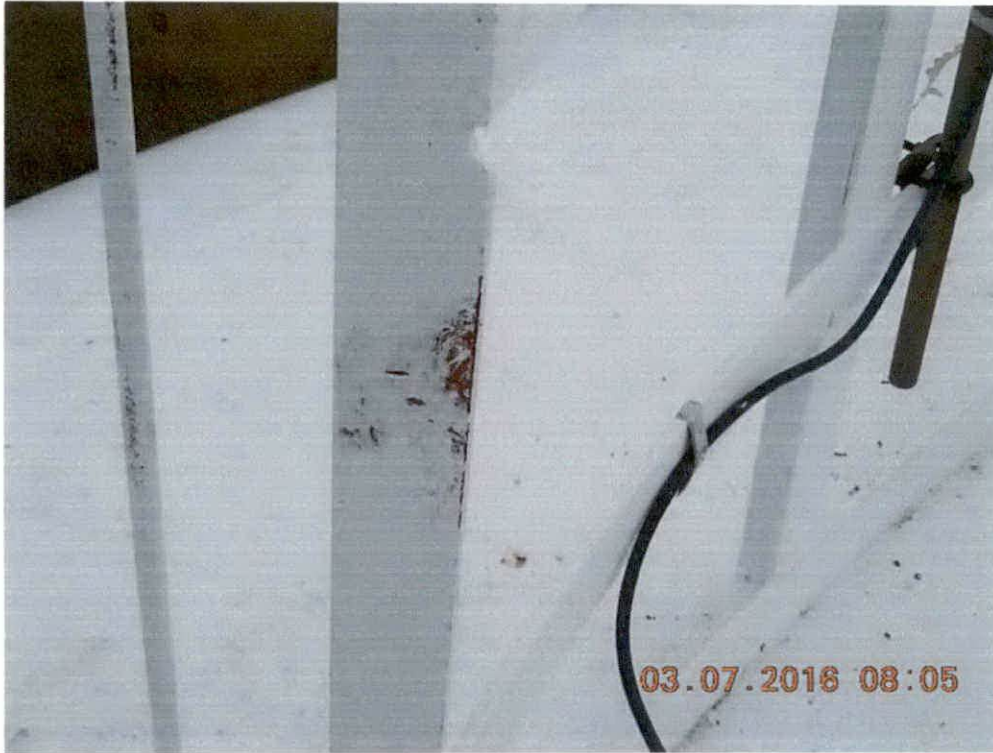
Failed coating roof corral

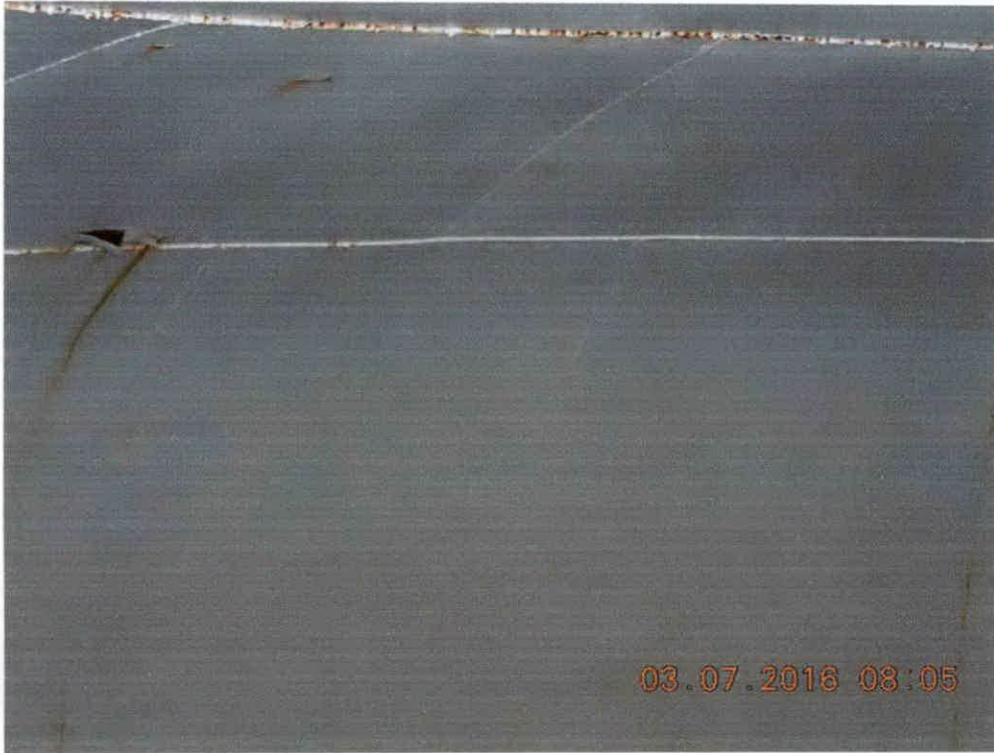
It is beyond time to repaint the interior. There are large areas of the coating that have failed. In the roof, sidewalls and floor of the tank(one area in the floor is several square feet with no coating in place, raw exposed steel).

Rusing and failed coating interior roof

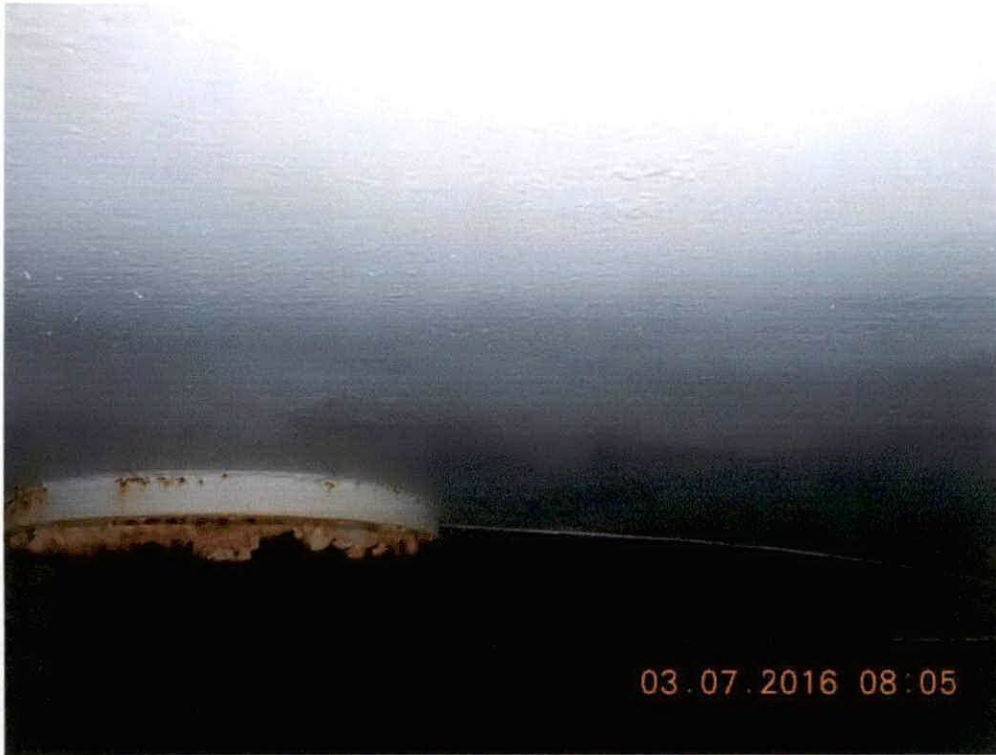
Failed coating interior roof vent

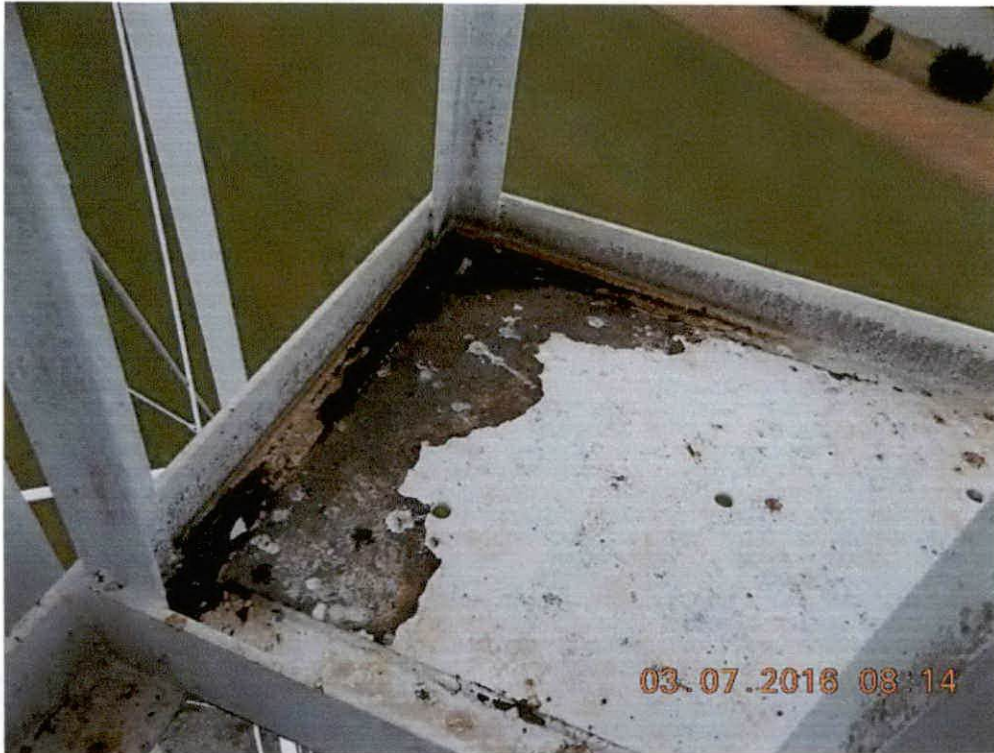
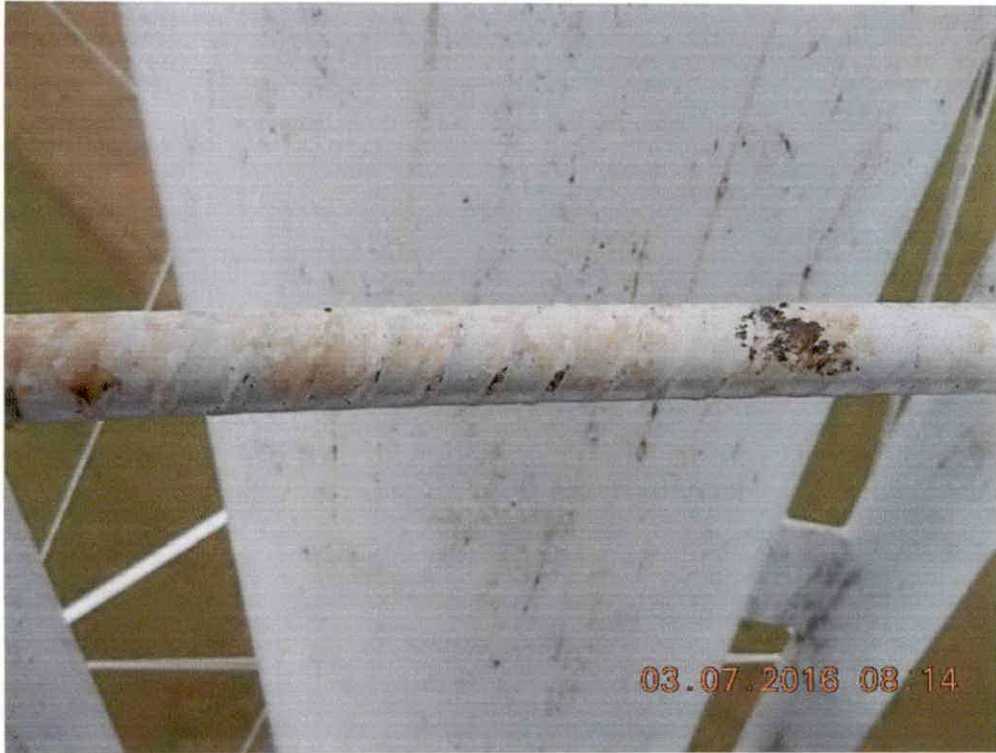
Failed coating ladder platforms

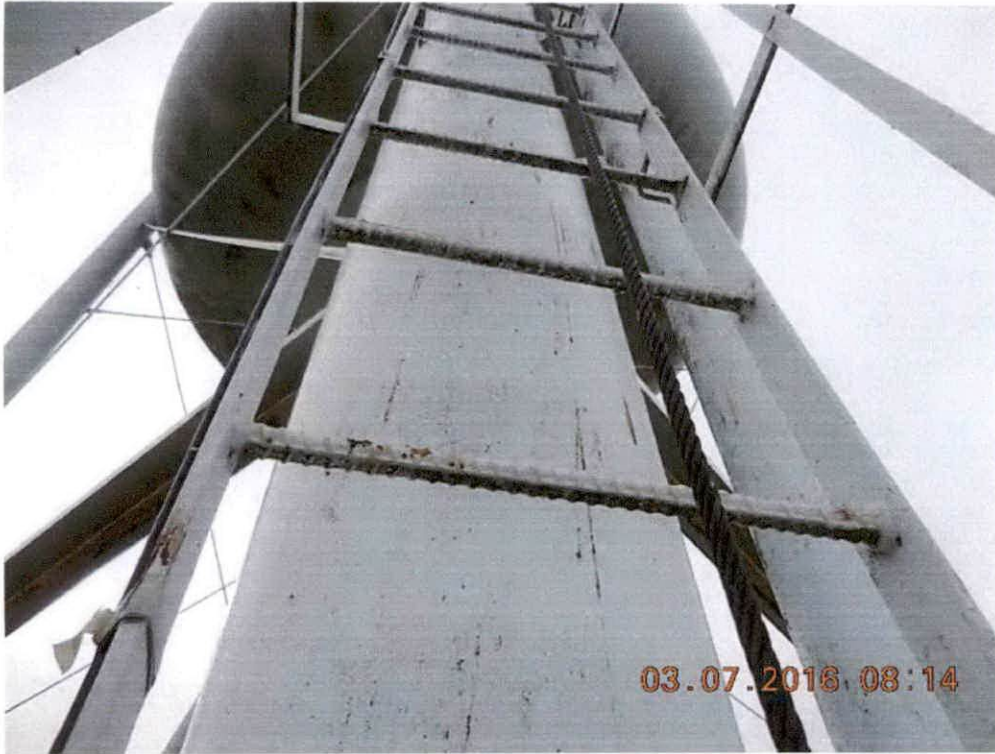
Backs of ladder rungs not painted, large amount of bird feces on leg

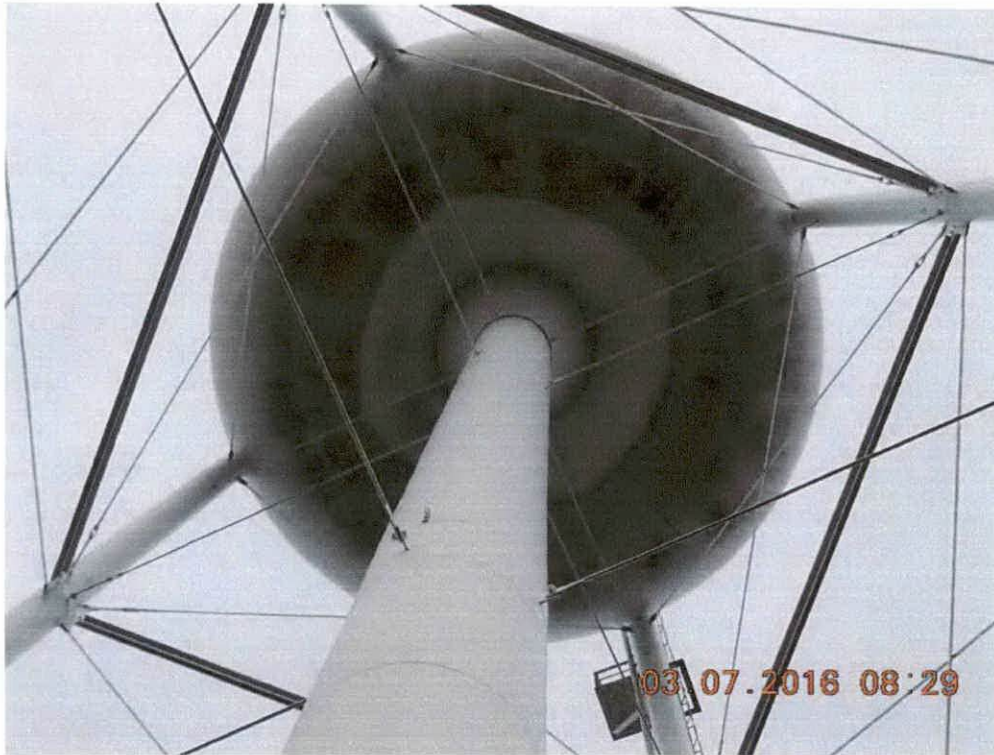
Belly of tank mildew

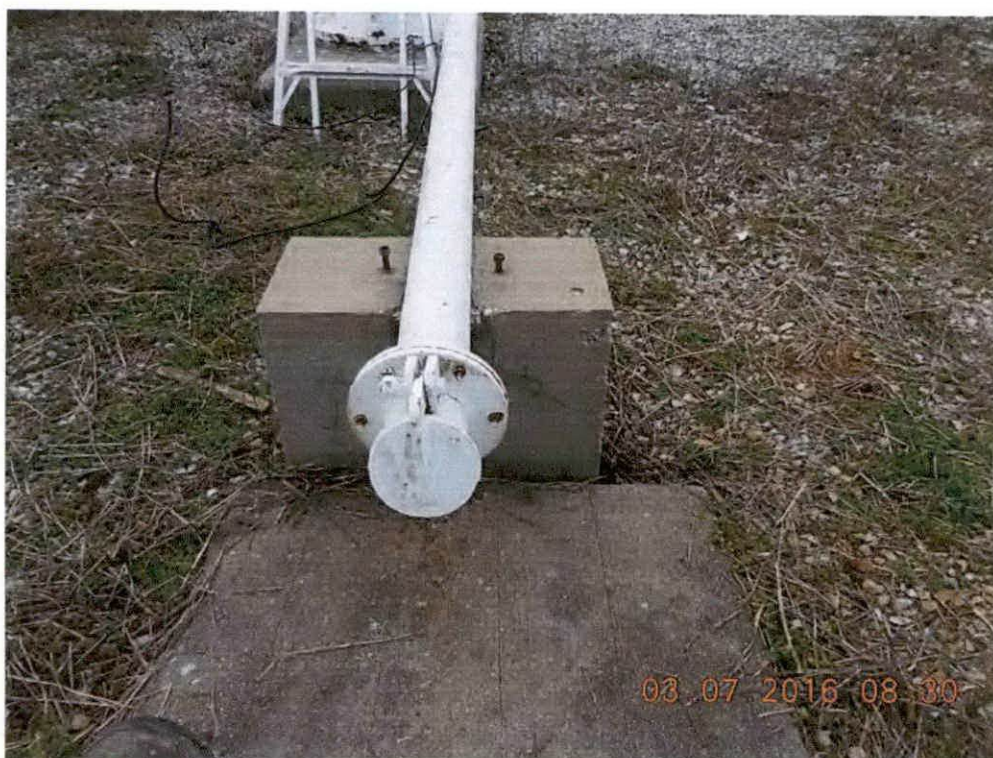
Overflow flap valve, not secured in place
