Case No. 2005-00148

**COMMONWEALTH OF KENTUCKY
BEFORE THE PUBLIC SERVICE COMMISSION**

**NORTHERN KENTUCKY WATER DISTRICT'S RESPONSE TO THE
ATTORNEY GENERAL'S REQUEST FOR INFORMATION**

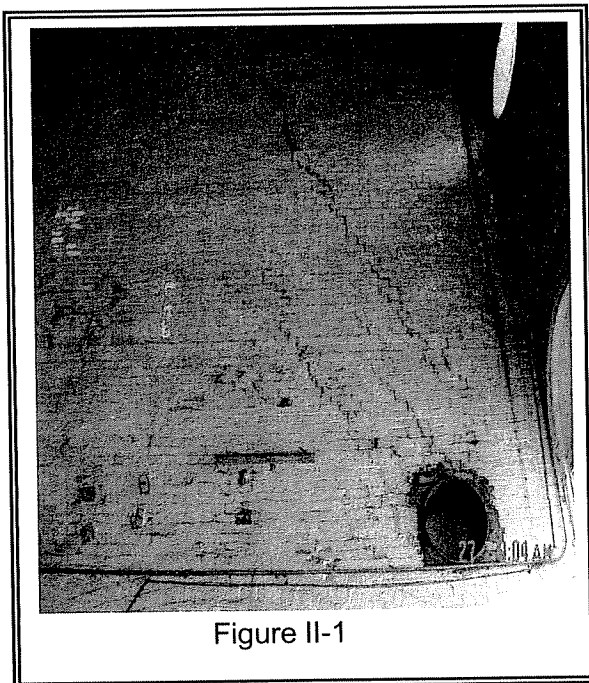
Figure II-1

The interior of the building is unsatisfactory. The brickwork and concrete floor are extremely deteriorated and show signs of age after numerous modifications over the years. The upper portion of the pumping station is brick and shows signs of differential settlement, as shown in Figure II-1. There are a number of places where radial cracks as wide as ½ inch are evident. The lower portion of the pumping station is constructed of cast-in-place concrete and there are a number of places where the deterioration is excessive. The concrete in the lower pump pit is in very bad shape, and the structural integrity of the pumping station is questionable.

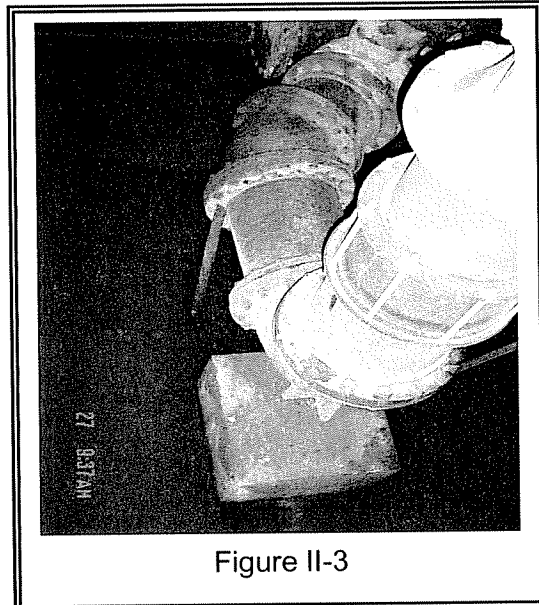
Pump inlet piping is located in the bottom of the lower pump pit. A sump pump system is used to pump water out of the lower pump pit. During the site investigation the lower pump pit was observed to be partially flooded, and efforts to de-water it only reduced the level of the water to approximately the top of the pump inlet piping. Figure II-3 shows the lower pump pit area and the water remaining in the pit.

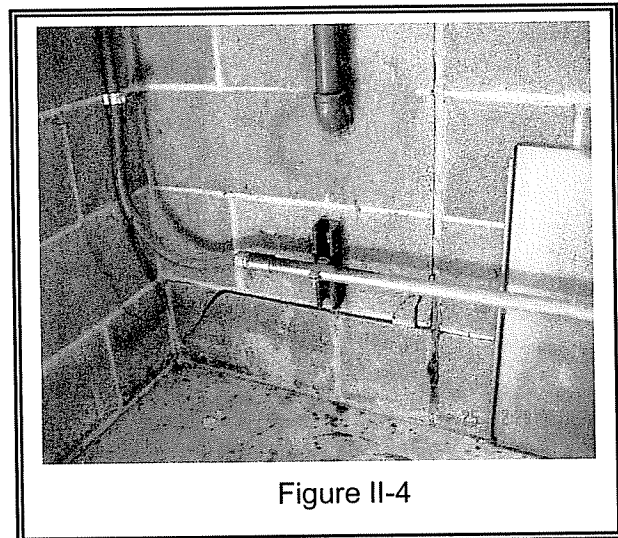
The interior of the building is in unsatisfactory shape, based on observed interior wall cracks. Walls are un-painted CMU. It was noted during the site investigation that there is strong evidence that the building is experiencing differential settlement due to the cracking apparent in the CMU walls at three corners of the building. Figure II-4 shows cracking in the southwest corner of the building.

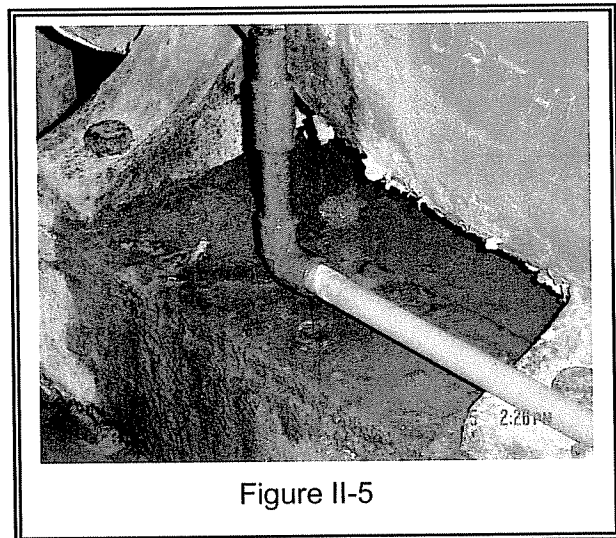
e. Pumping Equipment. The pumping equipment was installed when the building was constructed in 1961. The overall condition of the pumps is unsatisfactory. A number of excessive water leaks were noted from pump and valve seals throughout the pumping station. Heavy corrosion was noted along the pump bases, bearing housings, and pipe trench grating covers. Figure II-5 shows an example of typical degree of corrosion that was noted due to excessive water leaks. No vibration or maintenance history data was available for the pumping systems from the records provided by the District.

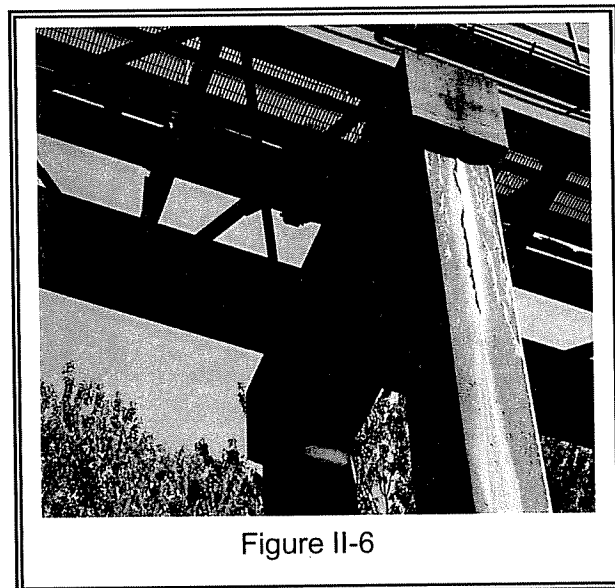
Figure II-6

A steel access bridge and deck extends from the pumping station to the nearby river bank. At the "shore" end of the bridge is a metal building which houses potassium permanganate storage and feed equipment. District staff indicated that the support columns for the bridge are cracking as shown in Figure II-6.

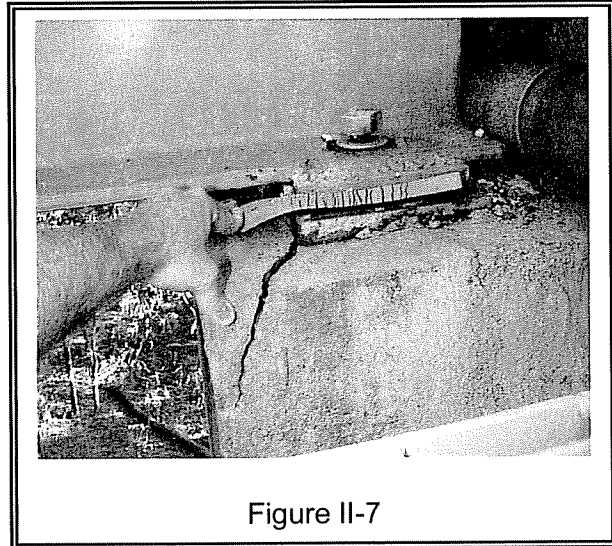
Figure II-7

a. Condition. Overall condition of the pumping station is unsatisfactory. The interior of the building is in satisfactory shape. Interior walls are painted brick. It was noted during the site investigation that the building may have structural problems due to cracking that is apparent in the walls and lower concrete foundation. Figures II-7 and II-8 show example of the cracking that was observed. The exterior of the pumping station is brick, in satisfactory condition; however, as mentioned above, some cracking was evident.

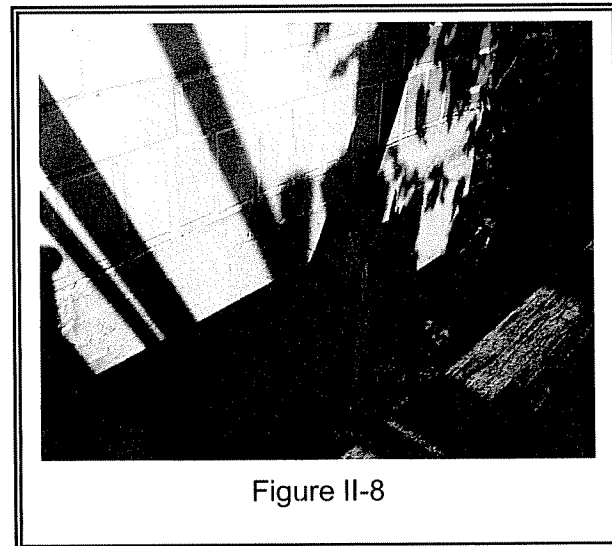
Figure II-8

The interior of the pumping station consists of a single story pump room which houses the pumps, discharge piping, valves, and electrical MCC and control panels. A 2-ton monorail with hoist is provided for piping and valve maintenance. Roof hatches are provided for pulling the pumps, which must be done from a boom barge located on the river or a large crane on shore. The exterior doors and wall mounted louvers are painted and moderate corrosion was noted.

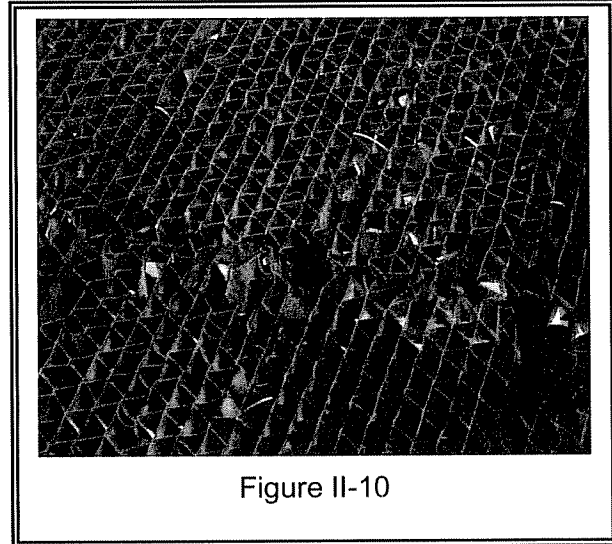
The tube settlers in Basin No. 4 are in unsatisfactory condition with more severe deterioration than the other three basins and several places where the tubes are damaged from cleaning and maintenance. The tube settler material appears to have deteriorated from ultraviolet radiation due to long-term sunlight exposure. District staff indicated that pieces of the tubes are found when the basin is taken down for regularly scheduled maintenance. The tube settlers will require replacement in the near future. Figure II-10 shows an example of the extent of the damage to the tube settlers. Structurally, the basin is in good condition with only a few places where minor cracking of the concrete was observed.
