# SHIELD Environmental Associates, Inc.

**SHIELD Environmental Associates, Inc.**  
**Manhole Inspection Checklist**  
**Cedarbrook Subdivision**

**CEDARBROOK SUBDIVISION  
Sanitary Sewer System Maximum Design Capacities**

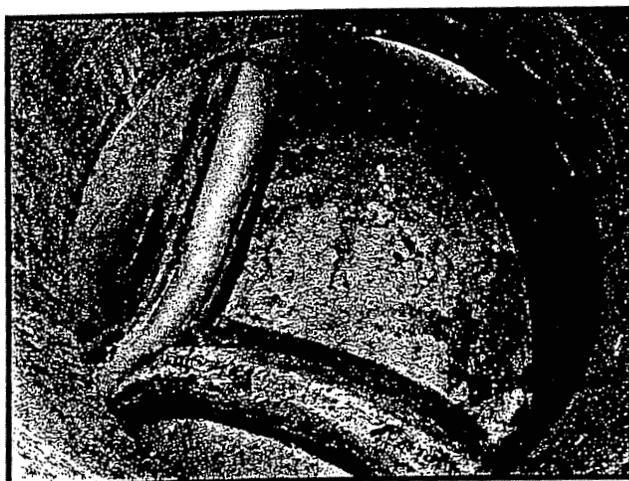
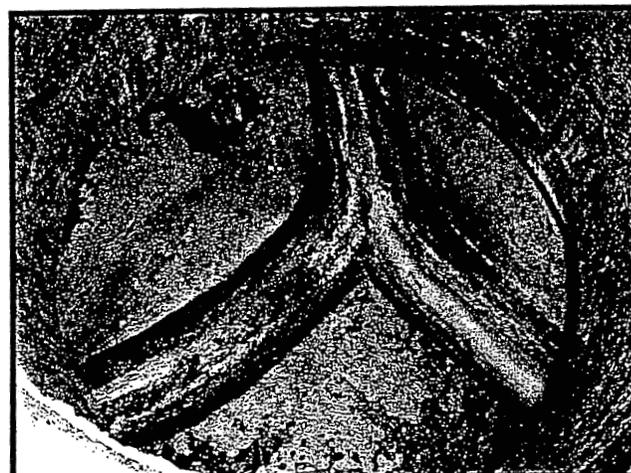
Subsystem: Maple Court Manhole Number: Manhole #1  
 Size: (4') 6' 8' 10' Inspector: KM Regan  
 Date: 10/19/00 Time: 0930  
 Weather Conditions: Sunny & dry Temperature: Mid-60s (F)

Comments: There are no visible cracks or other failures; ring and lid paved over slightly and somewhat loosely fitting; Slight sedimentation located on the bottom of the manhole out of the channel. Top of manhole ring recessed in pavement forming a depression around the manhole lid.

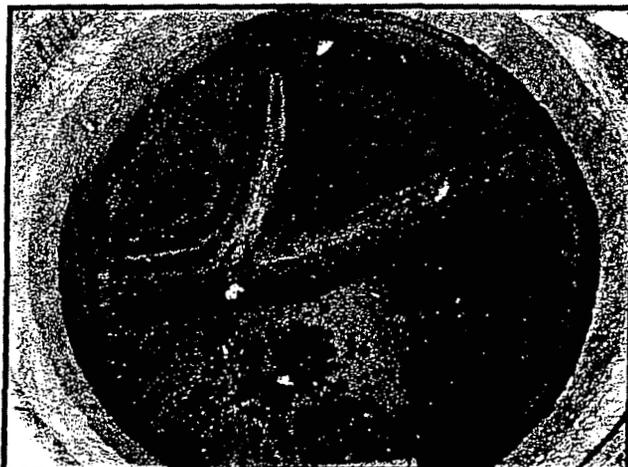
Subsystem: Elm Court Manhole Number: Manhole #2  
 Size: (4) 6' 8' 10' Inspector: KM Regan  
 Date: 10/19/00 Time: 1000  
 Weather Conditions: Sunny & dry Temperature: Mid-60s (F)

Comments: There are no visible cracks or other failures; ring and lid paved over slightly and somewhat loosely fitting;  
Slight sedimentation located on the bottom of the manhole out of the channel. Top of manhole ring recessed in pavement  
forming a depression around the manhole lid.

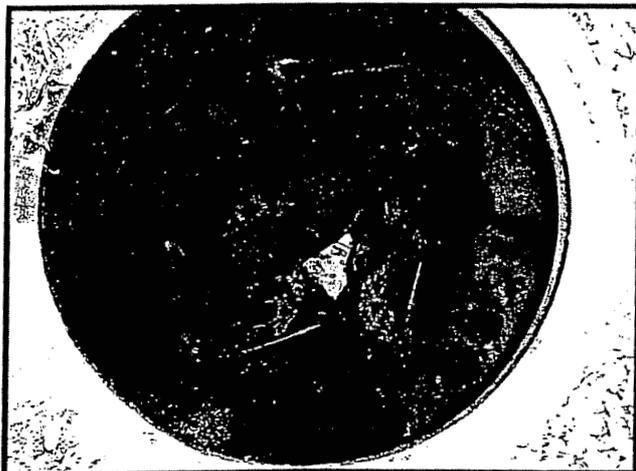
Subsystem: End of Pine Road Manhole Number: Manhole #5
Size: (4') 6' 8' 10' Inspector: KM Regan
Date: 10/19/00 Time: 1300
Weather Conditions: Sunny & dry Temperature: Mid-60s (F)

Comments: There are no visible cracks or other failures; slight corrosion of ring and lid; heavy sedimentation located on the bottom of the manhole out of the channel; sticks and non-organic debris is located in the manhole; there is standing water in the channel

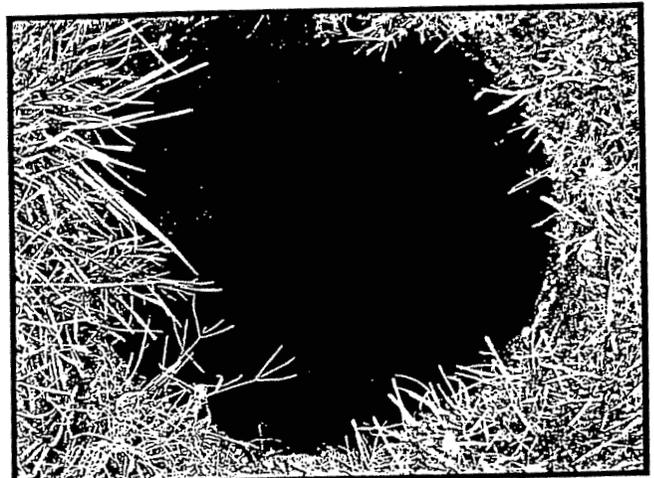
Subsystem: Backyard of Lot 4 Manhole Number: Manhole #8  
 Size: (4') 6' 8' 10' Inspector: KM Regan  
 Date: 10/19/00 Time: 1435  
 Weather Conditions: Sunny & dry Temperature: Mid-60s (F)

Comments: There are no visible cracks or other failures; slight corrosion of ring and lid; heavy sedimentation located on the bottom of the manhole out of the channel; manhole is in a naturally occurring depression; lid is very poorly seating.

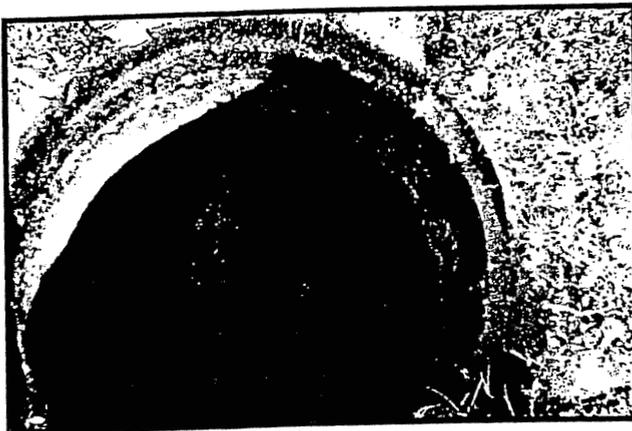
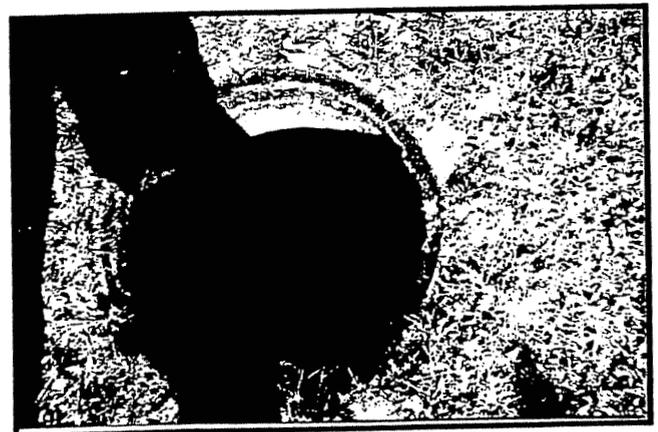
Subsystem: Backyard Lot 8 Manhole Number: Manhole #9  
 Size: (4') 6' 8' 10' Inspector: KM Regan  
 Date: 10/19/00 Time: 1510  
 Weather Conditions: Sunny & dry Temperature: Mid-60s (F)

Comments: There are no visible cracks or other failures; slight corrosion of ring and lid; slight sedimentation located on the bottom of the manhole out of the channel

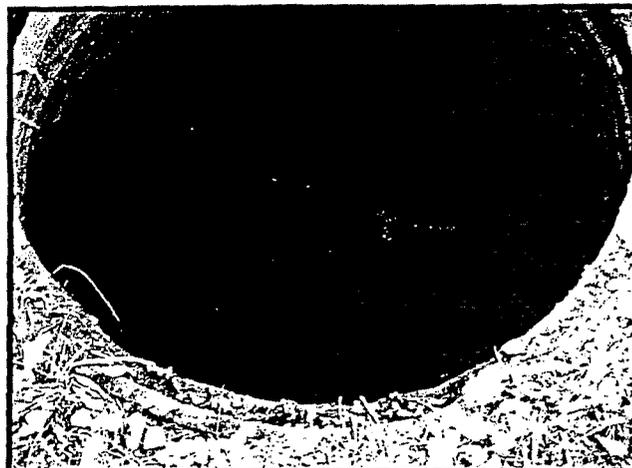
Subsystem: End of Evergreen Road Manhole Number: Manhole #10
Size: (4') 6' 8' 10' Inspector: KM Regan
Date: 10/19/00 Time: 1600
Weather Conditions: Sunny & dry Temperature: Mid-60s (F)

Comments: Large crack on south side of barrel; slight corrosion of ring and lid; heavy sedimentation located on the bottom of the manhole out of the channel; sticks, roots and non-organic debris is located in the manhole; there is stand-water in the channel
