RE: Case No. 2008-00147

UTILITY INSPECTION REPORT

Report Number: ShelbyEC-F-111307

**RESPONSE TO UTILITY INSPECTION REPORT
REPORT NO. SHELBYEC-F-111307**

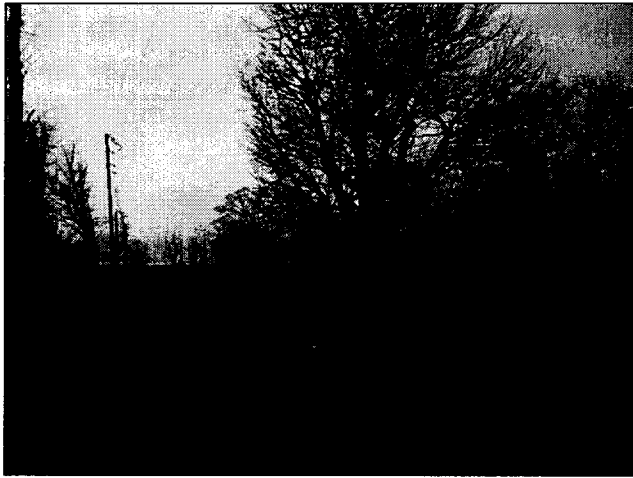
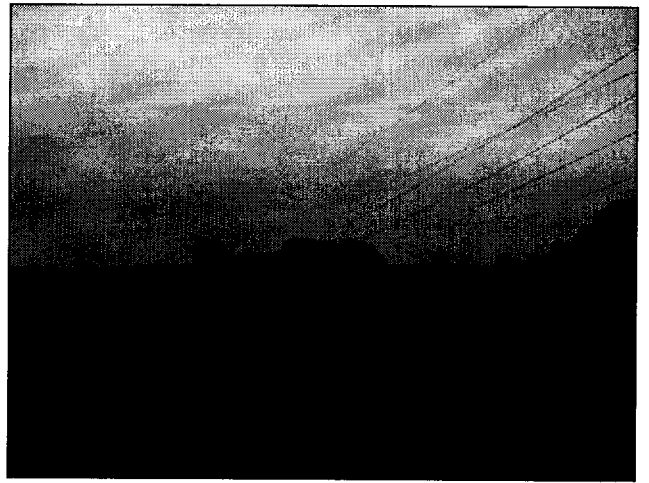
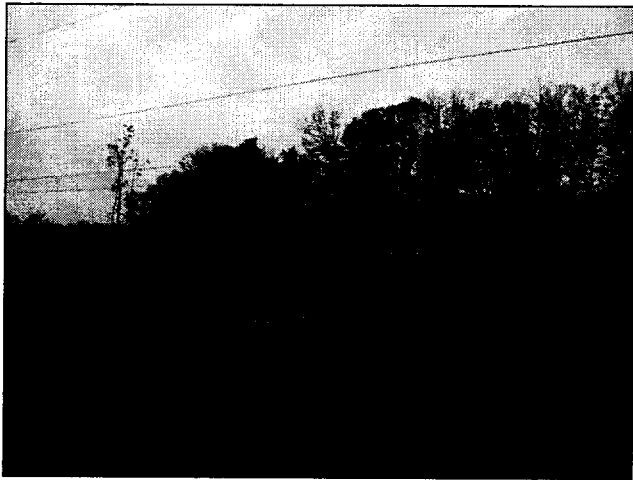
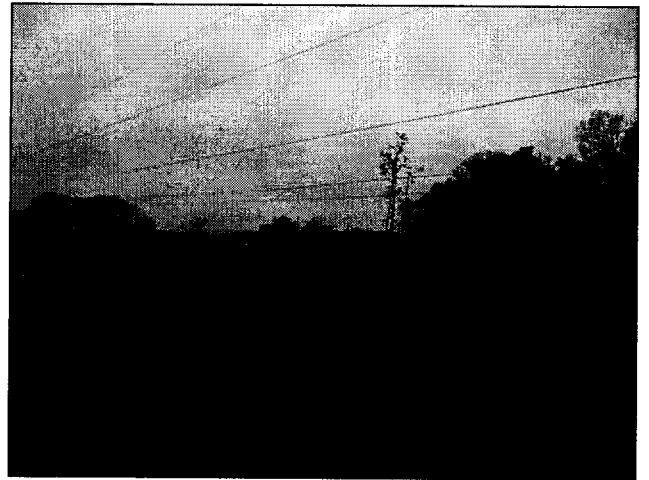
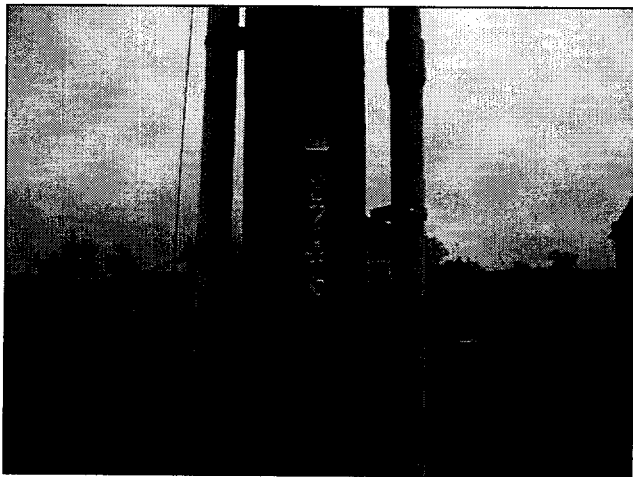
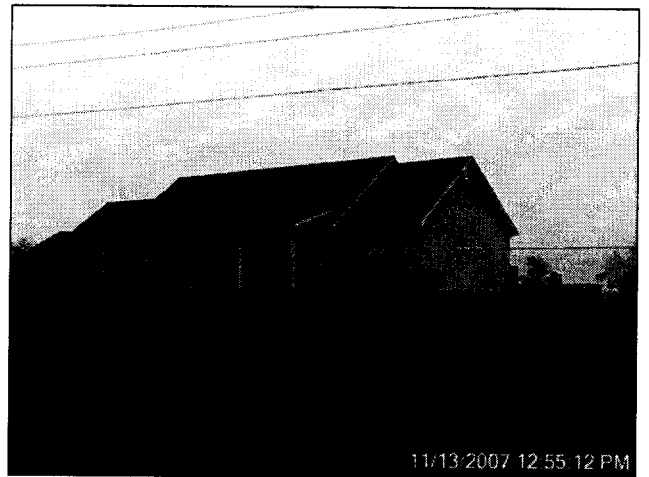
After completing the accident investigation, Mr. Kingsolver and I drove east on Vigo Road. and noticed the new conductors being pulled by Dobson Power Line crews were sagging just a few feet above the ground. We stopped to investigate the area because of possible clearance violations. While looking into possible clearance violations at this site, an employee with Dobson Power Line construction drove by this location. While Mr. Kingsolver stayed at this location I followed this employee. The employee

At this time we had a possible clearance violation and potentially energized conductors. I returned to the site and talked with Mr. Kingsolver about my discussion with Mr. Dobson. I then called Mr. Martin and asked him to meet me at the site. While waiting for Mr. Martin, a Dobson Power Line employee was dropped off at the location of the low conductors. Mr. Kingsolver and I took pictures of the site while waiting for Mr. Martin.

Relative to the finding that NESC ground clearance requirements were violated during the conductor stringing operation observed by Inspector Moore, it must be said that this is indeed the case. Since it has already been established that the new conductors were not effectively grounded and must therefore be considered energized, then NESC minimum ground clearance requirements from Table 232-1 for open supply conductors over 750 volts to 22 kilovolts would apply. The absolute minimum value given for this category of conductor is 14.5 feet, for spaces and ways subject to pedestrians or restricted traffic only. Inspector Moore's report references a particular span between Shelby poles No. 9746 and No. 9747, crossing a rural, residential "front" yard. While apparently no physical measurement of the actual ground clearance of these conductors was made by either Inspector Moore or by Shelby personnel (David Martin and Wayne Anderson) it was evident by casual observation that these conductors were less than 14.5 feet above grade. Sufficient means to provide conductor tensioning was not being applied to the conductor for this to have occurred.

First, a report of a low span of conductor on Vigo Road was made to Shelby Energy Cooperative on the above date. The span was observed by a representative of the Public Service Commission at approximately six (6) feet above the ground with no stationed guard of Dobson Power Line Construction within the area.

Next, the representative of the Public Service Commission reported an apparent absence of proper grounding on the new conductor being pulled in at the Vigo Road location. After review and discussion with managers of Shelby Energy's engineering and operations departments, it appears the method of grounding used by Dobson Power Line Construction did not meet the generally accepted criteria of the National Electrical Safety Code.

Actions taken to correct the deficiencies noted in this report included: immediately notifying Dobson personnel of the situation of NESC violations, particularly relative to the minimum ground clearance violation in the span between poles no. 9746 and no. 9747. This was done on the afternoon of November 13, 2007 by Wayne Anderson and David Martin, within an hour after this was called to our attention by Inspector Moore. Corrective action was taken by Dobson personnel immediately upon notice. Subsequently, conductor stringing operations by Dobson were halted until such time that Dobson could provide means of effectively bonding new conductors in stringing operations to the existing distribution system's effectively grounded neutral (namely use of mechanical, "traveling" grounds). After Shelby became aware of the safety violations, Debbie Martin, President & CEO of Shelby sent James D. Dobson the attached letter (Attachment 2-1), dated November 27, 2007, pointing out the safety violations and reminding him Dobson must abide by the NESC at all times. Subsequently, the attached letter (Attachment 2-2), dated December 20, 2007, from the cooperative's attorney, Donald T. Prather, was sent to Dobson placing it on probation, a future violation of which would result in the cancellation of the Dobson contract after the required twenty (20) day notice.

Additional action taken by Shelby to prevent potential reoccurrence of these or similar deficiencies includes: 1) requiring Dobson personnel to undergo instruction and review of the NESC, particularly to the requirements relative to the work performed on electric distribution systems and provide Shelby with evidence of compliance, 2) requiring Dobson to supply and use equipment accepted by best industry practices to effectively bond new conductors installed during conductor stringing operations to the existing electric distribution system neutral. Dobson complied with this on December 19, 2007, 3) requiring Dobson to review all work practices with employees, particularly relative to the conductor stringing operation, and furthermore recommending that at all times during the conductor stringing operation that both the conductor pay-out (reel trailer) end and the conductor take-up (tensioner) end be manned and that additional employees as necessary be used throughout the ruling span of the "conductor pull" to observe the behavior of the new conductor being installed to assure that any problems or abnormal conditions are spotted and corrective action is initiated promptly. Constant communication between both "ends" of the operation and the intermediate "scouts" or observers will also be emphasized. Shelby's responsible person for this will be David Martin – Manager of Operations.
