Mitchell Unit 1

Turbine – Generator Outage

Fall 2001

Report Prepared by
John Lackner
RSO Turbine Coordinator

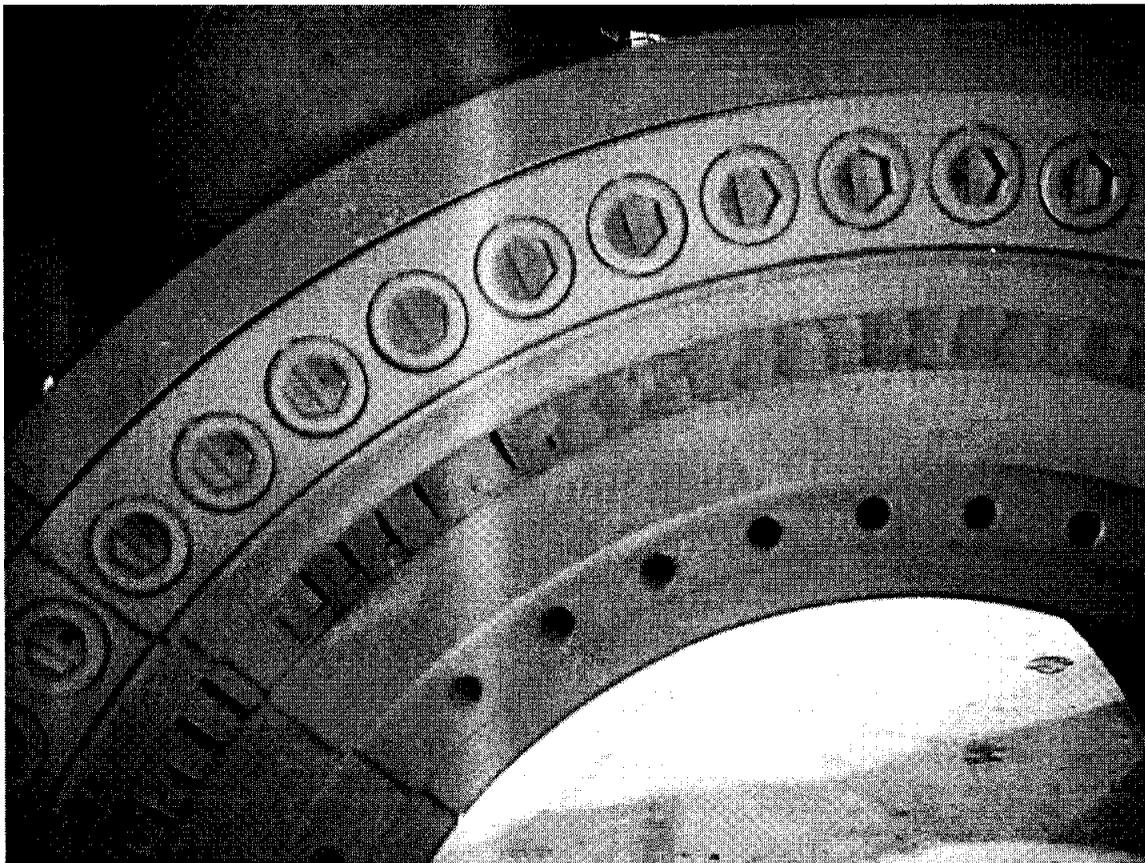
The upper inner shell was unbolted and removed. The nozzle was visually inspected in place. The blading on the nozzle was almost completely eroded away. The upper inner shell was then sent to CMS. The upper blade rings, dummy rings, and gland casings were unbolted and removed. A large number of nuts had to be damaged to facilitate disassembly.

This photo shows the HP nozzle as found. The nozzle was replaced with a spare nozzle.

It was the recommendation of Jim Cable (Turbine Engineering) that the nozzle that was removed should be scrapped and a new nozzle be purchased as the new spare.

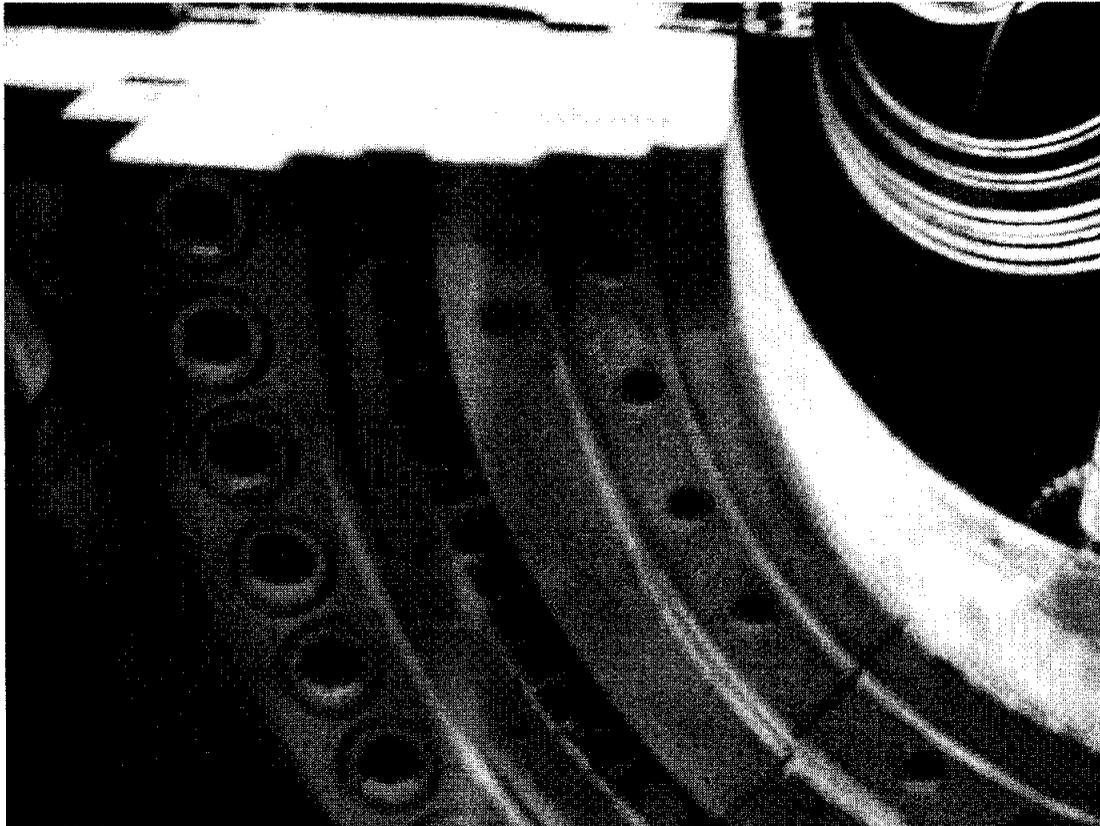
This is another photo showing the nozzle in an as-found condition. Note the heavy damage to the blading. A new nozzle was installed in the turbine.

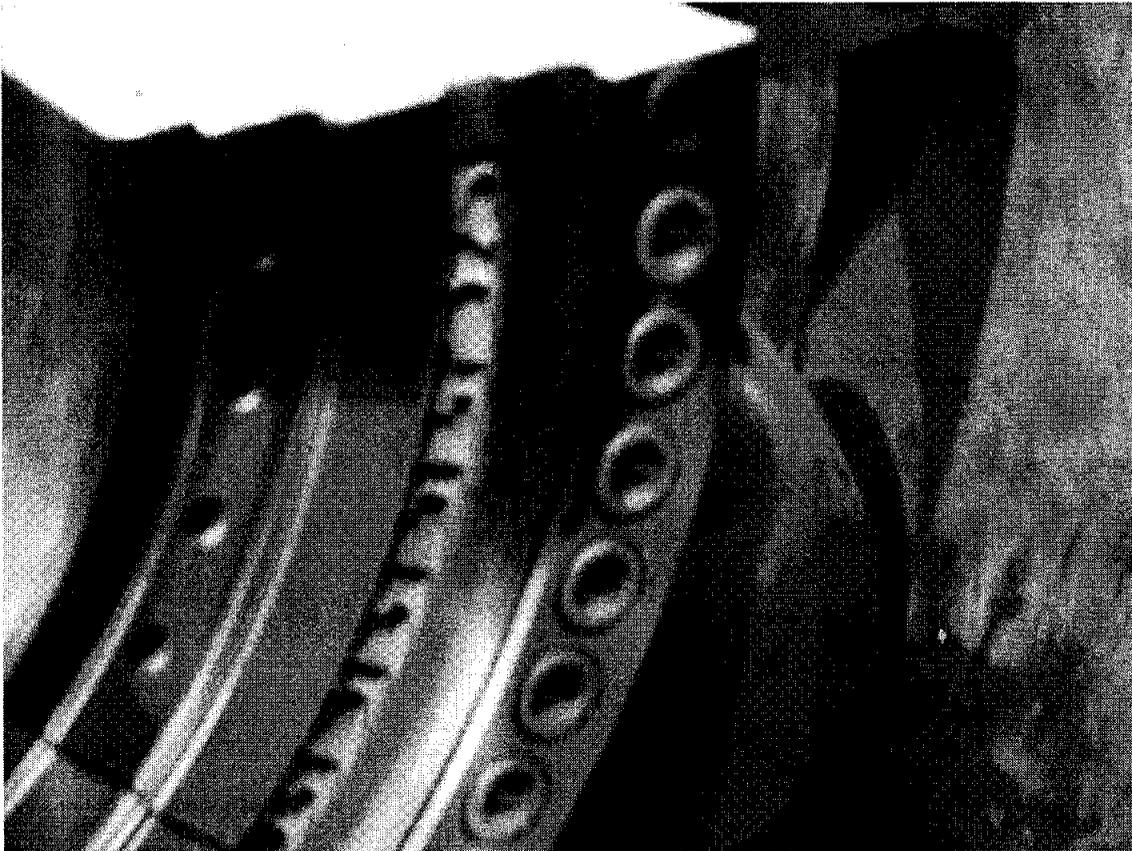
This is another photo showing the nozzle in an as-found condition. Note the heavy damage to the blading. A new nozzle was installed in the turbine.

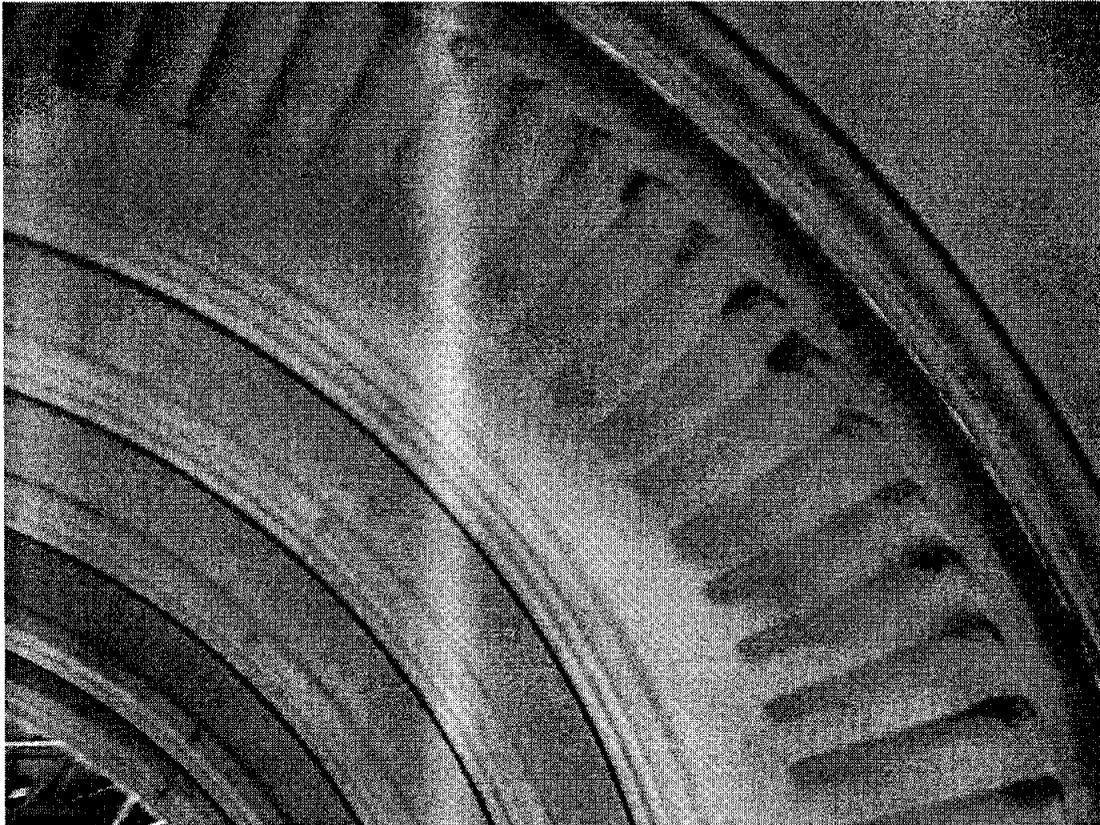
This photo shows the HP blade ring in an as found condition. Note the erosion of the blading. All repairs were completed by CMS.

The HP and VHP blade rings were shipped to CMS (both upper and lower halves). They were blast cleaned, NDE inspected and minor partition weld repairs were made. The seal strips were all replaced with new strips provided by STAR.
