MITCHELL UNIT 1 FORCED OUTAGE FINAL REPORT

July 28, 2012- August 6, 2012

SUMMARY

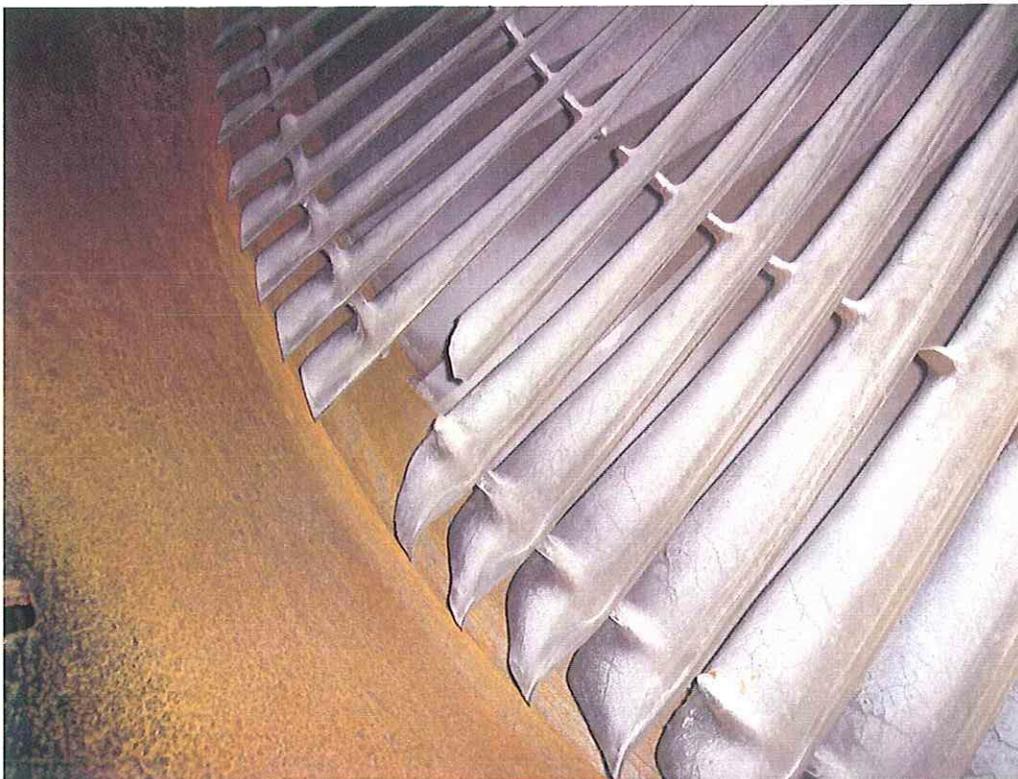
- The initial inspection revealed that an L-0 blade tip on the TE of the LPA rotor that broken off damaging the next 31 blades.
- CMS personnel performed NDE inspections on the L-0 blades on both LPA and LPB rotors.

- Information sent to Engineering included: There are a total of 120 L-0 blades on each end of the rotor. The broken blade is #91. The blade at 180° from #91 is #31. The blades are welded in groups of 5. #91 and #31 are both leading blades in their groups. All cracked lashing lugs were in the inner row.

As Found Damage- Broken Blade #91

- The Engineering repair scope called for removal of the remaining cracked blade back to 3” from the inner lashing lug. Removal back to the same location of the blade located 180° from the broken blade. Full weld repair of the cracked lashing lugs. The bent blades will be left as found, this rotor is scheduled to be replaced during a spring 2013 outage.

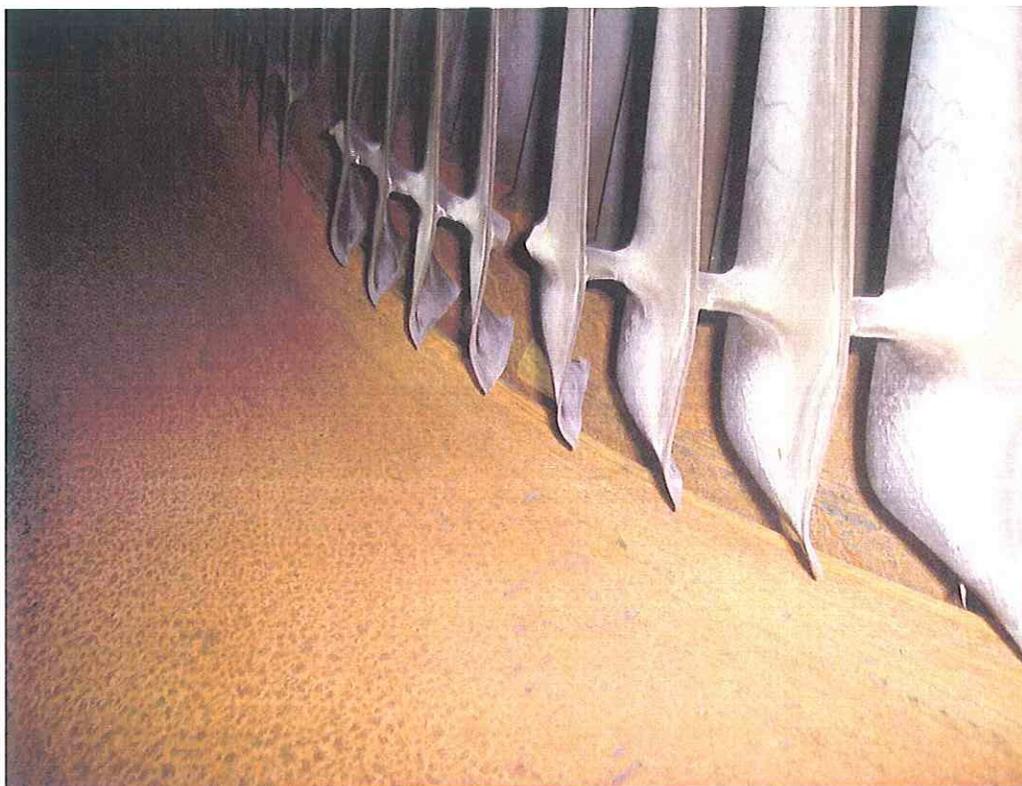
As Found Damage- Bend Blade Tips

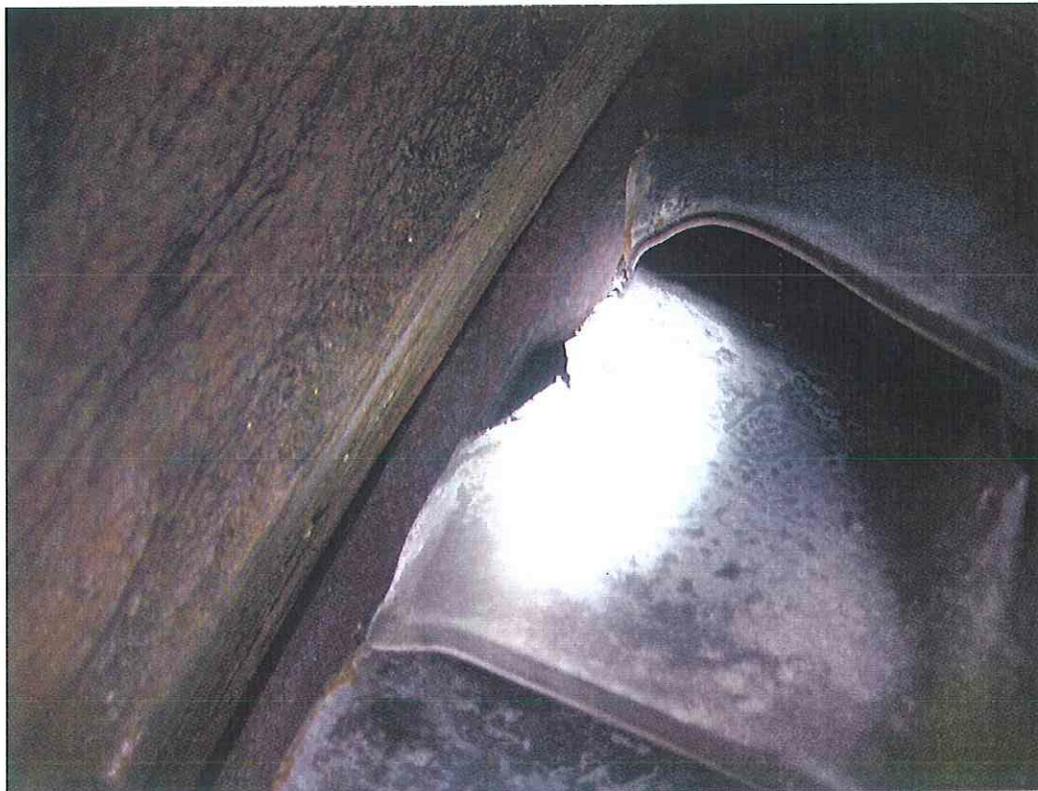
As Found Blade Tip Damage

- CMS personnel ground and blended impact areas on blade #53 and #66 and also smoothed some damaged blade tip with minimum removal of material.
- CMS provided NDE reports for LP L-0 blades and flow guide bolts.

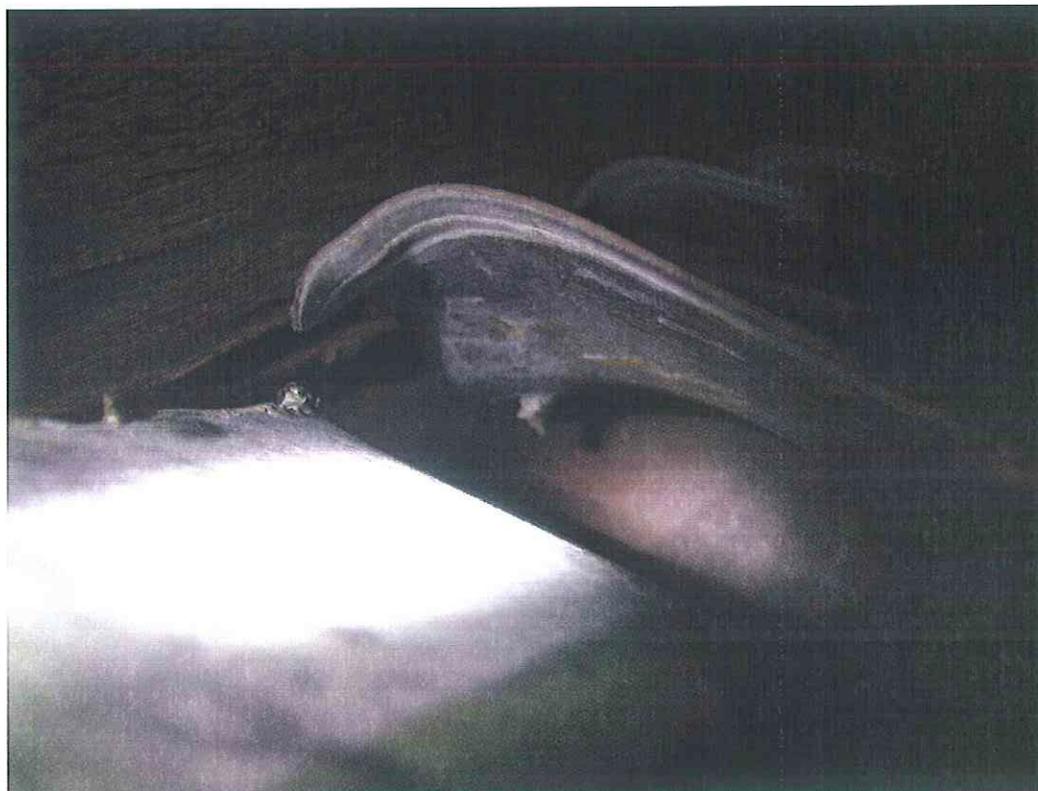
As Found Blade Tip Damage

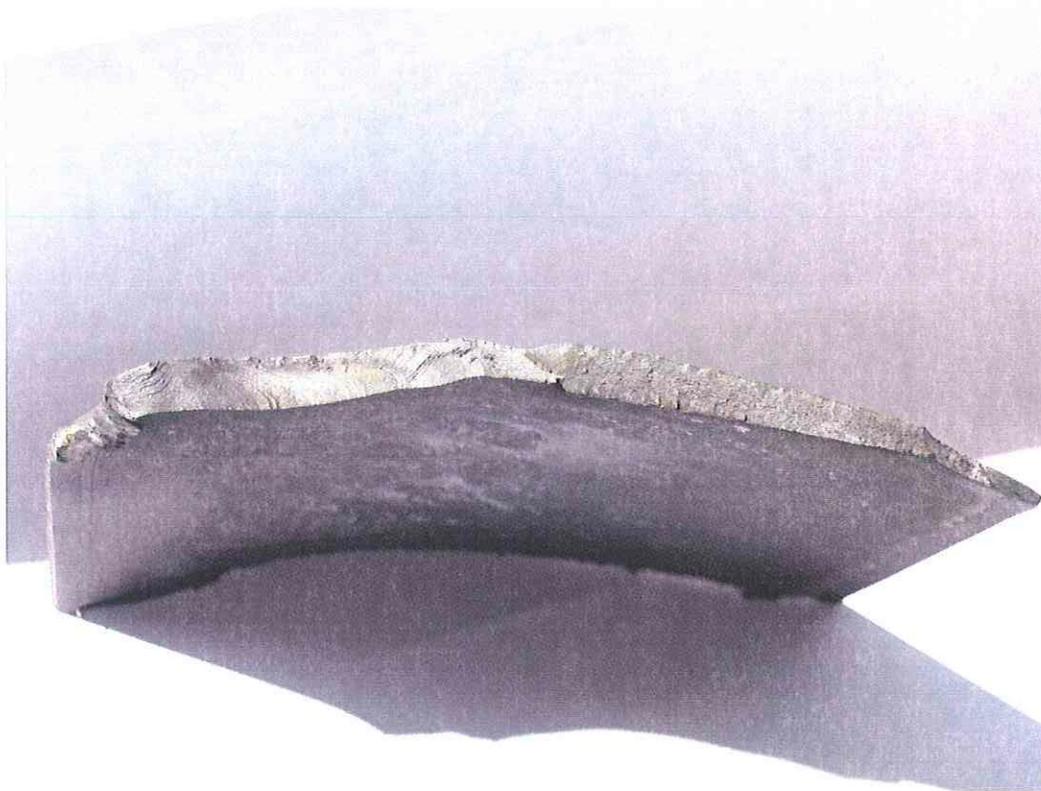
- The remaining broken blade end was sent to Columbus Engineering for examination. They determined that initial crack was started by an impact to the leading edge of the #91 blade which lead to its eventual liberation. The last two pictures in the following pages show this impact area.

Sample Piece Cut-off for Failure Analysis Testing- Impact Damage on Leading Edge (LS)

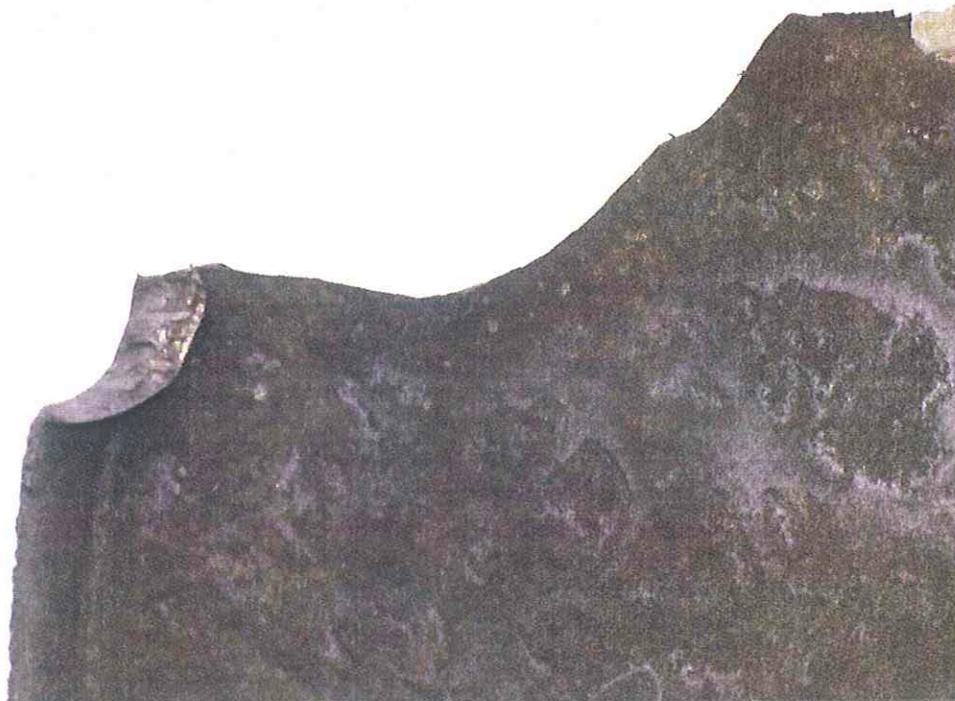
Close-up of Leading Edge Impact Damaged Area from Sample
