# STEAM TURBINE INSPECTION REPORT

## ADSP Installation

AMERICAN ELECTRIC POWER COMPANY INC  
MITCHELL, Unit 2

Report Printed: January 30, 2006

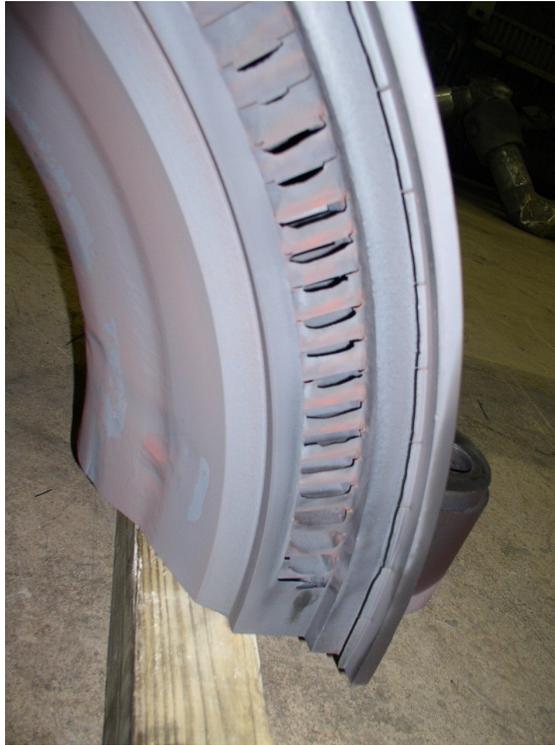
The as-found nozzle box partitions had severe erosion. The upper right inlet had a broken seal ring. See attached photos.

Nozzle Partition Erosion

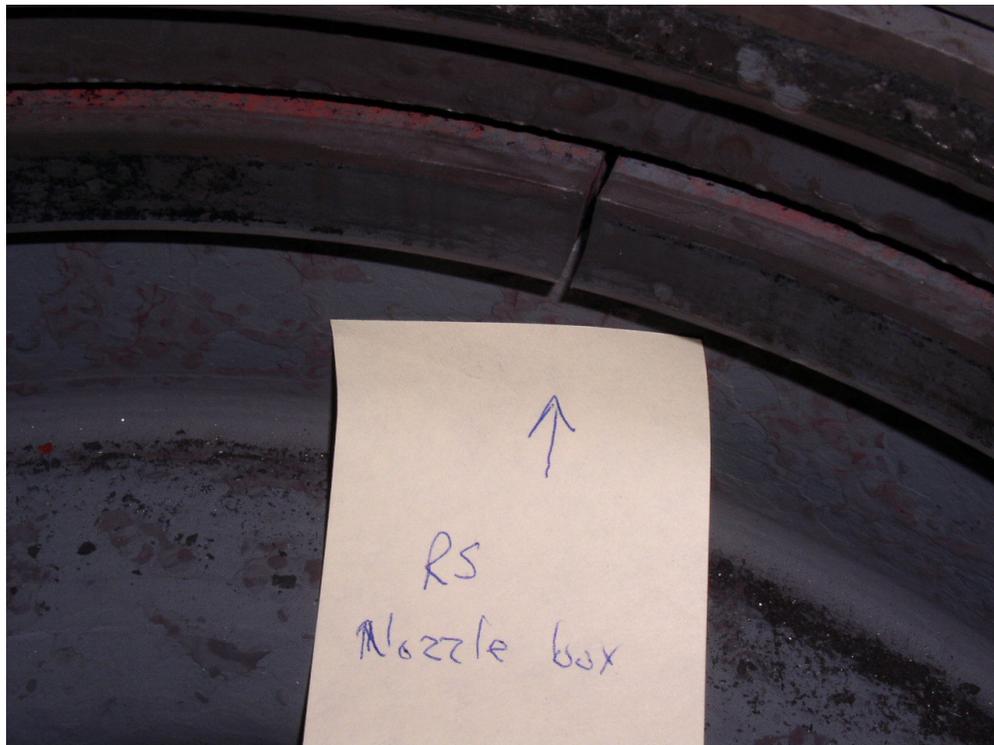
Broken Nozzle Seal Ring

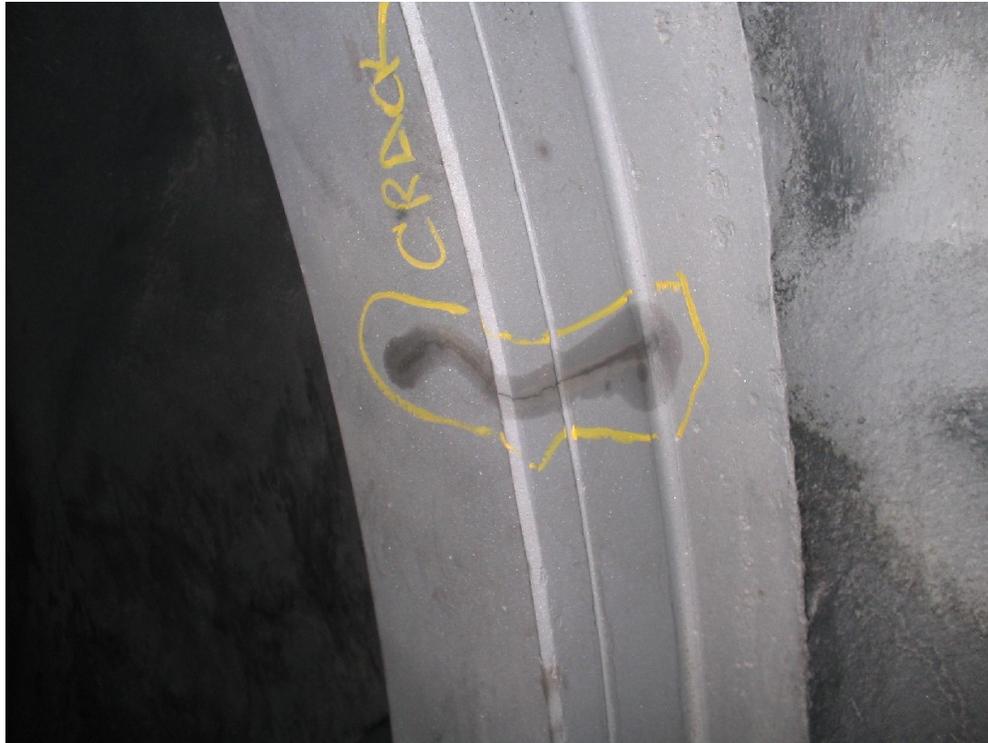
The outer shell inner surfaces were NDT'd by AEP personnel. A crack was found in the inner shell locating male fit in the lower half. This crack was in the ligament from the original mid-span eccentricity hole that was previously plugged. The crack was ground out and repair welded by AEP personnel.

Mid-span Ecc Hole Crack

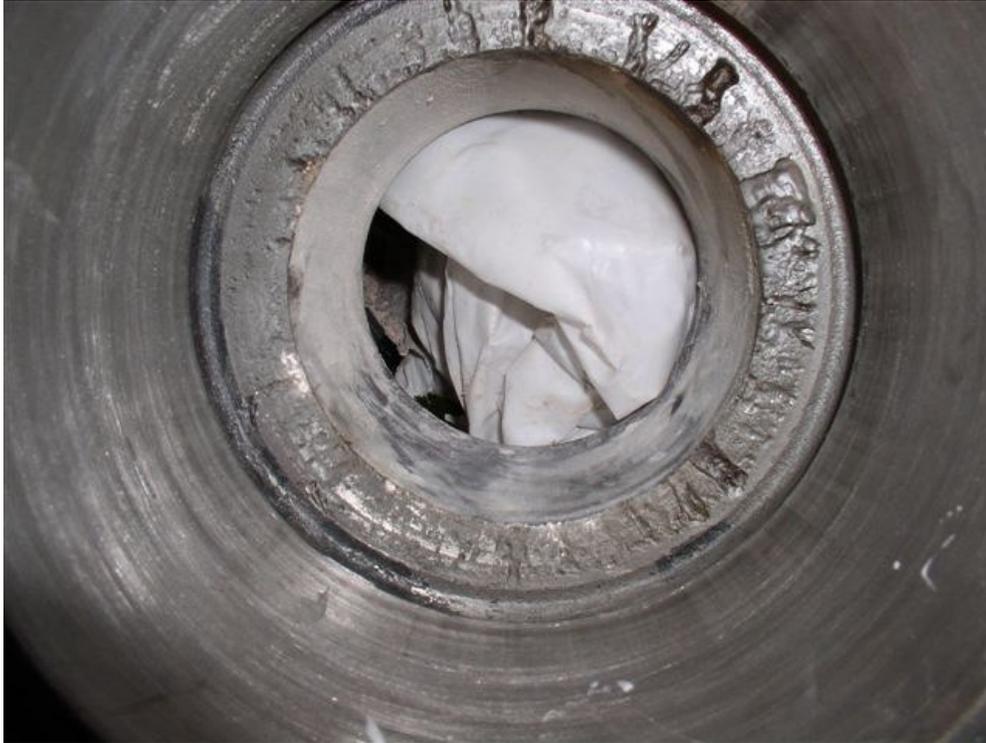
The upper surface of the seal ring bore for the mid-span balance access in the UH outer shell was found badly damaged from apparent arc-cutting. The surface was weld repaired and machined by I&RS. I&RS installed new seal rings.

Mid-span Balance Seal Ring Bore

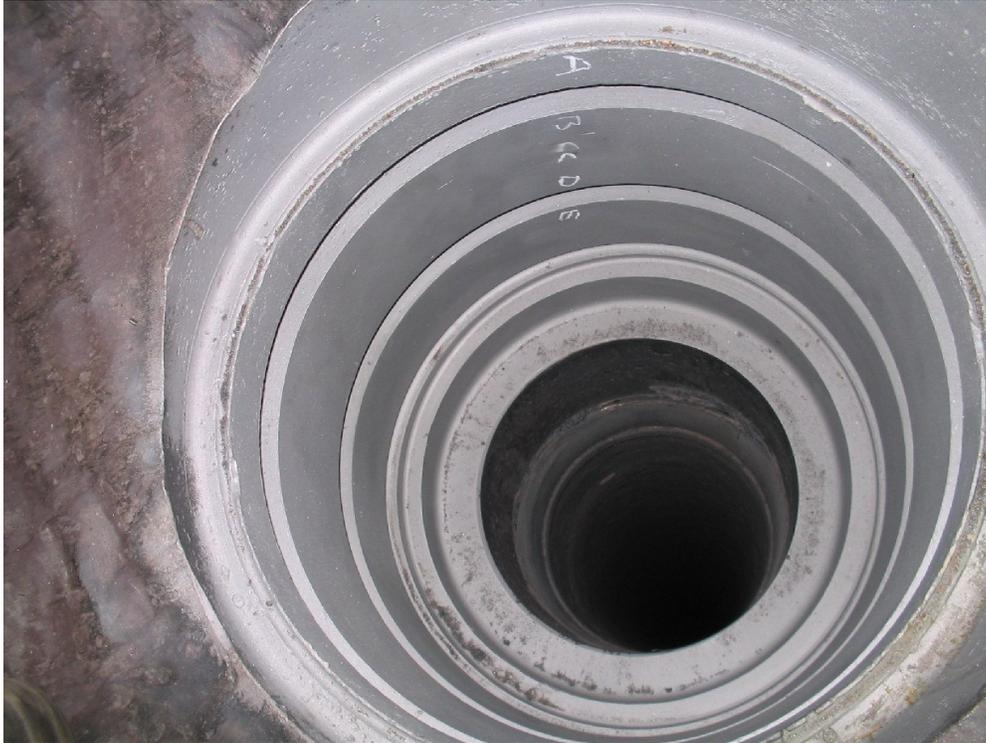
The lower left inlet in the outer shell was found damaged from the first ring fretting down into the face. The face was remachined by I&RS about 1/2" deeper than drawing and a special thicker first inner ring was installed.

Lower Inlet Face Fretting

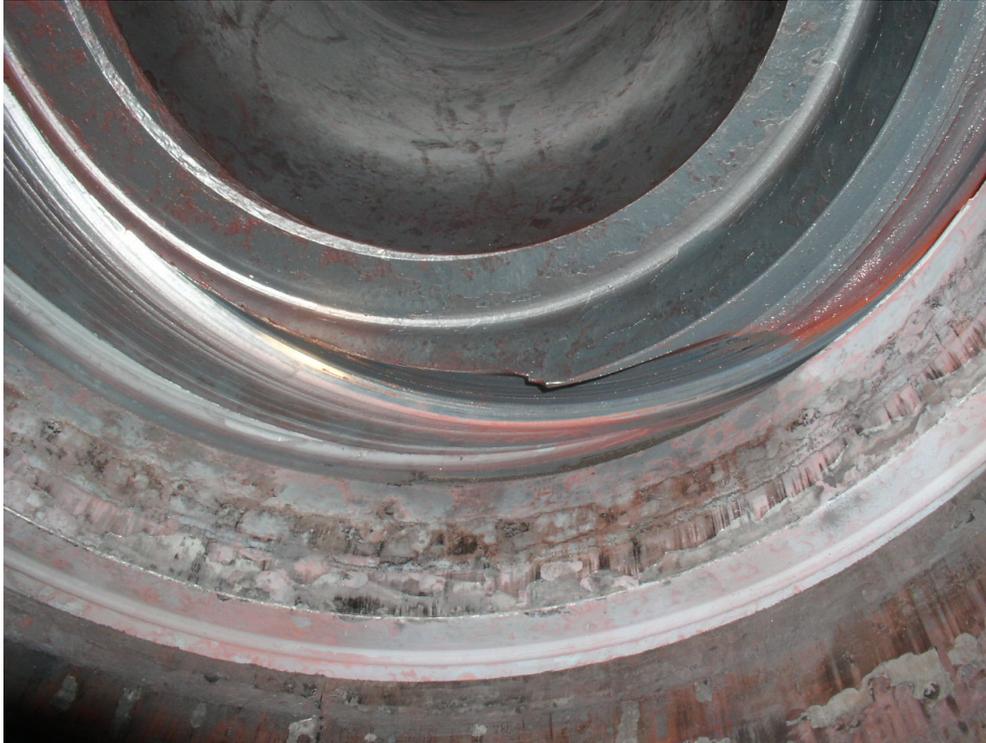
The upper left inlet bore in the outer shell was found badly fretted from the first upper ring. These rings had been installed incorrectly, with the outer fit ring first. This ring was apparently too loose, and fretted into the bore and up into the face. The bore was weld repaired using GE's "Torch Temper" process and machined by I&RS.

Upper Inlet Bore Damage

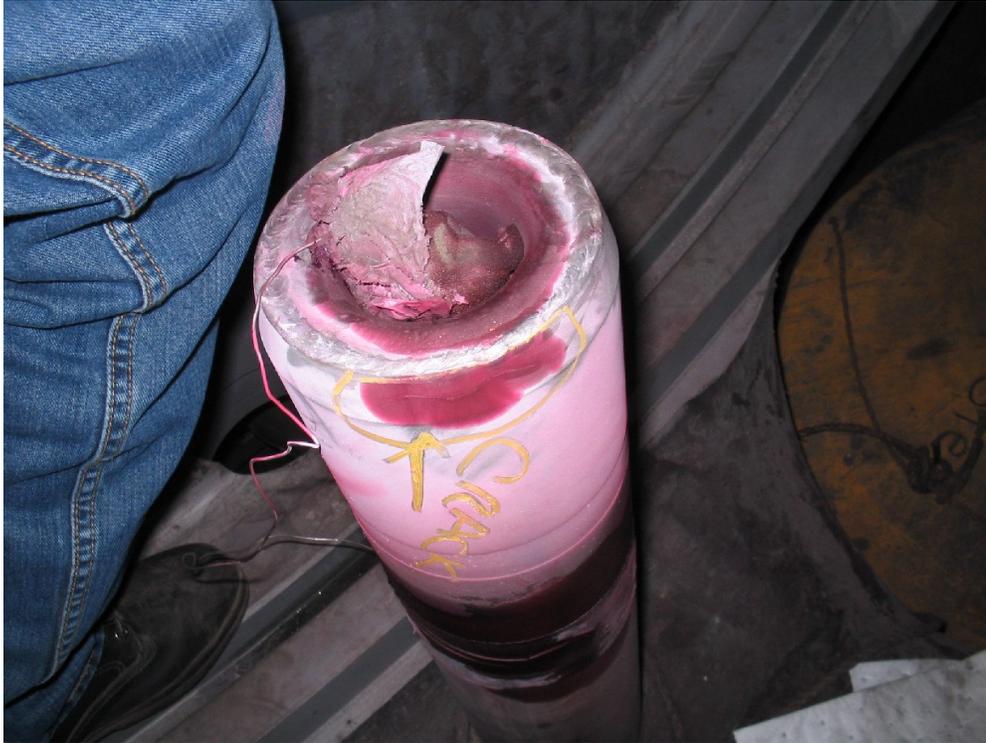
The reheat extraction pipe in the lower outer shell was found cracked in the stellite at the taper on the end. The crack was ground out and blended.

Stellite Crack Before Grinding

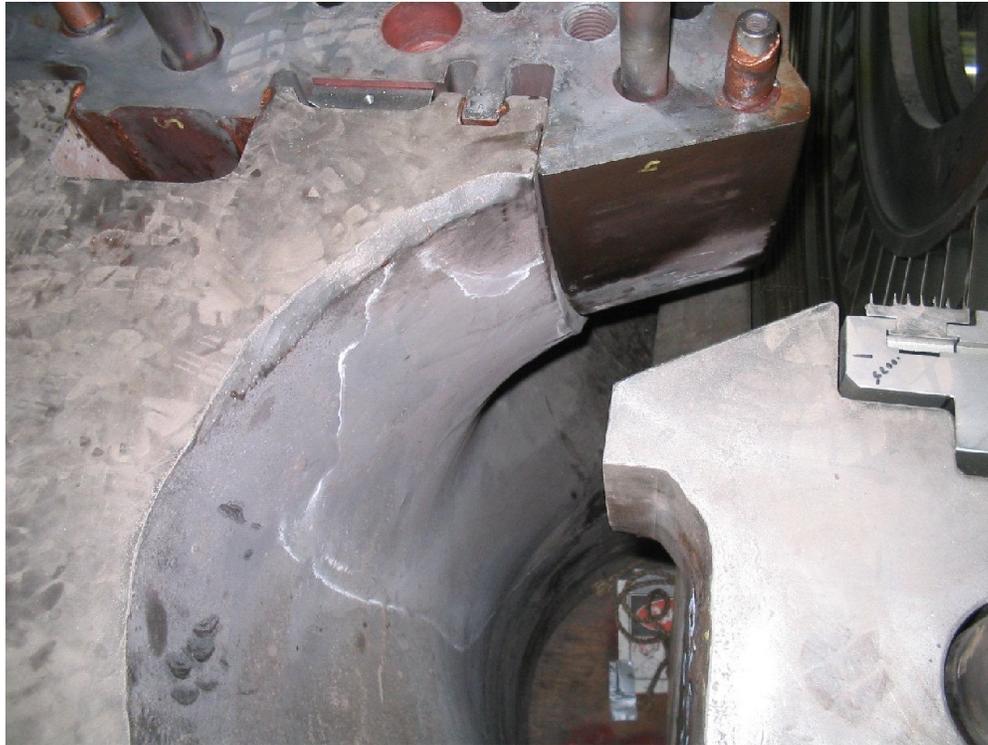
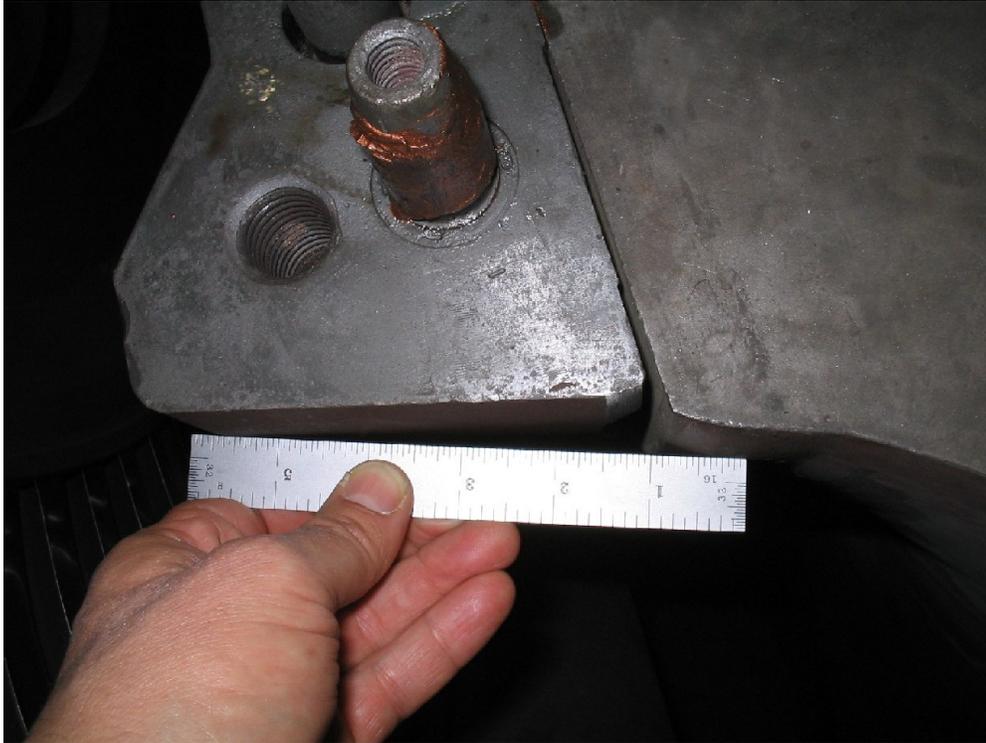
Flow steps in the shell casting were found at the interface to the N1 and N3 packing heads. These were ground and blended to allow uninterrupted steam flow for performance improvement.

N1 Before Grinding

N3 Before Grinding

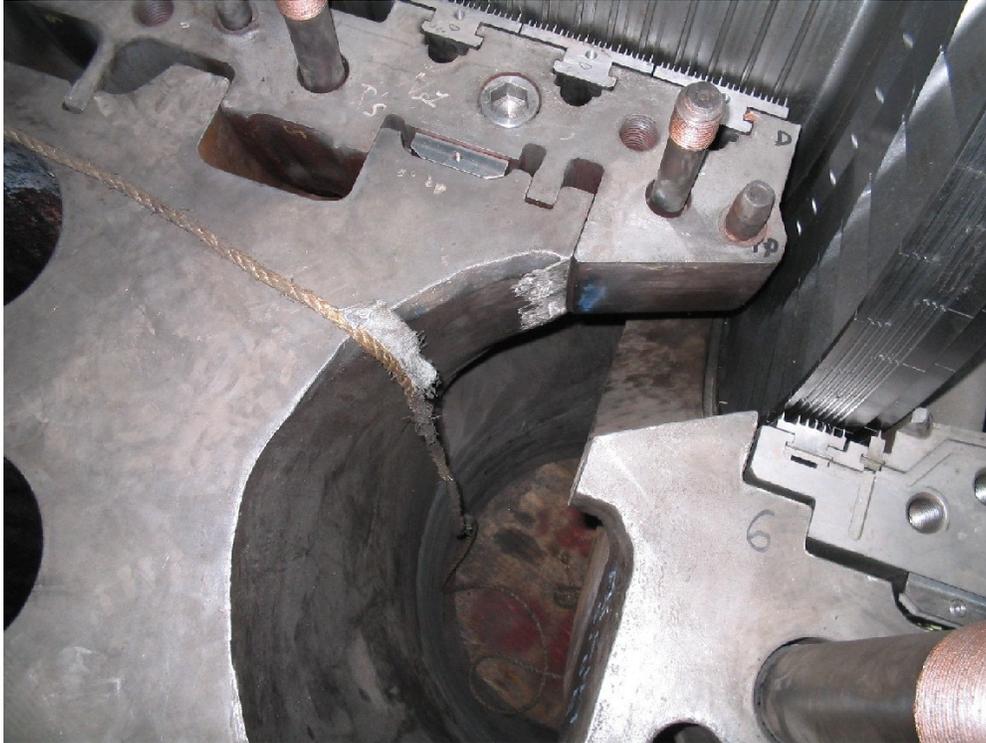
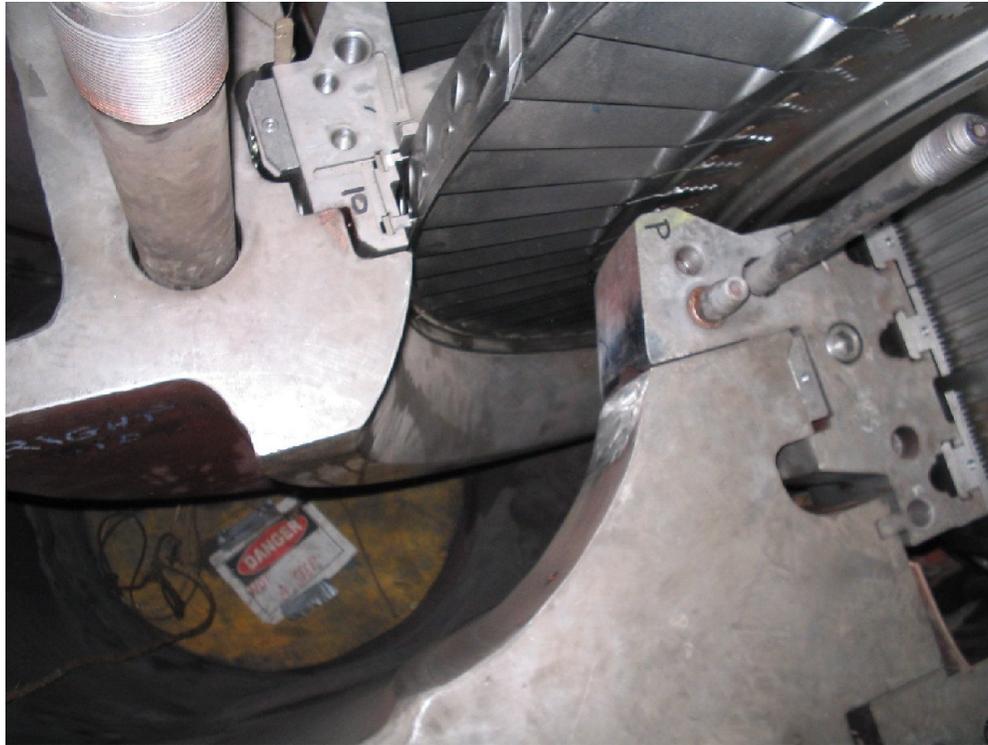
N1 After Grinding

N3 After Grinding

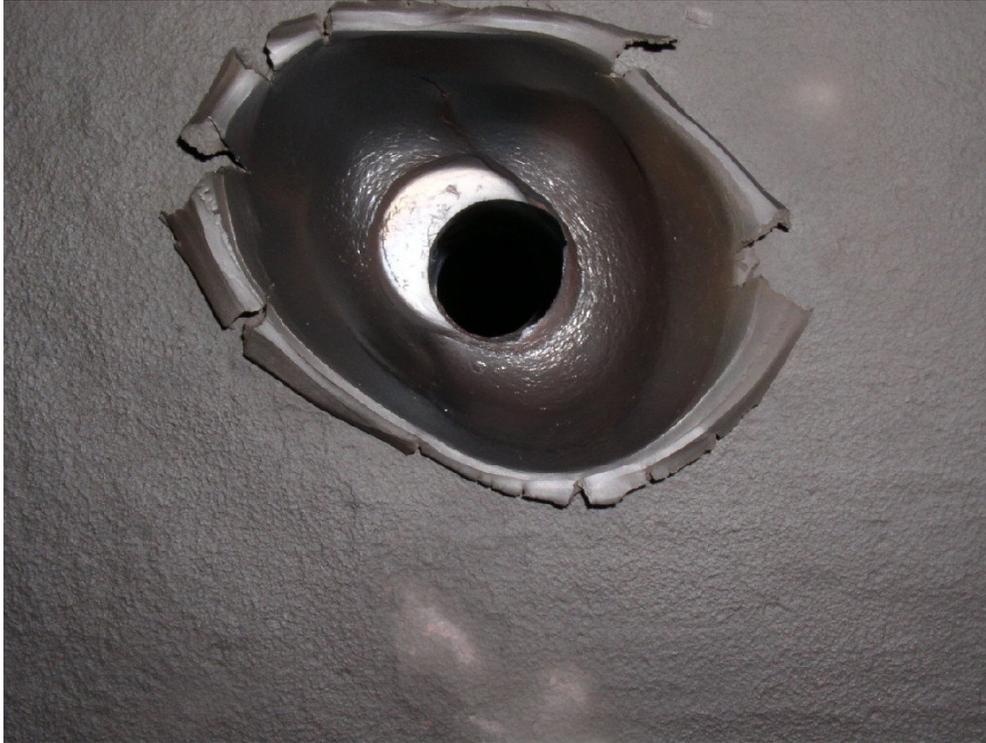
The right side 3rd stage pressure tap hole in the lower inner shell was found badly pounded out. The pressure tap was missing. The hole was repair welded by I&RS and a new hole was machined.

Damaged PT hole

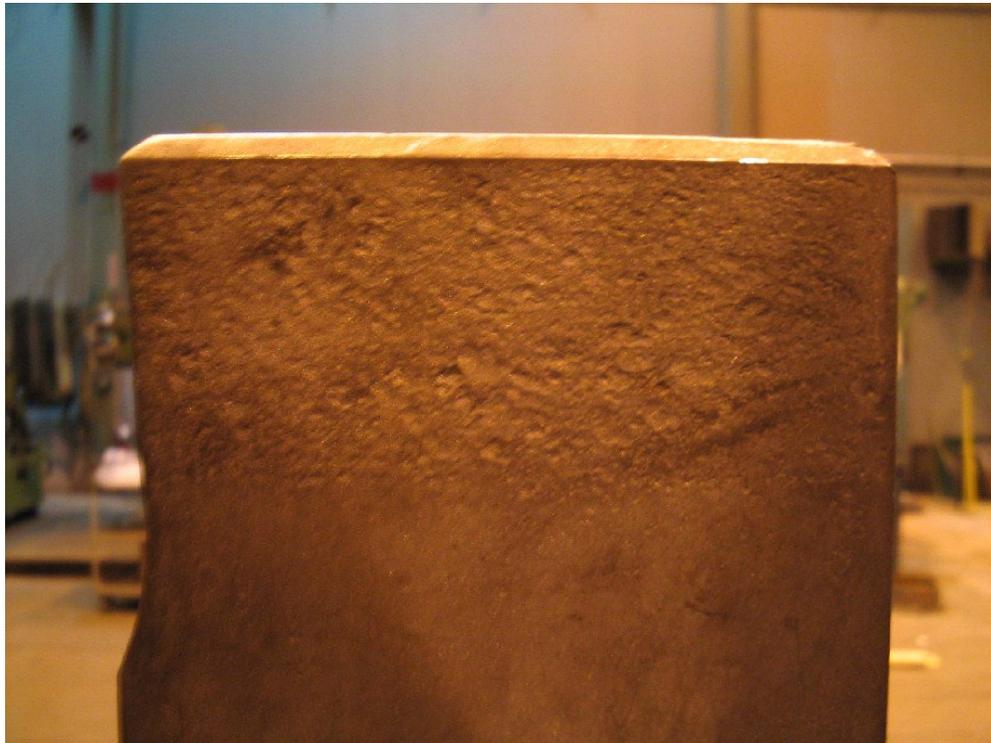
The upper inner shell center gib posts were found badly pitted from apparent corrosion. These surfaces were remachined at CMS. The lower shell posts were pitted to a lesser degree, and were hand dressed by I&RS.

Shell Gib Surface Pitting

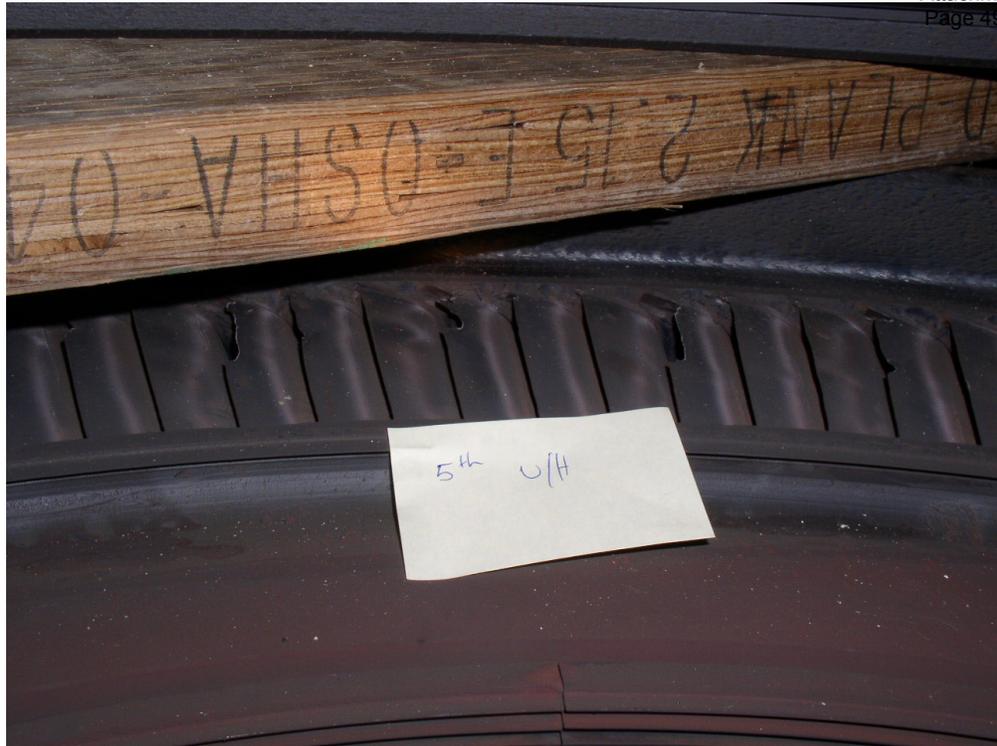
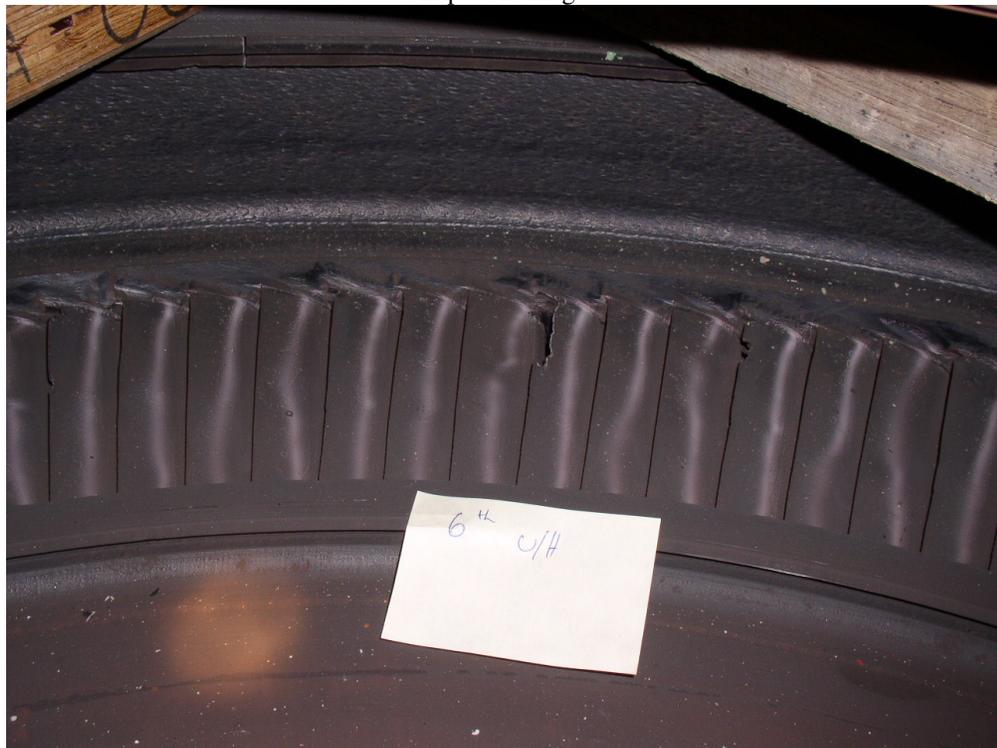
The 5th and 6th stage diaphragm partitions had severe impact damage. See attached photos.

Impact Damage

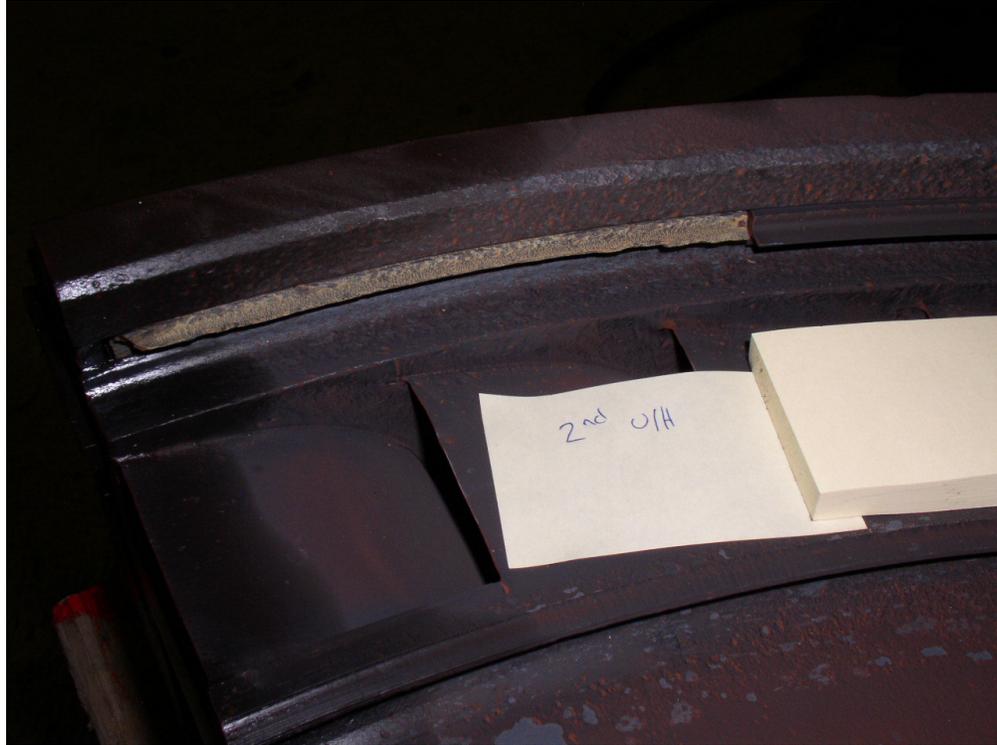
A badly deteriorated spill strip segment was found in the second stage diaphragm, probably incorrect material. See attached photo.

Deteriorated 2nd Stage Spill Strip

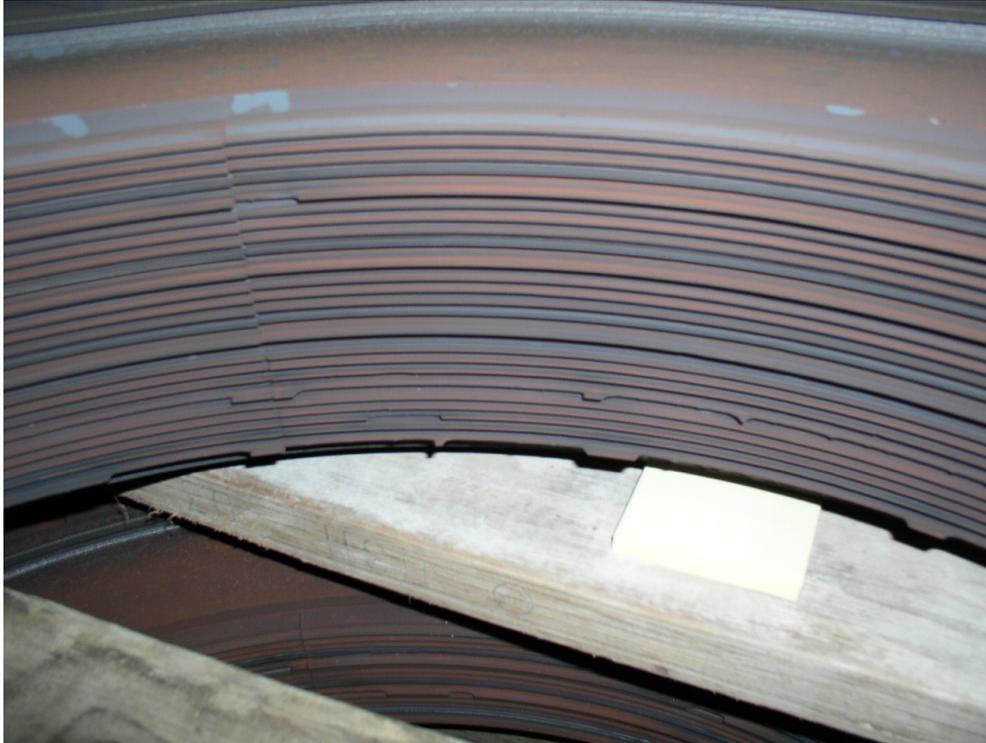
HP packing as found was in poor condition, with chipped teeth in the 2nd and 3rd stages. See attached photo.

As Found Packing Damage - 2nd Stage

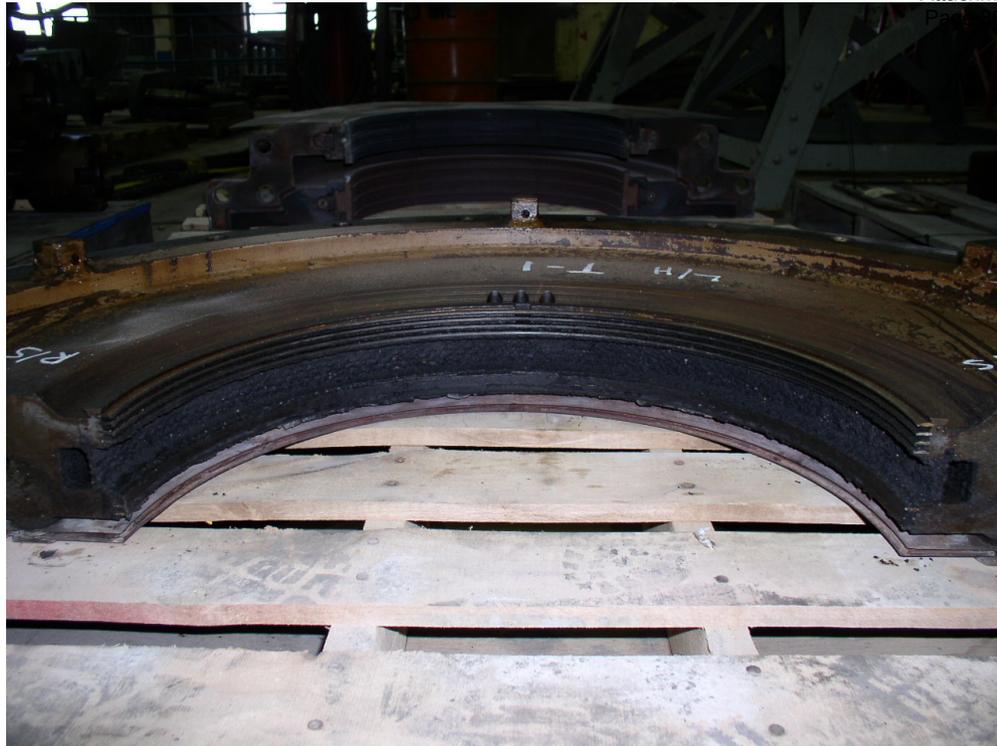
The T1 and T2 oil deflectors were found rubbed and packed with coal dust. Both were retooled by AEP and aligned at assembly.

T1 Oil Deflector Coal Dust Contamination
